Kerr Lake Vegetation Survey

October – November 2012

Report submitted by NC State University

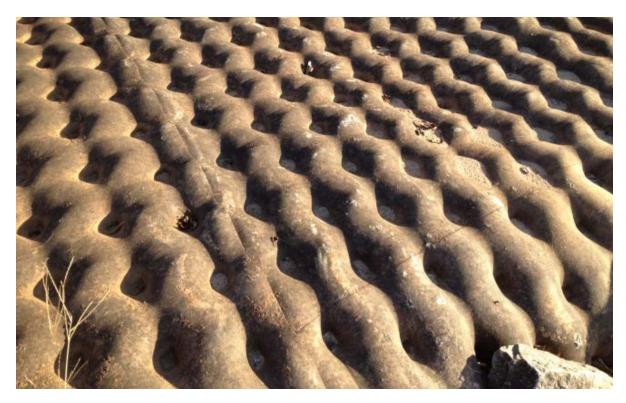
Hydrilla was observed growing in the area of several boat ramps growing on the concrete "mattress" paved areas.

Concrete Mattress Structure Exposed

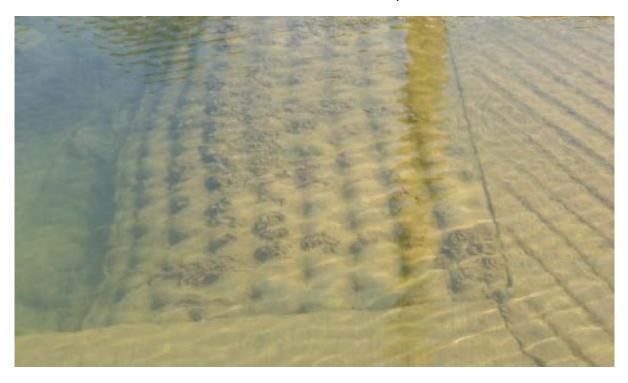
Hydrilla Growing on Mattress

Public funds (unknown sources) should be used to treat in areas around public facilities including swimming areas and boat ramps. Repeat applications may be needed and applicators should be required to follow-up in order to reduce tuber formation.
