Kerr Lake Vegetation Survey

October – November 2011

Report submitted by NC State University

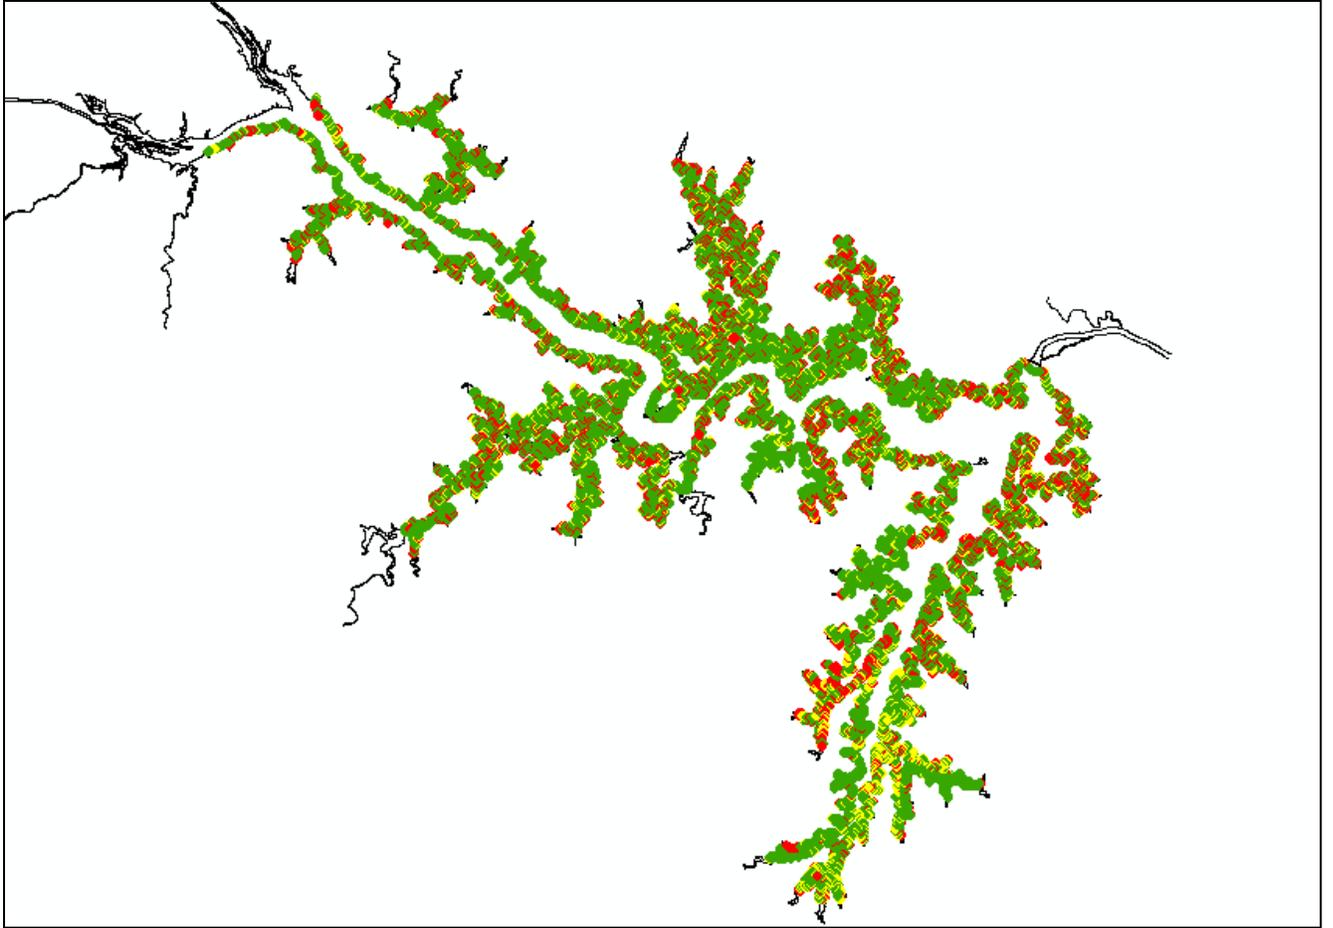
Total Area Surveyed With Relative Plant Density Mapped

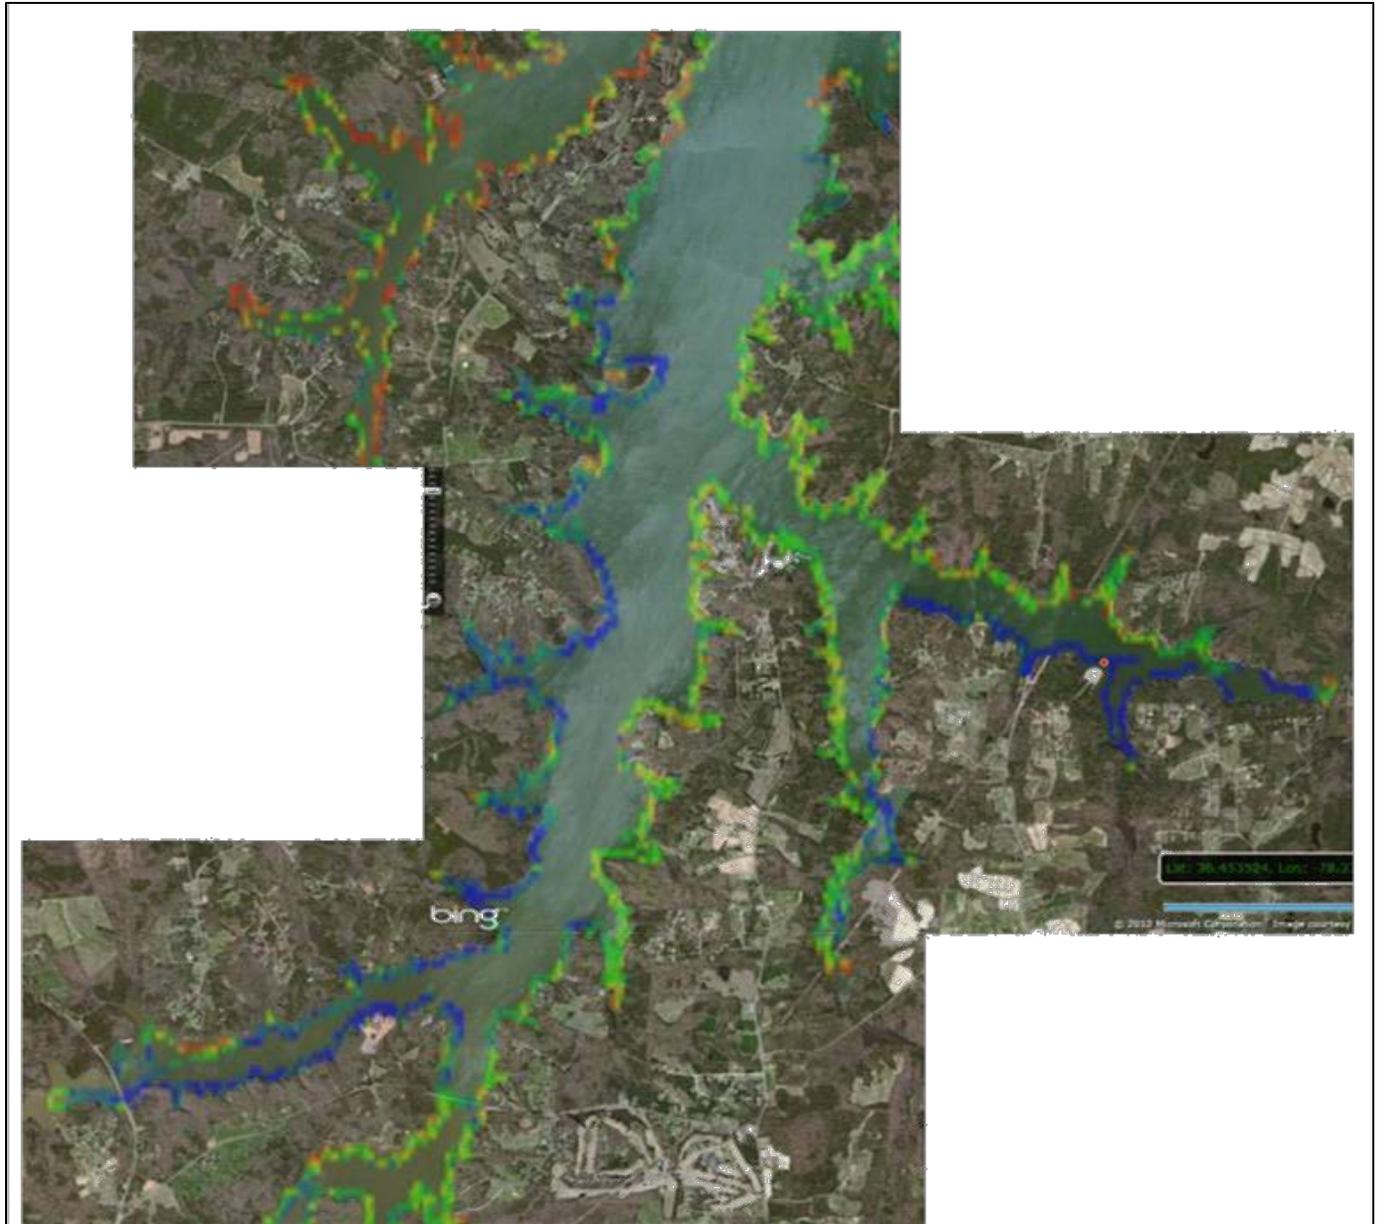
Nutbush and Little Nutbush Creeks

Contour Innovations map of plant density

Red high density, Blue low density

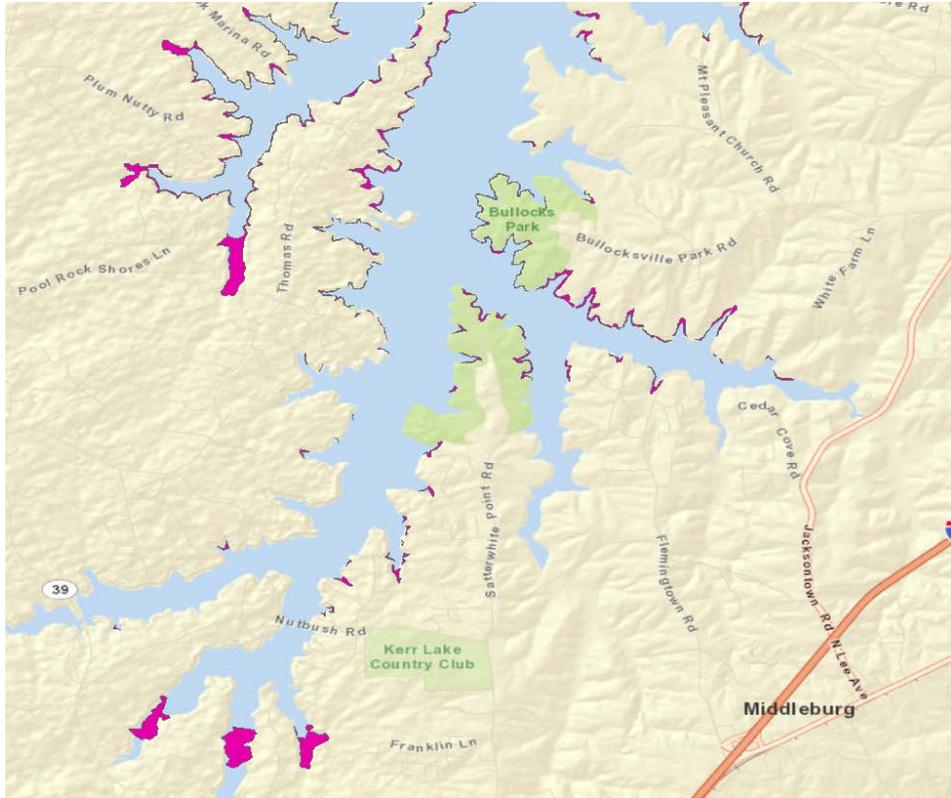
1. Little Nutbush Creek had the largest continuous areas of shoreline containing Hydrilla; the back of numerous coves had extensive populations.
2. Nutbush Creek has several large populations of Hydrilla, but also large areas with Chara/Nitella and Naiads (esp. *Najas minor*).
3. North Bend Park the site of the original infestations has several small populations in the same general areas as 1993.
4. Clarksville Va. areas include Staunton View ramp area, Occoneechee State Park ramp area, Clarksville Marina, dock at convenience store, and scattered locations mainly along the south shore, west of Clarksville bridges

Nutbush Creek Mapped Hydrilla Locations

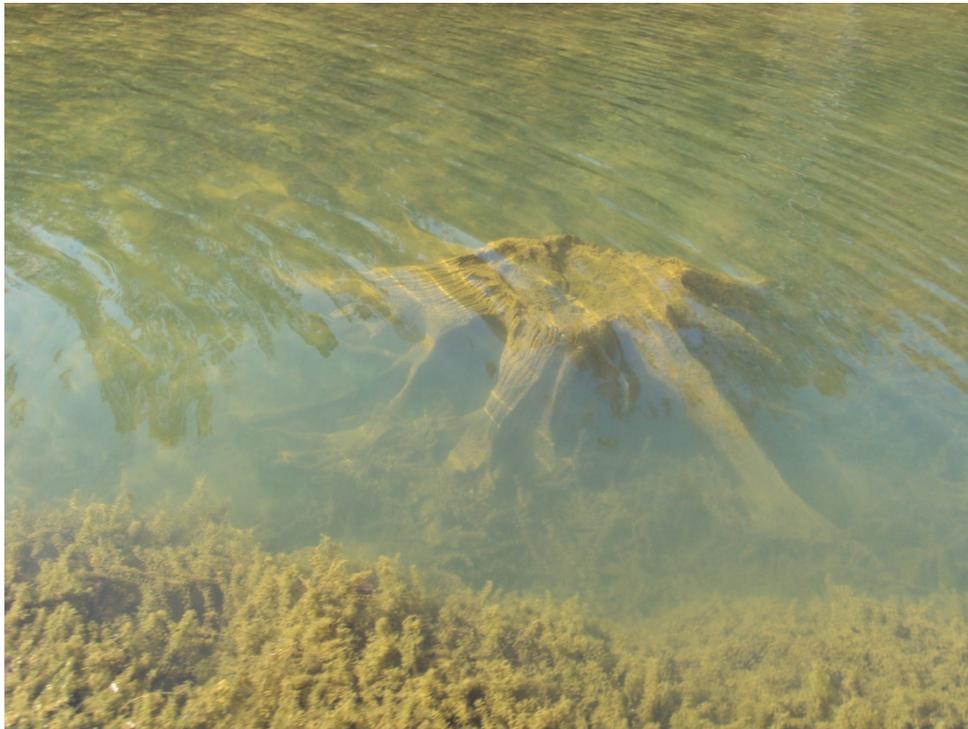
Hydrilla

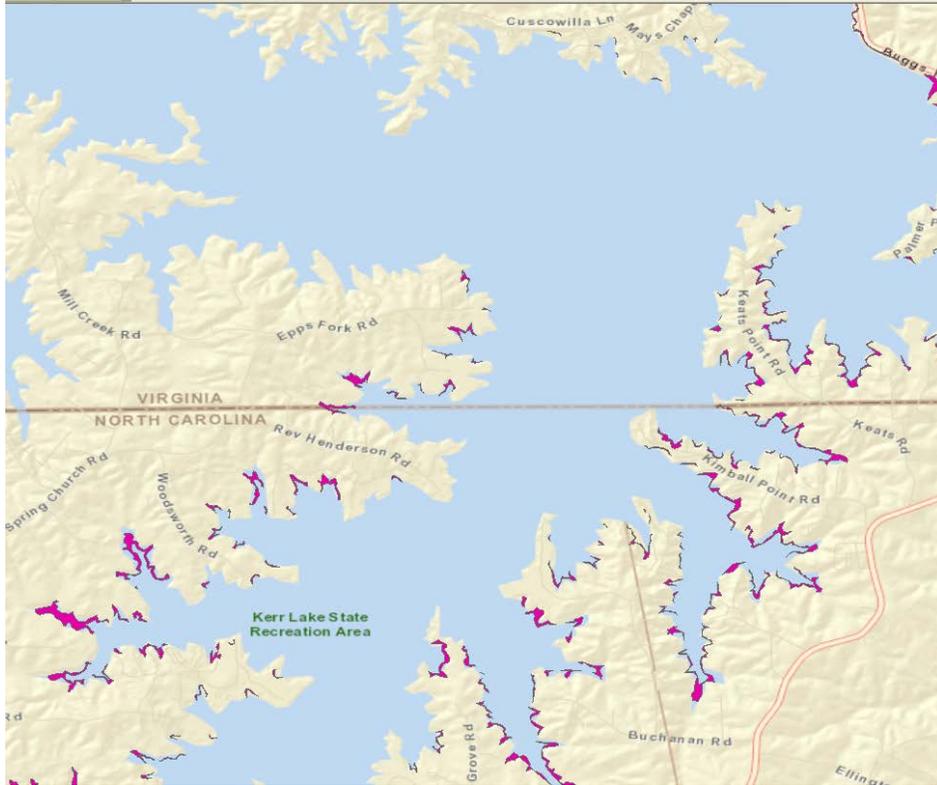
North Section of Nutbush Creek Mapped Hydrilla Locations

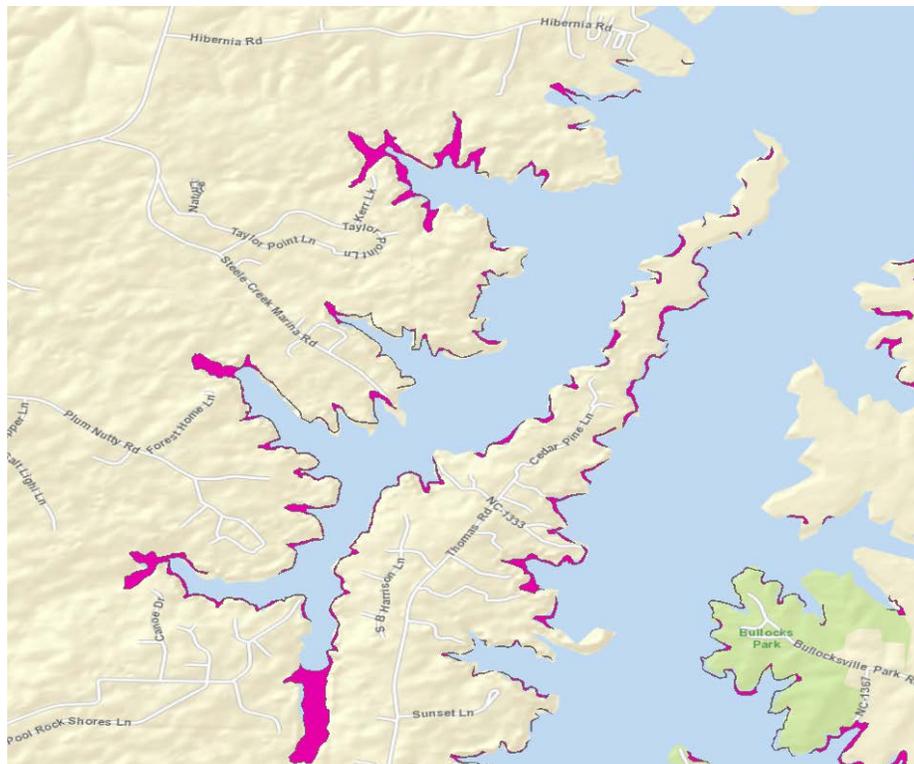
Little Nutbush Creek Mapped Hydrilla Locations

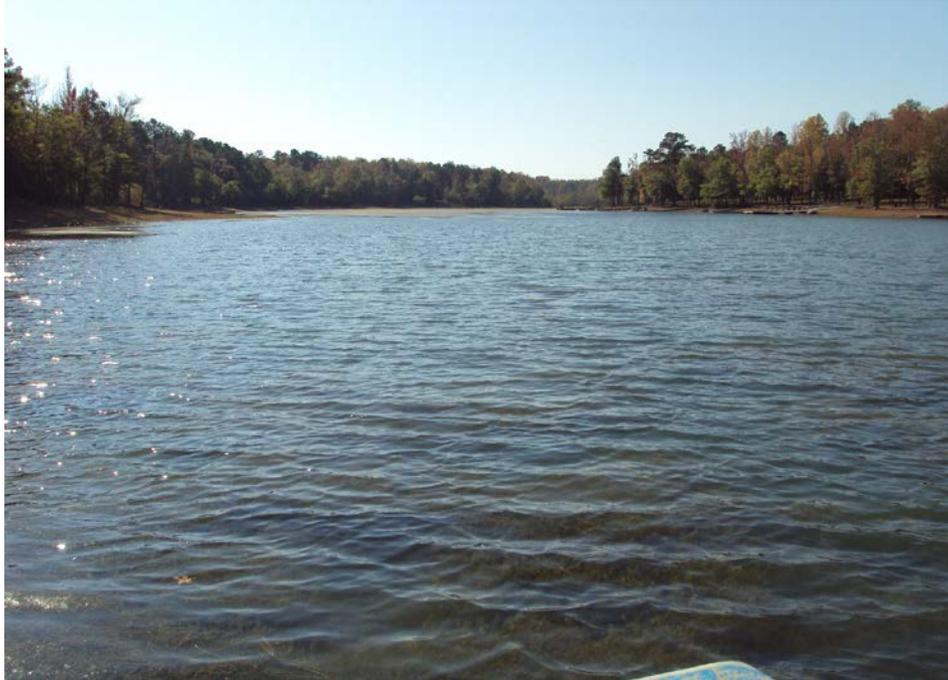
Large Hydrilla site, from boat location to back of Little Nutbush Creek

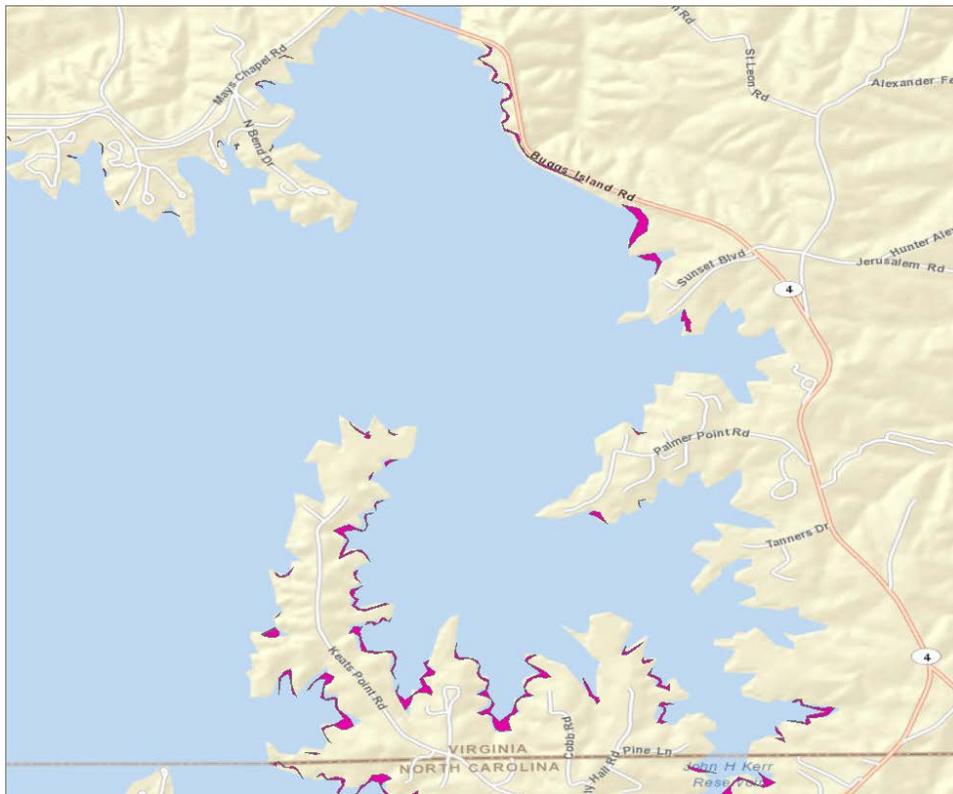
North Bend Park Mapped Hydrilla Locations

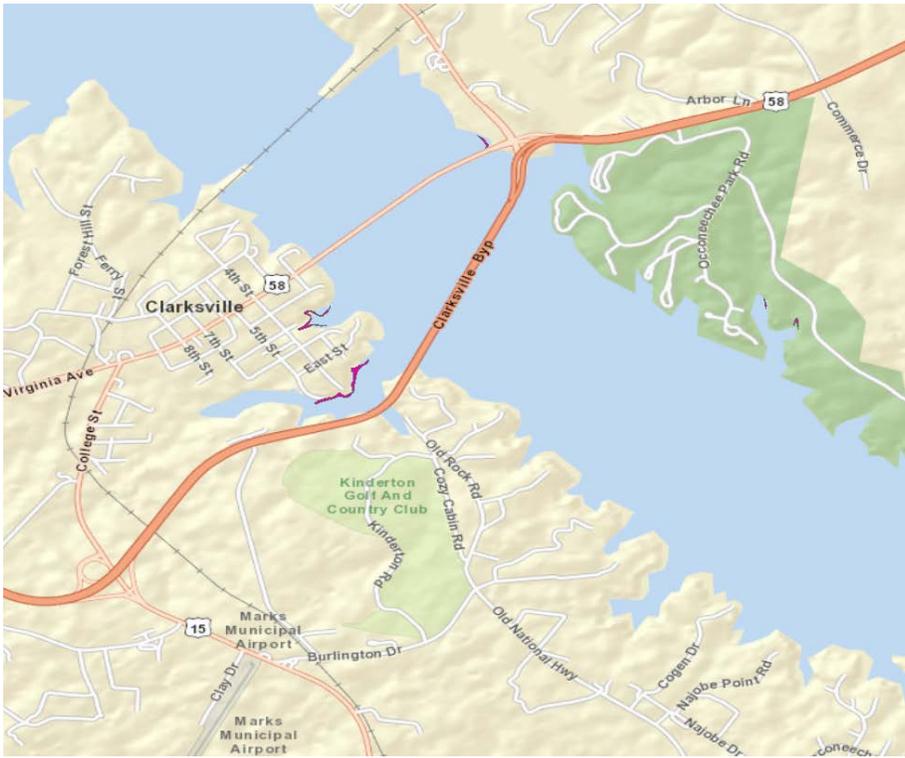
Clarksville Marina and State Park Mapped Hydrilla Locations

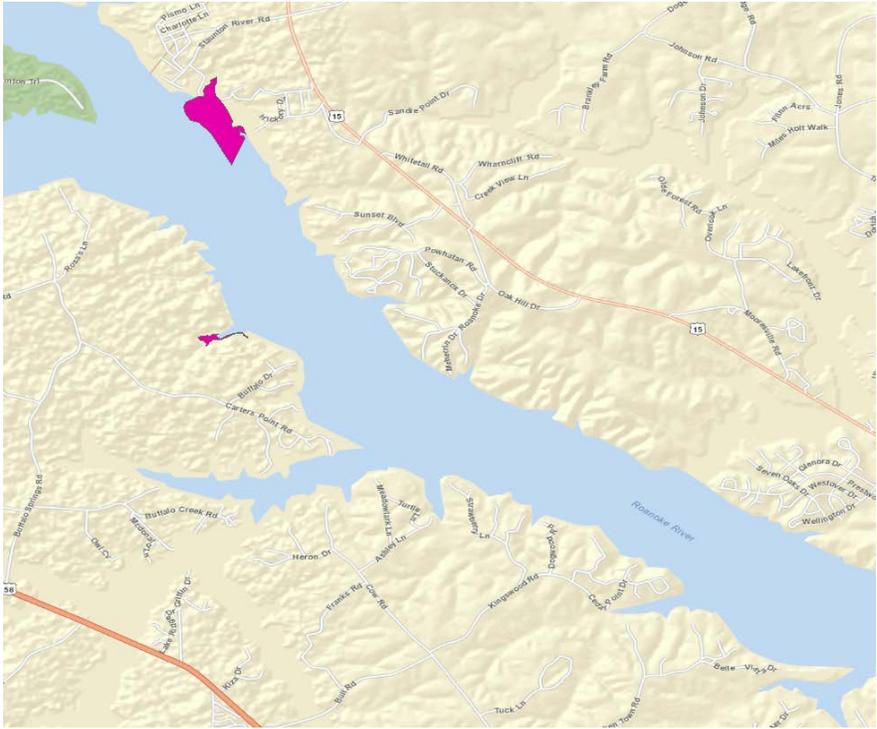
Areas West of Clarksville Mapped Hydrilla Locations

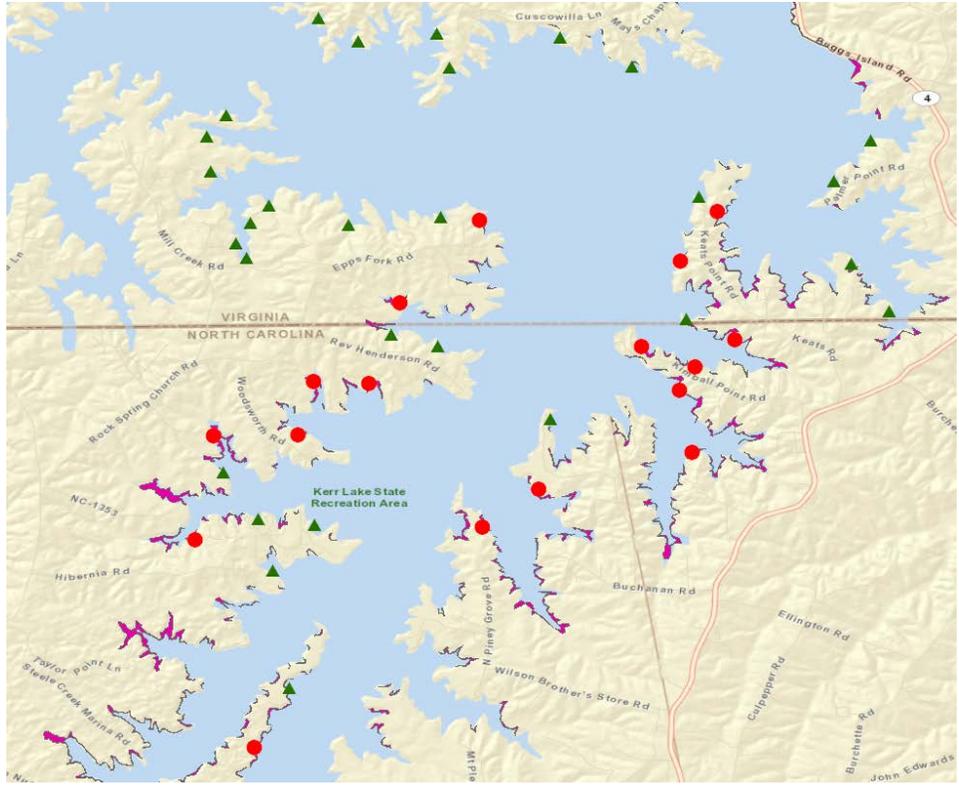
Point Survey Locations
Green – No Hydrilla
Red - Hydrilla
