RE: FINAL PROSPECTUS FOR CAPE FEAR 02 UMBRELLA STREAM MITIGATION BANK

CAPE FEAR 02 UMBRELLA MITIGATION BANK FINAL PROSPECTUS

OCTOBER 2014

Axiom Environmental Inc and RiverBank Consultants LLC

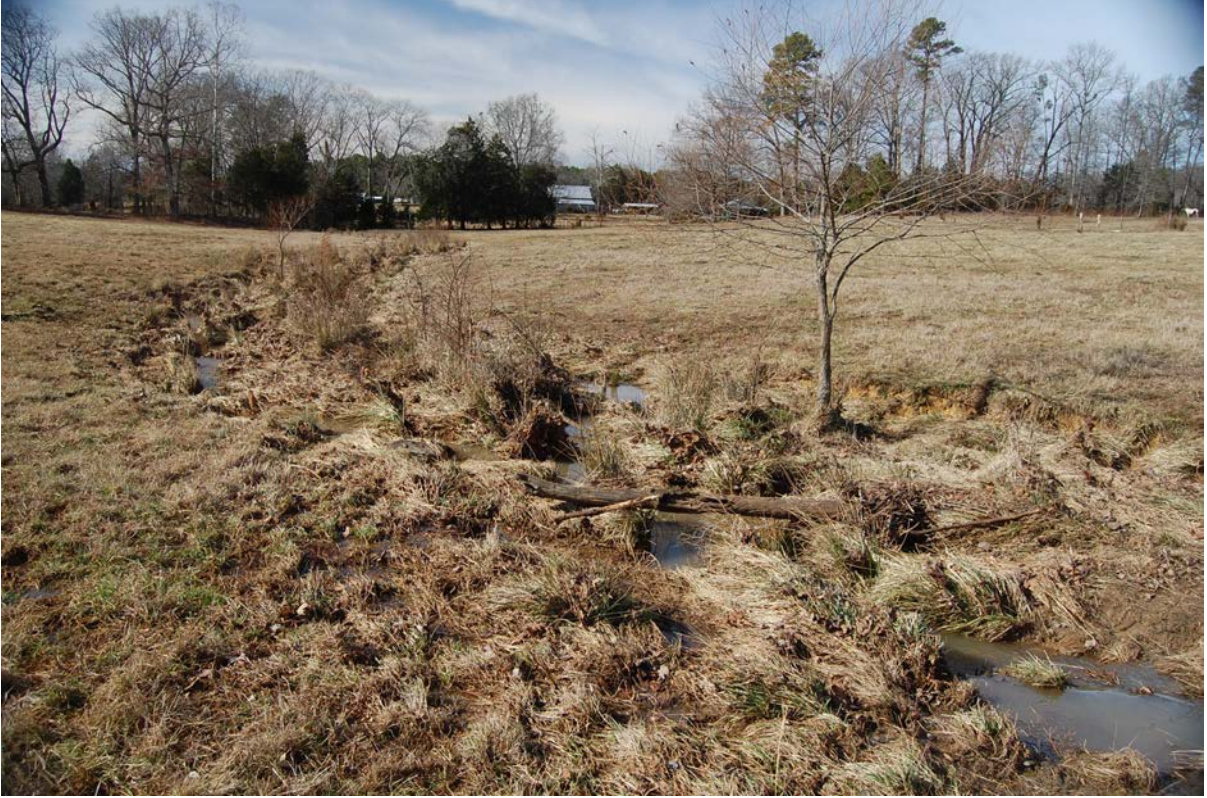
Photo 1: Motes Creek

Photo 1: Upper reaches of Motes Creek facing downstream at livestock trampled channel.

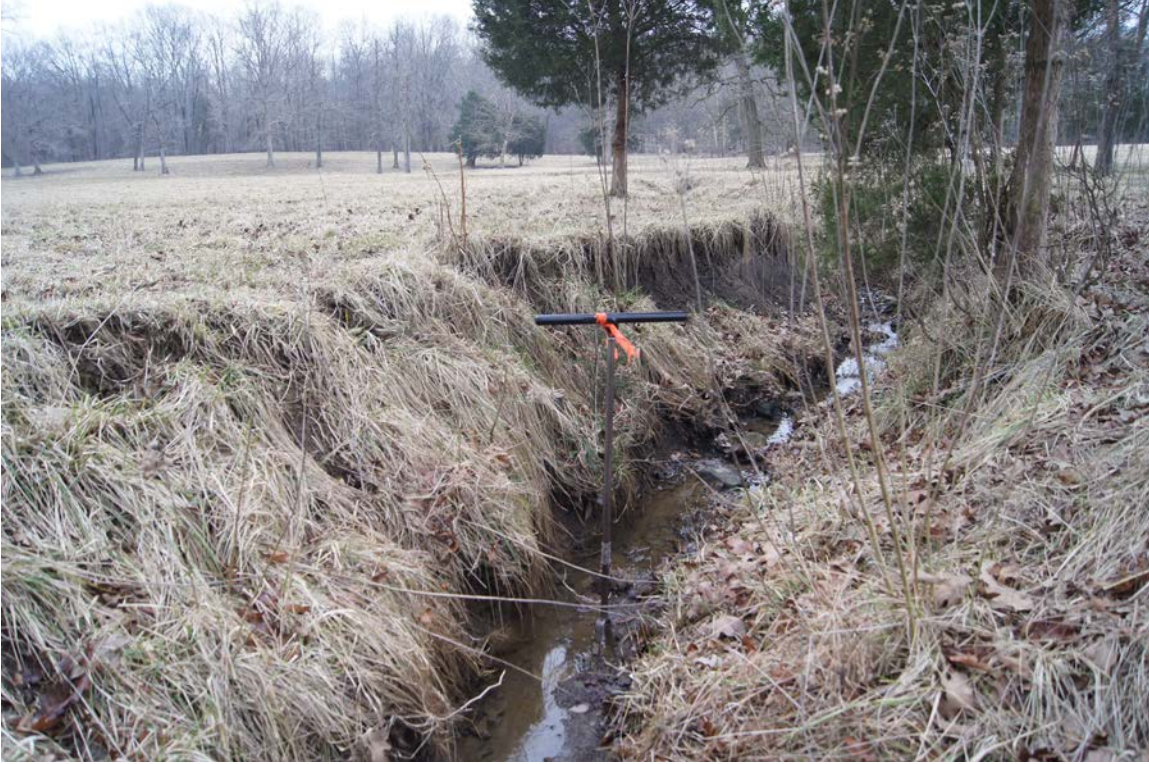
Photo 2: Benton Branch

Photo 2: Incised UT 3, looking upstream

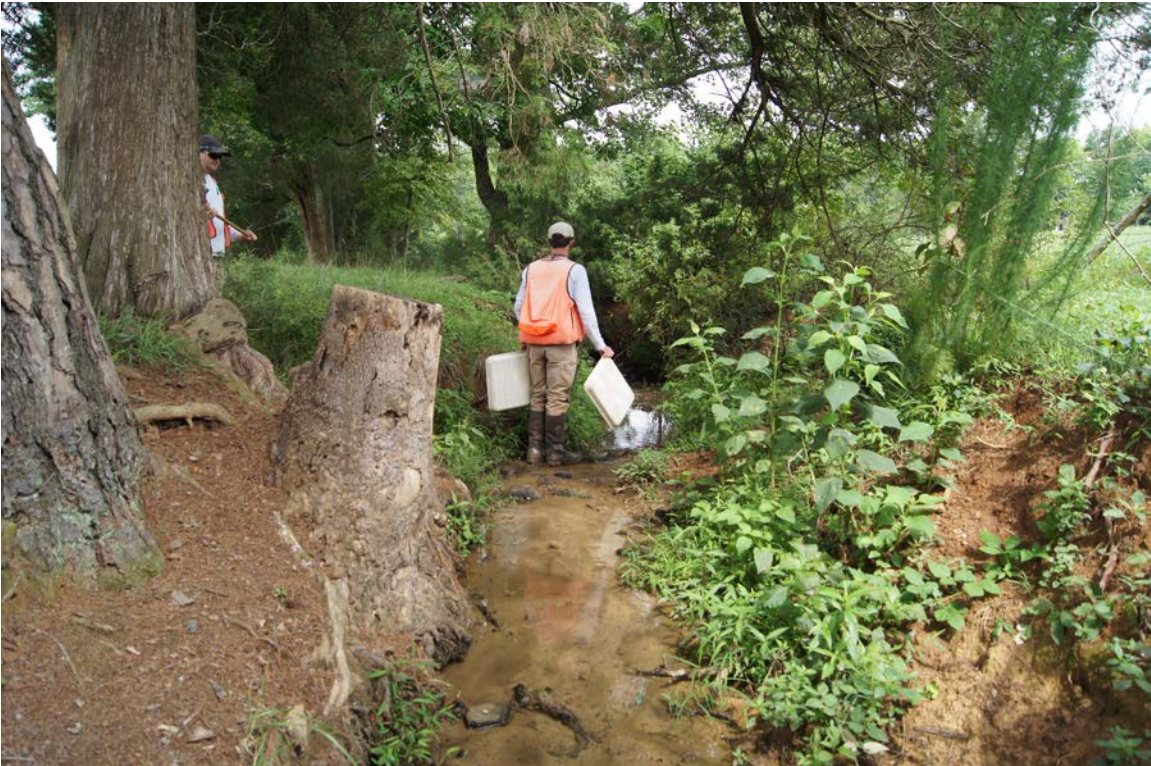
Photo 3: Orphan Creek

Photo 3: View of incised channel below confluence of UT 1A and UT 1B

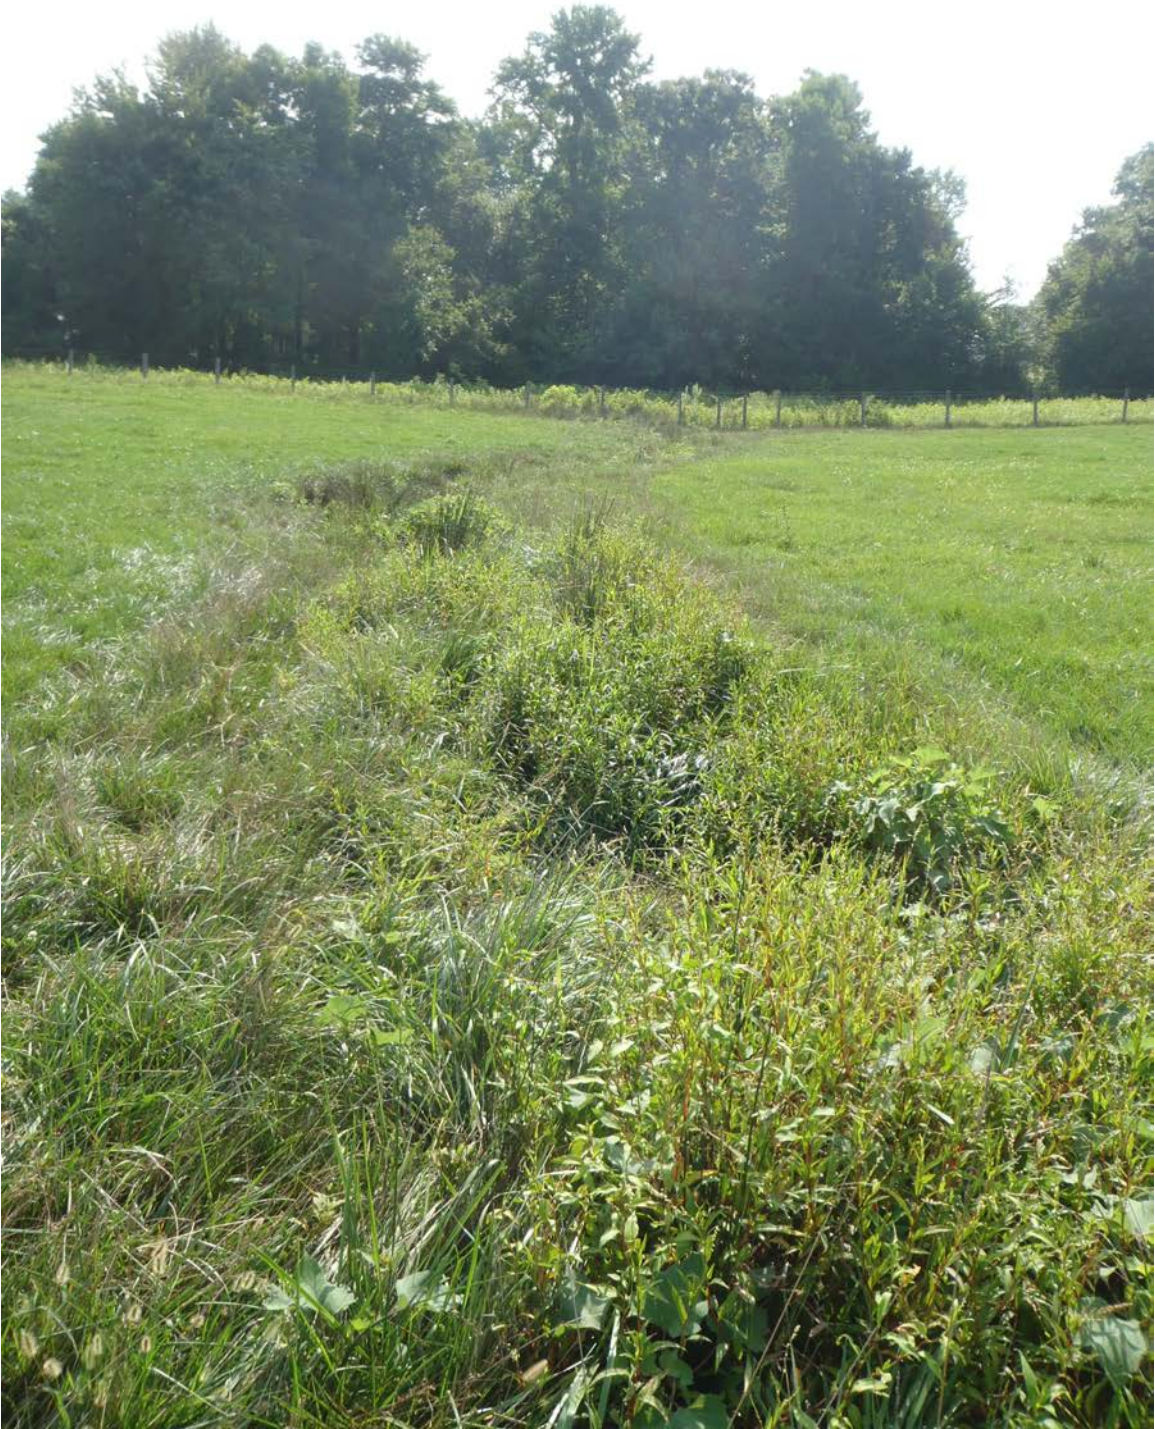
Photo 4: Chico Branch

Photo 4: UT 2, looking upstream at headwater wetlands

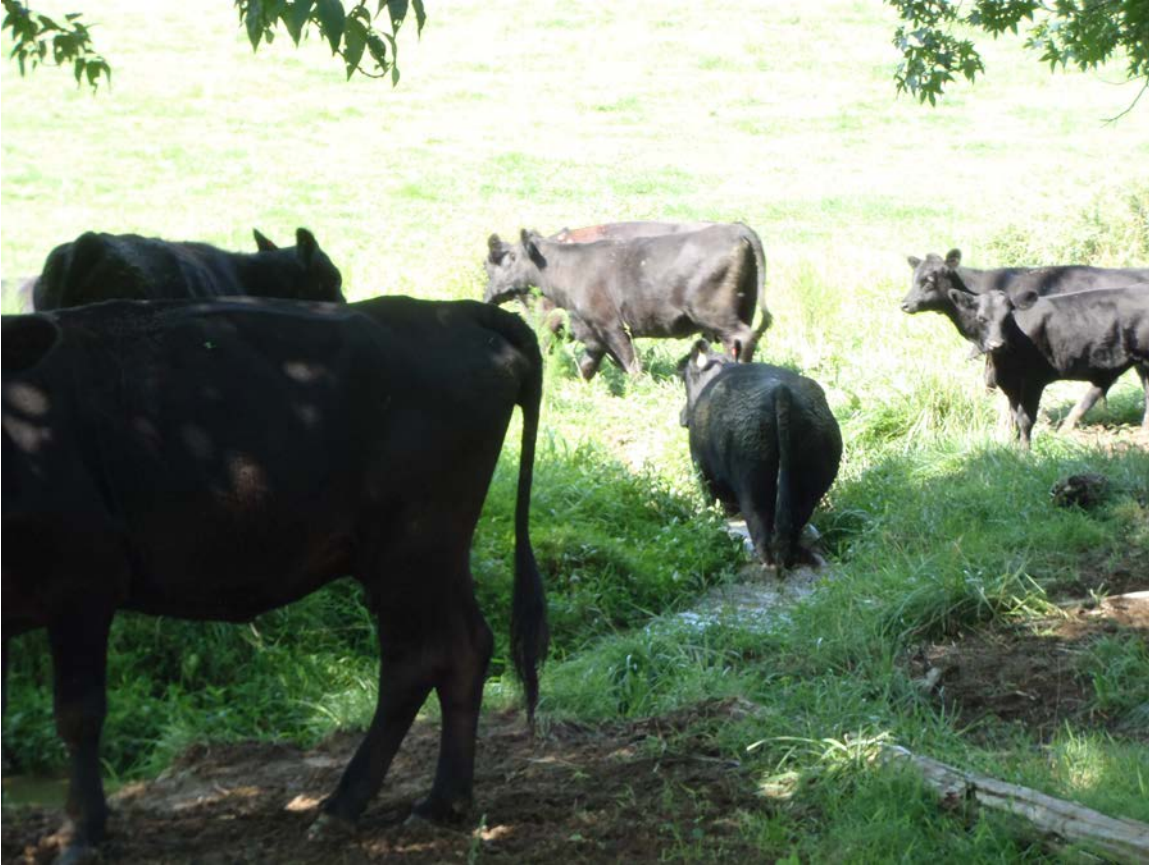
Photo 5: Major Hill

Photo 5: Cattle have full access to Major Hill's channels.

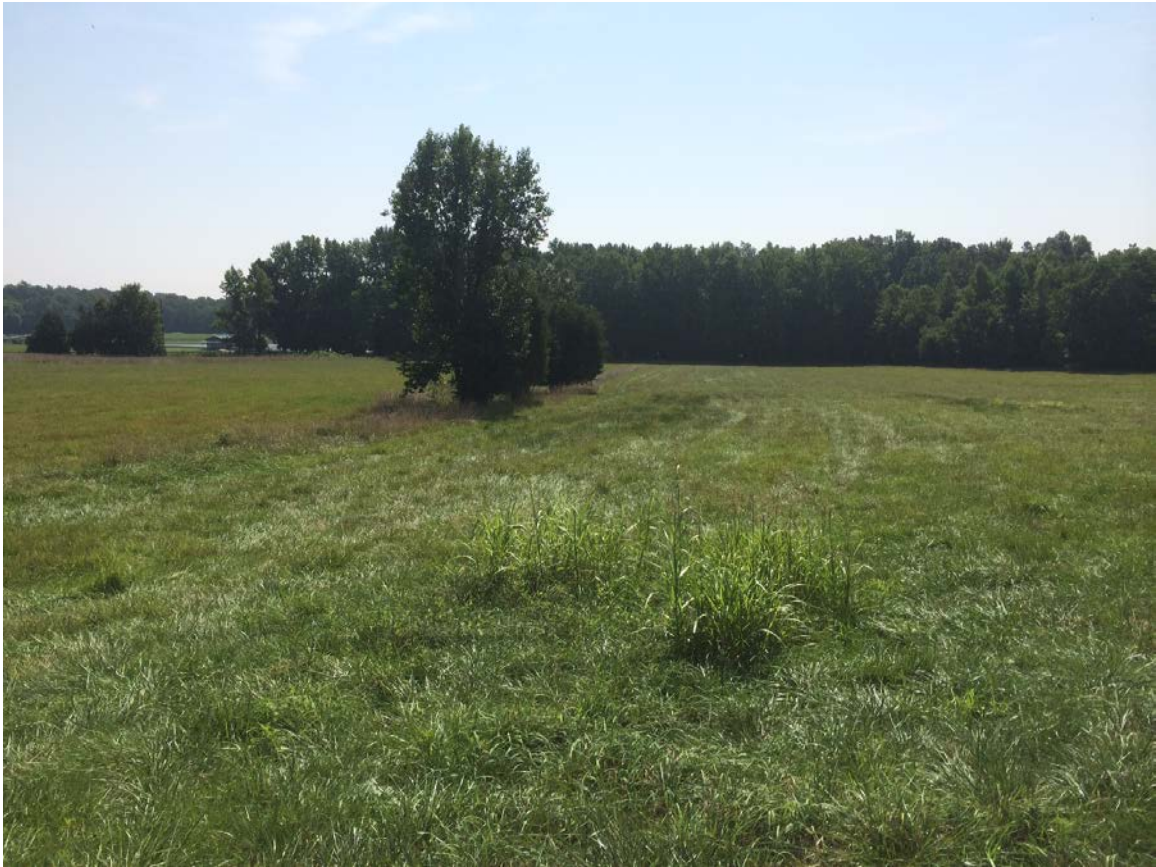
Photo 6: Maple Hill Farm

Photo 6: UT 1, abandoned floodplain with relict channel depression

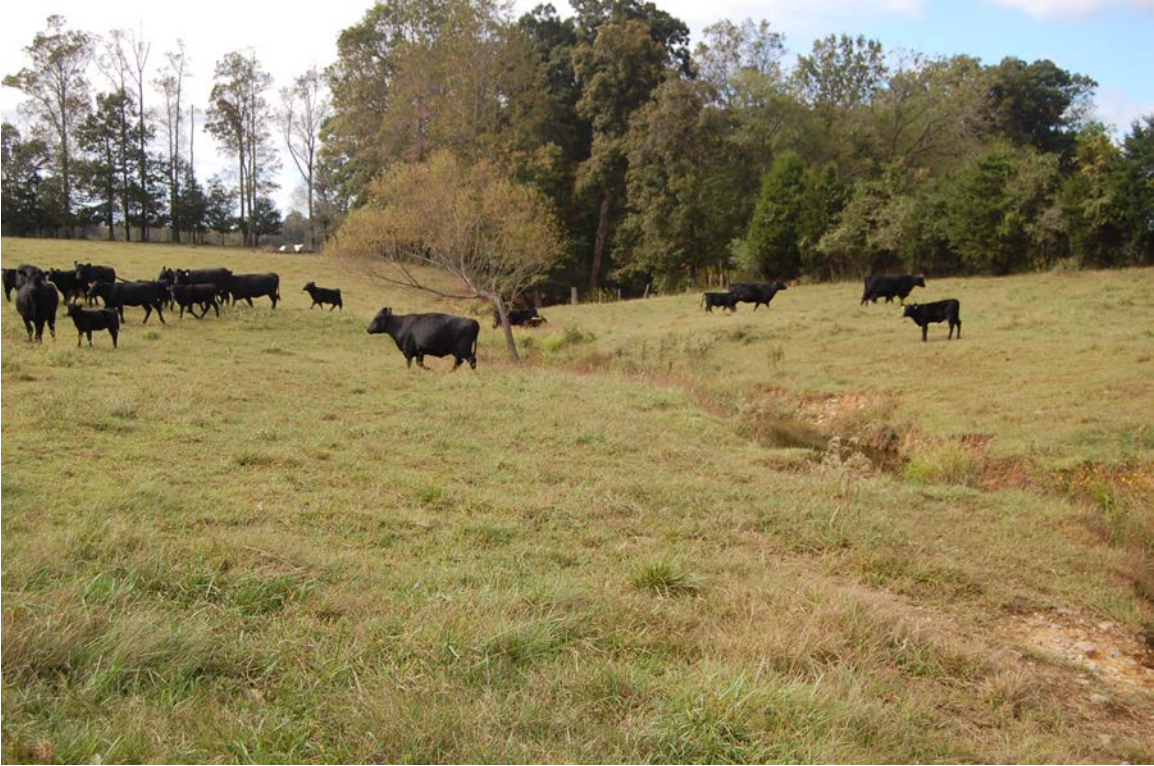
Photo 7: Rocky Top restoration reach, looking downstream

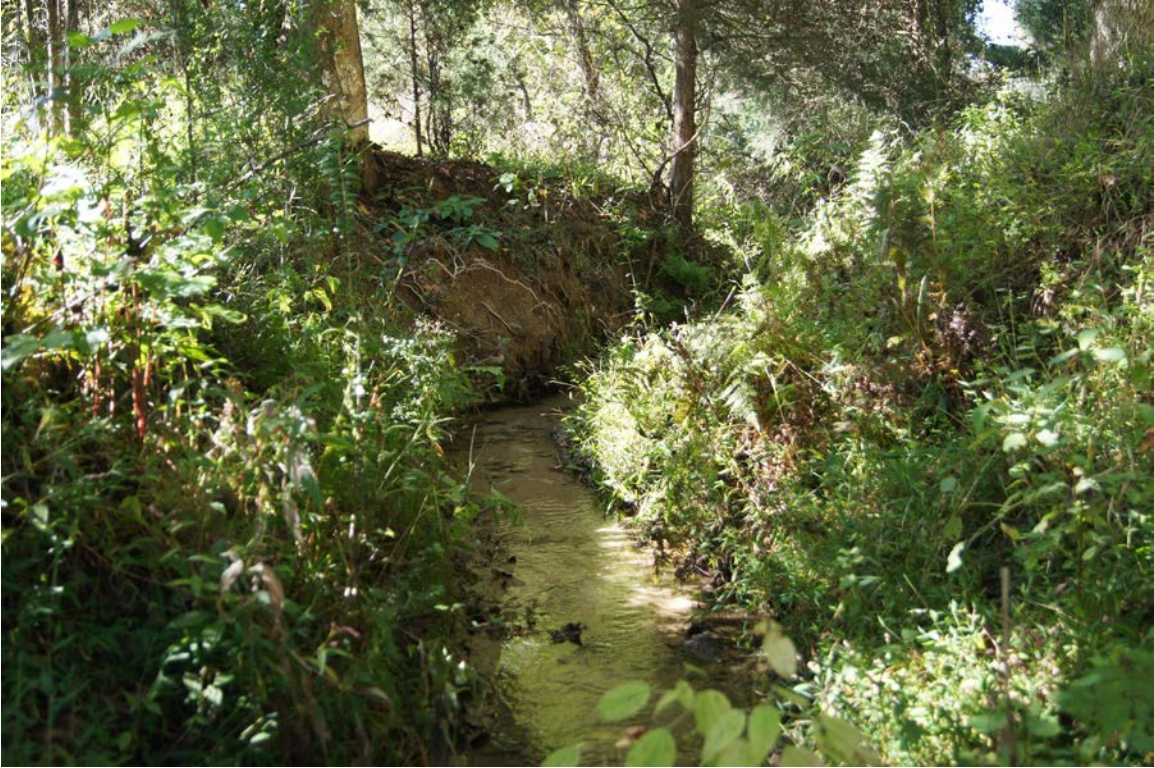
Photo 8: Slingshot Creek

Photo 8: Channel incision in upper reaches of Slingshot Creek
