Kerr Lake Vegetation Survey

February 8, 2017

Report submitted by NC State University

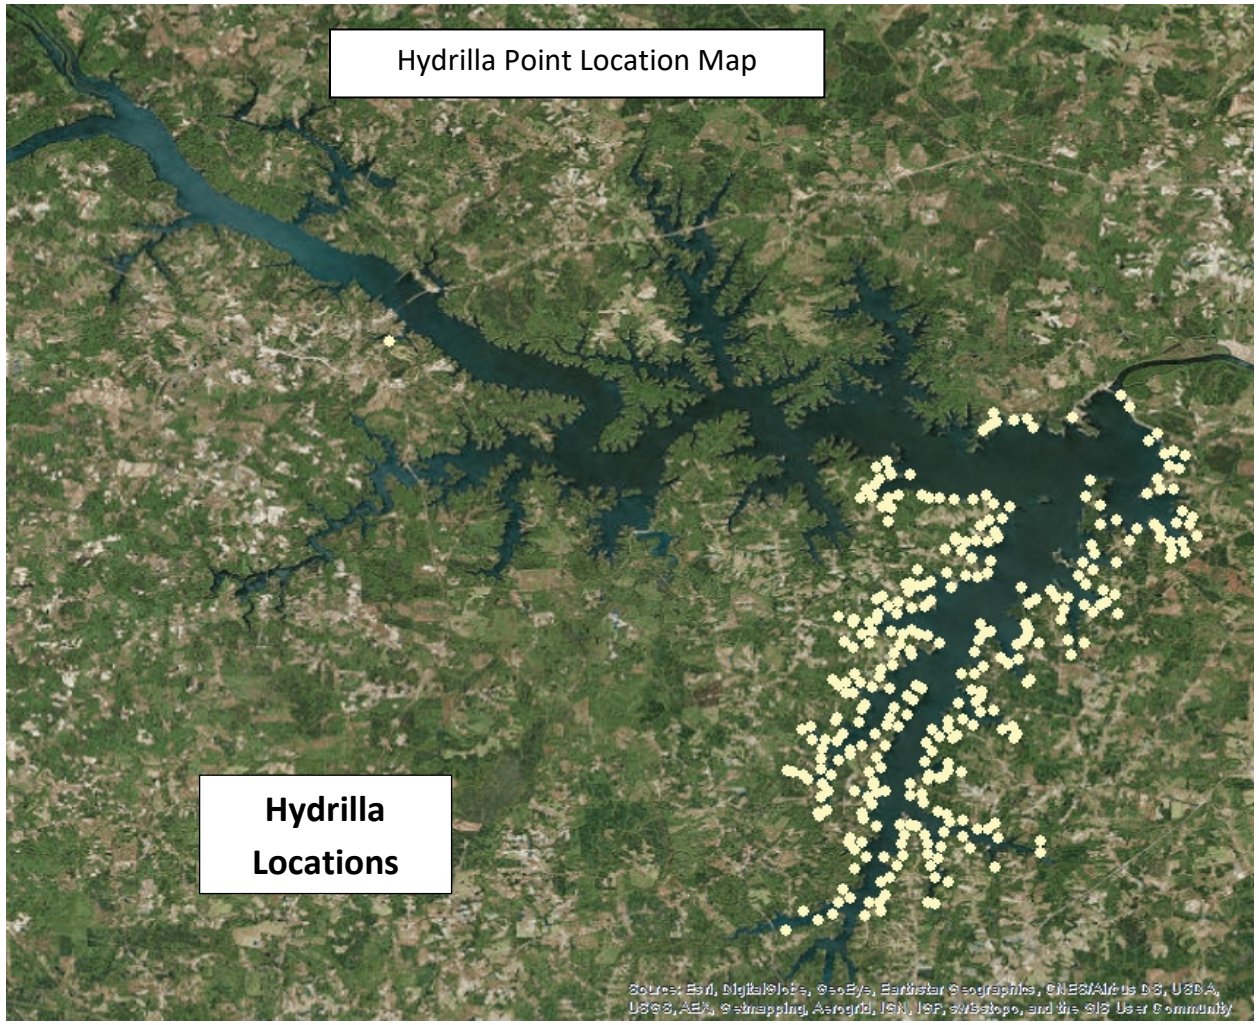
Hydrilla Point Location Map

During the survey process it was again noted that most of the hydrilla infestations occurred in areas of high human use including State Parks, boat ramps, commercial marinas, and in areas of higher populations of people based on number of docks. As in previous years large areas of undeveloped shoreline west of Nutbush Creek were found to contain almost no Hydrilla. It was noted in 2013 that Hydrilla has begun to spread west and north outside the Nutbush Creek area. Additional points were found in the same area in 2016, but infestations are generally small in size. No hydrilla was found in 2016 in Eastland Creek in the area that was identified in 2013 as having Hydrilla. Close monitoring of this area will continue in future surveys. Several additional points had rooted hydrilla, on the North shore, west of the Corps boat ramps and swim areas but the total area was very limited (.1 A total).

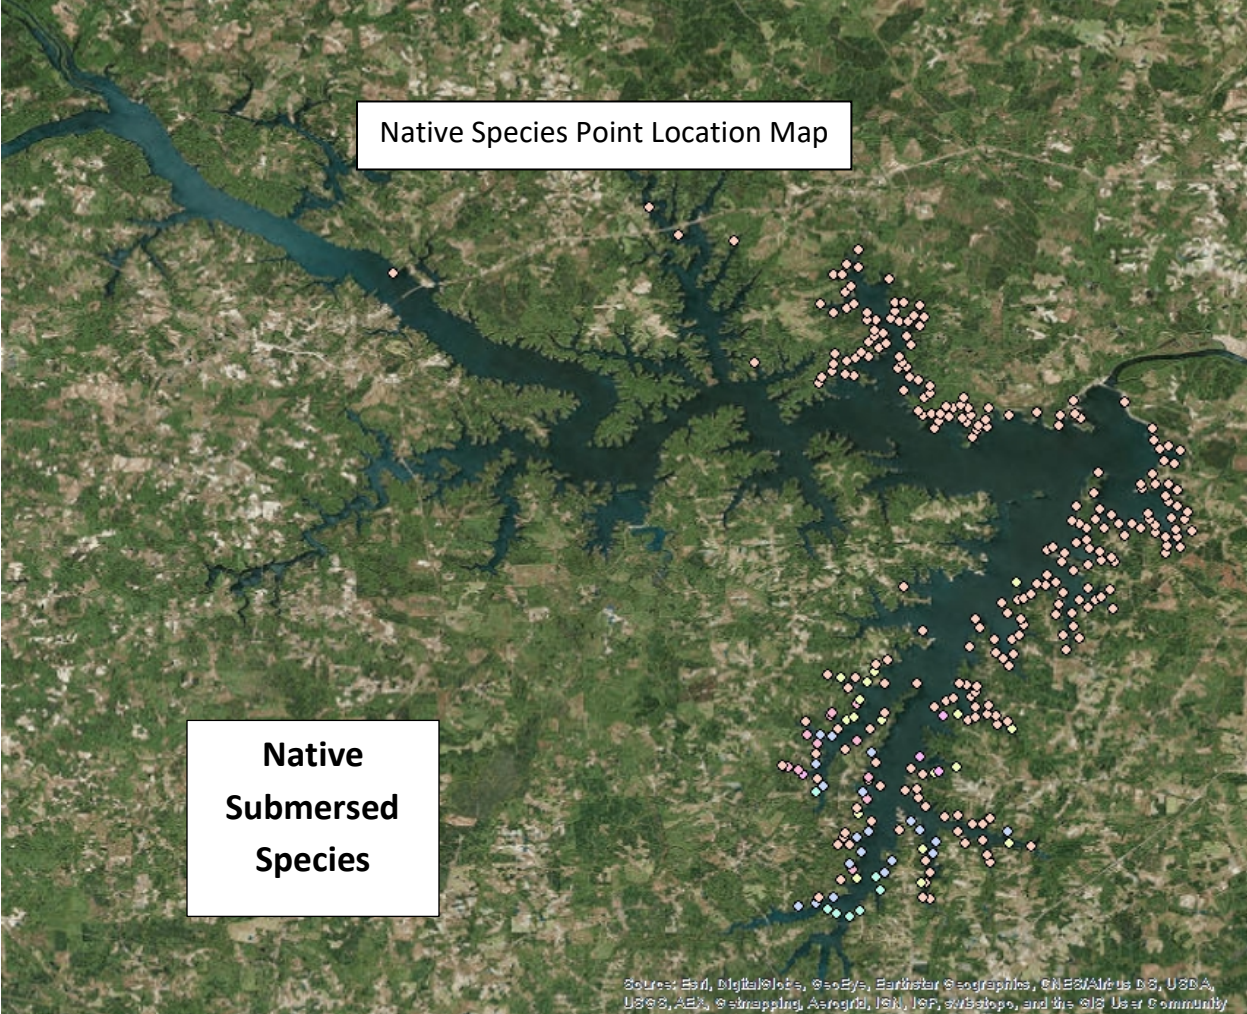
Percent Plant Occurrence by Species

During the survey period, with the exception of October 8 – 23, lake elevations remained between elevation 300 and 298 allowing for accurate sonar and rake toss data collection. Most of the living hydrilla biomass remained well below the surface. In shallow water (2 ft. or less) no rooted plants were observed, however beds of plants were found in water depths of 6 to 8 ft. Based on previous surveys, hydrilla growth was sparse and relatively shorter than in other years. Hydrilla was the most frequent plant observed in areas where plant beds were present. Unlike previous years, the only other submersed plant species found were *Najas guadalupensis* (southern naiad) and *Chara sp./Nitella sp.* (macroalgae).

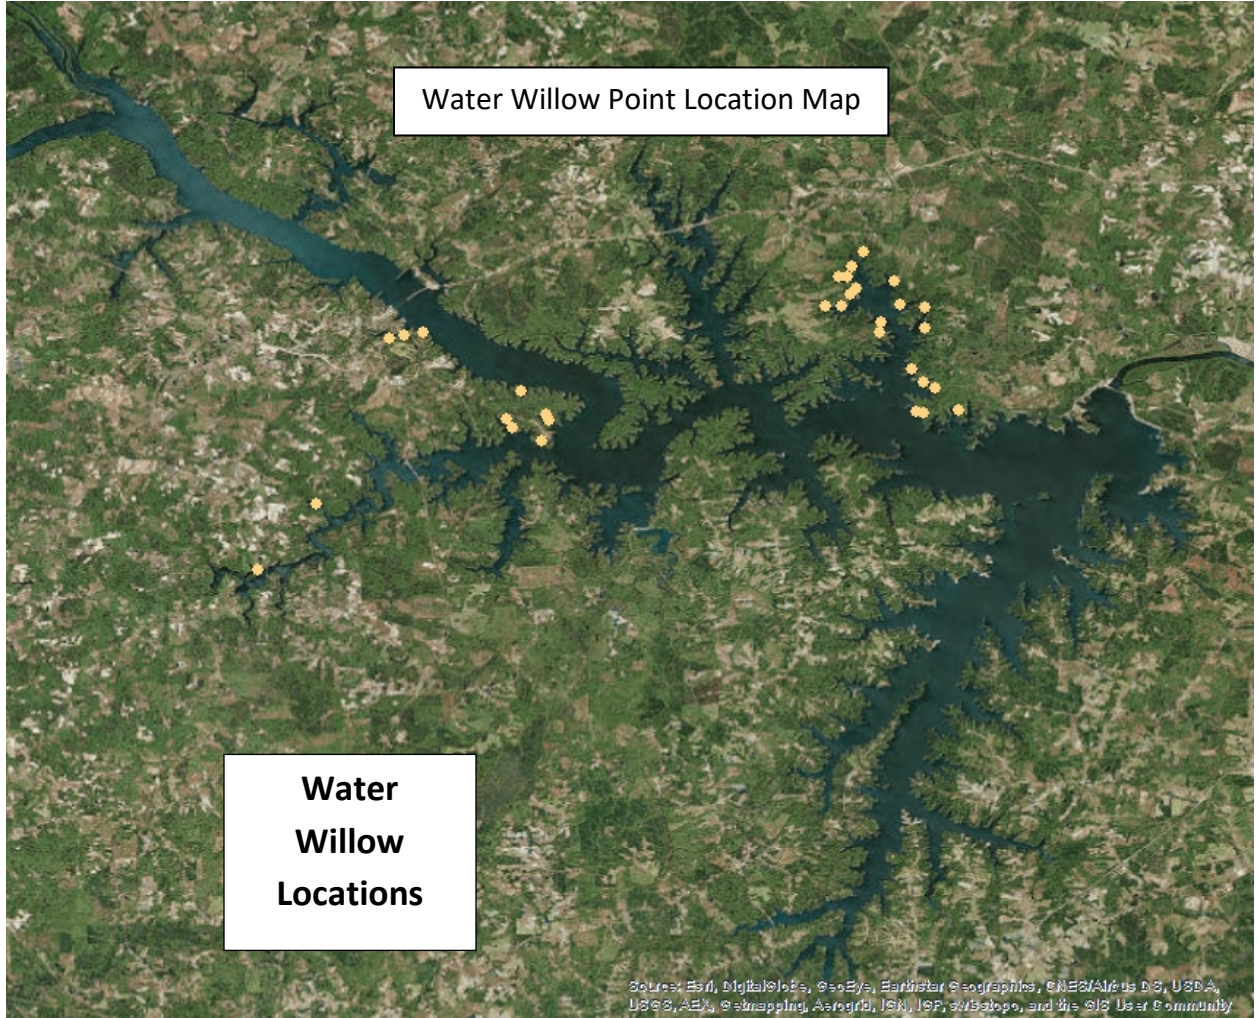
Water Willow Point Location Map

6. In 2016 we started trying to monitor water willow (*Justicia americana*) populations, continued monitoring of this desirable species will continue in future years.

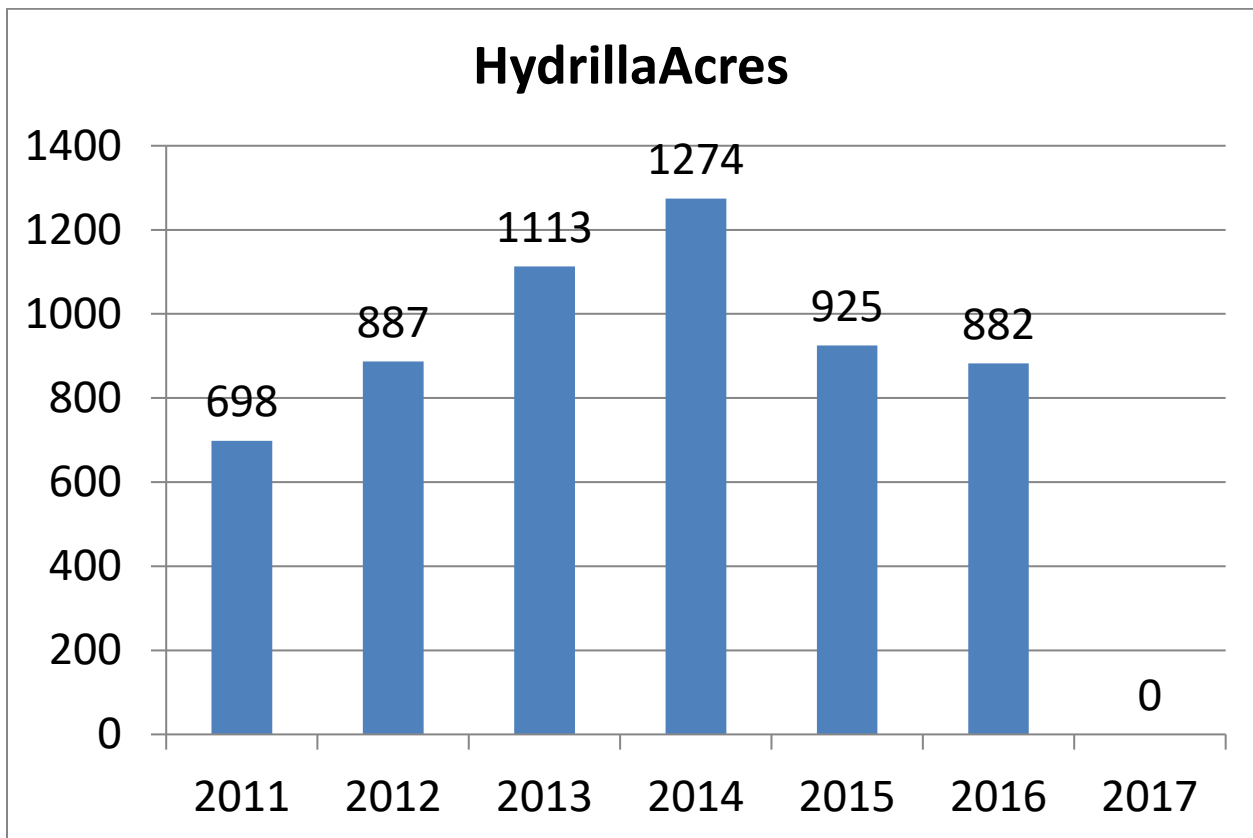
Based on the information obtained during the survey, our estimated total acreage of Hydrilla in Kerr Lake is 882 acres, located mainly in Nutbush Creek and Little Nutbush Creek. The 43 acre decrease in 2016, continues a trend in reducing hydrilla acreages, currently back to the levels of 2012. The introduction of grass carp has shown a trend in other lakes to reduce the height and density of hydrilla and it appears to be occurring at Kerr.

Additional whole lake surveys should be conducted to determine spread and document impacts on public use areas and native plant populations. Frequency of these whole lake surveys could be based on random point surveys conducted annually.

Maintain grass carp (*Ctenopharyngodon idella*) populations based on stocking rates from Va and NC Wildlife officials.

Contact herbicides applied by USACE approved applicators may be the best option for control in some areas. Certain sections of the currently infested North Carolina portion of the lake may be suitable for systemic herbicides, but water flow will limit their use. Any herbicide applications should be made by these approved applicators and reports containing acres treated, herbicides used and rates, evaluation of biomass reduction (treatment effectiveness), and other information should be made to the USACE for future determinations of treatments.
