Kerr Lake Vegetation Survey

January 21, 2015

Report submitted by NC State University

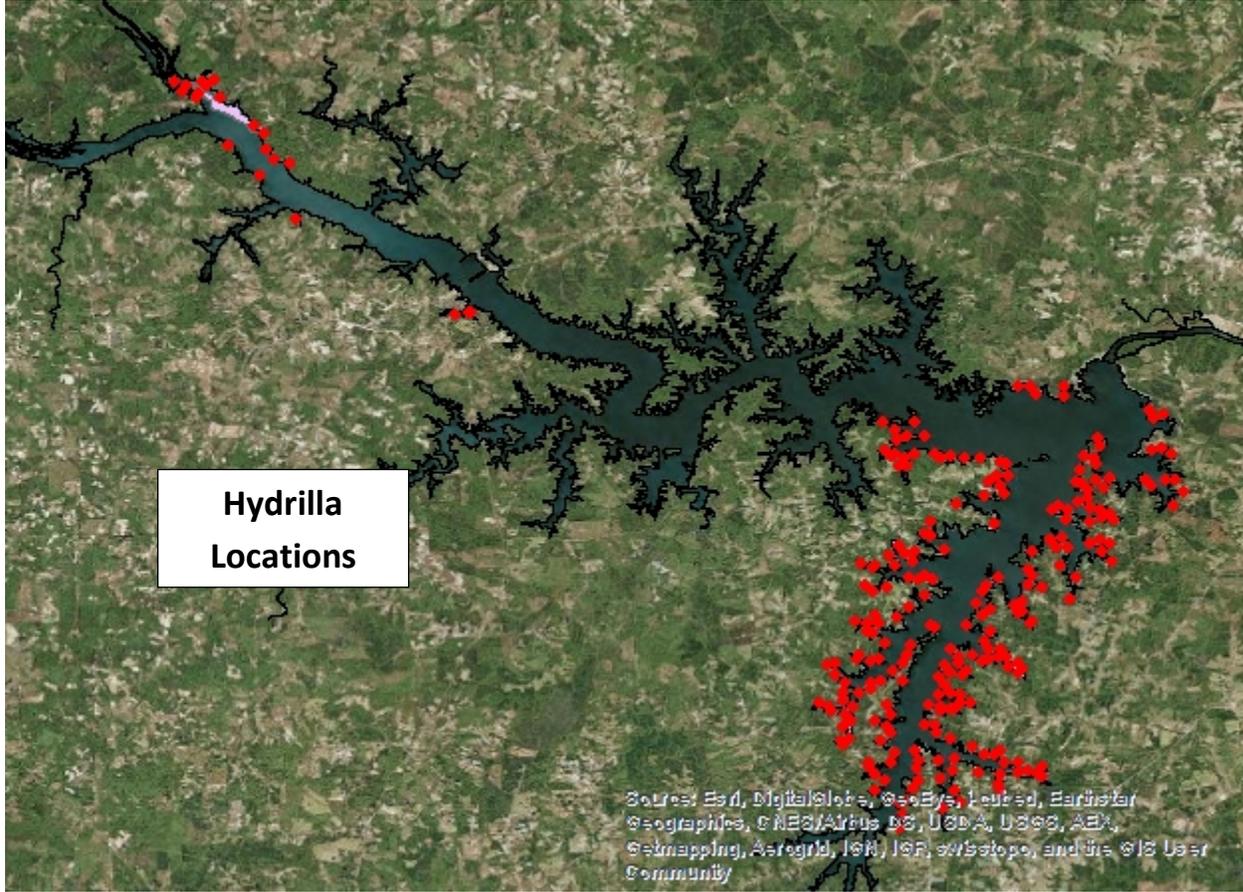
**Hydrilla
Locations**

During the survey process it was noted that most of the Hydrilla infestations occurred in areas of high human use including State Parks, boat ramps, commercial marinas, and in areas of higher populations of people based on number of docks. As in previous years large areas of undeveloped shoreline west of Nutbush Creek were found to contain almost no Hydrilla. It was noted in 2013 that Hydrilla has begun to spread west and north outside the Nutbush Creek area. Additional points were found in the same area in 2014, but infestations are generally small in size. The single point in Eastland Creek that was identified in 2013 as having Hydrilla was carefully examined in 2014 and no Hydrilla was found. Close monitoring of this area will continue in future surveys. Higher than usual water levels again allowed more points to be surveyed in 2014, than in previous years.

Areas around Stanton View contained significant acreages of Hydrilla similar to that seen in 2011 and 2013. Higher water levels allowed more of this area to be surveyed and also may have allowed more Hydrilla to grow.

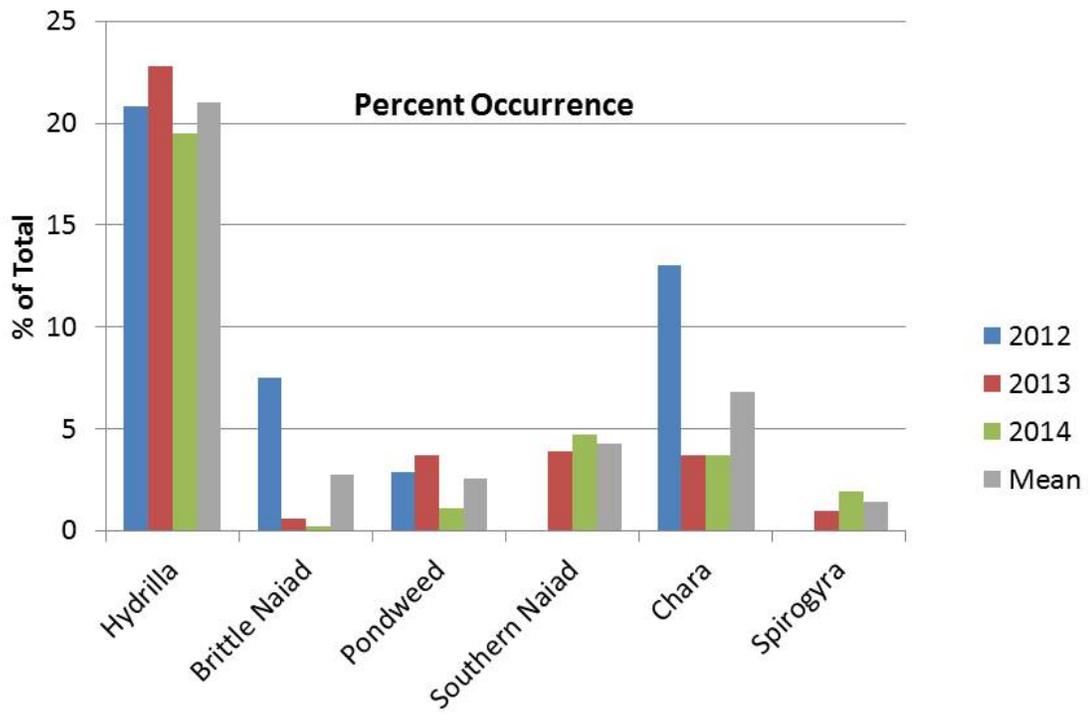
Percent Plant Occurrence by Species
 (based on 1245 points in 2012, 1345 points in 2013 and 1336 points in 2014)

During the survey period, high water levels made acreage estimations difficult. Topped out plants were observed in some locations, however most of the Hydrilla biomass remained well below the surface. In extremely shallow water (1 ft or less) rooted scattered plants were observed, however as in previous years dense beds of plants were found in water depths to 10 to 12 ft. Hydrilla was the most frequent plant observed in areas where dense plant beds were present. Several other plant species were found in significant quantities in many locations throughout the lake. Native submersed plants included ***Chara sp./Nitella sp.*** (macroalgae), ***Potamogeton diversifolius*** (variable leaf pondweed), ***Potamogeton pectinatus*** (sago pondweed), ***Najas guadalupensis*** (southern naiad). Several locations also had ***Najas minor*** (brittle naiad) a non-native invasive species.

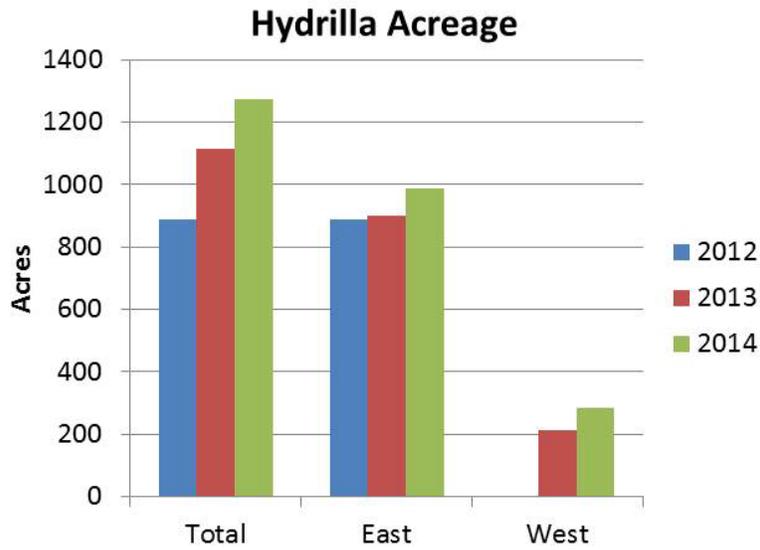
Based on the information obtained during the survey, our estimated total acreage of Hydrilla in Kerr Lake is 1,274.3 acres, located mainly in Nutbush Creek and Little Nutbush Creek. Of the 159 acre increase in 2014, approximately 71 acres of additional Hydrilla were found in the western part of the lake near the Staunton View area account for most of the difference. Hydrilla populations in this area have been noted in previous years and density will be extremely dependant on water level and flow in future years.
