**Feasibility Report  
and  
Final Environmental Impact Statement**

**Coastal Storm Damage Reduction**

**SURF CITY AND NORTH TOPSAIL BEACH  
NORTH CAROLINA**

**Hardbottom Survey Reports**

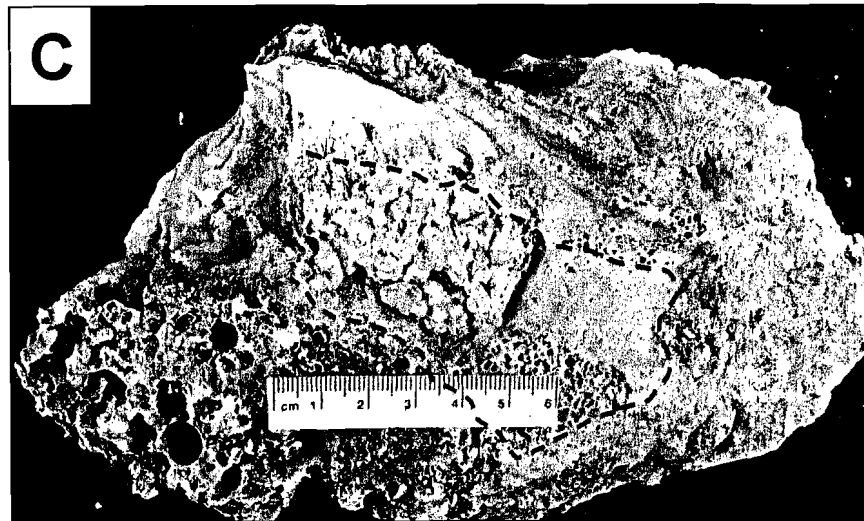
Figure 14. Giant oyster (*Crassostrea Gigantissima*) valves. **A.** Articulated oyster from Site 720. **B.** Articulate oyster with few encrusting organisms from Site 720. **C.** Fragment of valve estimated to be >50cm in length. Interior is filled with sandy lime mud (micrite).

demonstrated that the feature was an erosional remnant of the lithified channel complex (see Figure 13). The base of the scarp along this hardbottom has been interpreted to coincide with the floor of the channel (Crowson, 1980; Johnston, 1998). The large oyster valves commonly observed on the shoreface (see Figures 13 and 14) and the adjacent beach is derived from the Tertiary channel complex whose floor is lined with the giant oyster (*Crassostrea Gigantissima*).

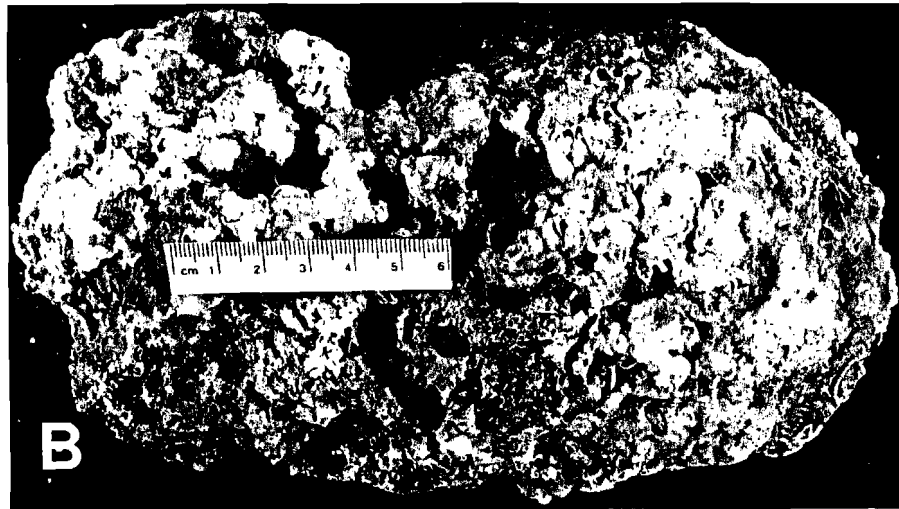
Figure 15. Giant oyster (*Crassostrea Gigantissima*) valves. A. Encrusted disarticulated oyster valve from Site 721 offshore North Topsail Beach (interior view). B. Bored and encrusted disarticulated oyster valve from Site 721 (top view) C. Large fragment of disarticulated valve of oyster estimated to be ~75cm in length from Site NTP 5014. D. Interior view of valve pictured in "C". Most encrusting organisms have been worn off due during landward transport of clast.

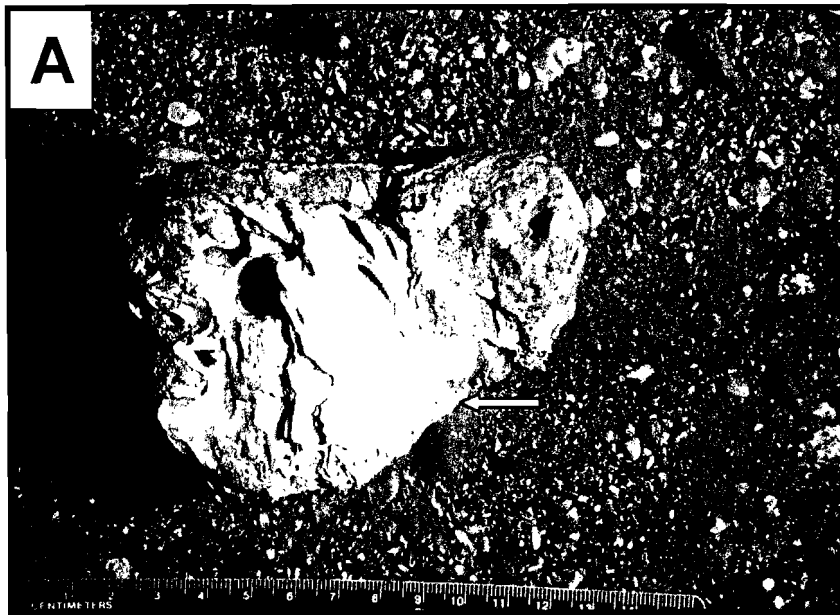
Figure 37. Bottom photographs at dive Site 504 on North Topsail Beach shoreface. Scale in A and B is 15 cm in length. **A.** Abraded lower valve of *Crassostrea gigantissima* (Oyster) and sand/ gravel mixture on limestone platform. **B.** Contact between limestone exposure (hardbottom) and silty fine sand veneer. Large white elongated cobble is fragment of oyster. **C.** In-place *Crassostrea gigantissima* Oyster Reef. Cobbles of *Crassostrea gigantissima* (arrows) are abundant in the vicinity of the lower Miocene channel structures. Divisions on crowbar are 10 cm in length. **D.** Mud draped oyster shell fragments litter the platform area. The sediment veneer in the area is generally less than 10-15 cm. Dissolution related depressions in the area are filled by modern sediment. Scale bar is ~ 5cm in length.

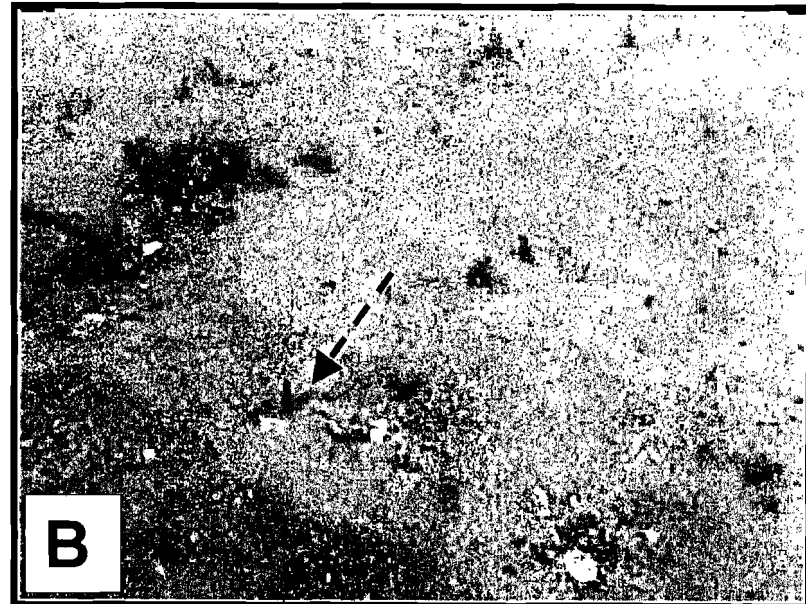
Figure 44. Bottom photos of hardbottom area with thin sand veneer off Surf City (Site SC 78). **A. - C.** Thin rippled sand veneer overlying limestone exposure. Gorgonians and epifauna are partially buried by mobile sand cover. **D.** Thin sand veneer with bored limestone protruding above sediment cover.

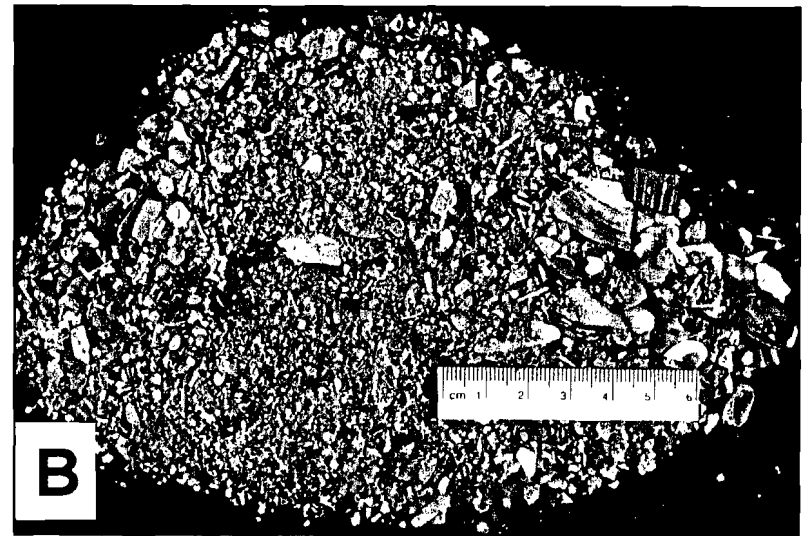
Figure 49. Sandy gravel and gravelly sand from the southern segment of the shoreface. A. (SC 82) and B. (SC113) are typical of the patches of rippled coarse sand and gravelly sand found near hardbottoms C. (TP 4) and D. (SC 22) are typical coarse sand and fine gravel. C. and D. contain 10-15 % coarse silt.

Gravel size material is abundant and is generally comprised of limestone lithoclasts and molluscan material (see Figure 47). The shell material is most commonly fragmented and stained orange brown or gray-black in color. The majority of the gravel and gravelly sand is found near or on hardbottoms and within the linear shore-normal features that contain patchy, rippled coarse material (see Figures 49 to 51). Much of the sediment on the shoreface is related to and a by-product of epifauna (encrusters and grazers) and infauna (borers) activity (see Figures 24 to 28 and 46 to 52).

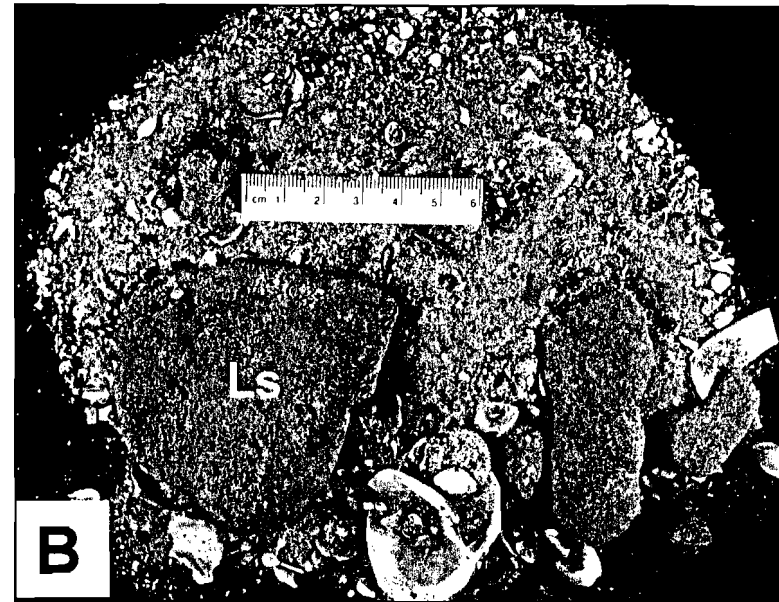
Figure 50. Gravel rich sand from the southern segment of the shoreface. A. – D. The composition of the gravel fraction varies from site to site depending upon the nature of the underlying substrate. Arenaceous and moldic limestone lithic fragments constitute a range of sizes. The black and gray shell material reflects reworked backbarrier channel deposits. A. SD 4 (49). B. SC 84. C. SC-VC 28. D. TP 10.

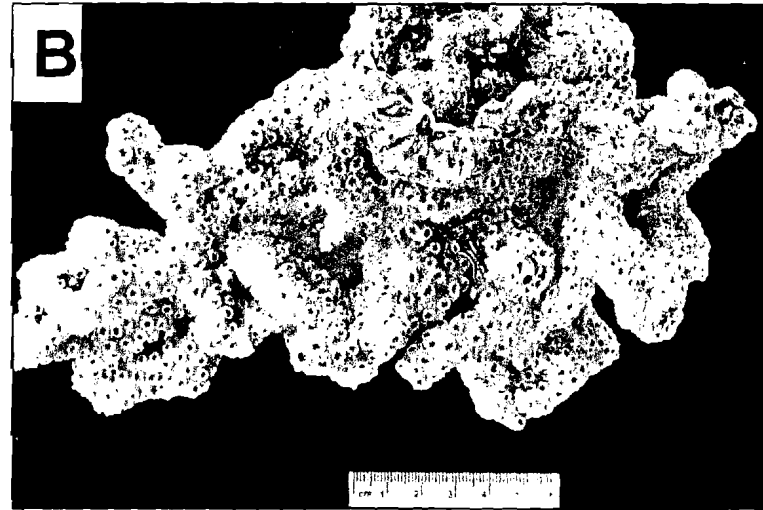
Figure 52. Hardbottom fauna and flora. A. (SC105) A variety of mollusks and worm tubes are commonly found encrusting large cobbles and surfaces. B. (SC 9 [29]) A variety of species of corals are typically found on the higher relief hardbottoms and on some cobbles in areas where sedimentation rates are low. C. (SDA 12) Cobble encrusted with mollusks, worm tubes, algae, and coral. D. (SDA 12) Bottom surface of cobble pictured in C. Note articulated mollusks and barnacles. Limestone fragment is extensively bored.

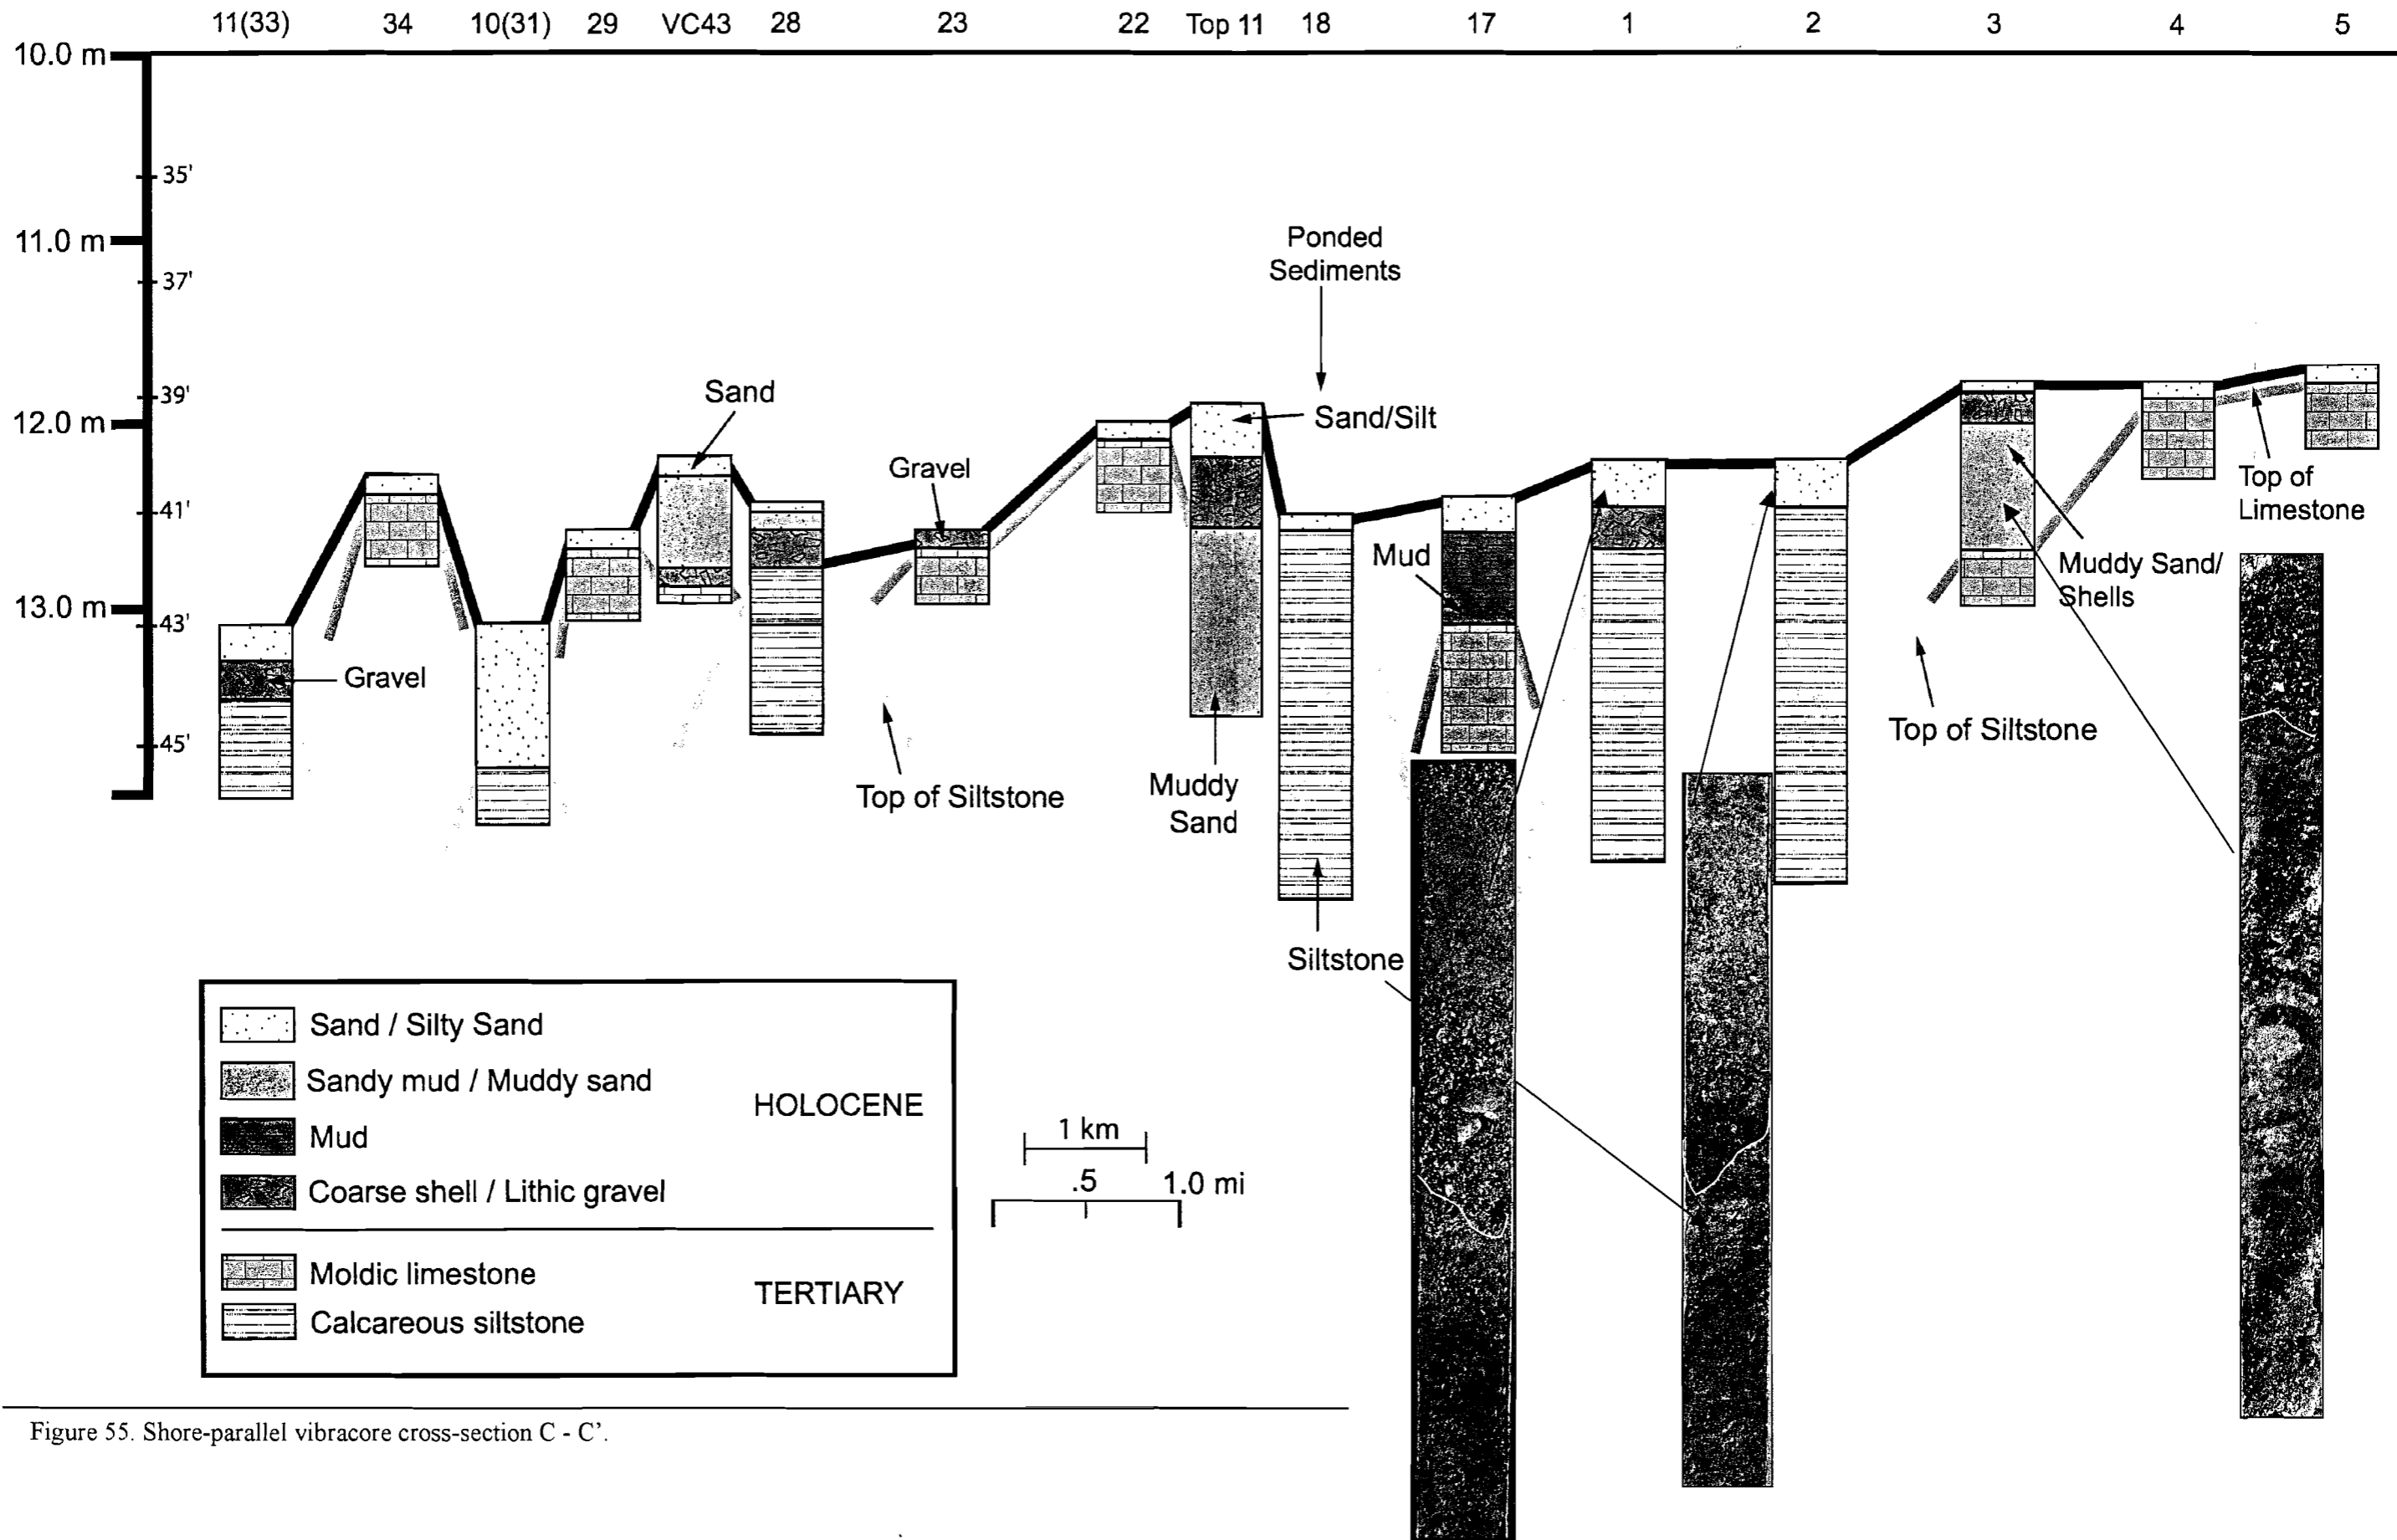
Figure 55. Shore-parallel vibracore cross-section C - C'.

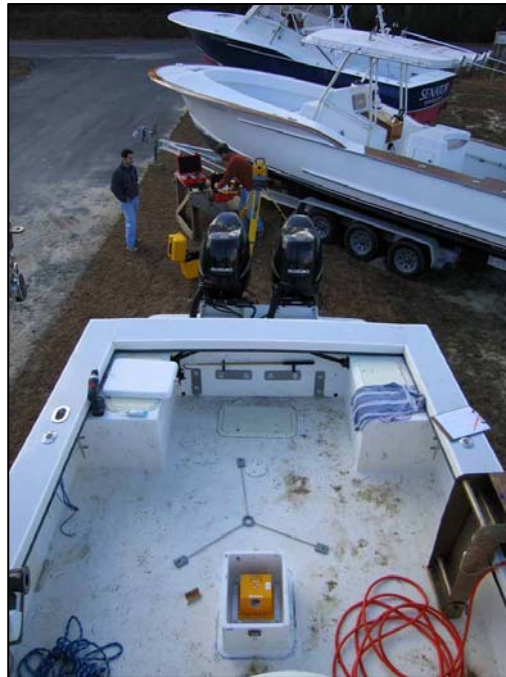
Figure 5. Photo of the centerline and instrument survey by NGS.

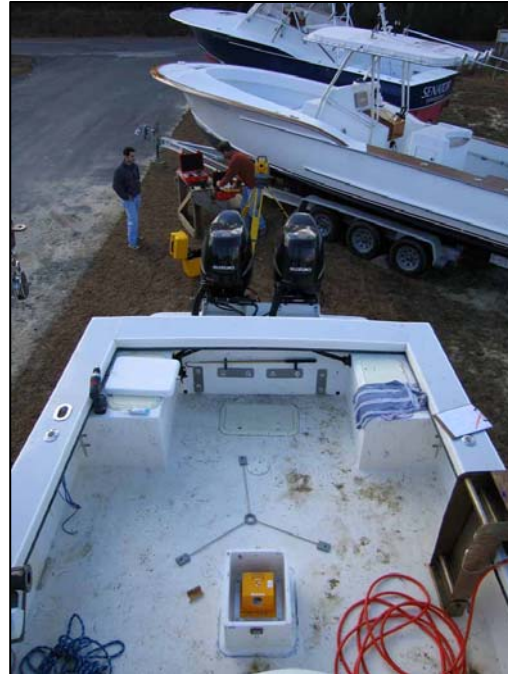
Figure 3. Photo of the centerline and instrument survey by NGS.

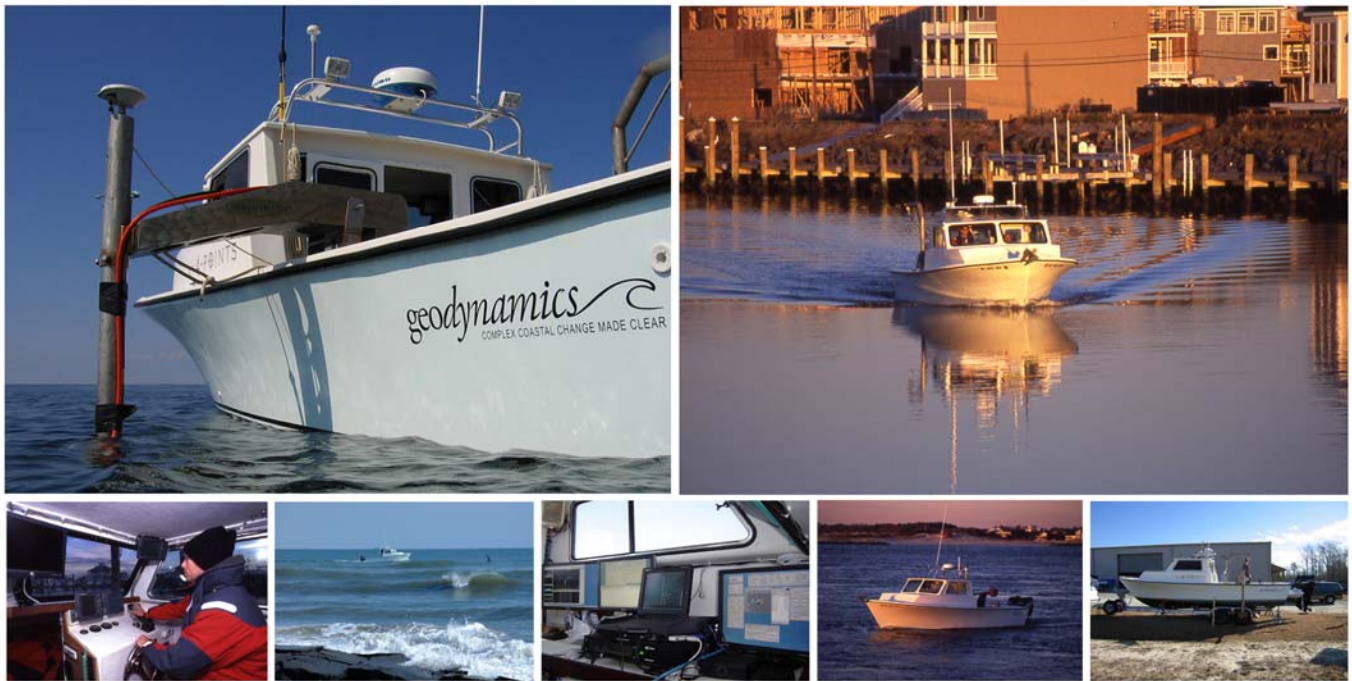
The research vessel *4-Points* is a custom fiberglass survey boat designed specifically for shallow water sonar and acoustical operations. The vessel is 25' long with a 10' beam; the bottom tapers from a deep "Carolina" style Vee to a relatively flat-bottomed stern that provides a shallow draft of approximately 1.2'. Twin 140 four-stroke engines, hung on a stainless steel bracket, power the vessel. All electronics and generators are grounded to the sea via a bottom mounted bonding plate to eliminate all electrical noise. Side-scan instrumentation is deployed, towed and retrieved from custom davit on starboard side.
