**Final General Reevaluation Report
and
Final Environmental Impact Statement**

Hurricane Protection and Beach Erosion Control

**WEST ONSLOW BEACH AND NEW RIVER INLET
(TOPSAIL BEACH), NORTH CAROLINA**

Appendix B: Economic Analysis

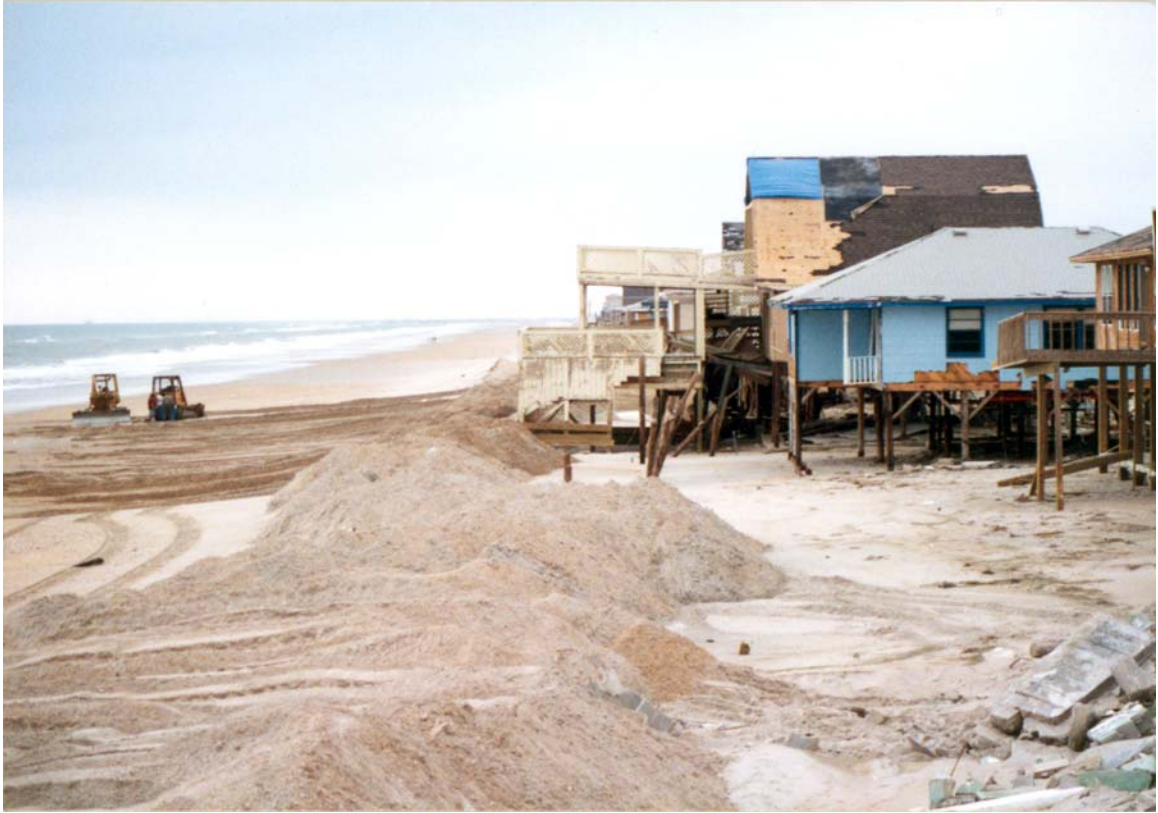
Figure B- 3 - Post storm Beach Scraping – Emergency Costs

Beach scraping/pushing refers to the practice of bull dozing a short dune or small berm in front of a residence or business so that it might offer some measure of protection from erosion. These costs are based on a bulldozer and operator pushing sand during two or three low tides. The practice requires a permit, and these records were used to help quantify these expenditures as project benefits. A large shore protection project would prevent the owners of the residence or business from incurring this expense. Figures B-3 and B-4 show scraping and pushing after hurricane Fran at Topsail Beach in 1996.

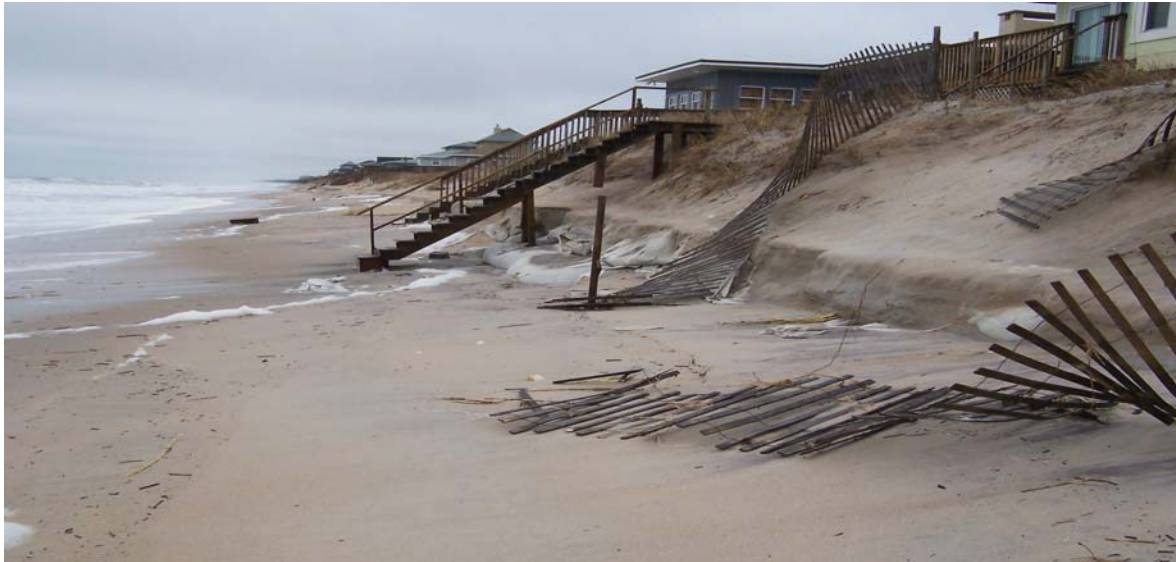
Figure B-5 - Sandbags in place but threatened February 2005.

Sandbagging structures is another emergency measure that has been fairly commonplace over recent years in this area. An example of sandbagging is shown in Figure B-5. This requires a permit that is only granted if the property is in eminent danger of being lost to erosion.

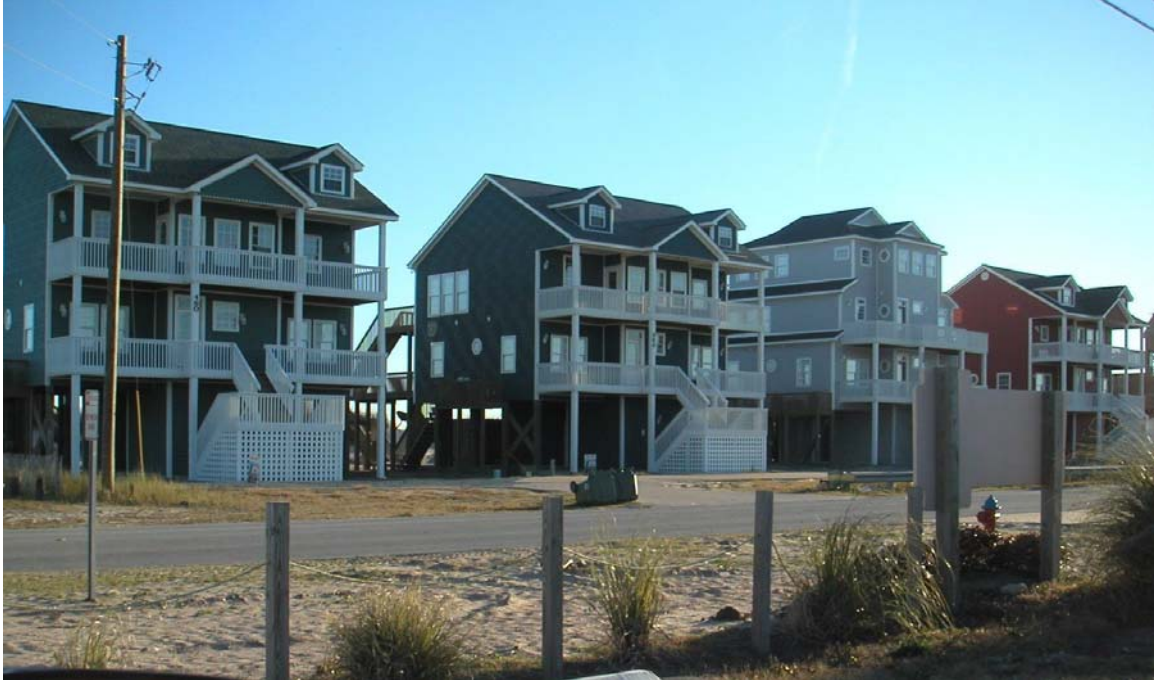
Figure B- 6 - Four typical new structures (all Type 56) built in 2004 on Topsail Island, NC

The typical residential structure presently constructed on Topsail Island has the following characteristics: two-story, approximately 2,100 square feet of heated space, built on a piling foundation, and includes no more than a small enclosure on the ground level to provide a staircase or elevator for access.

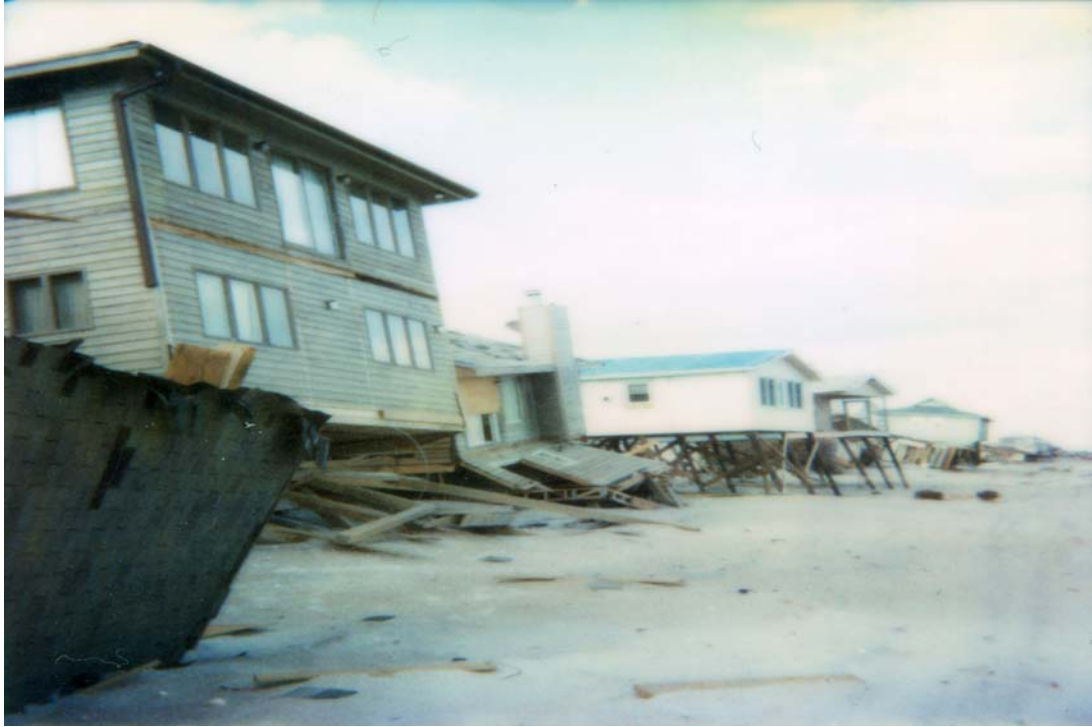
Figure B-11 - Hurricane and storm damage after Hurricane Fran 1996

Examples of hurricane and storm erosion damage at Topsail Beach are shown in Figure B-11. The present value of hurricane and storm damages by damage category and reach is shown in table B-6 and figure B-12 for the without project condition.

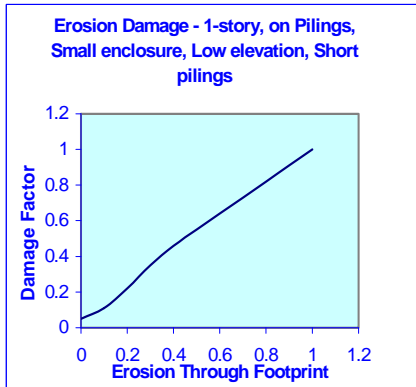
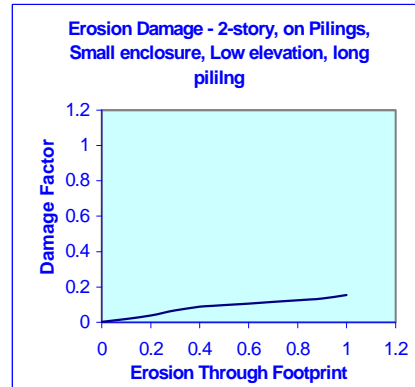
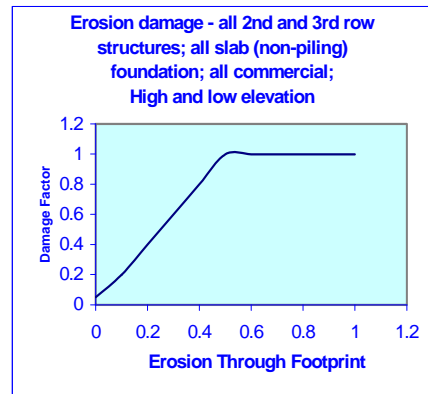
Figures -13, 14, 15, and 16 Composite Erosion Damage Curves

Based on the significant number of first row structures, sample erosion curves are shown by structure type in Figures 13, 14, 15, and 16. A complete set of erosion types and associated erosion curves are found in attachment B-2 to this appendix. The erosion-damage curves used for this analysis are compilations of curves assigned for each part of the structure. The enclosure is given a value of 40 percent of the entire structure and the rest of the structure is given a value of 60 percent of the entire structure value. These percentages were then used to weight the damage curves for the home and the enclosure and derive a composite damage curve.

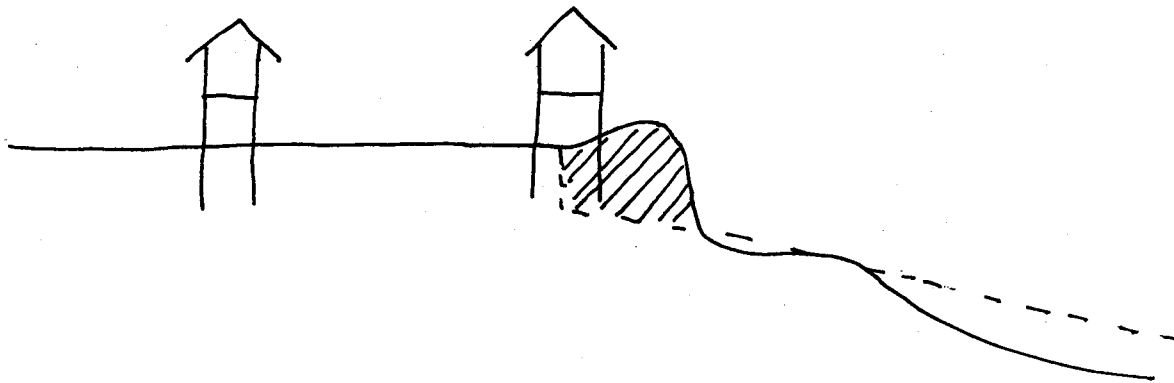
- B.** Small overtopped dune
1. Erosion zone with waves and flooding
 2. Waves zone with overwash deposition and flooding
 3. Stable ground elevation with flooding
 4. High ground: (no erosion, waves or flooding)

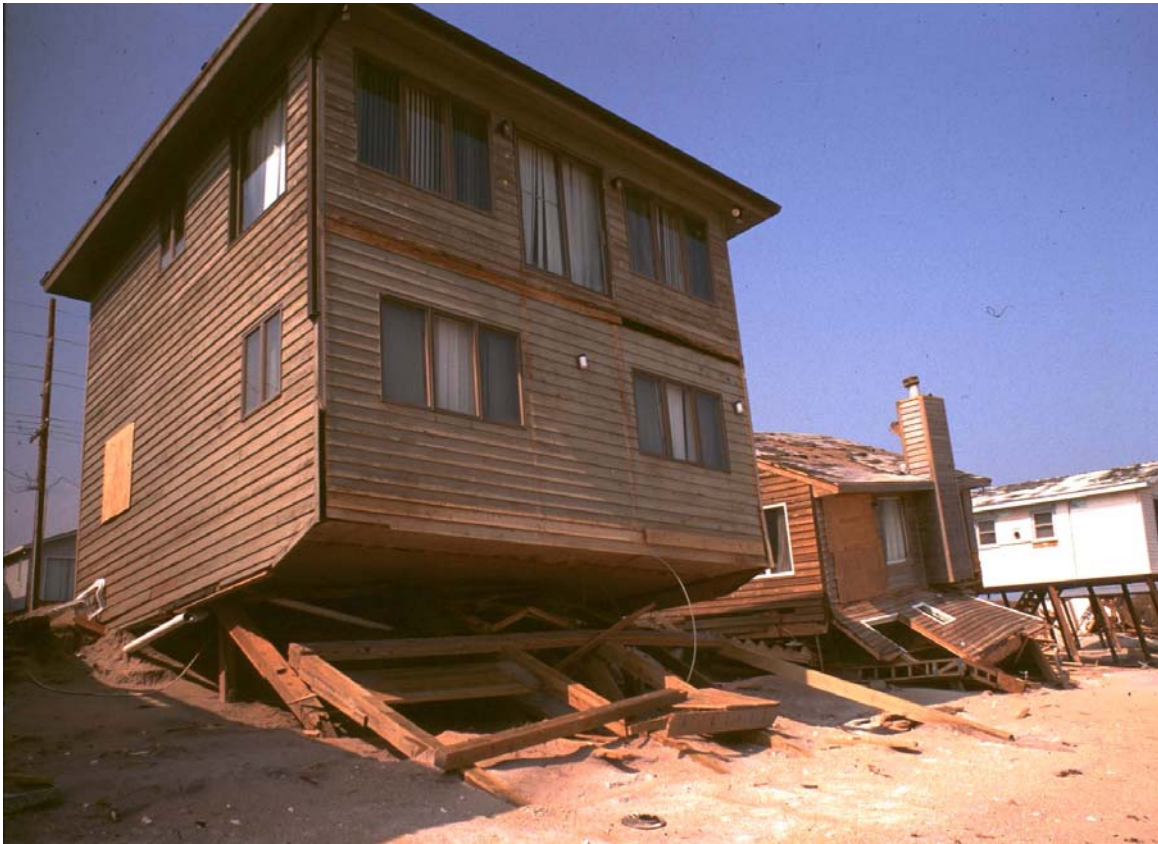
Figure 3: Short piling foundation failures (Class 1b) on high-elevation shoreline (Type A). Location: Kure Beach NC after Hurricane Fran.

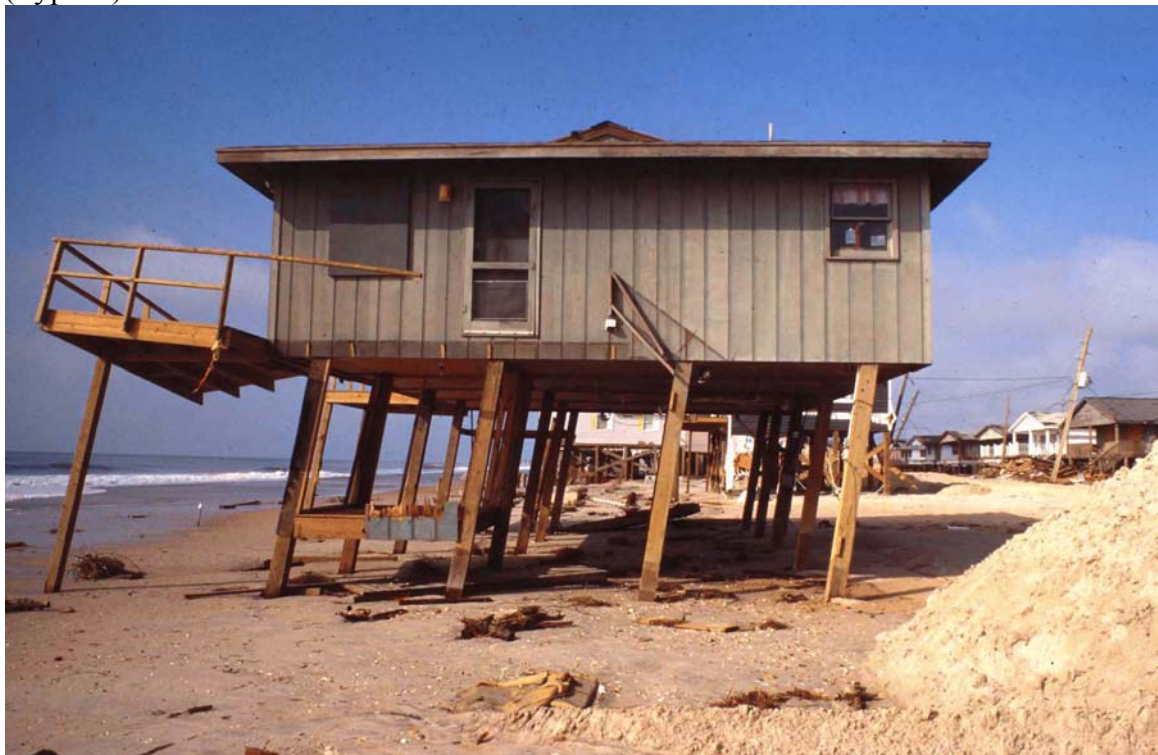
Figure 4: Short piling foundation (Class 1b) near failure on low-elevation shoreline (Type B). Location: Surf City NC after Hurricane Fran.
