Hanover Lakes
 New Hanover County, NC
 October 2014
 40-14-052

Figure 1. Rapanos photo demonstration sketch

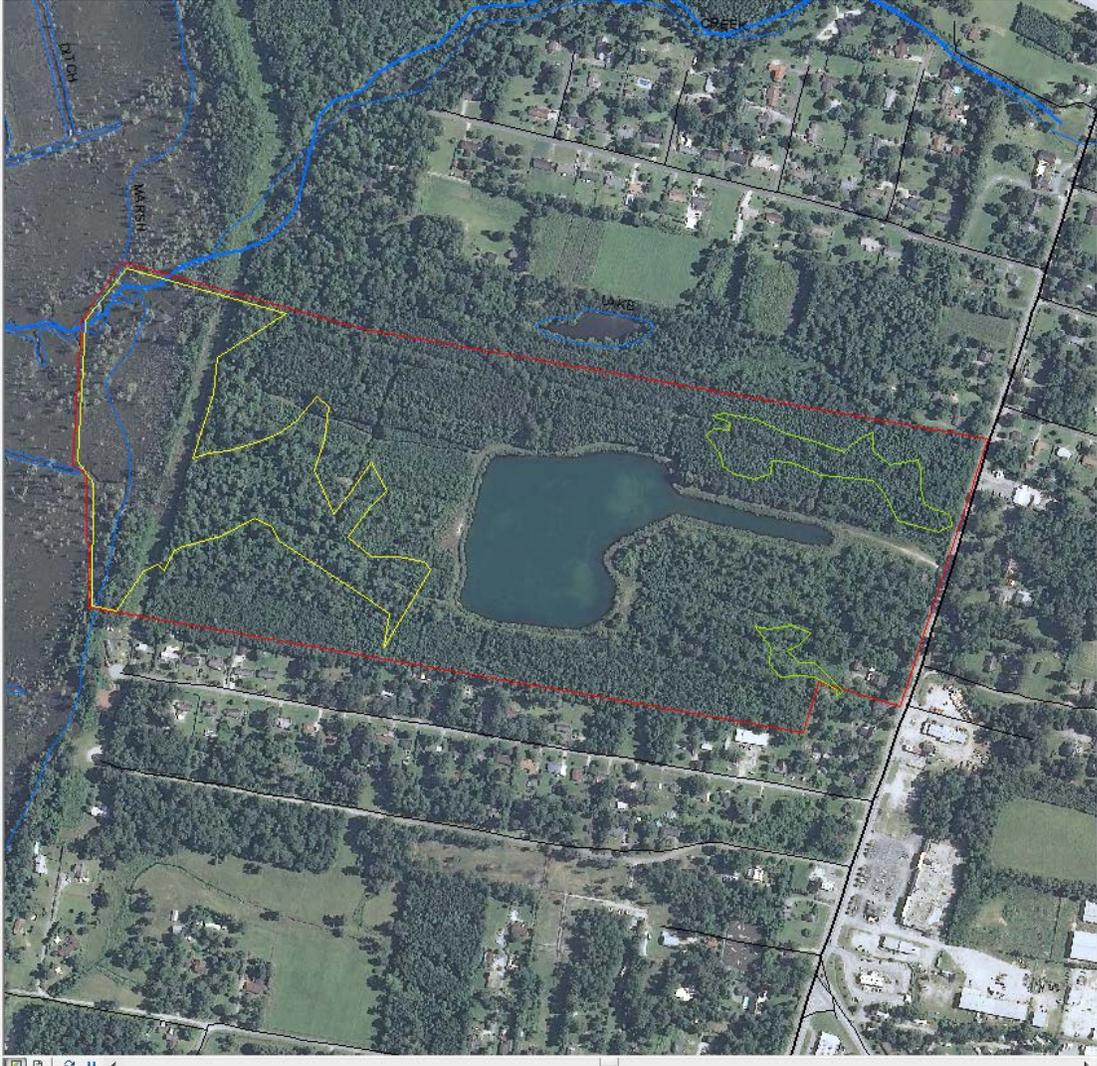
Wetlands are not to scale, this is only a sketch. Can see that the 2 jurisdictional wetlands are within crenulations, the permitted storm water pond was created in uplands and the isolated wetland is not in a crenulation. Walked on the west side of isolated wetland and it is surrounded entirely by high ground. No roadside ditch to connect it either. Walked on east side of isolated wetland and the “ditch” was no more than an inch swale that did not show any signs of conveying water and it eventually terminated. See pictures below.
