# Prospectus

## Falling Creek Mitigation Site

Wayne County, NC

USACE Action ID No. 2015-00940

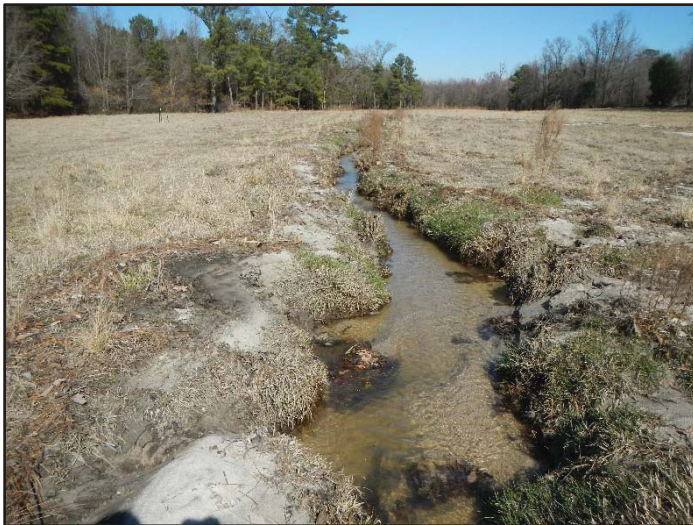
Coriander Creek, downstream of Confluence with Adams Branch. Restoration Reach

Downstream of Adams Branch, Coriander Creek transitions from a forested riparian buffer to an open agricultural pasture. This reach has been historically channelized and relocated to its westernmost valley wall. While the channel is not incised, it lacks a natural meandering pattern, aquatic habitat, and bedform diversity. As Coriander Creek flows downstream towards the floodplain of Falling Creek its width to depth ratio increases, its channel slope decreases and its floodplain widens. This decrease in channel slope has caused a significant increase in sediment deposition. Sediment deposition within the first 200 feet of forested area is so great that it has buried the forest understory and is endangering the existing trees. At this point Coriander Creek transitions into a braided system, creating several flow paths through the deposited sediment.

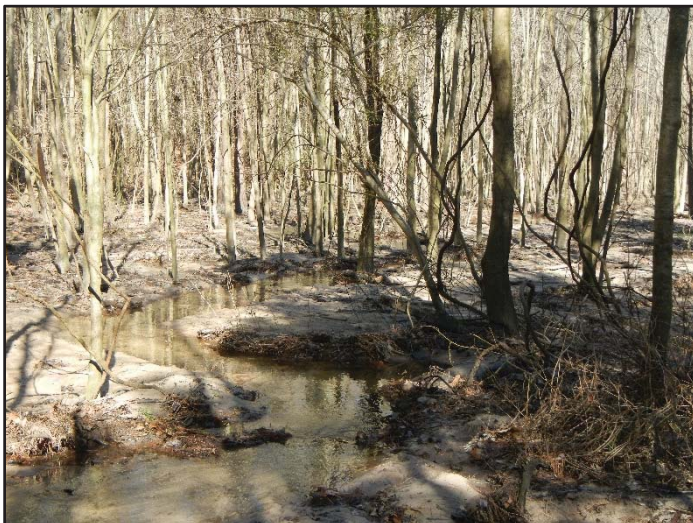
Coriander Creek, downstream end. Preservation Reach

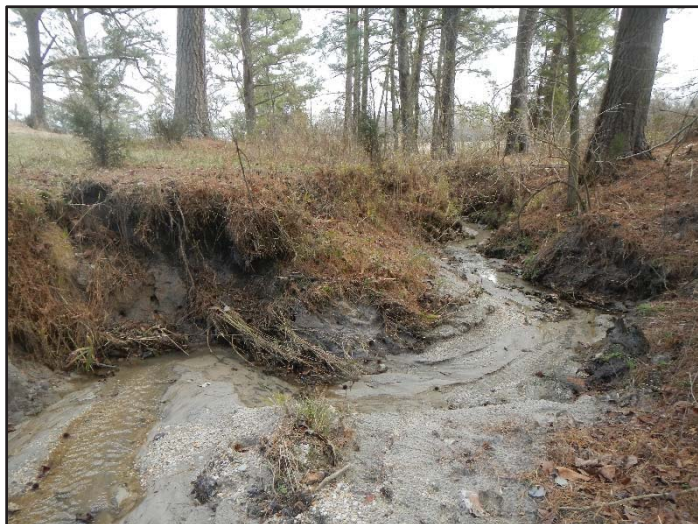
Adams Branch. Restoration Reach

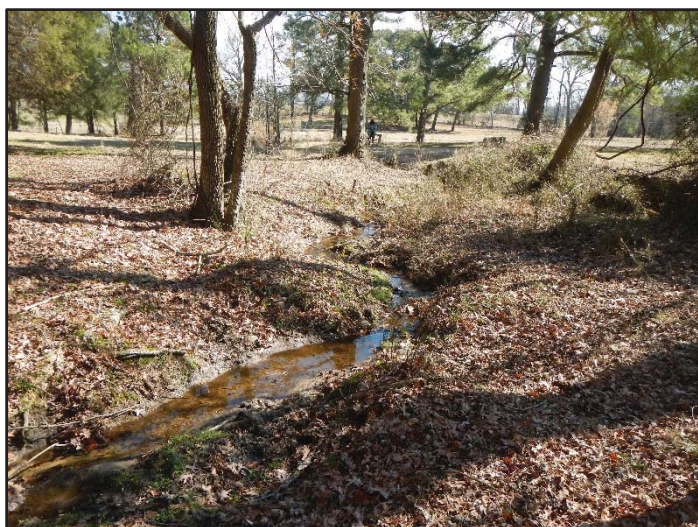
Finch Creek, upstream. Enhancement II Reach

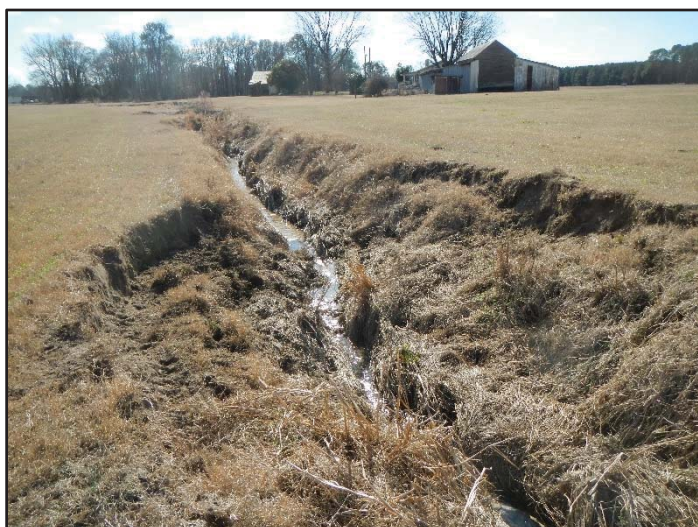
Gurley Branch. Restoration Reach.

Gurley Branch enters the site at the southern boundary along Corbet Hill Road, west of Grady Branch. It is a severely incised and entrenched ditched system that travels south through an active livestock pasture. This reach is undergoing a recurring process of bank failure whereby water flowing through Gurley Branch erodes the bottom third of the streambank and creates an undercut bank. This bank eventually collapses and the sediment from the bank travels downstream and deposits in the stream channel and floodplain. This is one source of excess sediment found in the floodplains of Coriander Creek. The lack of riparian vegetation also contributes to the lack of stability within the system. All of the aforementioned factors and processes have left Gurley Creek with poor aquatic and riparian habitats.

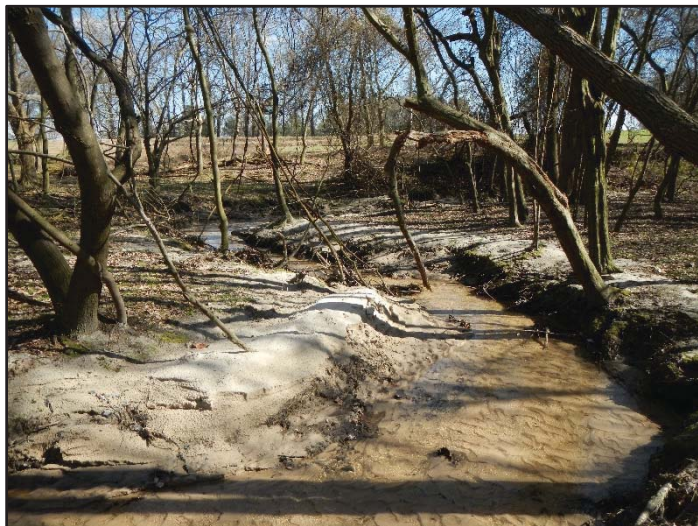
Grady Branch. Enhancement II Reach

Once Grady Branch flows into the wooded riparian area (downstream of its intersection with Gurley Creek) it becomes only mildly incised. It is hydraulically connected to the floodplain and has a stable pattern that can be used as reference during design. Grady Branch appears to be successfully moving a large amount of sand through the system while remaining relatively stable. Livestock do have access to this area, which is the primary source of stress to this reach. The riparian area has mature trees, but lacks an understory, and there is evidence of minor bank failures from cattle crossing.

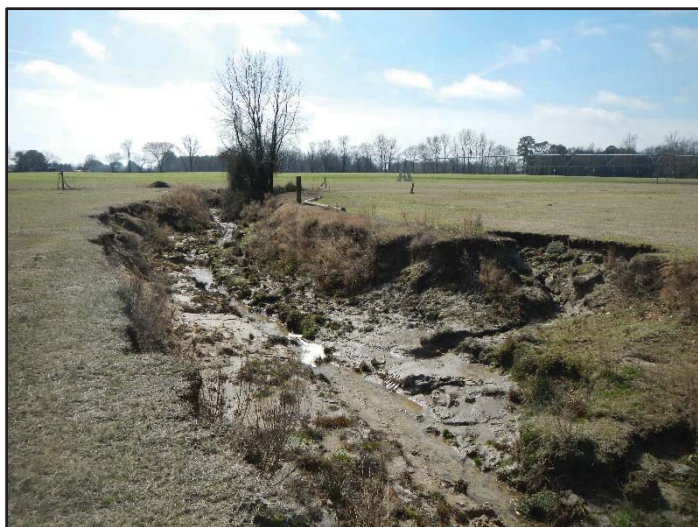
Mourning Dove Branch, Restoration Reach

Mourning Dove Branch originates from roadside ditches draining along Grantham School Road and flows northwest across a livestock pasture. The stream has been ditched and is incised, with banks greater than six feet in height. Erosion along the channel length has led to bank failure and mass wasting of bank material. A small bench has formed along the bottom of the channel as it begins to change from a process of widening to one of aggradation. The lack of vegetation and bedform diversity has resulted in poor aquatic and terrestrial habitat along the reach.

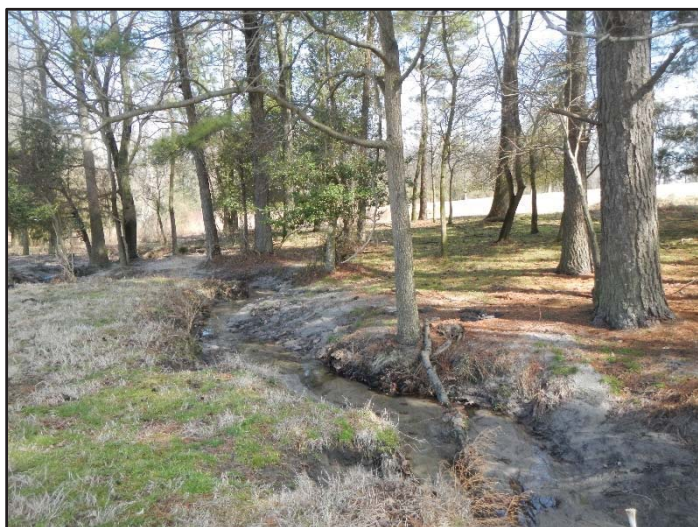
Thornton Creek. Enhancement II Reach

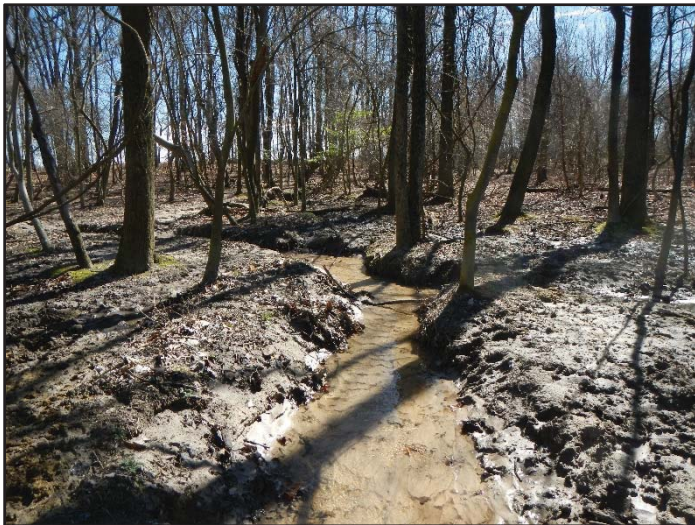
Sadler's Brach. Enhancement II Reach

Sadler's Branch originates upstream of Grantham School Road and enters the site through a roadway culvert before flowing northeast towards Falling Creek. It is the mainstem of the stream system on Falling Creek East. The upstream portion flows through an agricultural field used for livestock grazing and pasture. The upstream reach is severely incised (banks > 6 feet) with evidence of ongoing bank failure along its length. Bank failure can be attributed to cattle access as well as erosive flows from runoff. The eroded channels draining the fields are lined with Cattail and green briar. As Sadler's branch enters the forested area the incision gradually decreases from severe to moderate and floodplain connectivity varies along the length. There are some riffle pool sequences and several debris jams within the channel. Banks in this reach are eroded due to shear stress in the channel, lack of bank vegetation and livestock access.

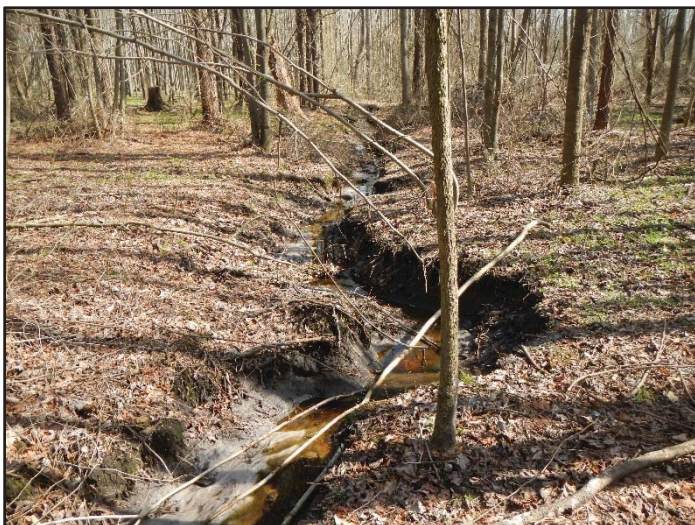
Chicory Creek. Enhancement II Reach

Chicory Creek starts at a headwater wetland located in the southwest region of Falling Creek East near Grantham School Road. It is a forested wetland complex with a small single thread channel traversing the length of the valley. Small sections are moderately incised, but the majority of the channel has no incision and is hydraulically connected to its floodplain. Cattle have access to this area which has led to the degradation of banks and the associated riparian wetlands.

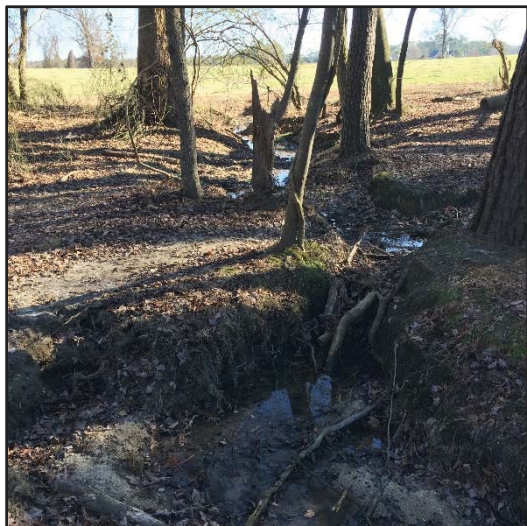
Anise Branch. Enhancement II/Restoration Reach Break.

Anise Branch is a small tributary to Sadler's Branch that drains an agricultural field. The upstream end is relatively stable in dimension, but has been trampled by livestock access. A headcut is located approximately 50 feet downstream of the edge of the field, after which the channel becomes moderately incised. There is erosion on the top third of the stream banks that indicates the stream has been susceptible to bank failure. The riparian area of Anise Branch is forested with the same species composition of Sadler's Branch.

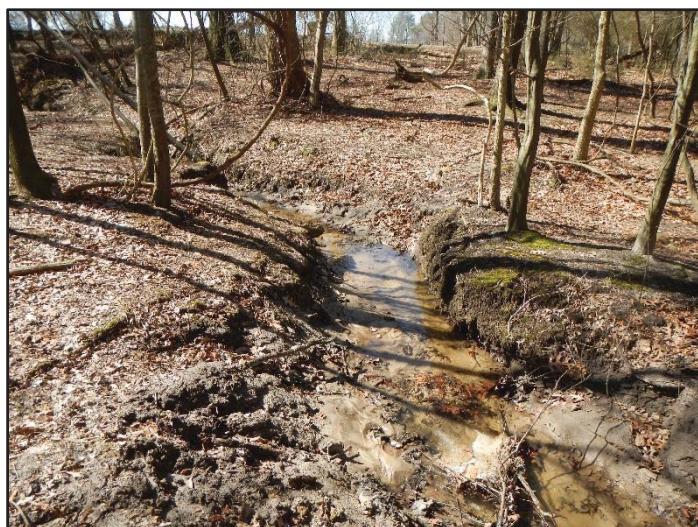
Cornet Creek. Enhancement II Branch

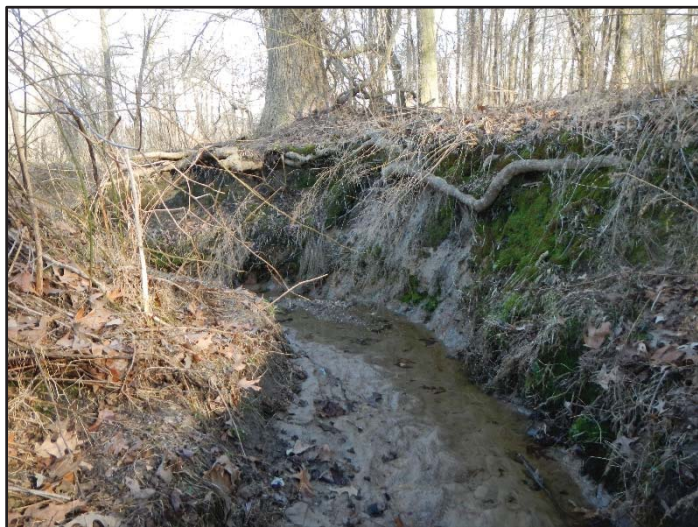
Tarragon Creek. Restoration Reach

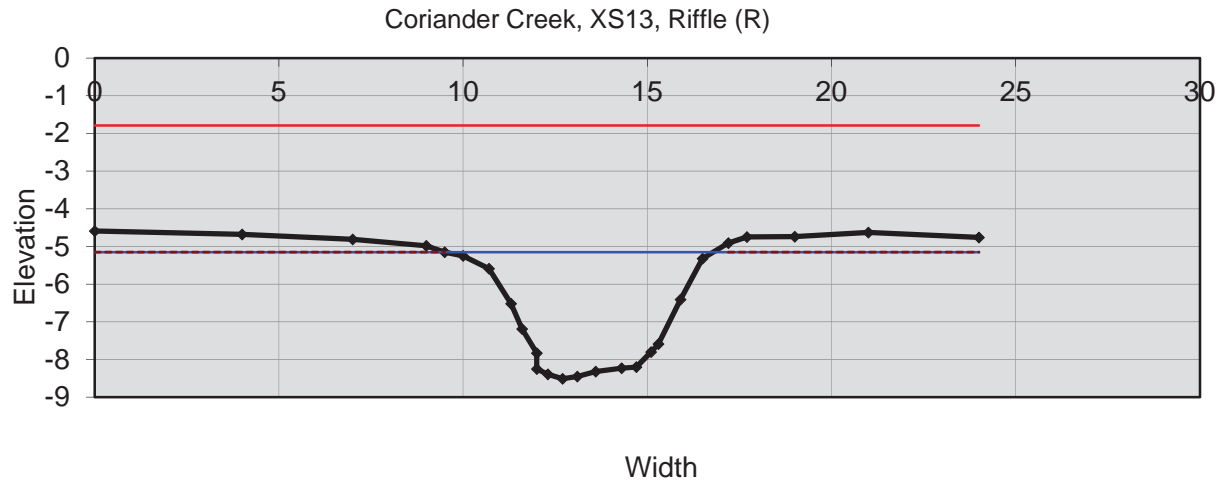
14.1	x-section area (ft.sq.)
7.3	width (ft)
1.9	mean depth (ft)
3.4	max depth (ft)
10.8	wetted parimeter (ft)
1.3	hyd radi (ft)
3.8	width-depth ratio

24.0	W flood prone area (ft)
3.3	entrenchment ratio
3.4	low bank height (ft)
1.0	low bank height ratio

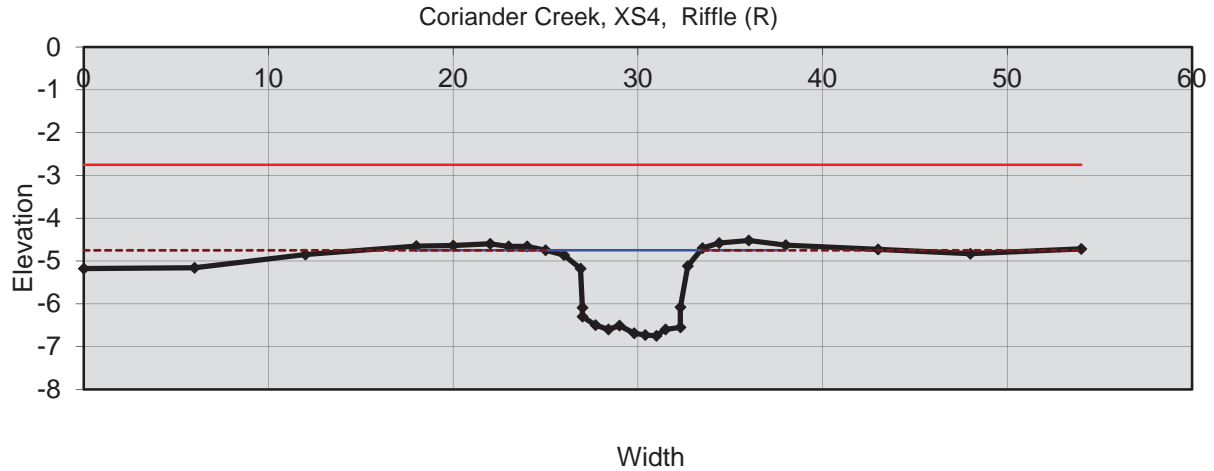
10.6	x-section area (ft.sq.)
8.4	width (ft)
1.3	mean depth (ft)
2.0	max depth (ft)
10.8	wetted parimeter (ft)
1.0	hyd radi (ft)
6.6	width-depth ratio

100.0	W flood prone area (ft)
11.9	entrenchment ratio
2.0	low bank height (ft)
1.0	low bank height ratio

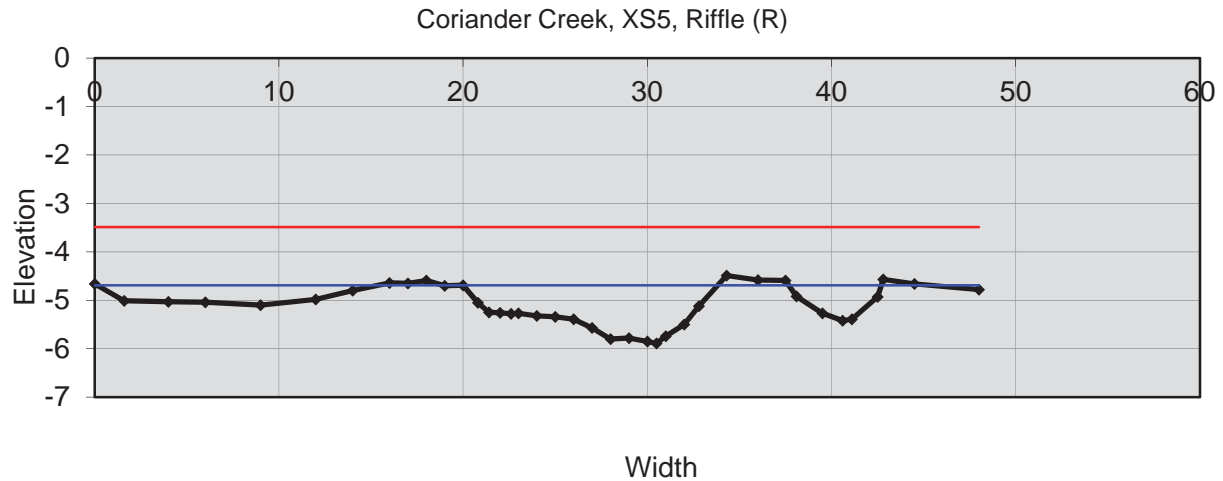
16.9	x-section area (ft.sq.)
37.8	width (ft)
0.4	mean depth (ft)
1.2	max depth (ft)
38.5	wetted parimeter (ft)
0.4	hyd radi (ft)
84.3	width-depth ratio

100.0	W flood prone area (ft)
2.6	entrenchment ratio
1.2	low bank height (ft)
1.0	low bank height ratio

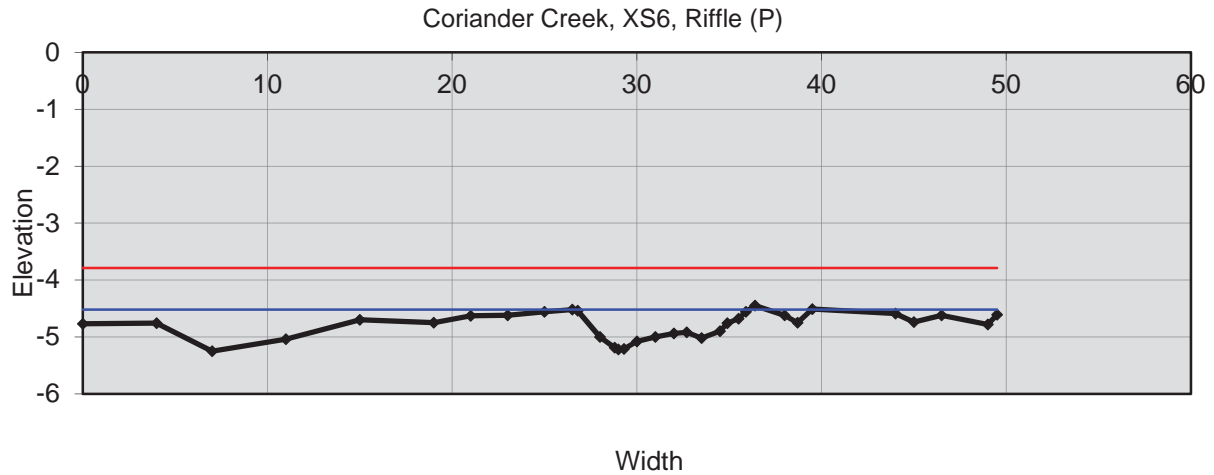
13.1	x-section area (ft.sq.)
47.9	width (ft)
0.3	mean depth (ft)
0.7	max depth (ft)
48.3	wetted parimeter (ft)
0.3	hyd radi (ft)
175.7	width-depth ratio

200.0	W flood prone area (ft)
4.2	entrenchment ratio
0.7	low bank height (ft)
1.0	low bank height ratio

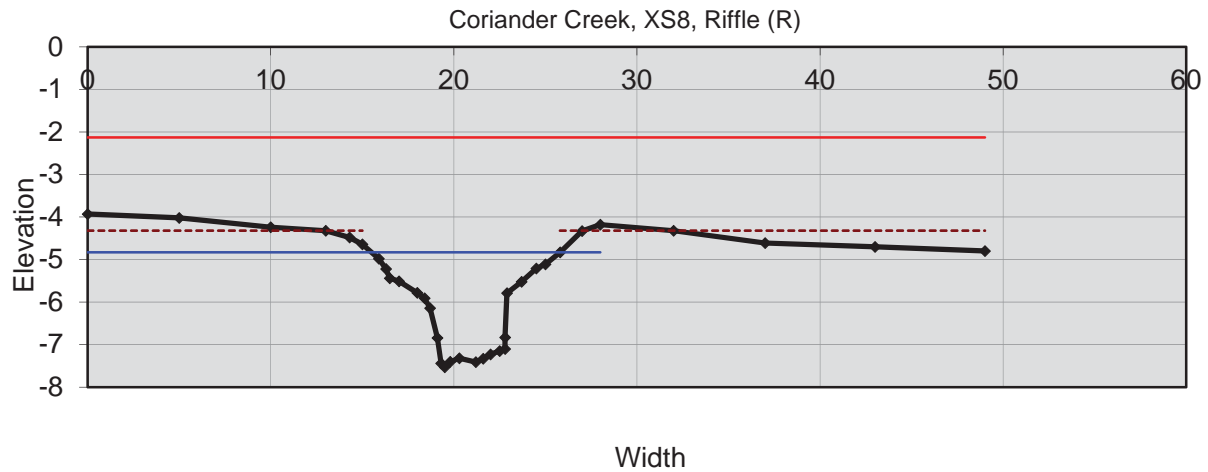
13.5	x-section area (ft.sq.)
10.3	width (ft)
1.3	mean depth (ft)
2.7	max depth (ft)
12.9	wetted parimeter (ft)
1.0	hyd radi (ft)
7.8	width-depth ratio

100.0	W flood prone area (ft)
9.7	entrenchment ratio
3.2	low bank height (ft)
1.2	low bank height ratio

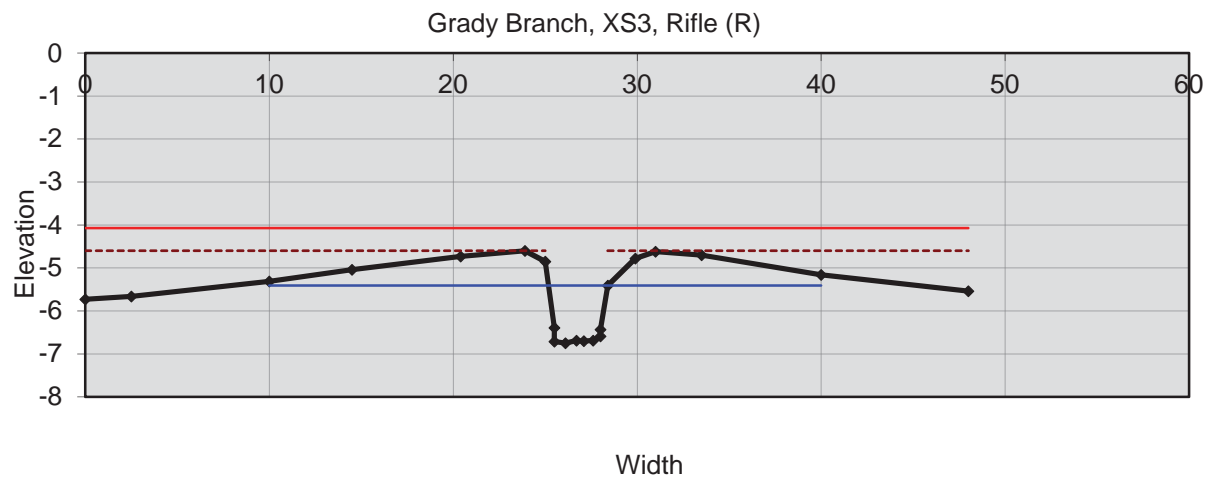
3.6	x-section area (ft.sq.)
3.2	width (ft)
1.1	mean depth (ft)
1.3	max depth (ft)
5.1	wetted parimeter (ft)
0.7	hyd radi (ft)
2.9	width-depth ratio

100.0	W flood prone area (ft)
31.1	entrenchment ratio
2.2	low bank height (ft)
1.6	low bank height ratio

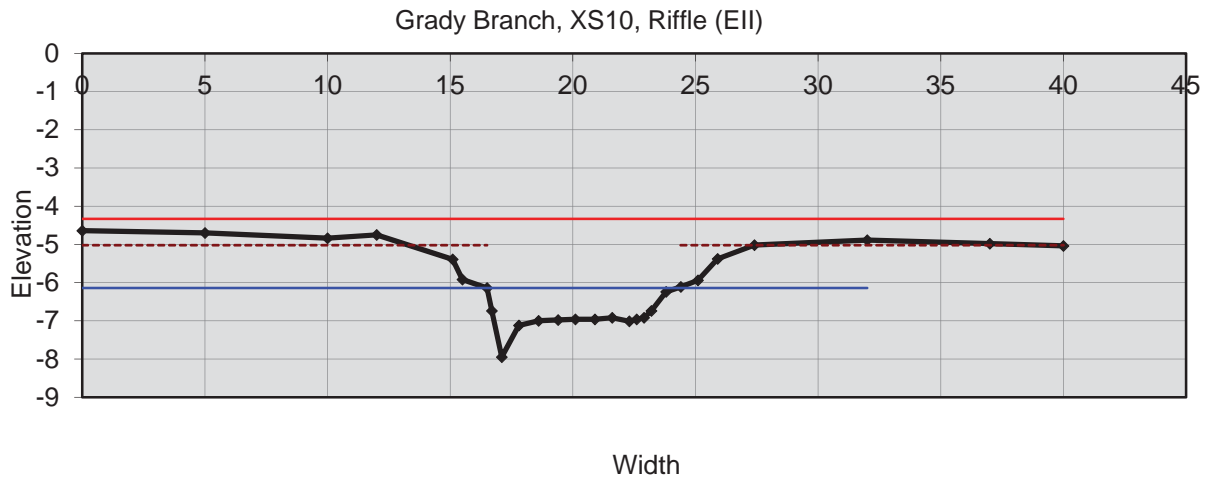
6.2	x-section area (ft.sq.)
7.8	width (ft)
0.8	mean depth (ft)
1.8	max depth (ft)
9.7	wetted parimeter (ft)
0.6	hyd radi (ft)
9.7	width-depth ratio

100.0	W flood prone area (ft)
12.9	entrenchment ratio
2.9	low bank height (ft)
1.6	low bank height ratio

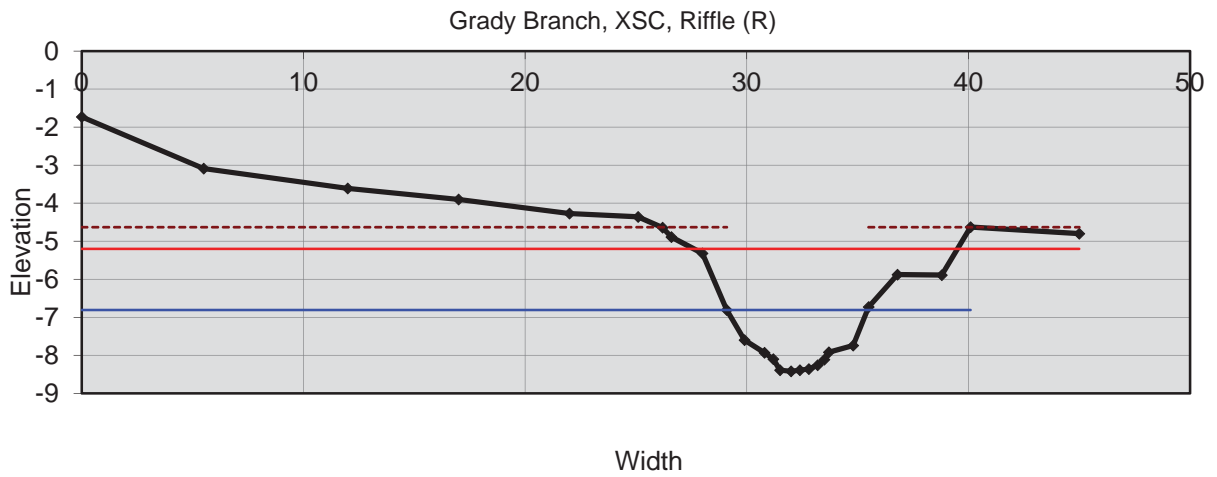
6.8	x-section area (ft.sq.)
6.3	width (ft)
1.1	mean depth (ft)
1.6	max depth (ft)
7.5	wetted parimeter (ft)
0.9	hyd radi (ft)
5.9	width-depth ratio

11.9	W flood prone area (ft)
1.9	entrenchment ratio
3.8	low bank height (ft)
2.4	low bank height ratio

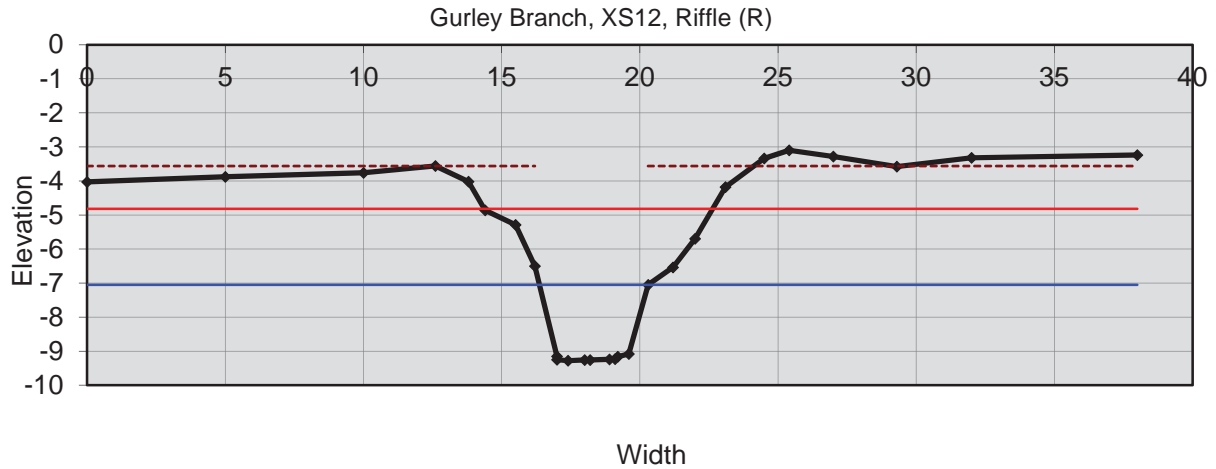
7.1	x-section area (ft.sq.)
3.9	width (ft)
1.8	mean depth (ft)
2.2	max depth (ft)
7.1	wetted parimeter (ft)
1.0	hyd radi (ft)
2.2	width-depth ratio

8.3	W flood prone area (ft)
2.1	entrenchment ratio
5.7	low bank height (ft)
2.6	low bank height ratio

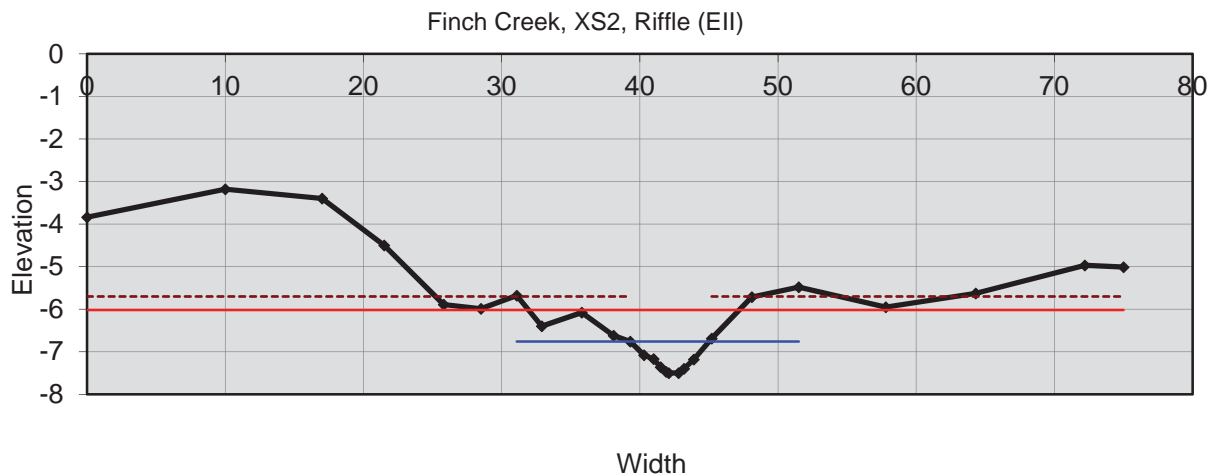
2.5	x-section area (ft.sq.)
5.7	width (ft)
0.4	mean depth (ft)
0.7	max depth (ft)
5.9	wetted parimeter (ft)
0.4	hyd radi (ft)
13.2	width-depth ratio

15.2	W flood prone area (ft)
2.7	entrenchment ratio
1.8	low bank height (ft)
2.4	low bank height ratio

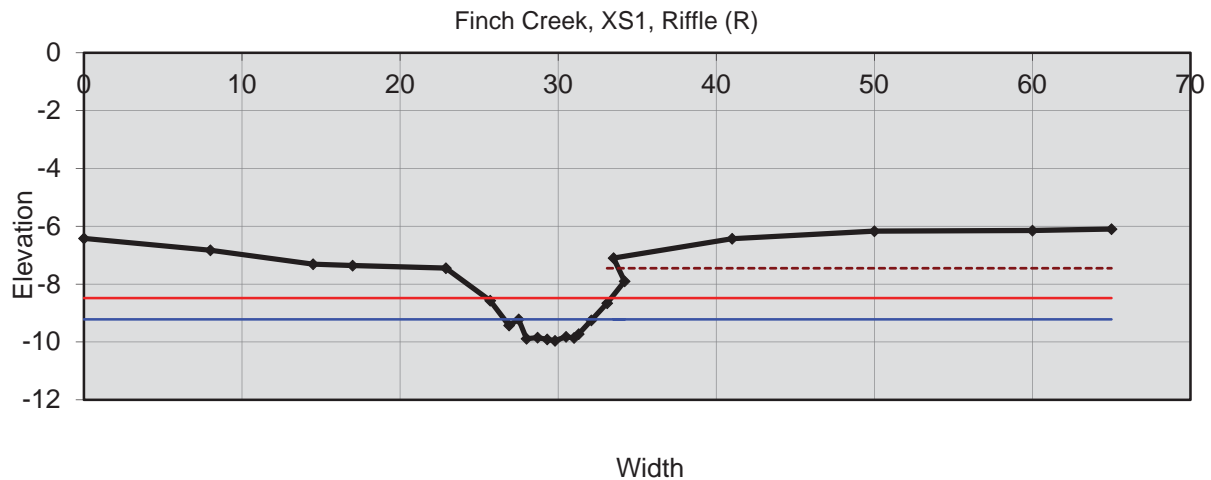
2.6	x-section area (ft.sq.)
5.5	width (ft)
0.5	mean depth (ft)
0.7	max depth (ft)
6.2	wetted parimeter (ft)
0.4	hyd radi (ft)
11.7	width-depth ratio

7.9	W flood prone area (ft)
1.4	entrenchment ratio
2.5	low bank height (ft)
3.4	low bank height ratio

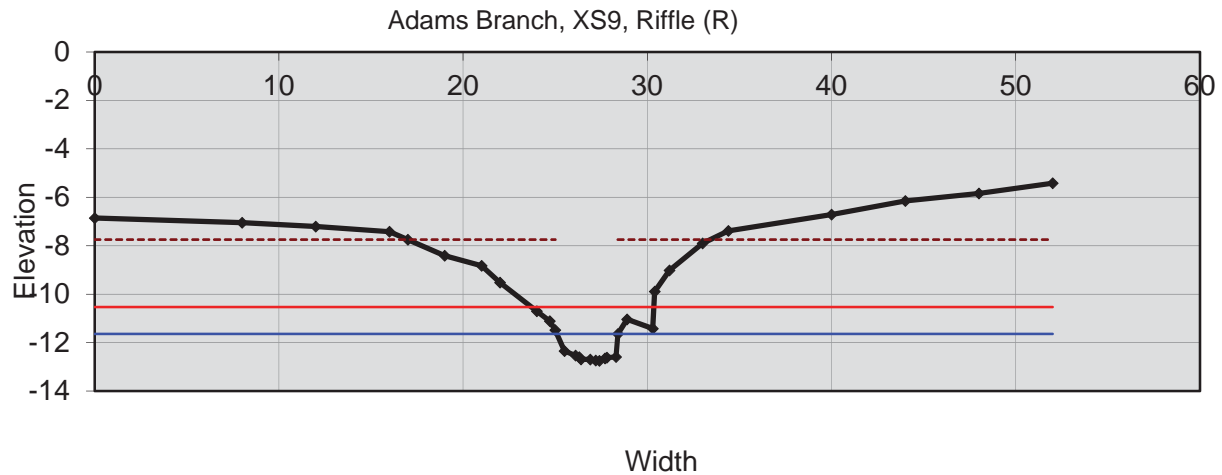
2.9	x-section area (ft.sq.)
3.3	width (ft)
0.9	mean depth (ft)
1.1	max depth (ft)
4.7	wetted parimeter (ft)
0.6	hyd radi (ft)
3.7	width-depth ratio

6.6	W flood prone area (ft)
2.0	entrenchment ratio
5.0	low bank height (ft)
4.5	low bank height ratio

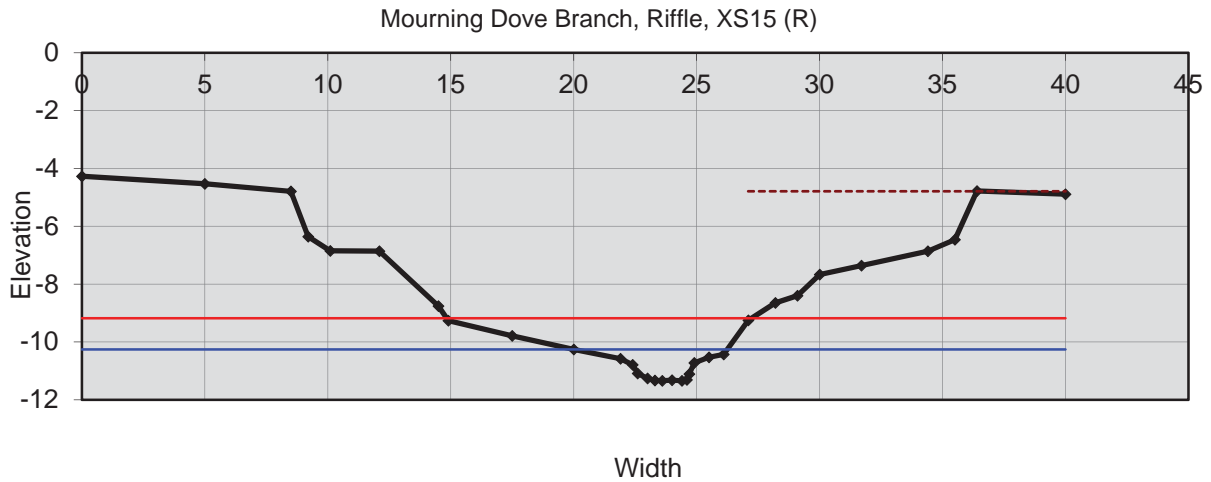
3.3	x-section area (ft.sq.)
6.2	width (ft)
0.5	mean depth (ft)
1.1	max depth (ft)
7.0	wetted parimeter (ft)
0.5	hyd radi (ft)
11.8	width-depth ratio

12.4	W flood prone area (ft)
2.0	entrenchment ratio
6.6	low bank height (ft)
6.1	low bank height ratio

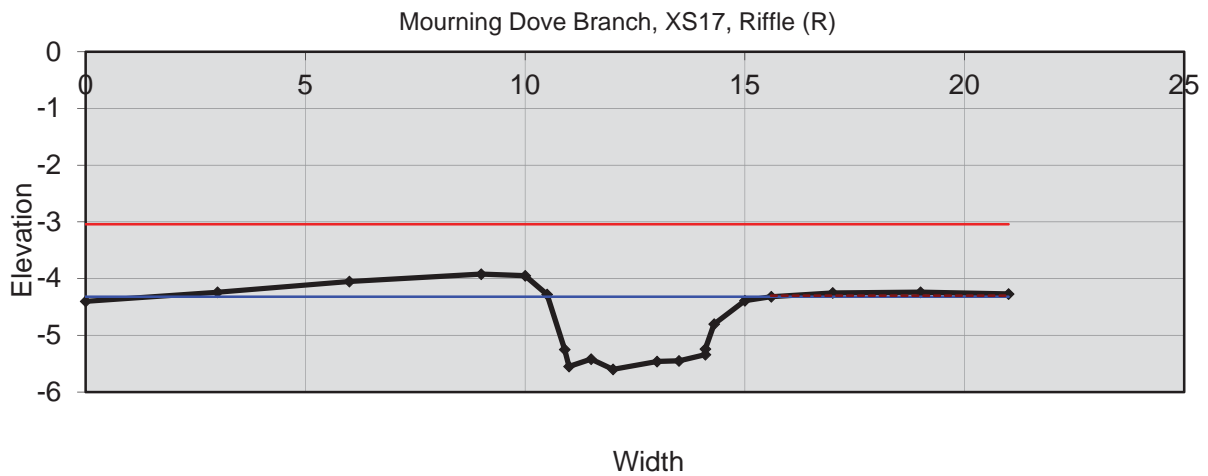
4.3	x-section area (ft.sq.)
6.6	width (ft)
0.7	mean depth (ft)
1.3	max depth (ft)
8.0	wetted parimeter (ft)
0.5	hyd radi (ft)
10.1	width-depth ratio

100.0	W flood prone area (ft)
15.2	entrenchment ratio
1.3	low bank height (ft)
1.0	low bank height ratio

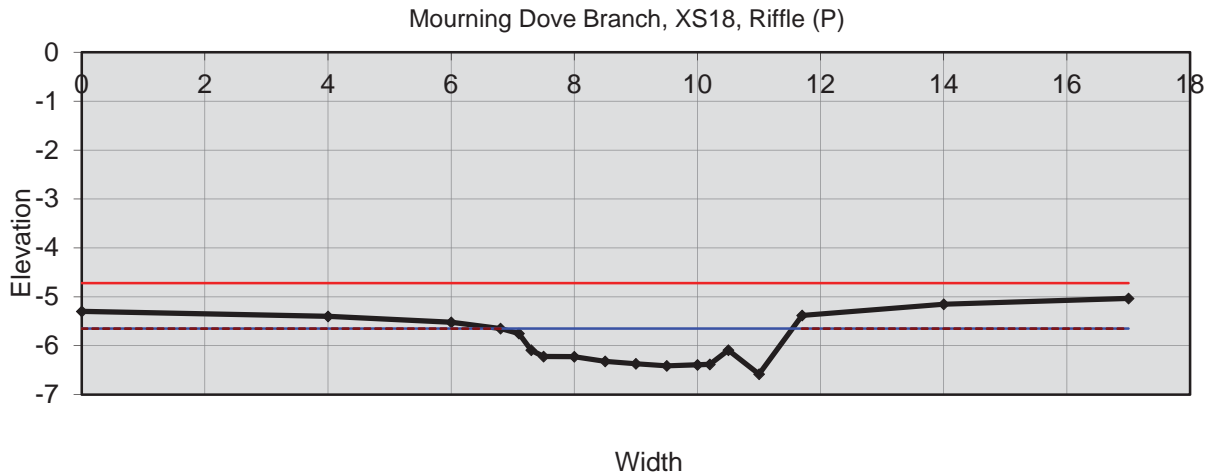
2.8	x-section area (ft.sq.)
4.7	width (ft)
0.6	mean depth (ft)
0.9	max depth (ft)
5.9	wetted parimeter (ft)
0.5	hyd radi (ft)
8.1	width-depth ratio

100.0	W flood prone area (ft)
21.1	entrenchment ratio
0.9	low bank height (ft)
1.0	low bank height ratio

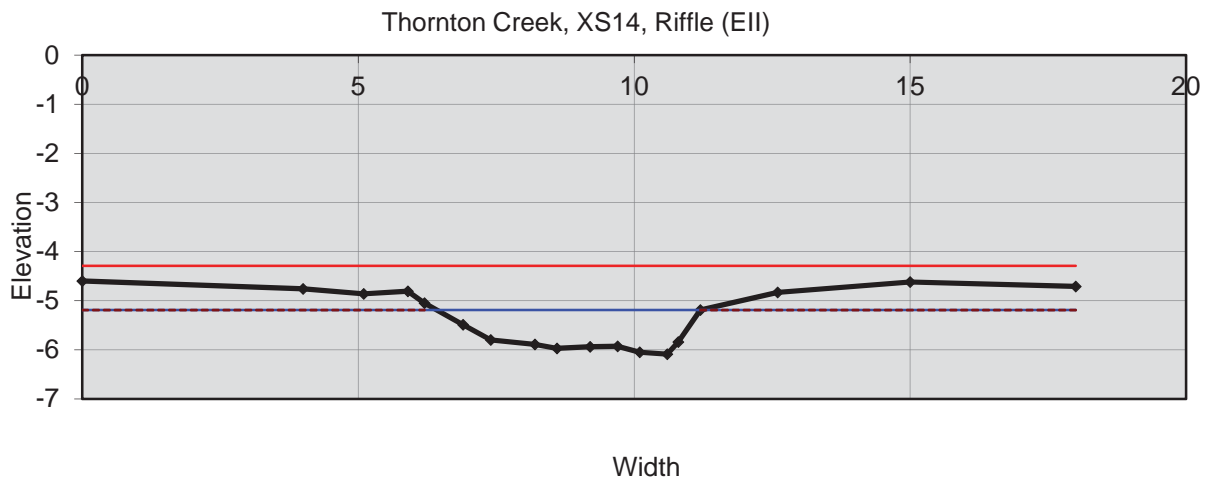
3.0	x-section area (ft.sq.)
4.8	width (ft)
0.6	mean depth (ft)
0.9	max depth (ft)
5.5	wetted parimeter (ft)
0.5	hyd radi (ft)
7.6	width-depth ratio

50.0	W flood prone area (ft)
10.5	entrenchment ratio
0.9	low bank height (ft)
1.0	low bank height ratio

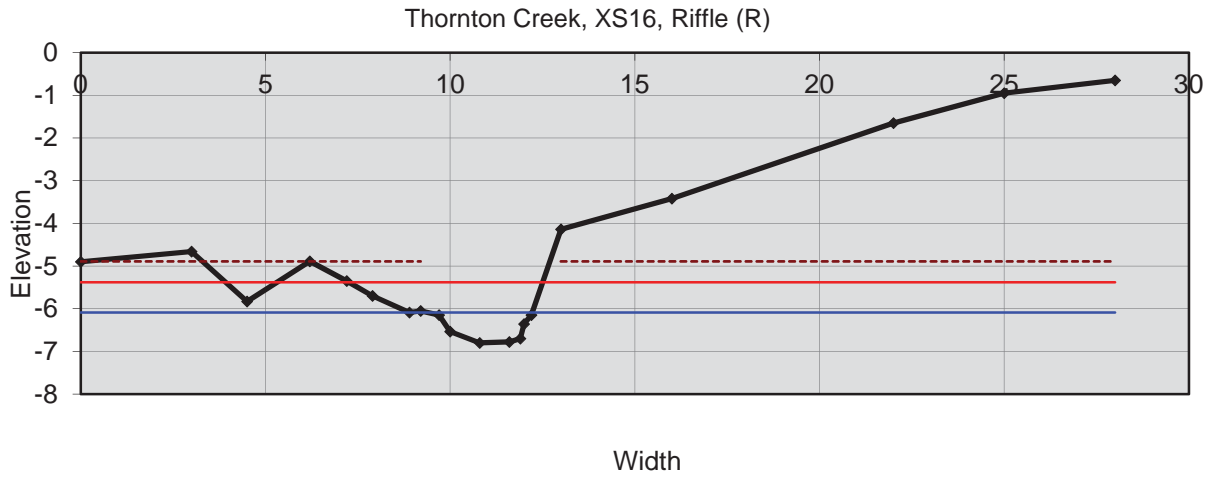
1.4	x-section area (ft.sq.)
2.8	width (ft)
0.5	mean depth (ft)
0.7	max depth (ft)
3.5	wetted parimeter (ft)
0.4	hyd radi (ft)
5.8	width-depth ratio

6.6	W flood prone area (ft)
2.4	entrenchment ratio
1.9	low bank height (ft)
2.7	low bank height ratio

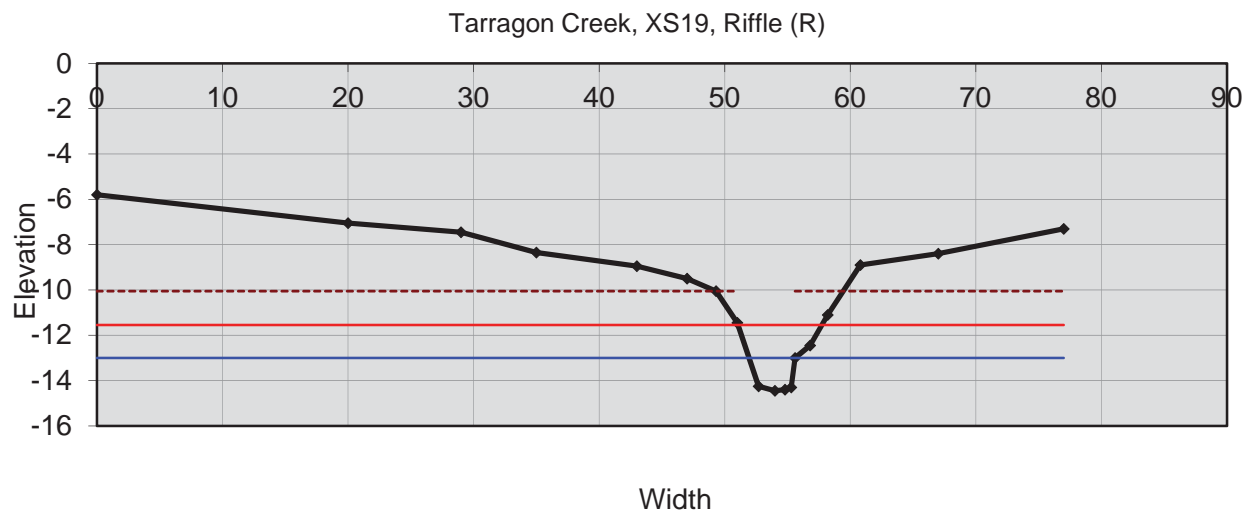
4.2	x-section area (ft.sq.)
3.7	width (ft)
1.2	mean depth (ft)
1.5	max depth (ft)
5.4	wetted parimeter (ft)
0.8	hyd radi (ft)
3.2	width-depth ratio

6.7	W flood prone area (ft)
1.8	entrenchment ratio
4.4	low bank height (ft)
3.0	low bank height ratio

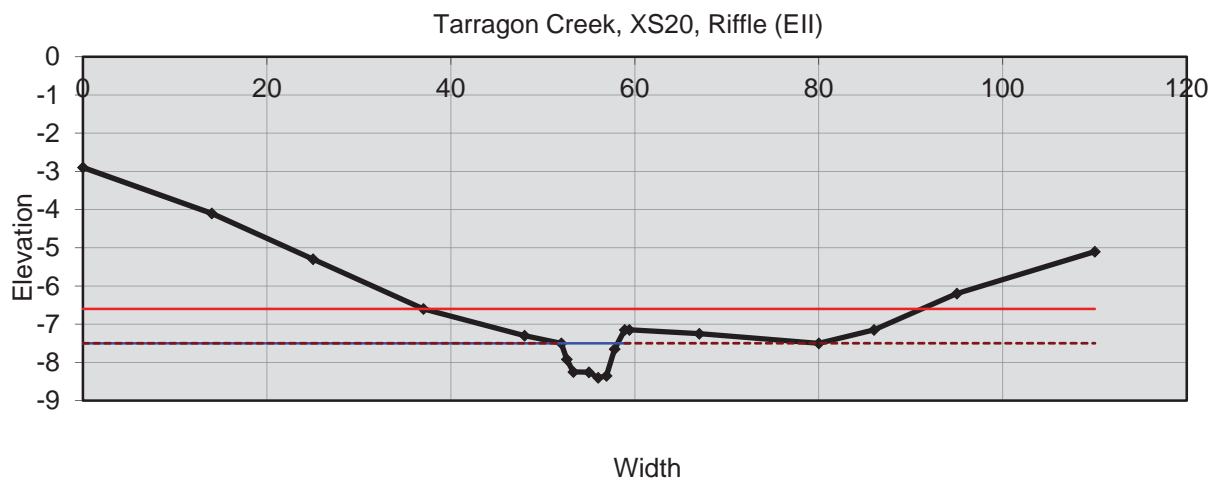
3.9	x-section area (ft.sq.)
6.1	width (ft)
0.6	mean depth (ft)
0.9	max depth (ft)
6.6	wetted parimeter (ft)
0.6	hyd radi (ft)
9.6	width-depth ratio

54.2	W flood prone area (ft)
8.8	entrenchment ratio
0.9	low bank height (ft)
1.0	low bank height ratio

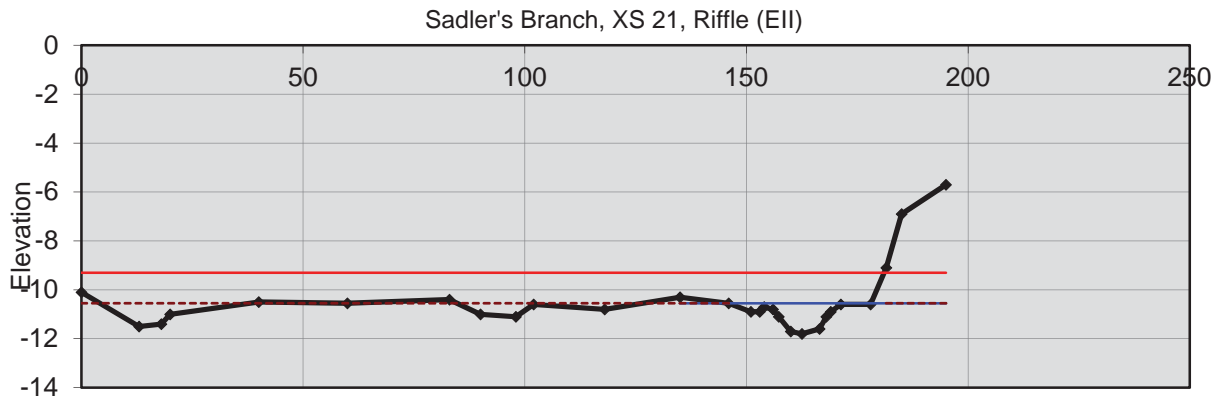
200.0	W flood prone area (ft)
6.2	entrenchment ratio
1.3	low bank height (ft)
1.0	low bank height ratio

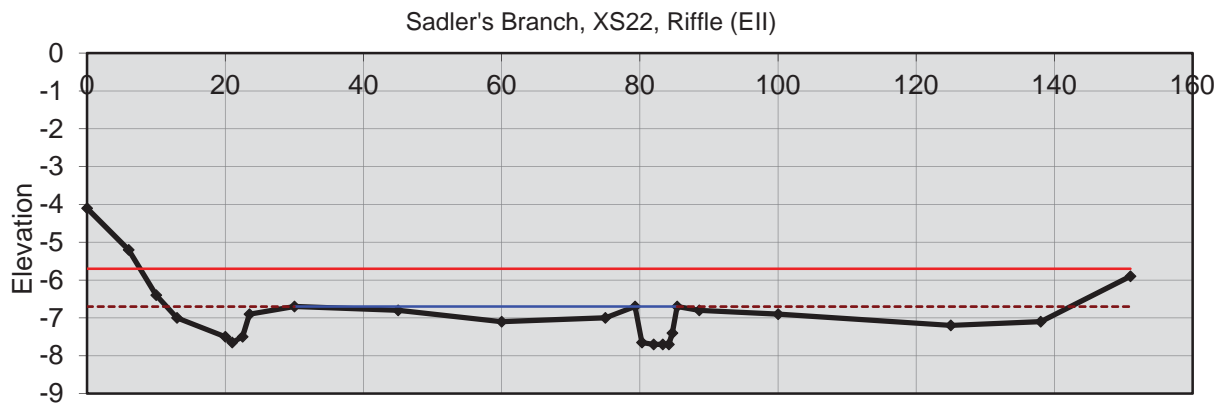
143.0	W flood prone area (ft)
2.6	entrenchment ratio
1.0	low bank height (ft)
1.0	low bank height ratio

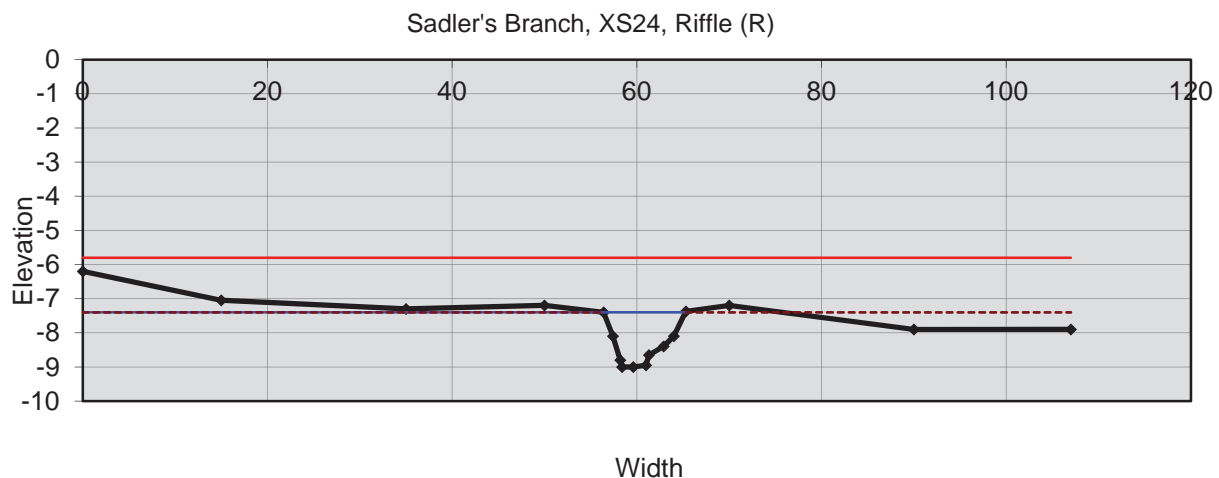
9.2	x-section area (ft.sq.)
8.8	width (ft)
1.0	mean depth (ft)
1.6	max depth (ft)
9.8	wetted parimeter (ft)
0.9	hyd radi (ft)
8.5	width-depth ratio

200.0	W flood prone area (ft)
22.6	entrenchment ratio
1.6	low bank height (ft)
1.0	low bank height ratio

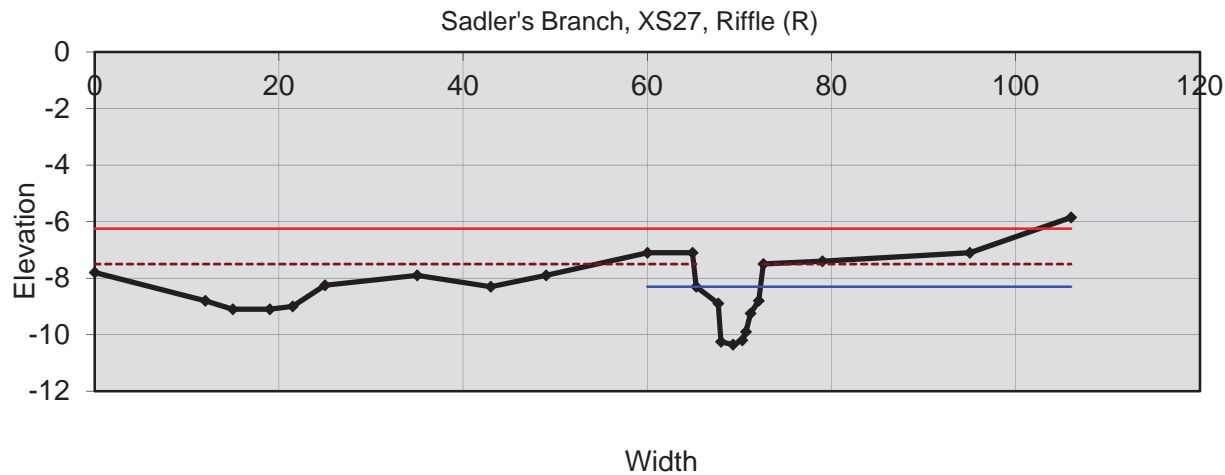
7.7	x-section area (ft.sq.)
7.0	width (ft)
1.1	mean depth (ft)
2.1	max depth (ft)
9.0	wetted parimeter (ft)
0.9	hyd radi (ft)
6.3	width-depth ratio

102.5	W flood prone area (ft)
14.7	entrenchment ratio
2.9	low bank height (ft)
1.4	low bank height ratio

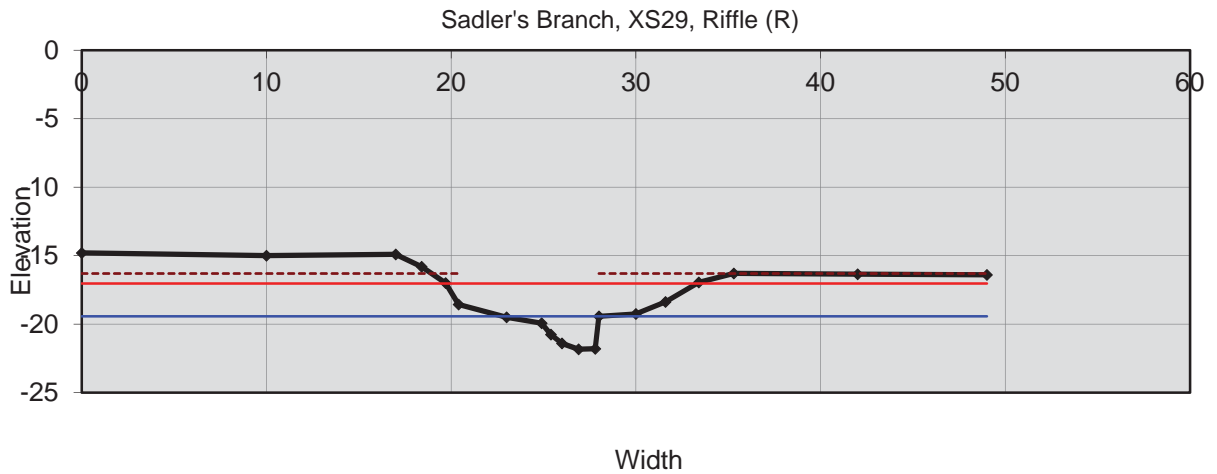
6.3	x-section area (ft.sq.)
5.2	width (ft)
1.2	mean depth (ft)
2.4	max depth (ft)
8.3	wetted parimeter (ft)
0.8	hyd radi (ft)
4.3	width-depth ratio

13.6	W flood prone area (ft)
2.6	entrenchment ratio
5.5	low bank height (ft)
2.3	low bank height ratio

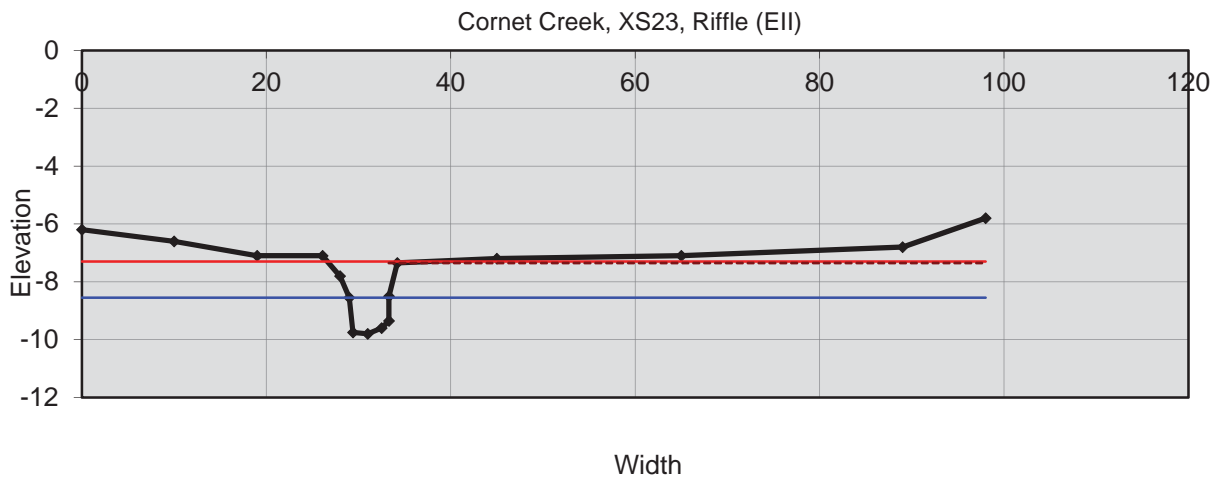
4.7	x-section area (ft.sq.)
4.3	width (ft)
1.1	mean depth (ft)
1.3	max depth (ft)
6.0	wetted parimeter (ft)
0.8	hyd radi (ft)
4.0	width-depth ratio

11.2	W flood prone area (ft)
2.6	entrenchment ratio
2.5	low bank height (ft)
2.0	low bank height ratio

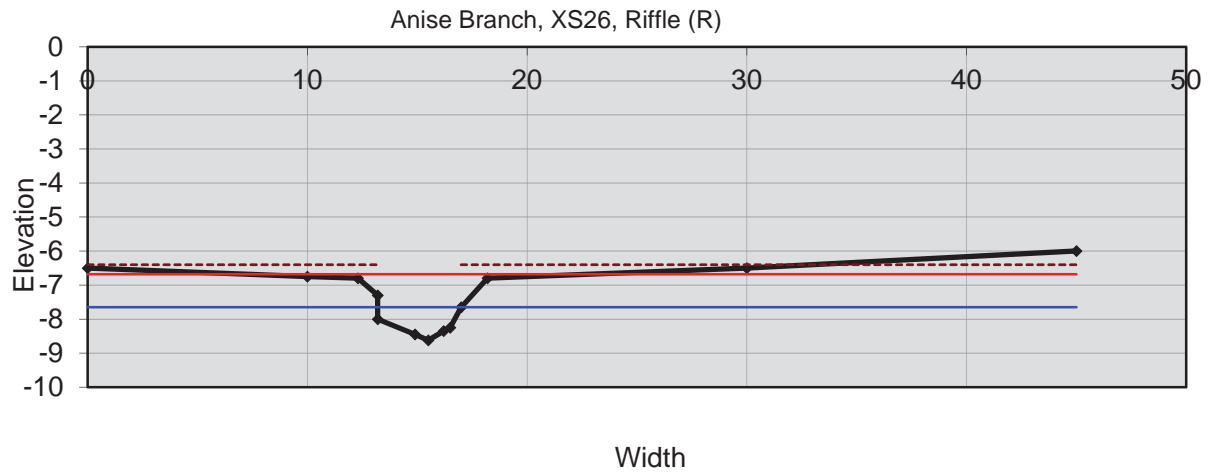
2.4	x-section area (ft.sq.)
3.8	width (ft)
0.6	mean depth (ft)
1.0	max depth (ft)
4.6	wetted parimeter (ft)
0.5	hyd radi (ft)
5.9	width-depth ratio

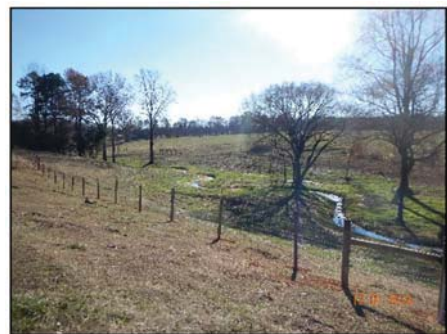
### **Hopewell Stream Mitigation Site – Randolph County, NC.**

Wildlands recently constructed a full-delivery project in Randolph County on unnamed tributaries to Little River in January, 2015. The project provided 7,436 SMUs for NCDMS
