# Prospectus

## Falling Creek Mitigation Site

Wayne County, NC

USACE Action ID No. 2015-00940

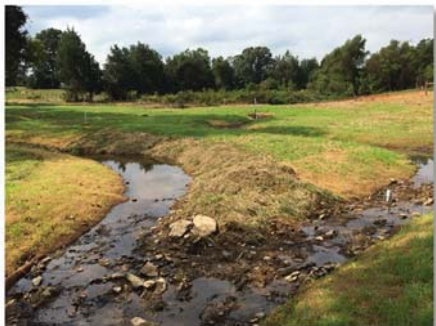
**Agony Acres Stream and Buffer Mitigation Site – Guilford County, NC.** Wildlands is currently performing ecological restoration work for DMS at a full-delivery site in Guilford County, north of the Town of Gibsonville. The project will provide 6,488 SMUs and 3.0 BMUs on four unnamed tributaries to Reedy Fork in the Cape Fear River Basin. The project includes categorical exclusion documentation, existing conditions assessment, landowner coordination, conservation easement acquisition, stream restoration design, permitting, construction, and seven years of post-construction monitoring. Construction was completed in summer 2014.

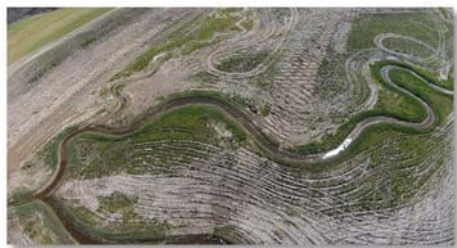
#### Devil's Racetrack Mitigation Site – Johnston County, NC.

Wildlands is currently performing ecological restoration work at a site in Johnston County, east of the Town of Four Oaks. The full-delivery project will provide 18,527 SMUs and 67 Riparian WMUs on several unnamed tributaries to the Neuse River for DMS. The project includes categorical exclusion documentation, existing conditions assessment, landowner coordination, conservation easement acquisition, stream and wetland restoration design, permitting, construction, and seven years of post-construction monitoring. Wildlands has completed

the categorical exclusion documentation, design, permitting, and easement acquisition for this site. Construction of the project was completed in early 2014.
