Village of Bald Head Island Terminal Groin Project

Bald Head Creek Borrow Site Expansion Geotechnical Analysis

Bald Head Island, N.C.

**Geotechnical Investigation of Bald Head Creek
Bald Head Island, North Carolina**

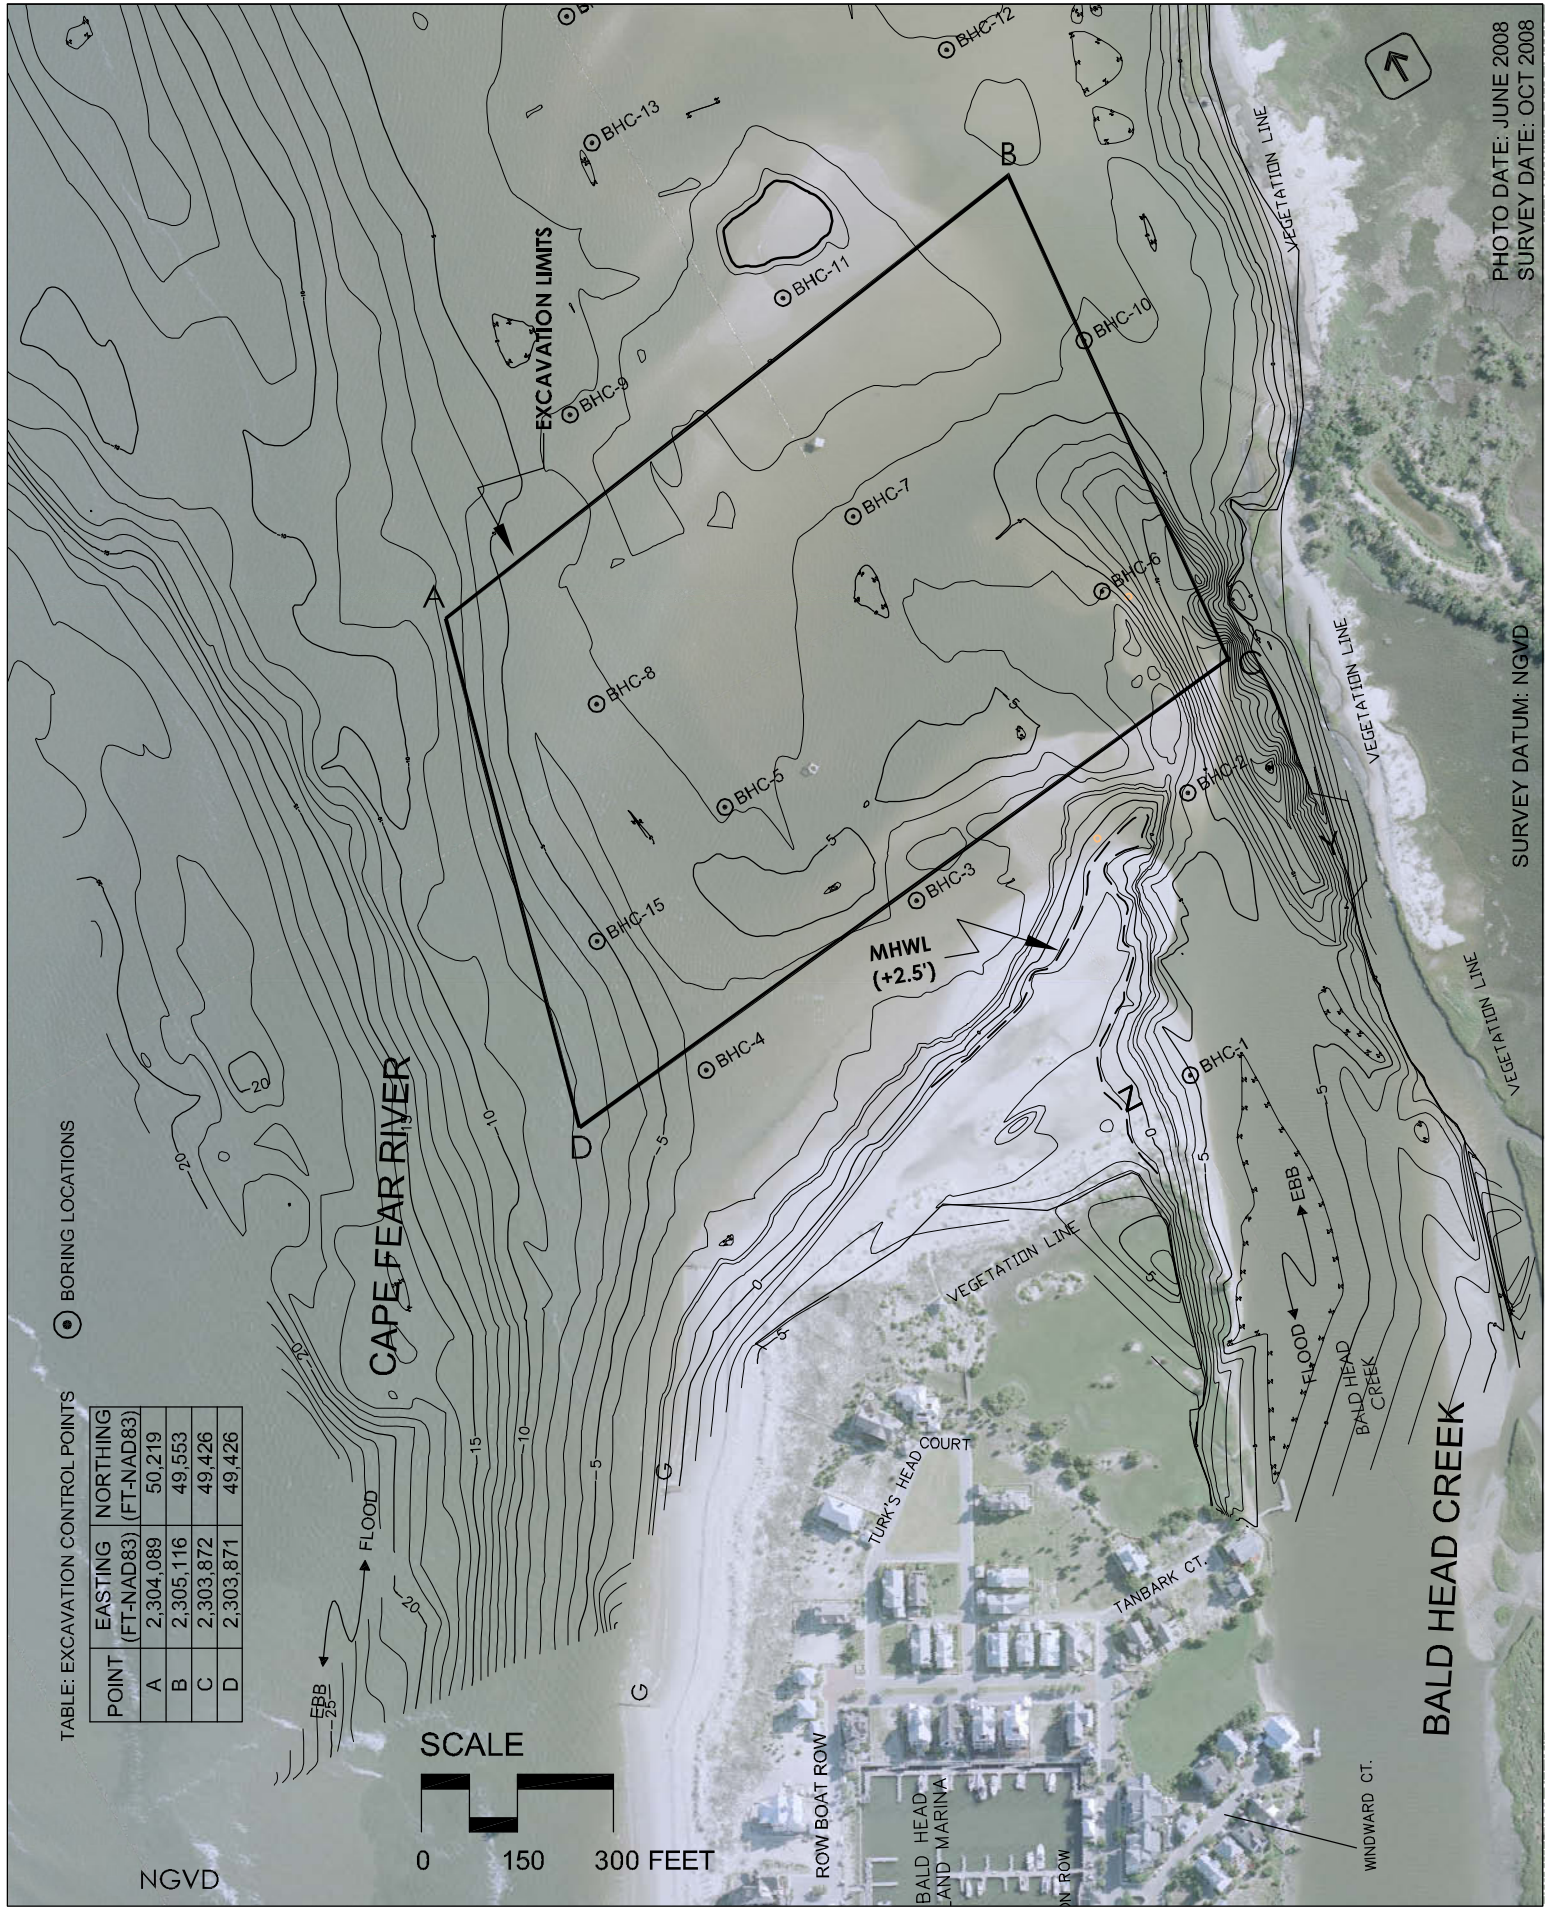
FIGURE 1 - ORIGINAL BALD HEAD CREEK BORROW SITE (PRE-DREDGE CONDITION)

A 21.34 acre ebb shoal borrow site (see **Figure 1**) was previously permitted at the mouth of Bald Head Creek in 2010 (ref. CAMA 139-10; DWQ #040561V3; COE-2009-02334). In

2006, approximately 47,800 cy had been dredged from the Creek mouth and placed along West Beach as a small scale beach restoration project located between baseline Sta. 16+00 and Sta. 34+00 (CAMA 02-05).

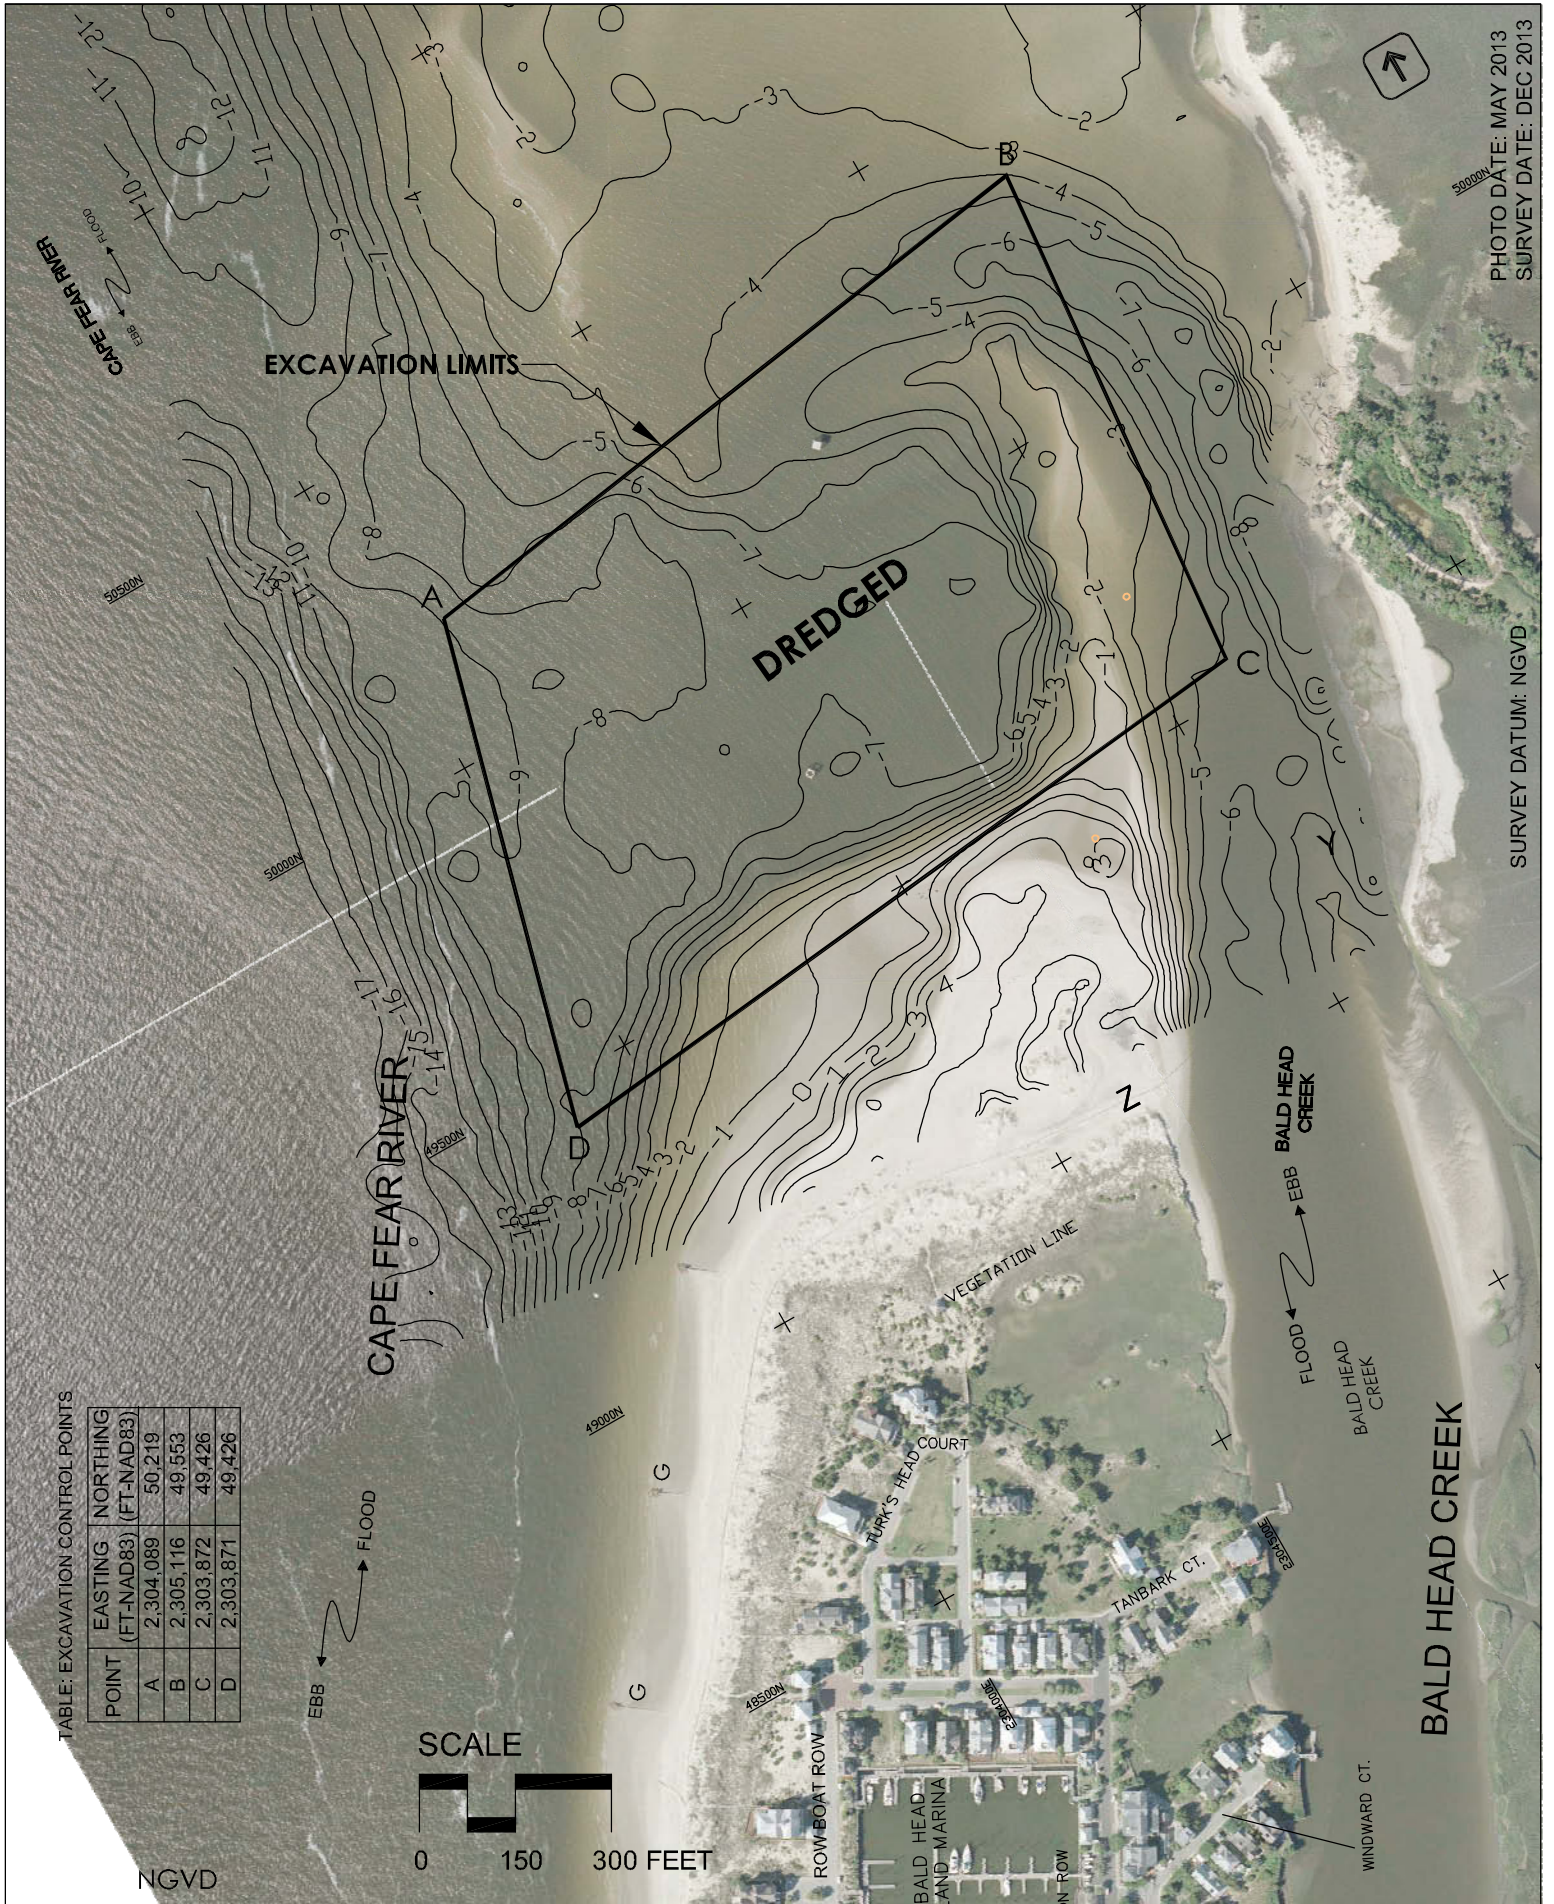
FIGURE 2 - ORIGINAL BALD HEAD CREEK BORROW SITE (POST-DREDGE CONDITION)

In 2012, following the offshore passage of Hurricane Irene, an *emergency* level beach fill operation partially funded by F.E.M.A. was performed along both West Beach and the westernmost segment of South Beach utilizing the 2010 permitted Bald Head Creek borrow site material. The total amount dredged at that time was 137,990 cy. This essentially depleted the majority of the sand potentially available within the limits of the 21.34 acre ebb shoal borrow site (see **Figure 2**).

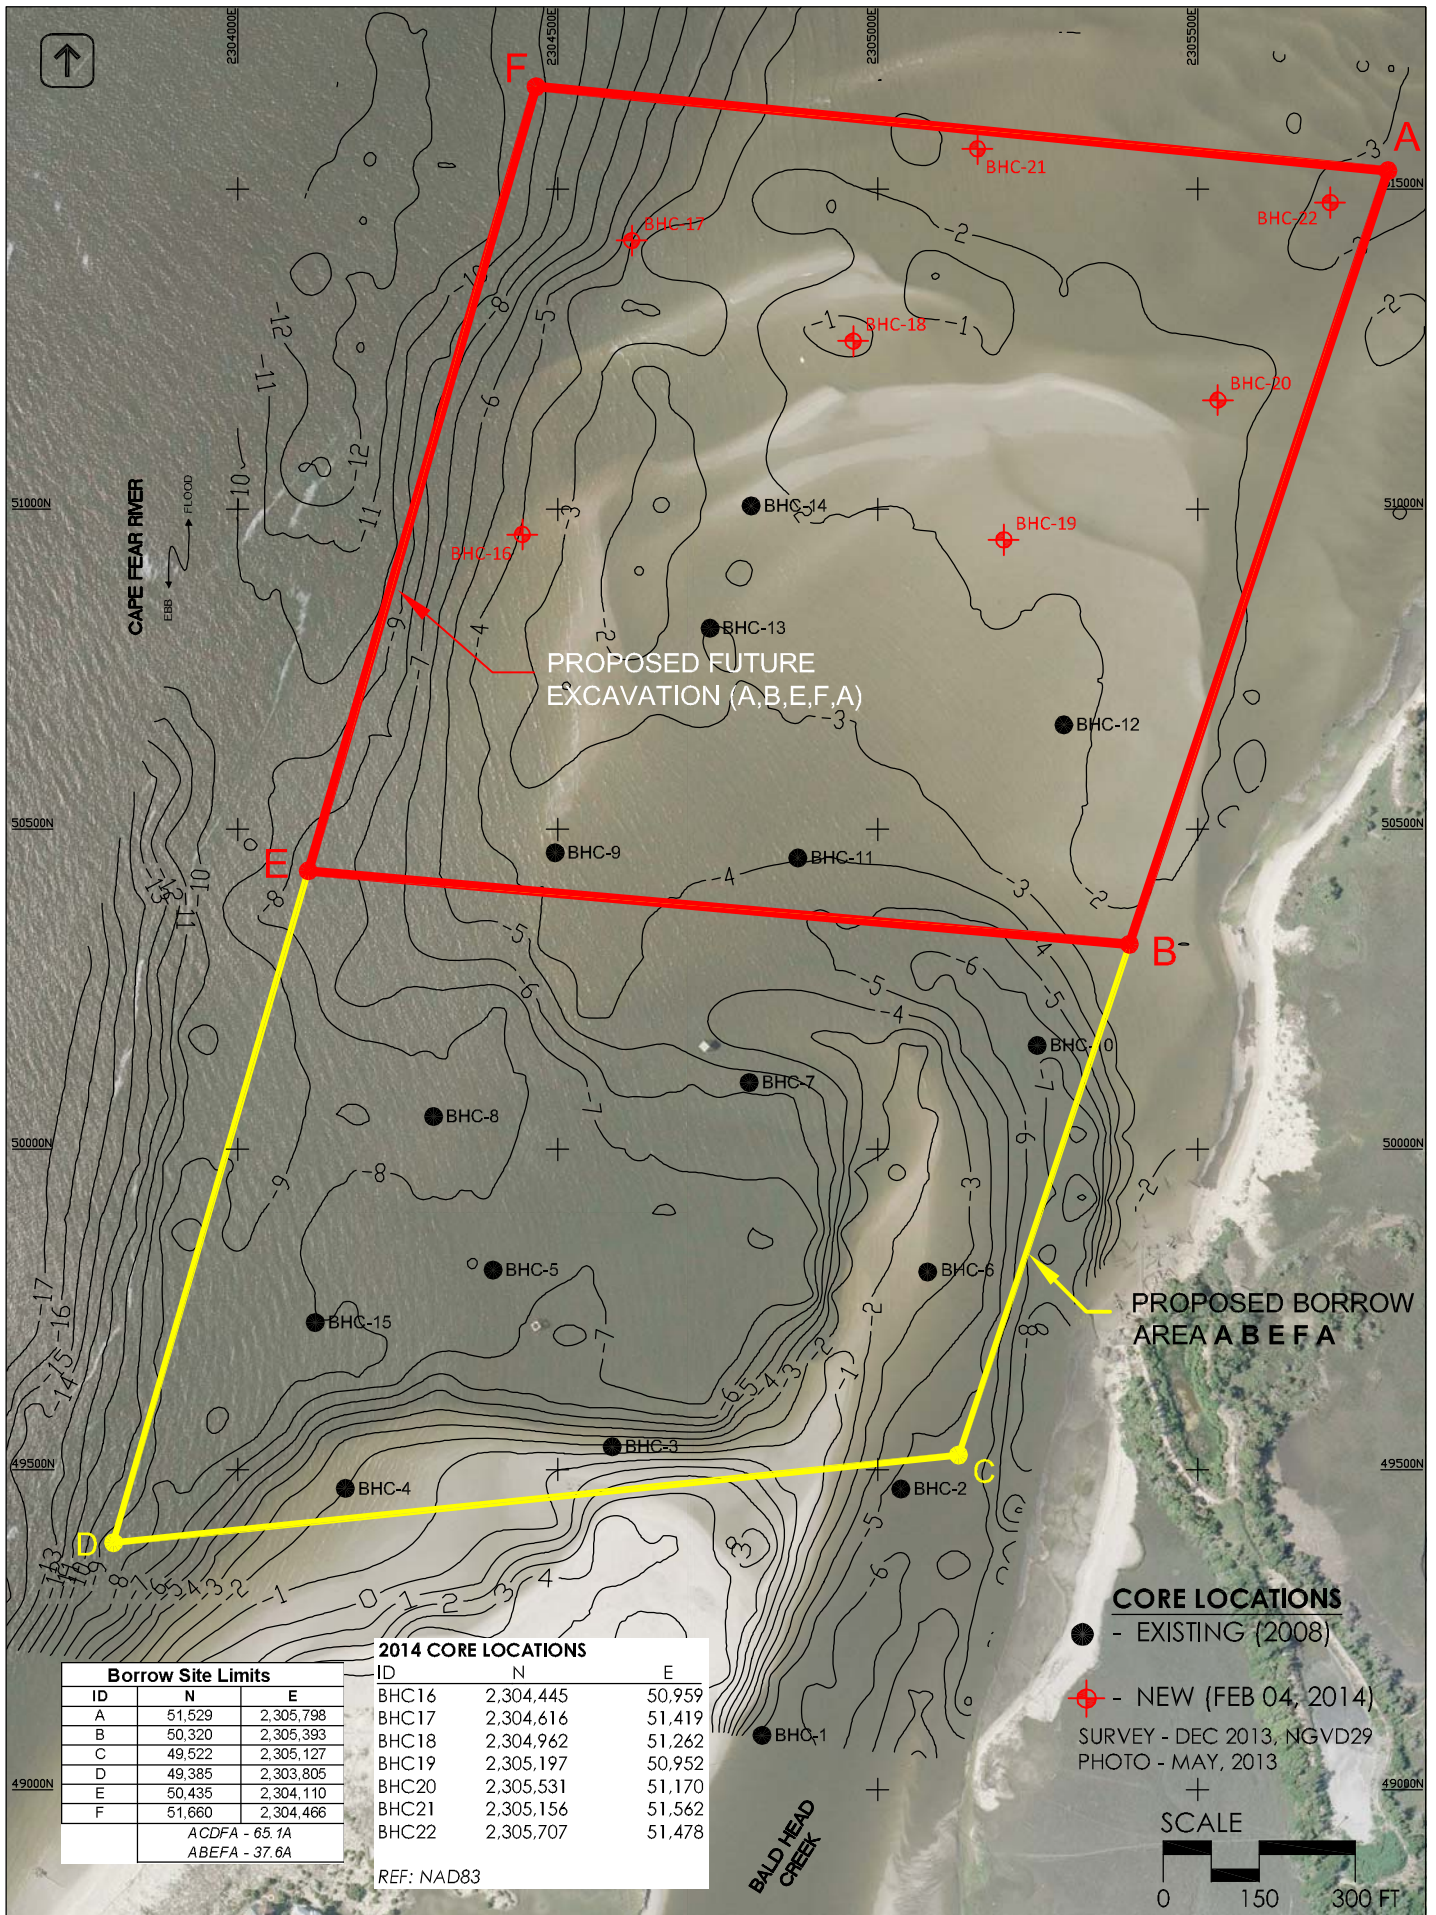
FIGURE 4 - LOCATION OF VIBRACORES

In January 2014, ATI was contracted by Olsen Associates, Inc. to collect additional geotechnical Vibracore samples for the Village northward of the entrance to Bald Head Creek. More specifically, the firm was directed to acquire seven (7) additional cores (designated as BHC-16 through BHC-22) at predetermined locations to a depth of ten (10) ft., mol below the existing seabed. Subsequently the Vibracores were logged, photographed and sub-sampled for grain size and carbonate content. A depiction of the twenty two (22) locations representing both the 2008 and 2014 Vibracores sampling programs are represented by **Figure 4**.

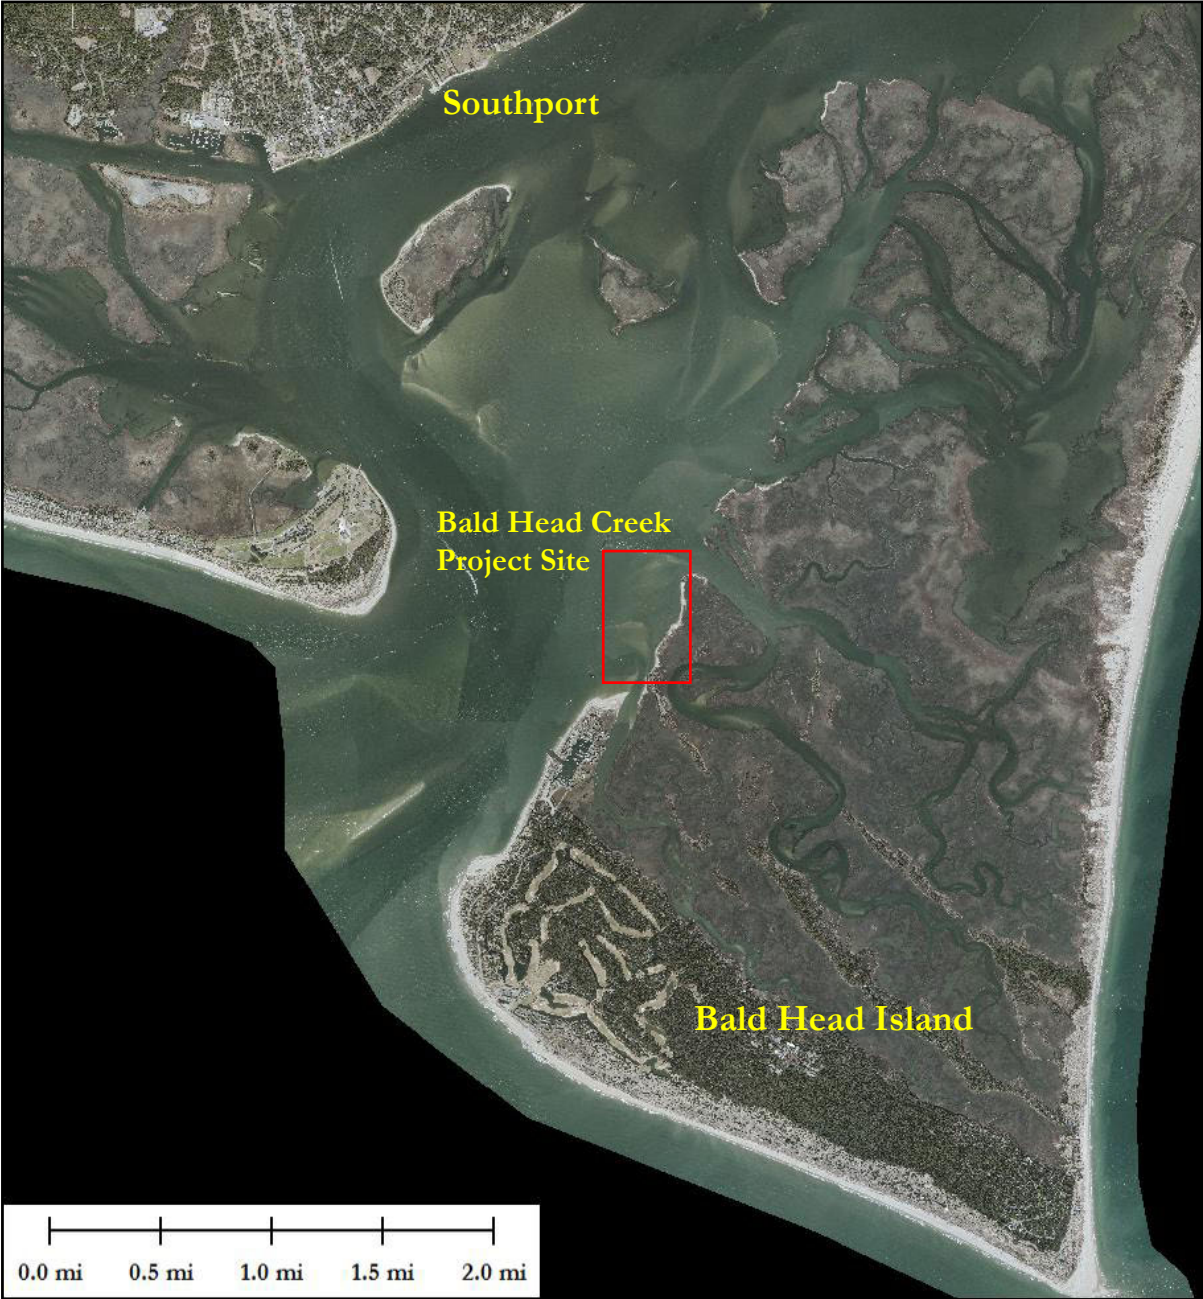
Figure 1: Bald Head Creek Site Map

The project site is located adjacent to Bald Head Island in Brunswick County, North Carolina. The site is positioned between the Cape Fear River to the west and the Smith Island back-barrier marsh sequence to the east and north. The Village of Bald Head Island borders the site to the south. A map of the study area has been included as **Figure 1**.

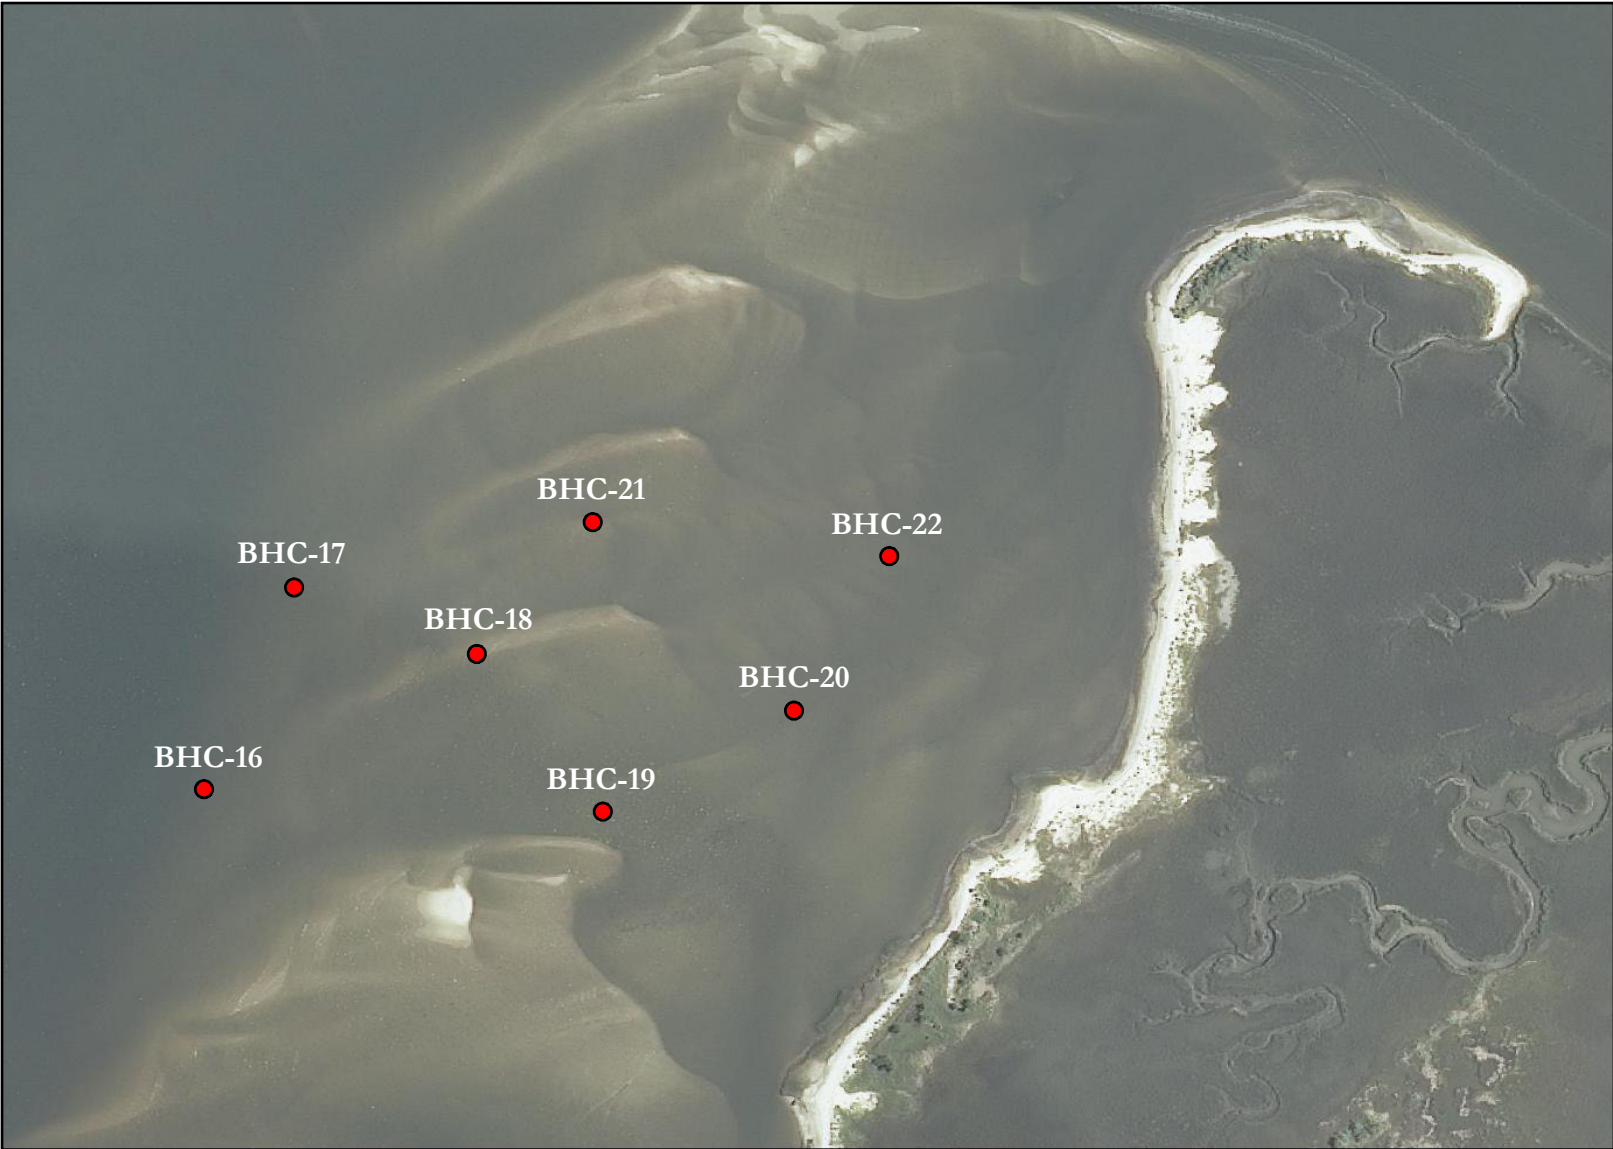
Figure 2: Bald Head Creek Vibracore Location Map

Athena mobilized to Southport, NC on February 3, 2014 in preparation for field sampling. Field sampling commenced and concluded on February 4. Sampling was schedule around a flooding tidal cycle in order to ensure that the sample locations could be accessed via vessel. Water depths at the sample sites averaged 4.6 feet, with a maximum depth of 6.4 feet at BHC-16, and a minimum of 3.0 feet at BHC-18. The wind direction was approximately 10 miles per hour (mph), with gusts to 20 mph, out of the North. The shallow water depths and predominant wind direction resulted in choppy conditions on top of the shoal complex. The average vibracore penetration and recovery for the Bald Head Creek cores was 10.4 and 8.6 feet, respectively. A map outlining the Bald Head Creek vibracore locations has been included as **Figure 2**.

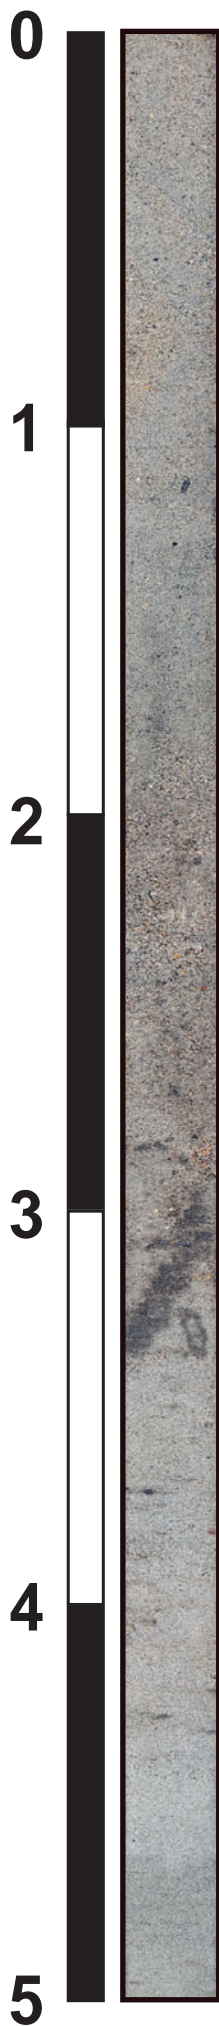
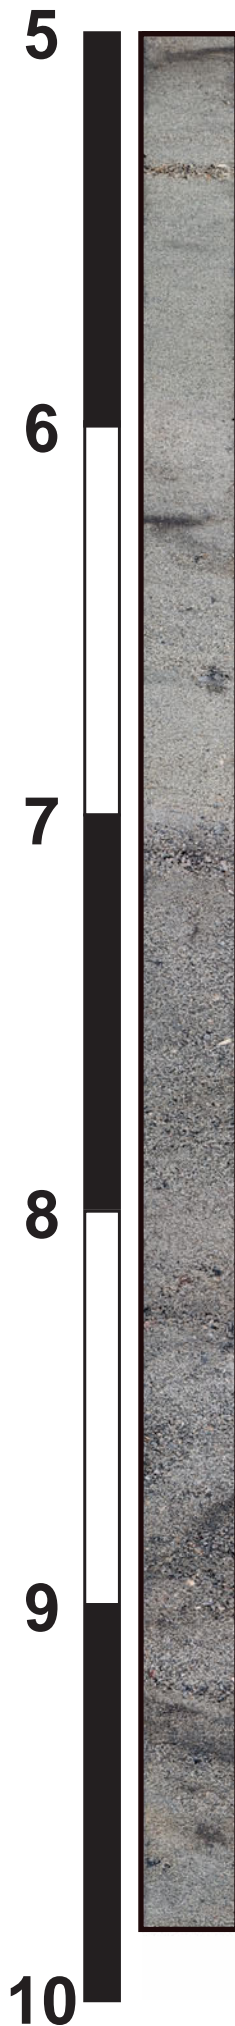
**Bald Head Island
North Carolina
BHC-16**

-13.2	9.3		Medium quartz SAND, few medium sand size shell, fine sand in layers, poorly graded, subrounded, bi-directional bedding present, gray (2.5Y-6/1), (SP).			
-13.7	9.8		Fine to medium quartz SAND, trace silt (in layers), trace fine sand size shell, poorly graded, subrounded, gray (2.5Y-6/1), (SP).			
			End of Boring

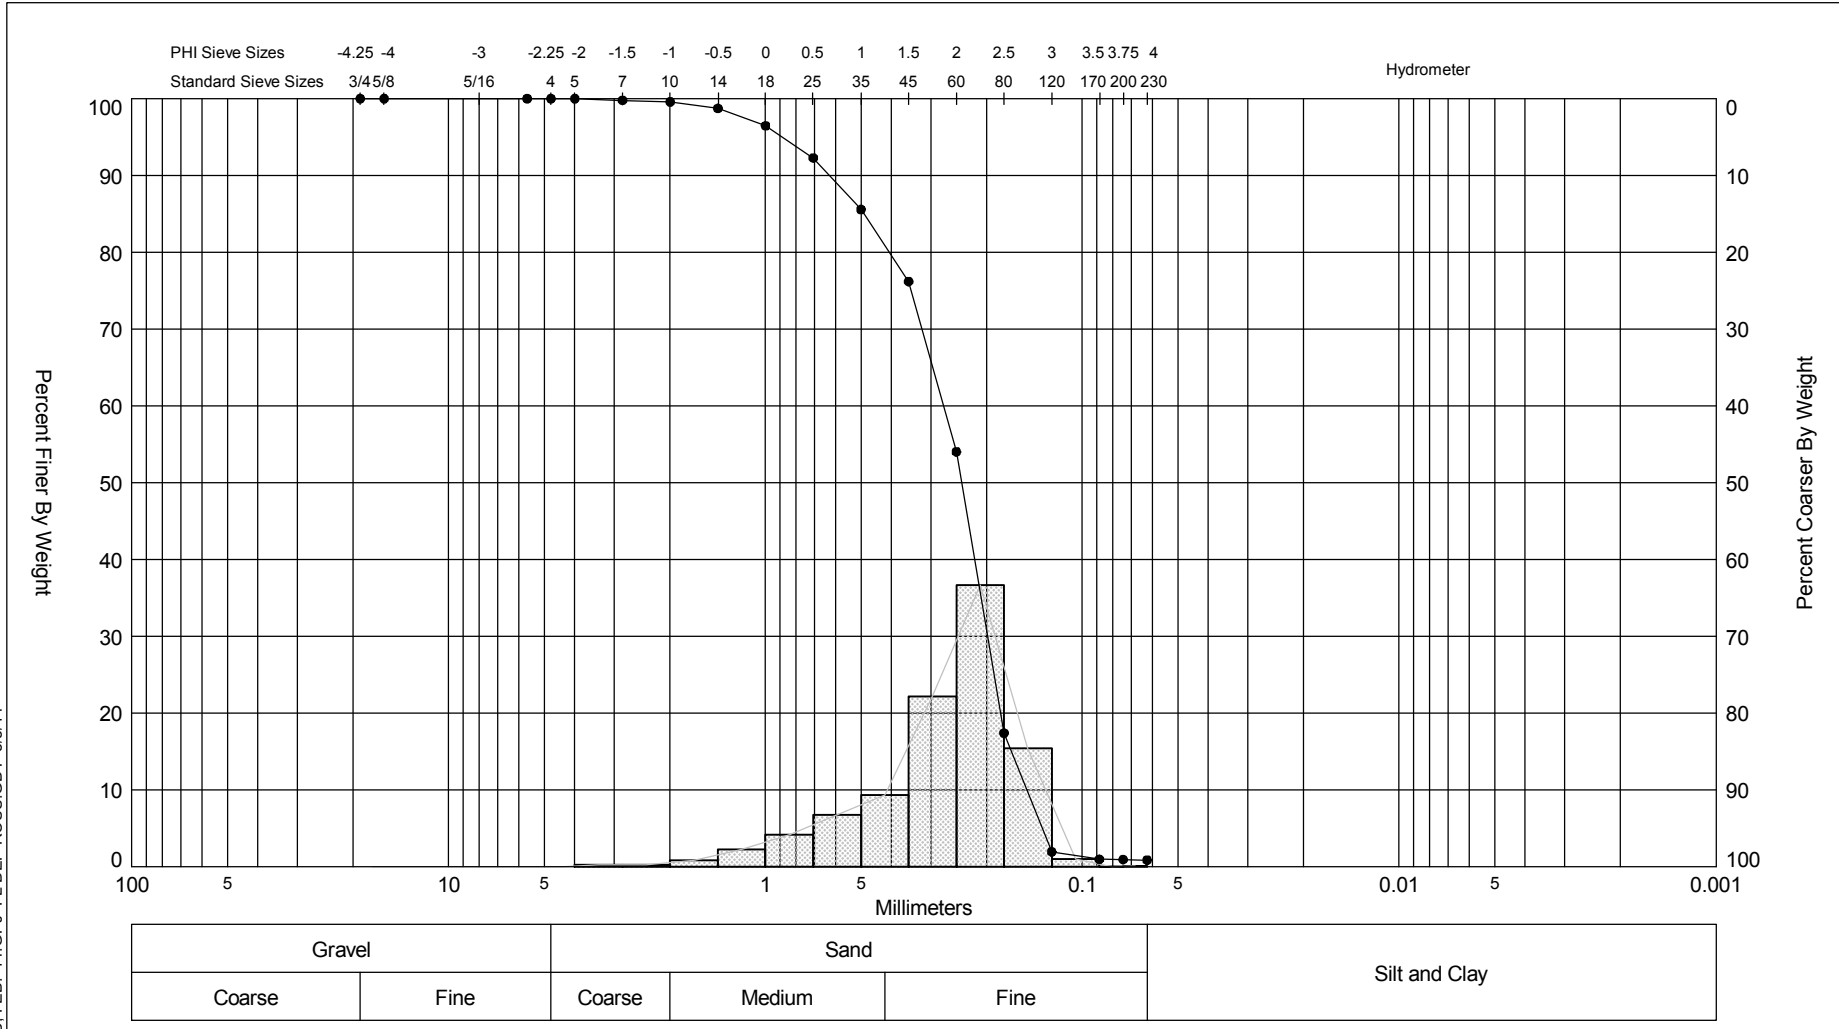
SIEVE ANALYSIS: BALD HEAD CREEK, NC, FEB. '14.GPJ FL DEP ROSS.GDT 3/3/14

Sample	Symbol	Elev. (ft)	USCS	% Fines	% Organics	% Carbonates	Median	Mean	Skew	Kurt	Sort	Sample Information	
BHC-16 #1	—●—	-3.9	SP	#200 - 0.93 #230 - 0.86		8.00	2.05	1.85	-1.23	4.7	0.8	Project Name:	Village of Bald Head Island
Comments:												Analysis Date:	02-17-14
Depths and elevations based on measured values												Analyzed By:	CRM Sr.

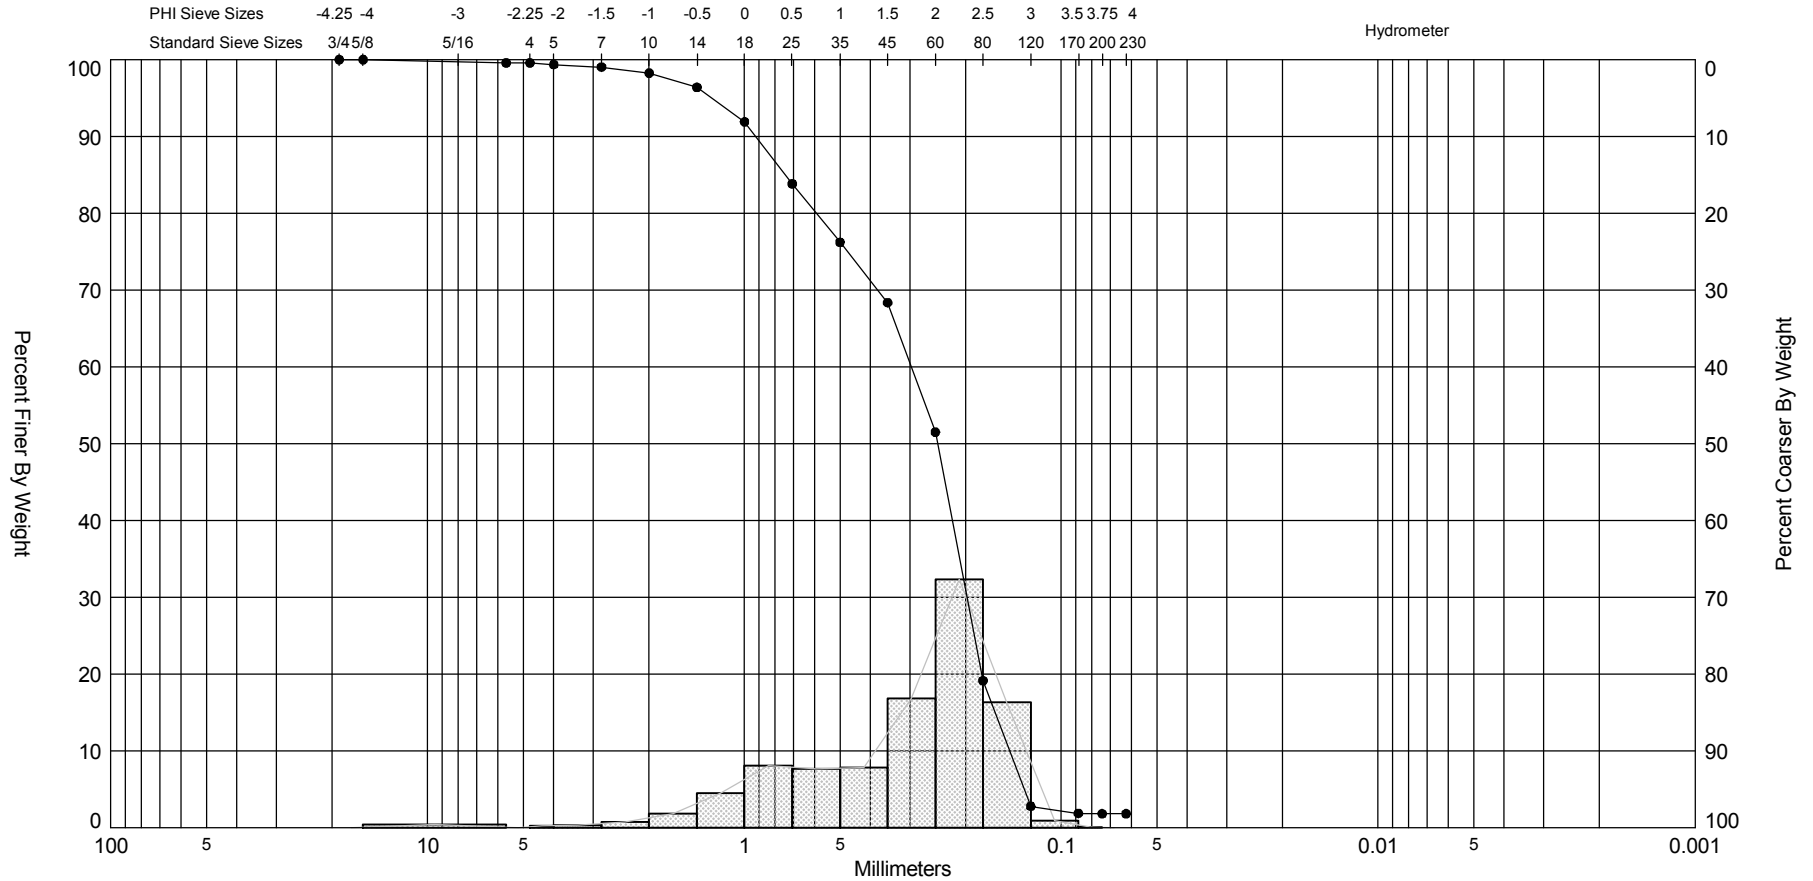
SIEVE ANALYSIS: BALD HEAD CREEK, NC., FEB. '14, GPJ, FL DEP ROSS.GDT 3/3/14

Sample	Symbol	Elev. (ft)	USCS	% Fines	% Organics	% Carbonates	Median	Mean	Skew	Kurt	Sort	Sample Information	
BHC-16 #Comp	—●—	-3.9	SP	#200 - 1.81 #230 - 1.81		11.80	2.02	1.65	-1.28	4.85	1.05	Project Name:	Village of Bald Head Island
Comments:												Analysis Date:	02-17-14
Depths and elevations based on measured values												Analyzed By:	CRM Sr.

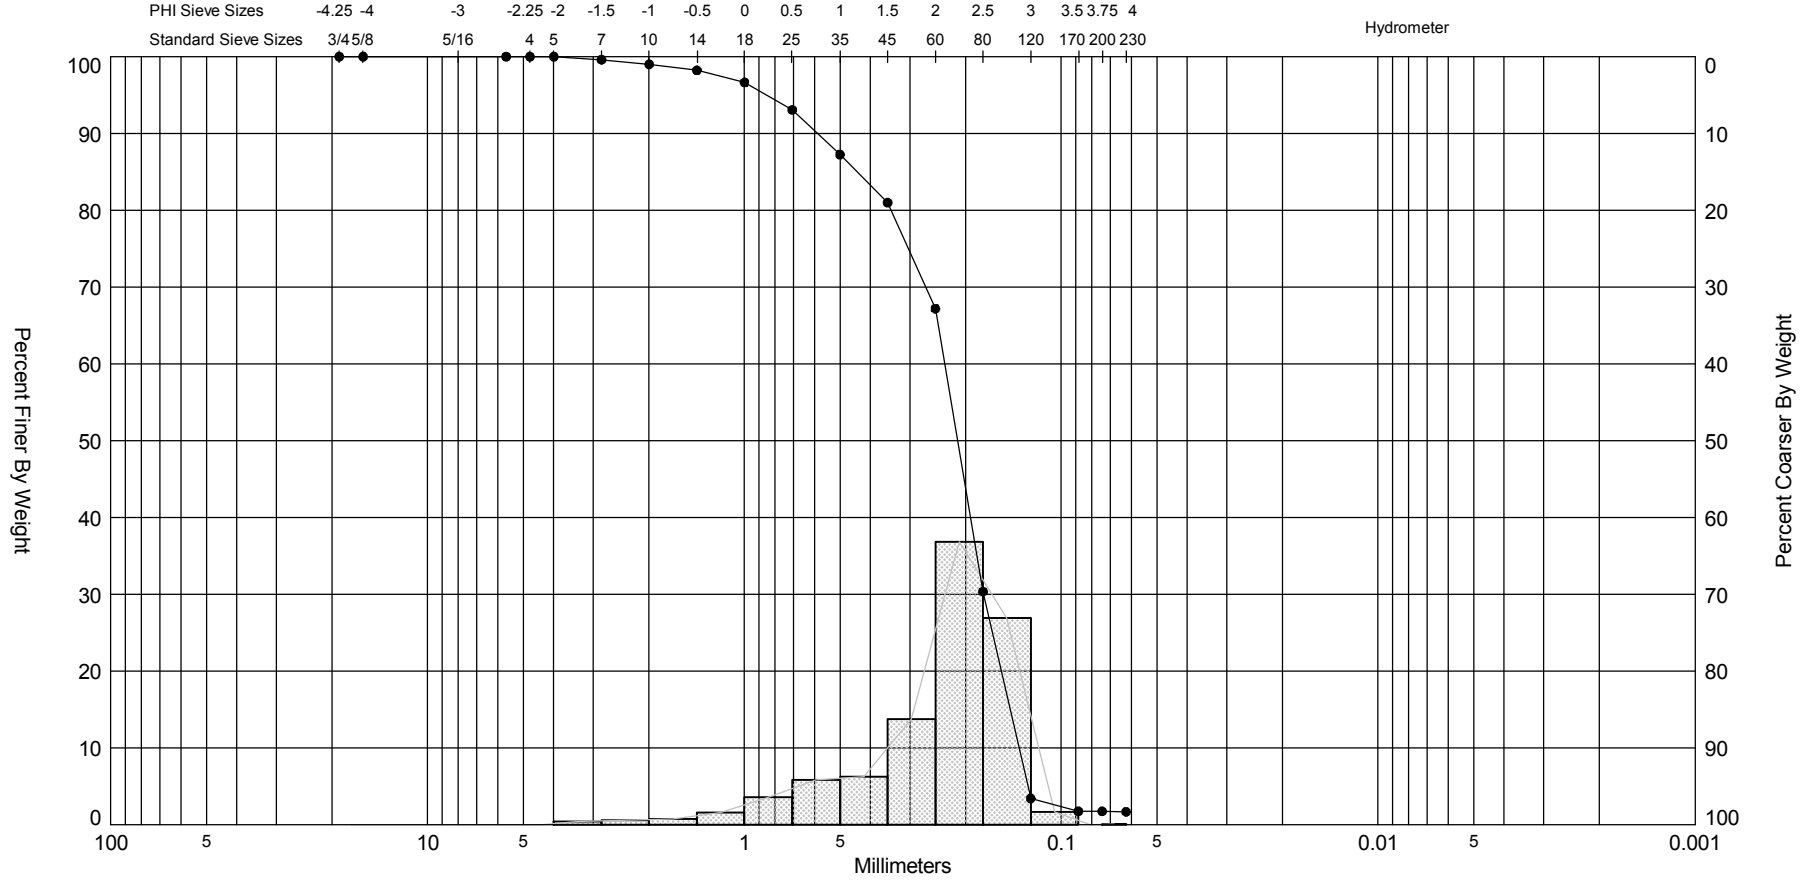
SIEVE ANALYSIS: BALD HEAD CREEK, NC., FEB. '14, GPJ, FL DEP ROSS.GDT 3/3/14

Sample	Symbol	Elev. (ft)	USCS	% Fines	% Organics	% Carbonates	Median	Mean	Skew	Kurt	Sort	Sample Information	
BHC-16 #2	—●—	-7.6	SP	#200 - 1.74 #230 - 1.68		8.90	2.23	2.01	-1.59	5.85	0.85	Project Name:	Village of Bald Head Island
Comments:												Analysis Date:	02-17-14
Depths and elevations based on measured values												Analyzed By:	CRM Sr.

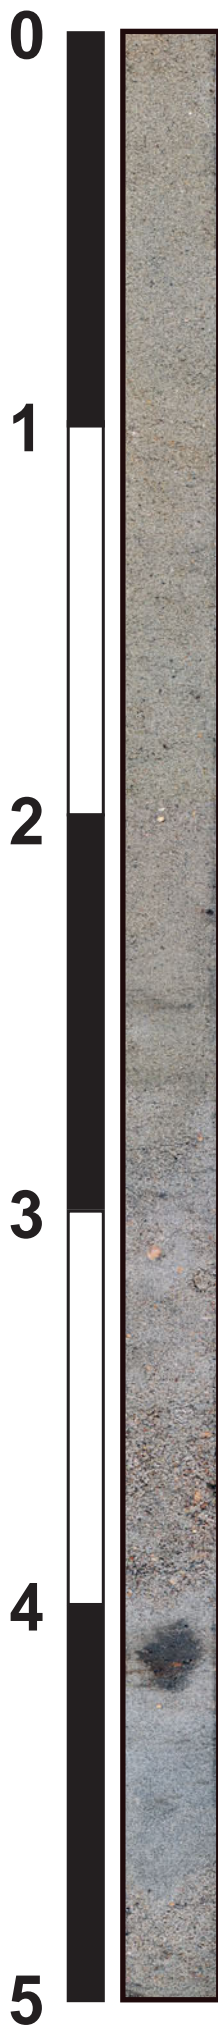
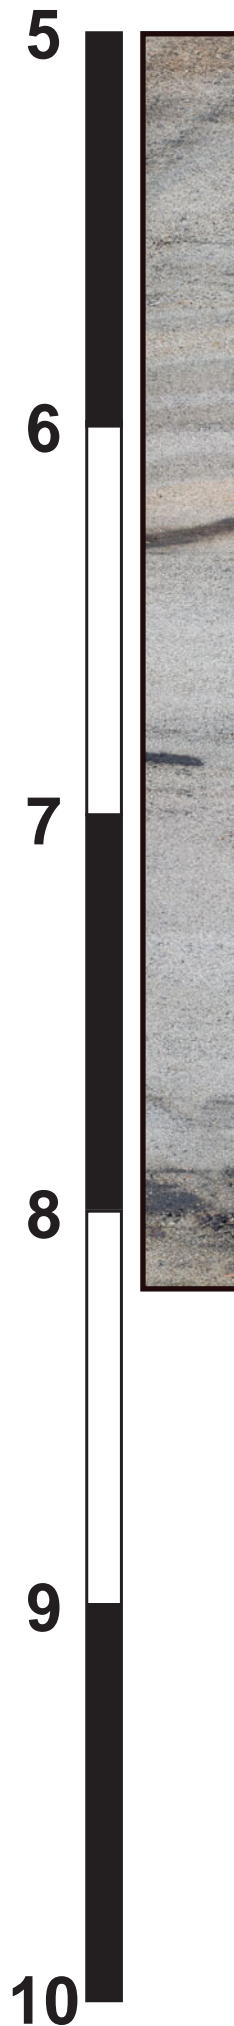
**Bald Head Island
North Carolina
BHC-17**

-7.5	3.5					
			Fine quartz SAND, trace silt (in burrows), trace fine sand size shell, poorly graded, subrounded, 4.1' = burrow trace, gray (2.5Y-6/1), (SP).			
-8.0	4.0					
			Medium quartz SAND, little fine sand size shell, trace silt, poorly graded, subrounded, light brownish gray (2.5Y-6/2), (SP).			
-8.8	4.8					
			Fine to medium quartz SAND, few medium sand and fine sand size shell (in layers), trace silt (in layers/burrows), poorly graded, subrounded, bioturbated, 6.25' = organic SILT (OL) layer, gray (2.5Y-6/1), (SP).			
-9.2	5.2					
			Fine to medium quartz SAND, trace fine sand size shell, trace silt, poorly graded, subrounded, 6.9' = organic SILT (OL) rip-up, gray (2.5Y-6/1), (SP).			
-10.3	6.3					
			Silty fine to medium quartz SAND, little silt, trace fine sand size shell, subrounded, bioturbated, gray (2.5Y-5/1), (SM).			
-11.9	7.9					
-12.2	8.2					
			End of Boring

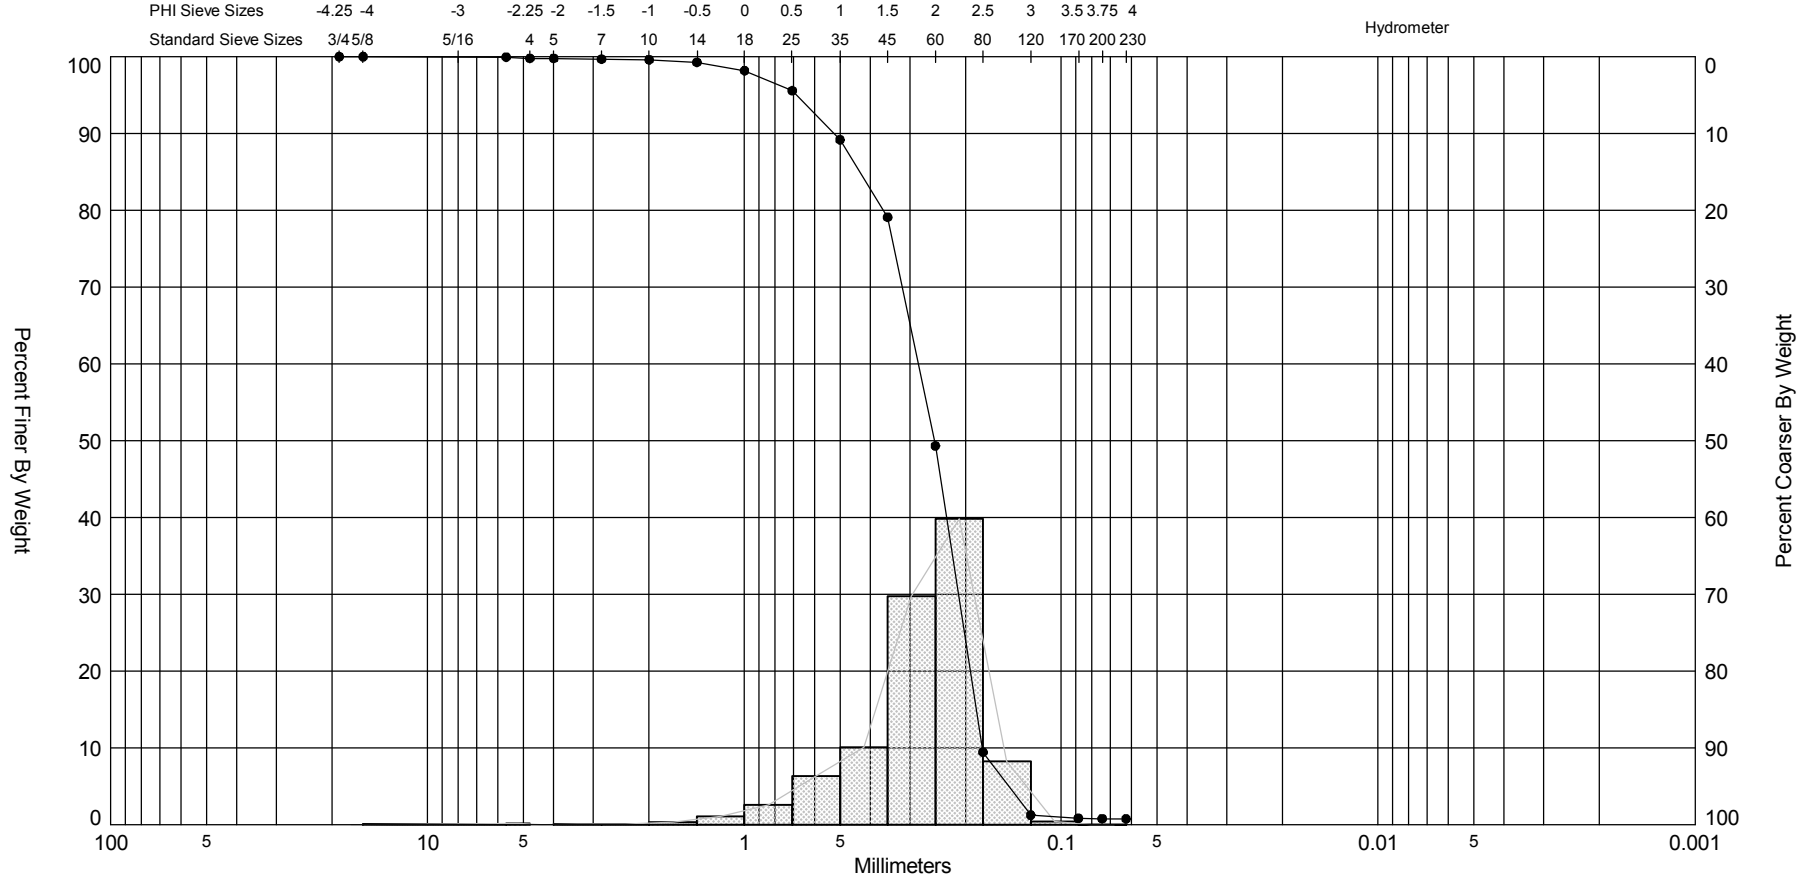
SIEVE ANALYSIS: BALD HEAD CREEK, NC., FEB. '14, GPJ, FL DEP ROSS.GDT 3/3/14

Sample	Symbol	Elev. (ft)	USCS	% Fines	% Organics	% Carbonates	Median	Mean	Skew	Kurt	Sort	Sample Information	
BHC-17 #1	—●—	-4.0	SP	#200 - 0.79 #230 - 0.77		7.50	1.99	1.84	-1.67	8.54	0.68	Project Name:	Village of Bald Head Island
Comments:												Analysis Date:	02-17-14
Depths and elevations based on measured values												Analyzed By:	CRM Sr.
