Village of Bald Head Island Terminal Groin Project

Bald Head Creek Borrow Site Expansion Geotechnical Analysis

Bald Head Island, N.C.

**Geotechnical Investigation of Bald Head Creek
Bald Head Island, North Carolina**

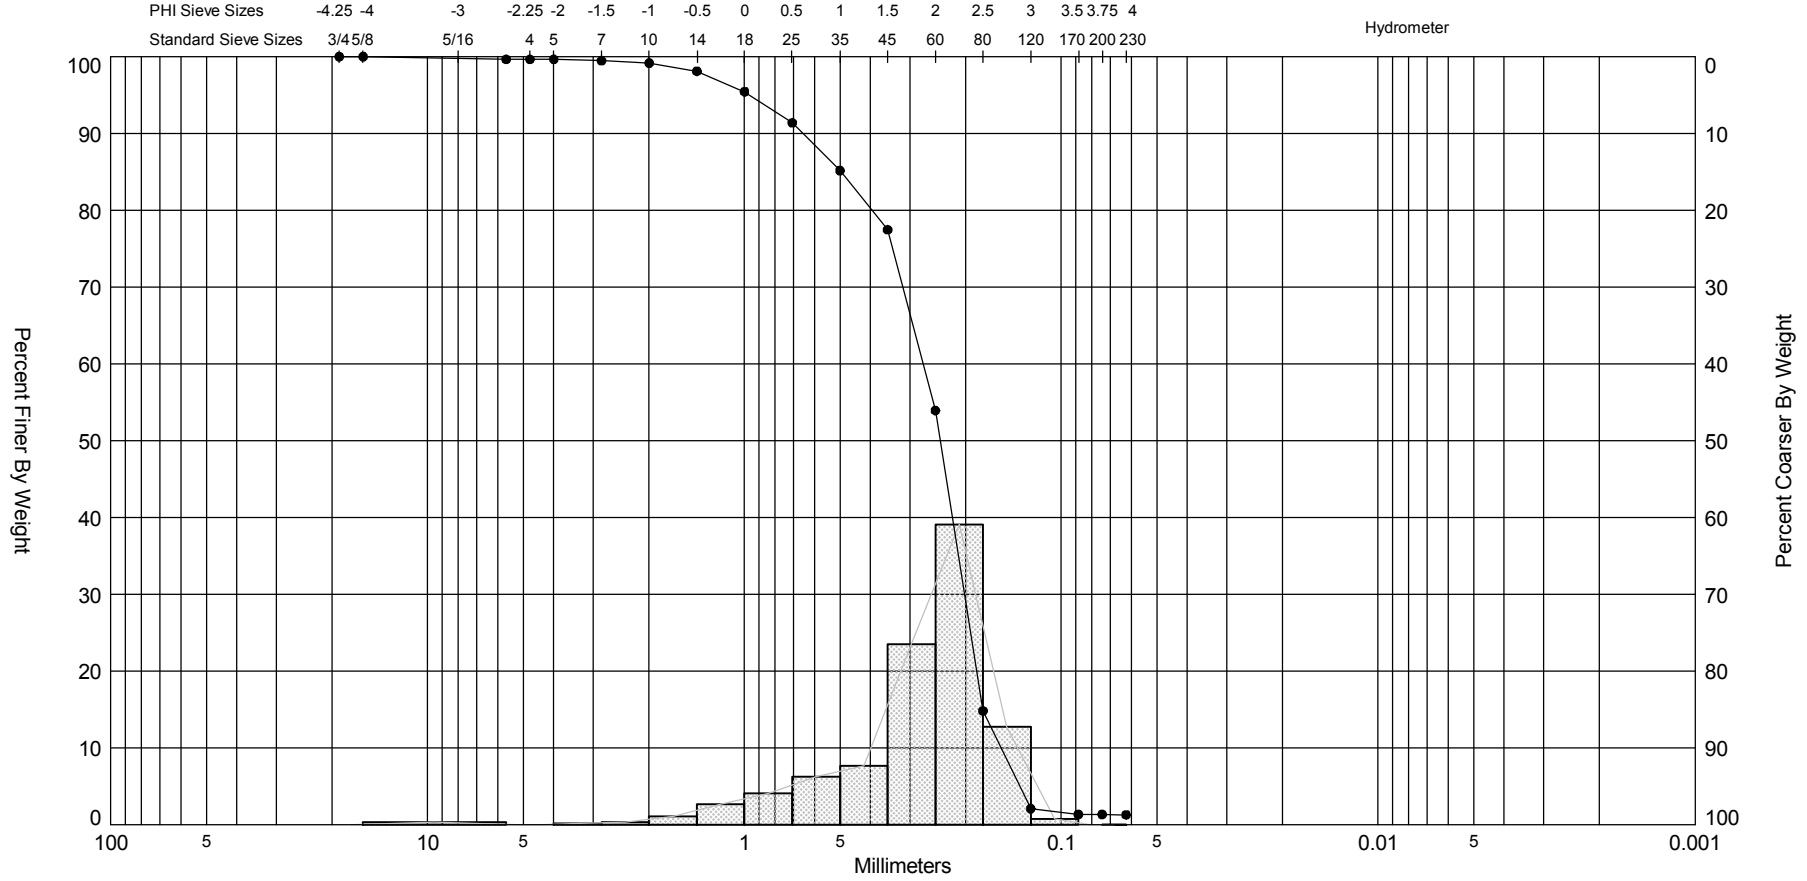
SIEVE ANALYSIS: BALD HEAD CREEK, NC., FEB. '14, GPJ, FL DEP ROSS.GDT 3/3/14

Sample	Symbol	Elev. (ft)	USCS	% Fines	% Organics	% Carbonates	Median	Mean	Skew	Kurt	Sort	Sample Information	
BHC-17 #Comp	—●—	-4.0	SP	#200 - 1.33 #230 - 1.29		8.50	2.05	1.81	-1.79	8.05	0.86	Project Name:	Village of Bald Head Island
Comments:												Analysis Date:	02-17-14
Depths and elevations based on measured values												Analyzed By:	CRM Sr.
						Athena Technologies, Inc. 1293 Graham Farm Road McClellanville, SC 29458 ph (843) 887-3800 fax (843) 887-3801						Easting (X, ft):	2,304,616
												Northing (Y, ft):	51,419
												Horizontal System:	NAD 1983
												Vertical System:	NGVD 29

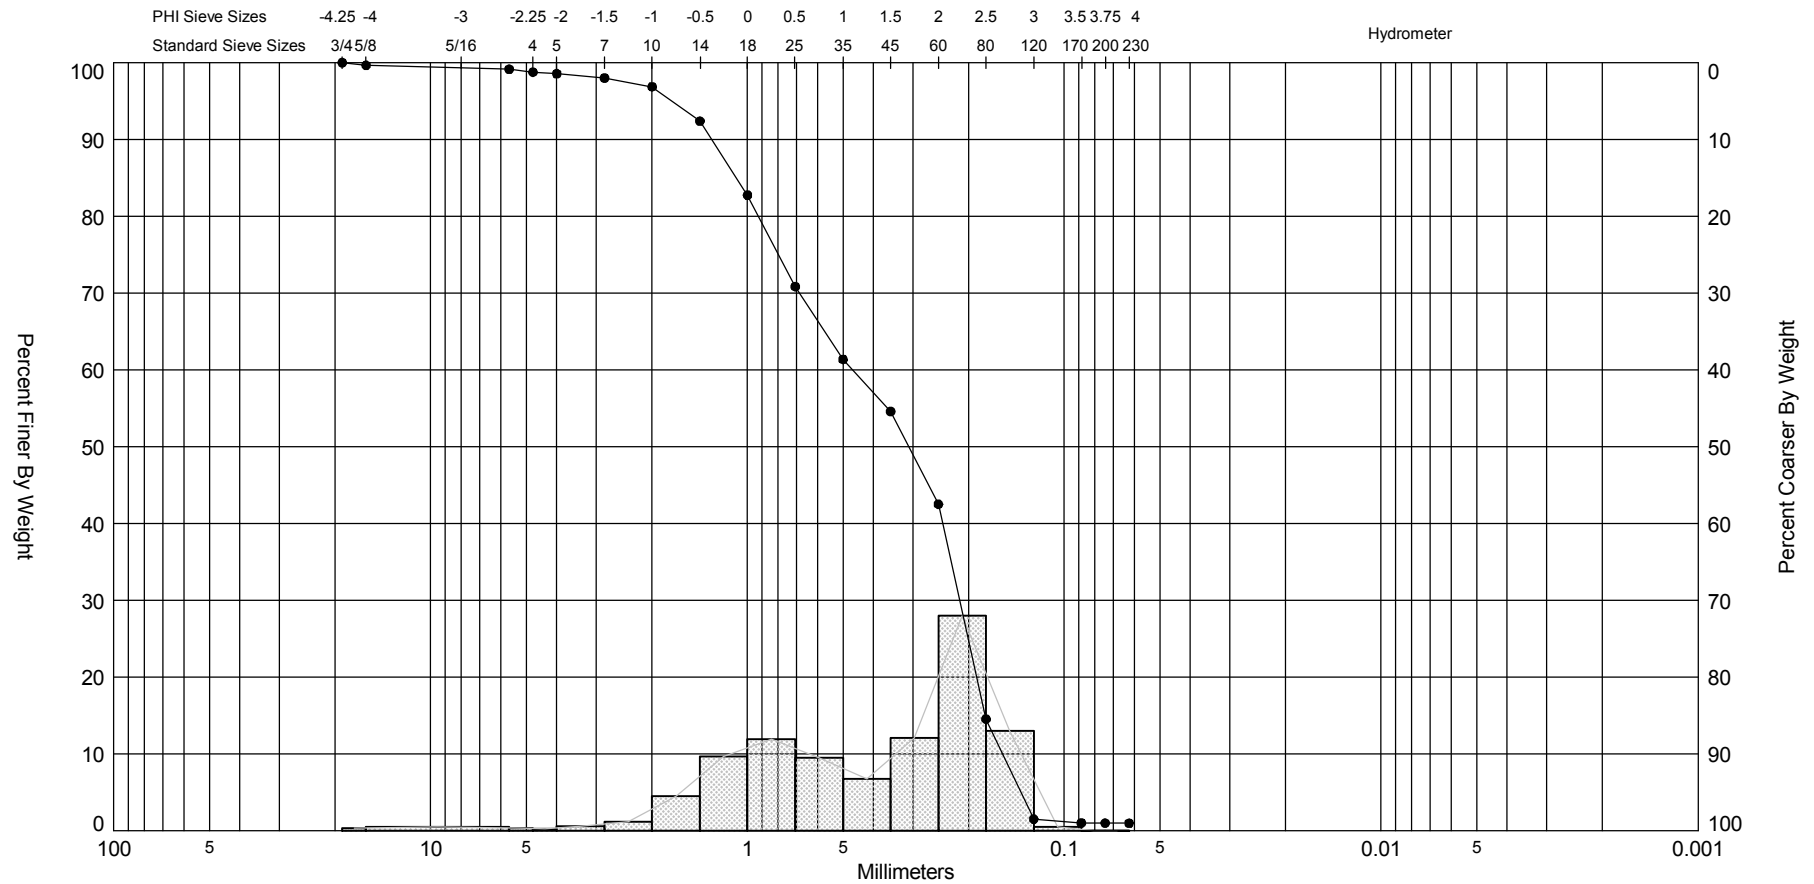
SIEVE ANALYSIS: BALD HEAD CREEK, NC., FEB. '14, GPJ, FL DEP ROSS.GDT 3/3/14

Sample	Symbol	Elev. (ft)	USCS	% Fines	% Organics	% Carbonates	Median	Mean	Skew	Kurt	Sort	Sample Information	
BHC-17 #2	—●—	-7.6	SP	#200 - 0.98 #230 - 0.96		13.70	1.69	1.29	-0.92	3.84	1.26	Project Name:	Village of Bald Head Island
Comments:												Analysis Date:	02-17-14
Depths and elevations based on measured values												Analyzed By:	CRM Sr.

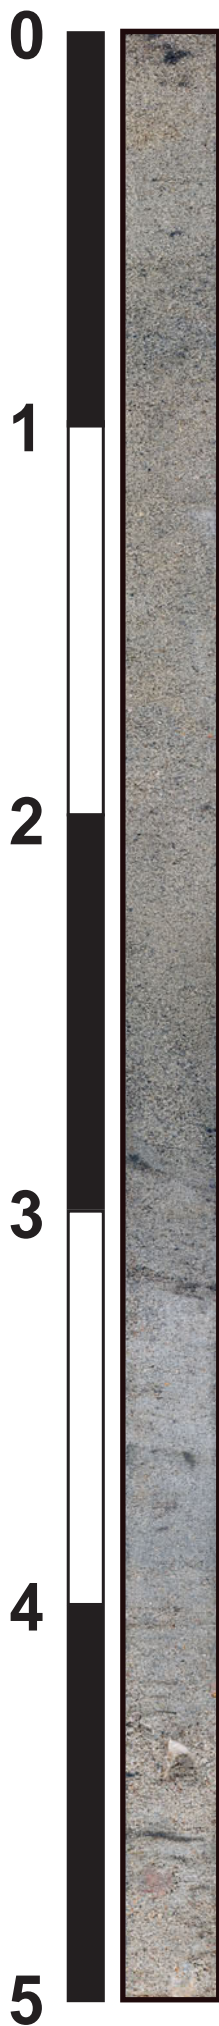
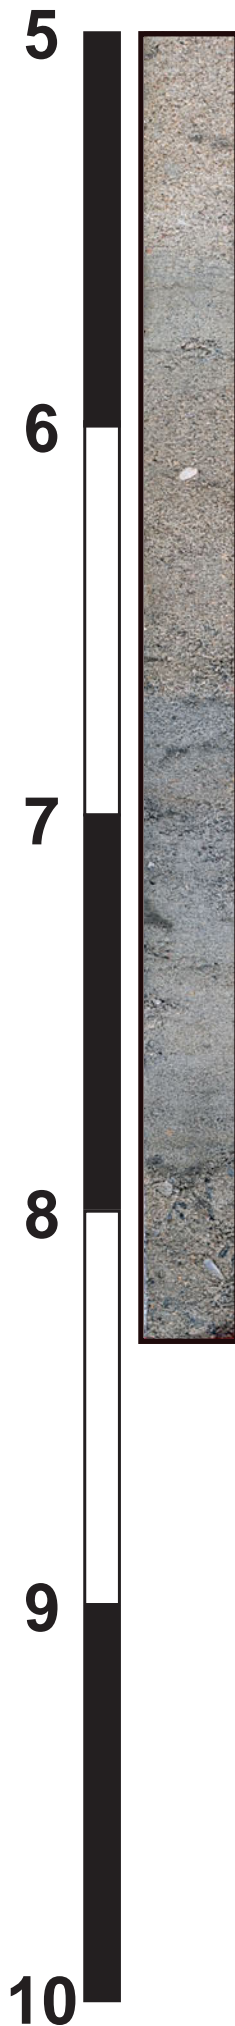
**Bald Head Island
North Carolina
BHC-18**

-9.7	6.7		Fine to medium quartz SAND, few medium sand size shell, trace silt, poorly graded, subrounded, bioturbated, gray (2.5Y-6/1), (SP).			
-10.9	7.9		Medium quartz SAND, little medium to coarse sand size shell, trace gravel size shell, poorly graded, subrounded, grayish brown (2.5Y-5/2), (SP).			
-11.3	8.3					
			End of Boring

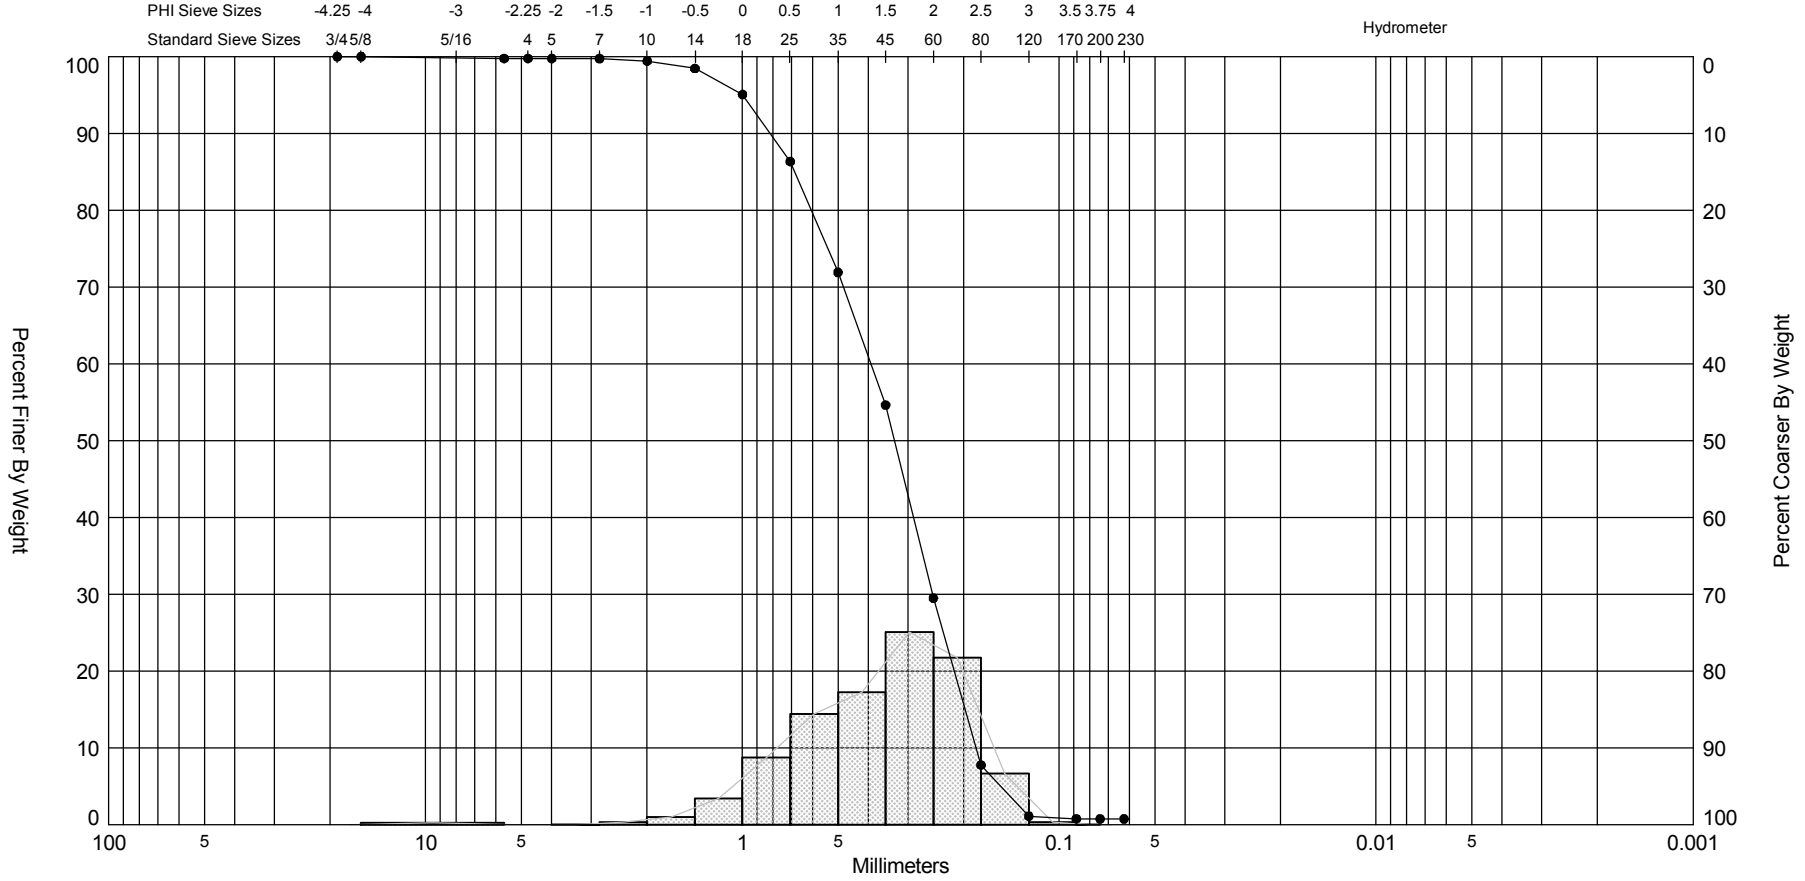
SIEVE ANALYSIS BALD HEAD CREEK, NC., FEB. '14, GPJ, FL DEP ROSS.GDT 3/3/14

Sample	Symbol	Elev. (ft)	USCS	% Fines	% Organics	% Carbonates	Median	Mean	Skew	Kurt	Sort	Sample Information	
BHC-18 #1	●—	-3.0	SP	#200 - 0.75 #230 - 0.75		8.90	1.59	1.45	-0.82	4.62	0.85	Project Name:	Village of Bald Head Island
Comments:												Analysis Date:	02-17-14
Depths and elevations based on measured values												Analyzed By:	CRM Sr.

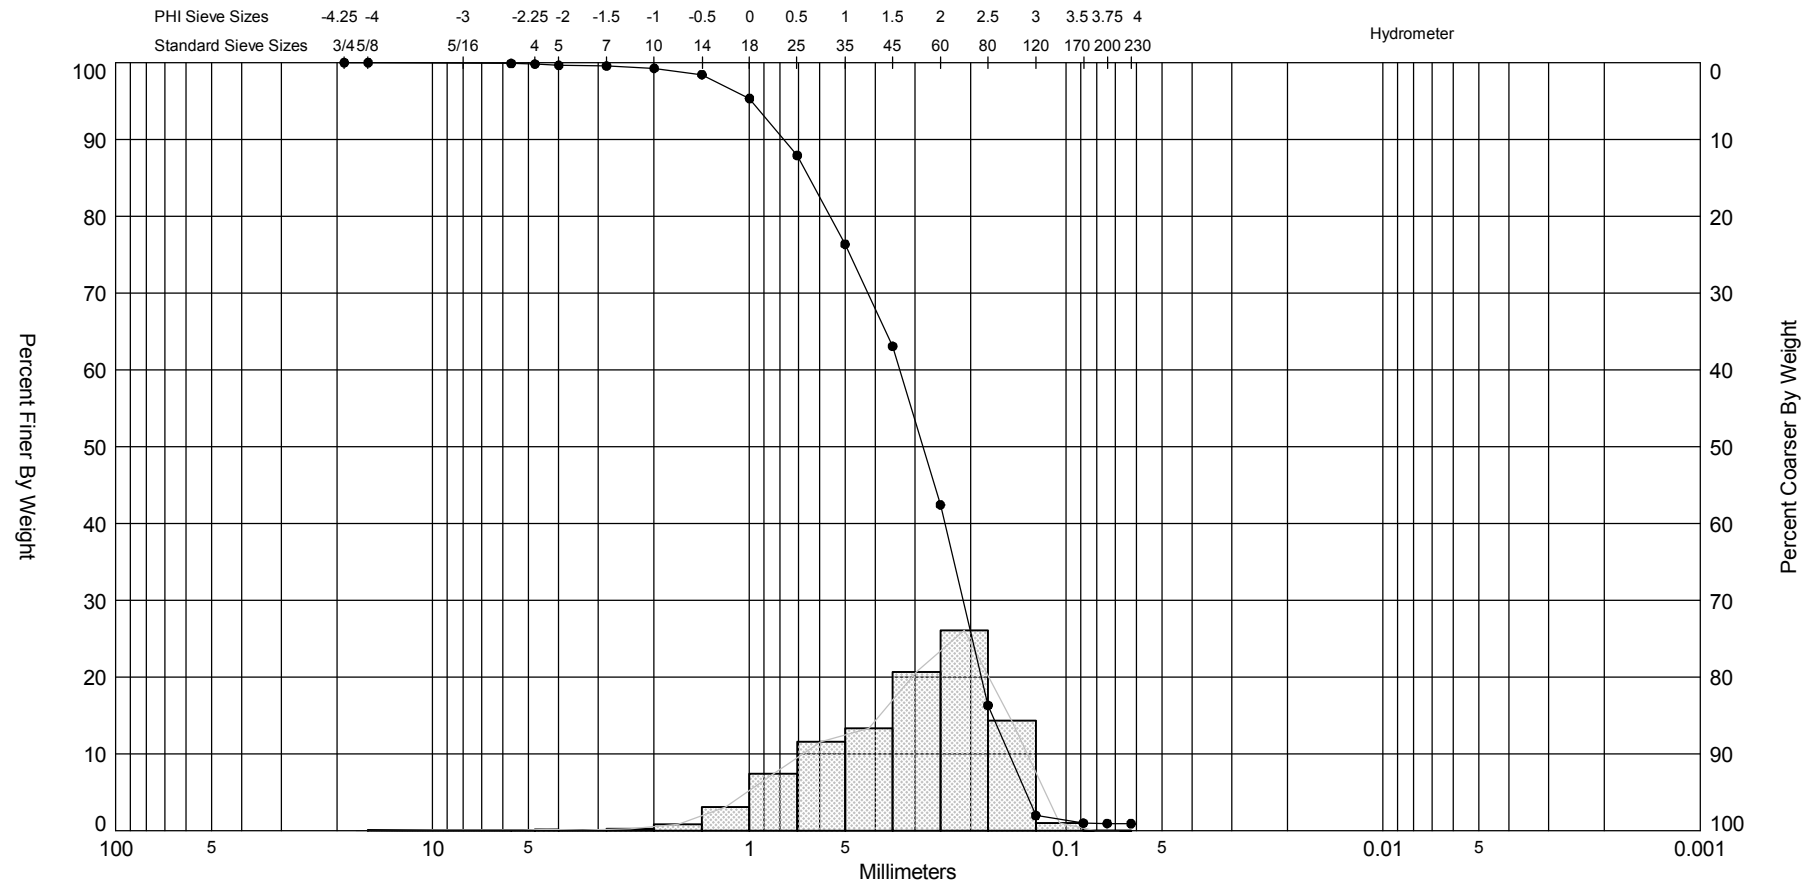
SIEVE ANALYSIS BALD HEAD CREEK, NC, FEB. '14, GPJ, FL DEP ROSS.GDT 3/3/14

Sample	Symbol	Elev. (ft)	USCS	% Fines	% Organics	% Carbonates	Median	Mean	Skew	Kurt	Sort	Sample Information	
BHC-18 #Comp	—●—	-3.0	SP	#200 - 0.94 #230 - 0.91		8.40	1.82	1.64	-0.91	4.22	0.91	Project Name:	Village of Bald Head Island
Comments:												Analysis Date:	02-17-14
Depths and elevations based on measured values												Analyzed By:	CRM Sr.

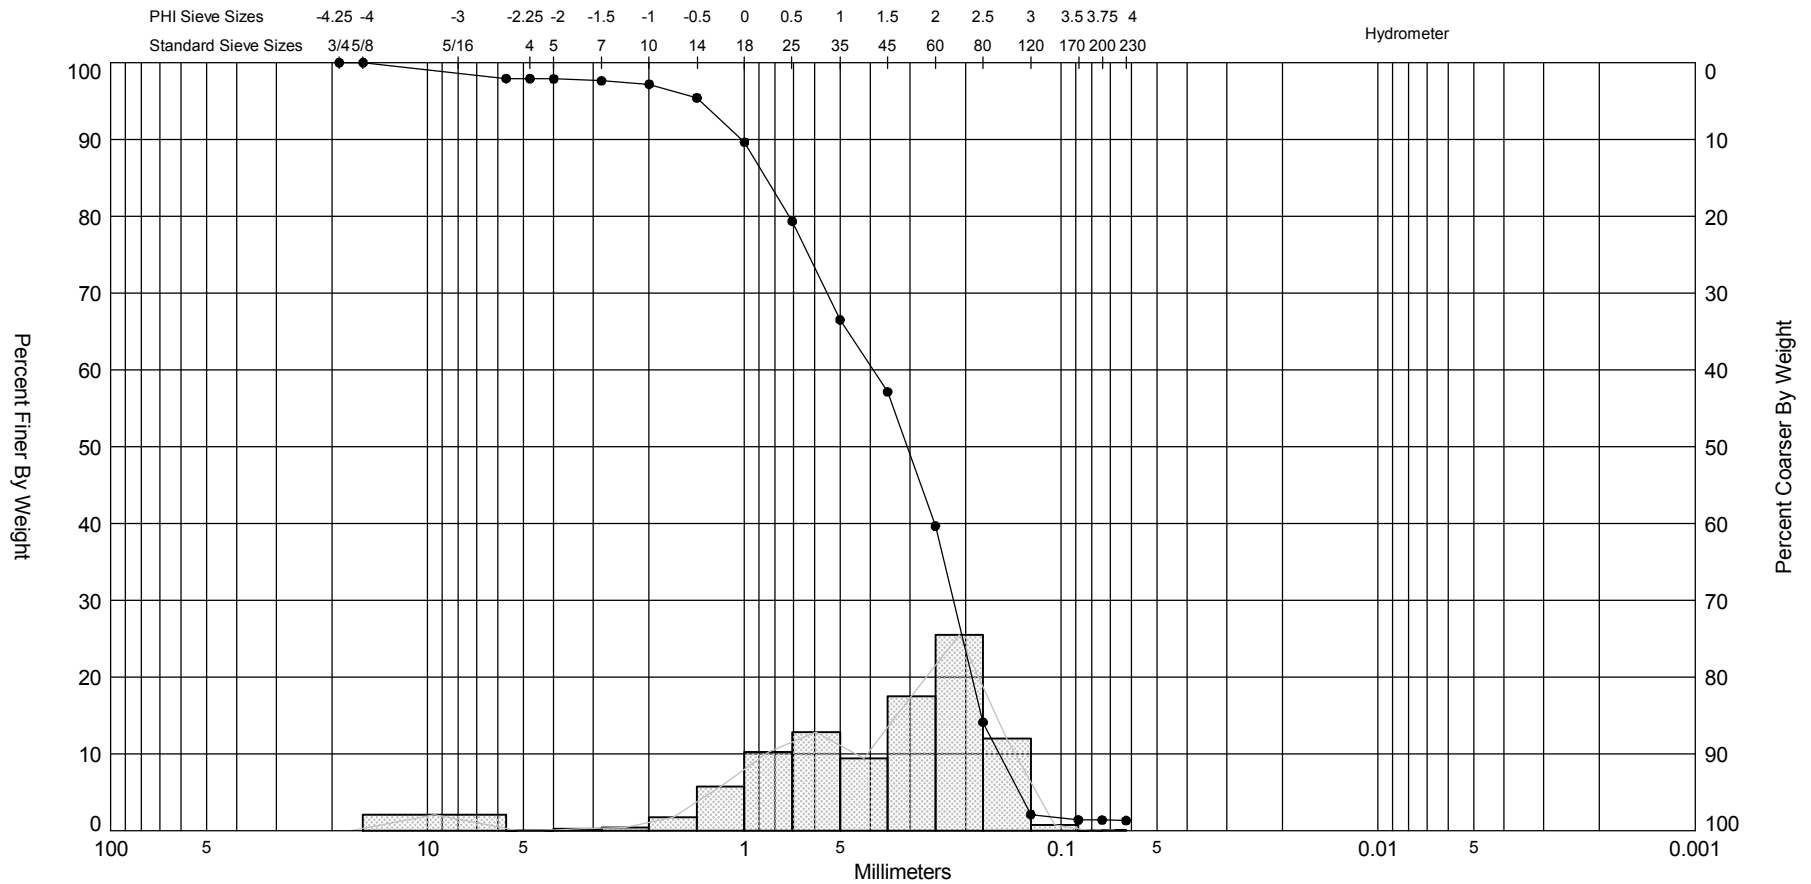
SIEVE ANALYSIS: BALD HEAD CREEK, NC., FEB. '14, GPJ, FL DEP ROSS.GDT 3/3/14

Sample	Symbol	Elev. (ft)	USCS	% Fines	% Organics	% Carbonates	Median	Mean	Skew	Kurt	Sort	Sample Information	
BHC-18 #2	—●—	-7.6	SP	#200 - 1.38 #230 - 1.31		12.40	1.7	1.39	-1.4	5.96	1.19	Project Name:	Village of Bald Head Island
Comments:												Analysis Date:	02-17-14
Depths and elevations based on measured values												Analyzed By:	CRM Sr.

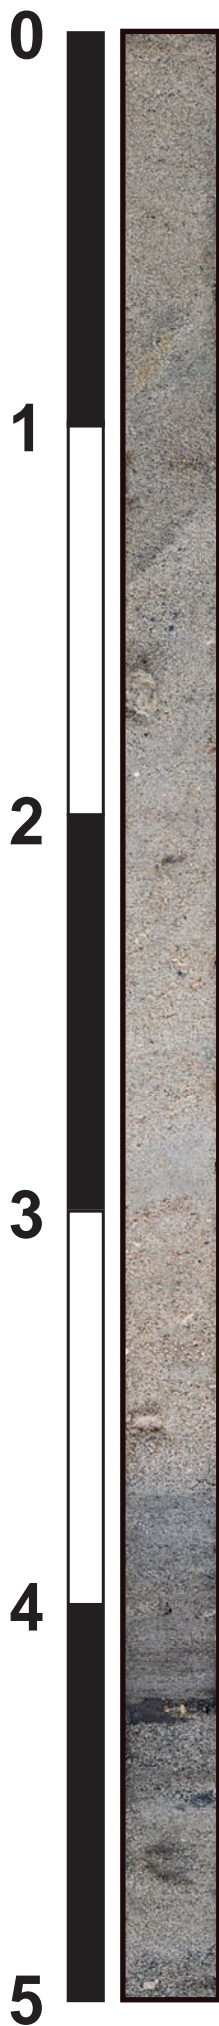
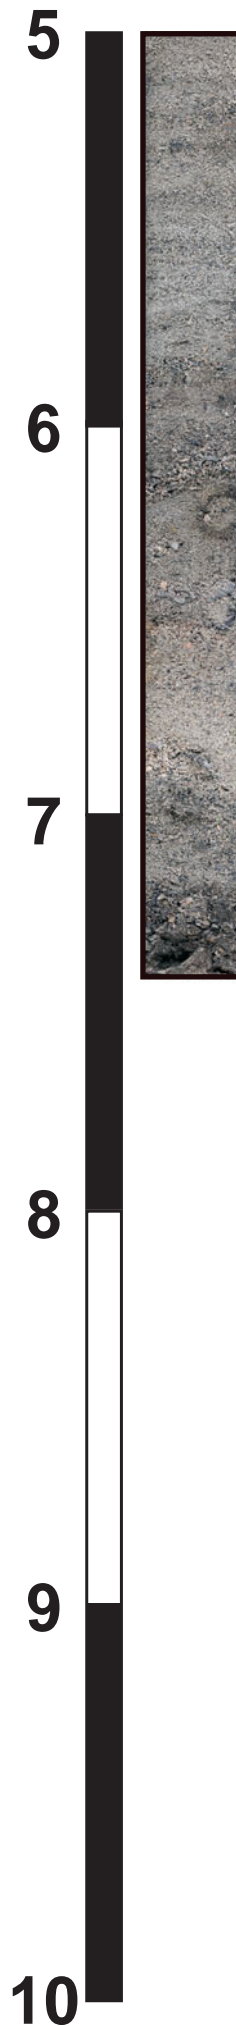
**Bald Head Island
North Carolina
BHC-19**

-9.0	7.2					
-9.2	7.4		Silty medium quartz SAND, some coarse sand to gravel size shell, little silt, subrounded, dark gray (2.5Y-4/1), (SM).			
			End of Boring

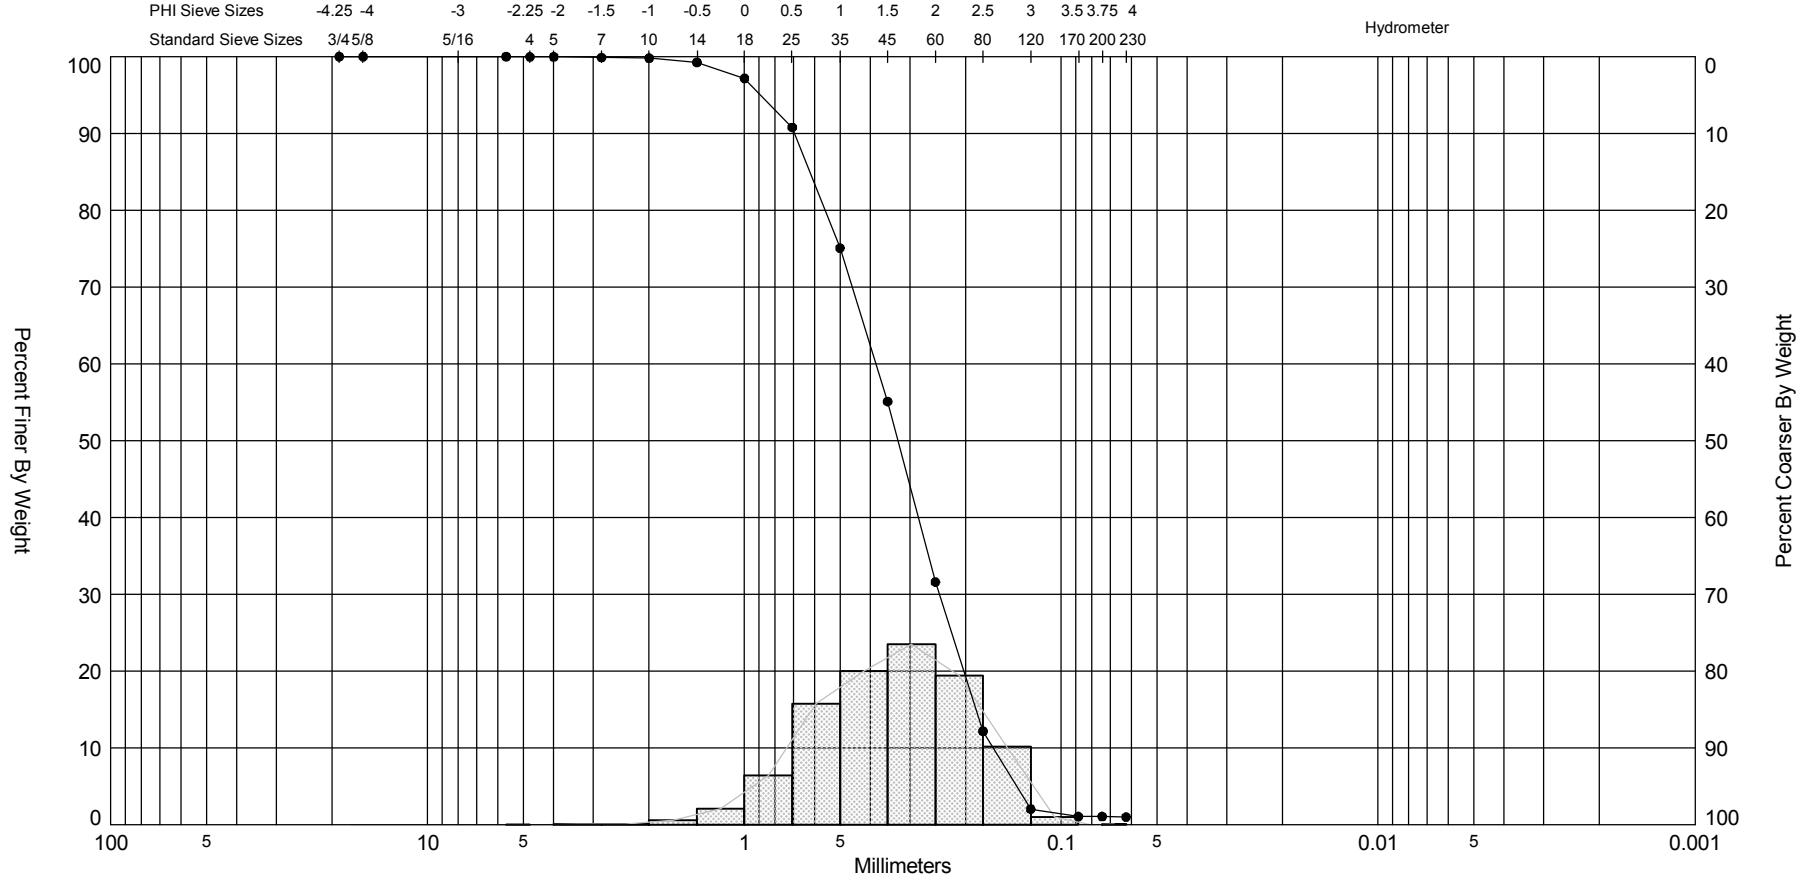
SIEVE ANALYSIS: BALD HEAD CREEK, NC., FEB. '14, GPJ, FL DEP ROSS.GDT 3/3/14

Sample	Symbol	Elev. (ft)	USCS	% Fines	% Organics	% Carbonates	Median	Mean	Skew	Kurt	Sort	Sample Information	
BHC-19 #1	—●—	-1.8	SP	#200 - 1.05 #230 - 0.98		8.70	1.61	1.55	-0.36	3.06	0.8	Project Name:	Village of Bald Head Island
Comments:												Analysis Date:	02-17-14
Depths and elevations based on measured values												Analyzed By:	CRM Sr.

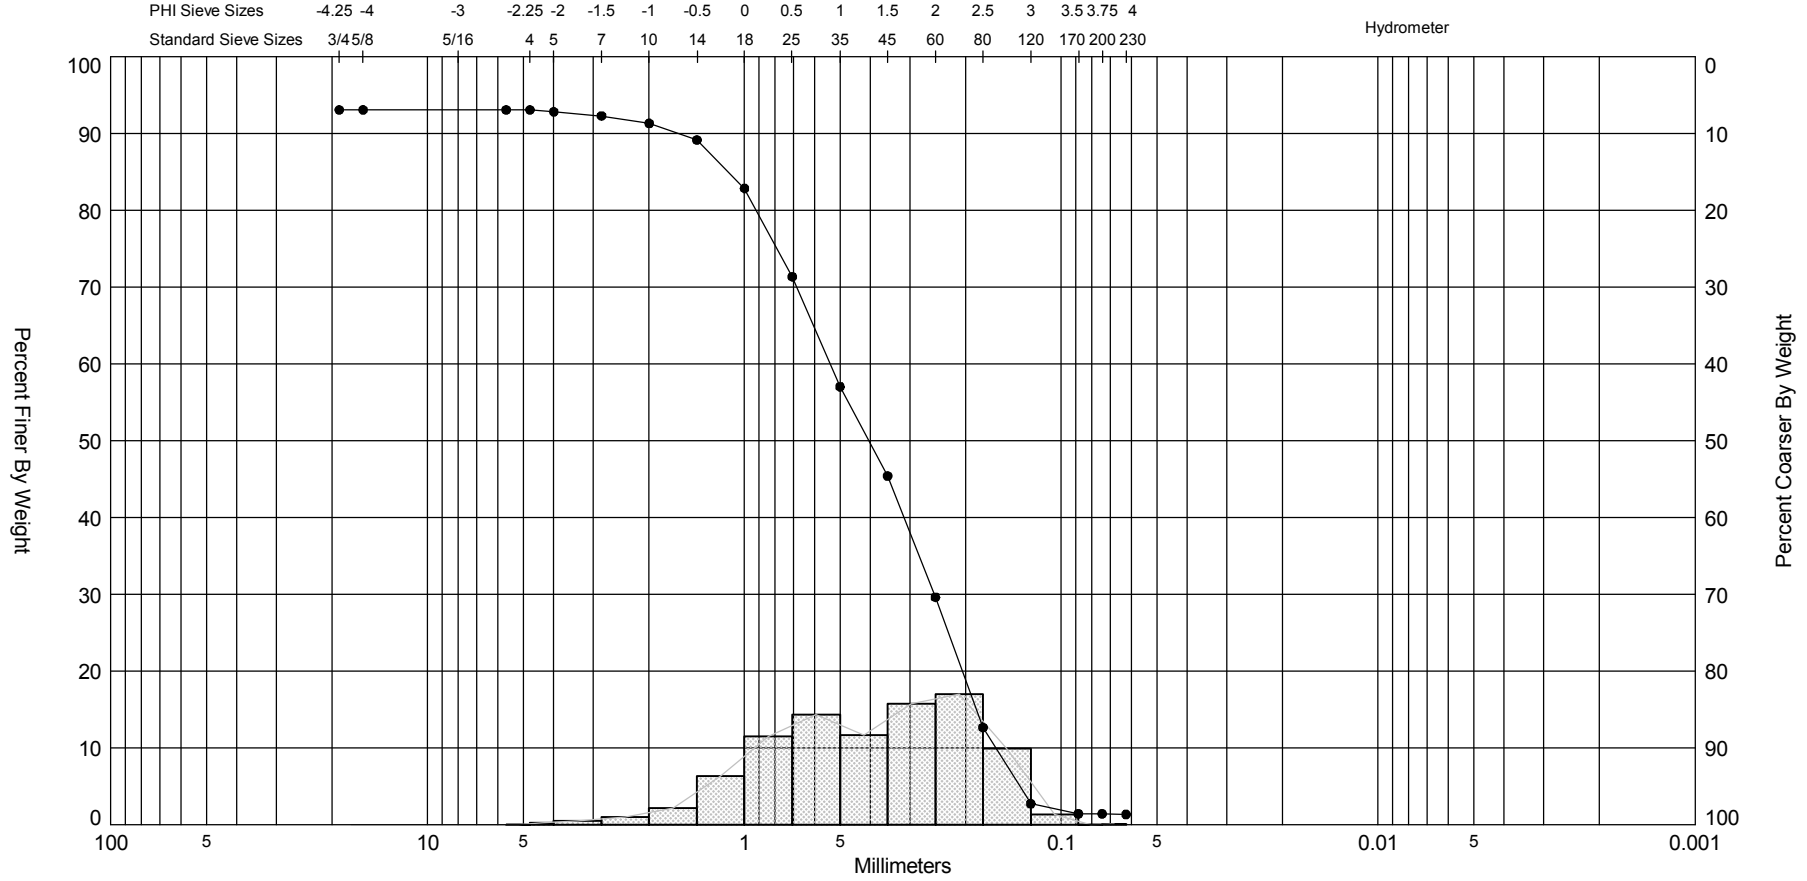
SIEVE ANALYSIS BALD HEAD CREEK, NC, FEB. '14.GPJ FL DEP ROSS.GDT 3/3/14

Sample	Symbol	Elev. (ft)	USCS	% Fines	% Organics	% Carbonates	Median	Mean	Skew	Kurt	Sort	Sample Information	
BHC-19 #Comp	—●—	-1.8	SP	#200 - 1.41 #230 - 1.34		17.60	1.3	0.91	0.66	2.4	1.08	Project Name:	Village of Bald Head Island
Comments:												Analysis Date:	02-17-14
Depths and elevations based on measured values												Analyzed By:	CRM Sr.

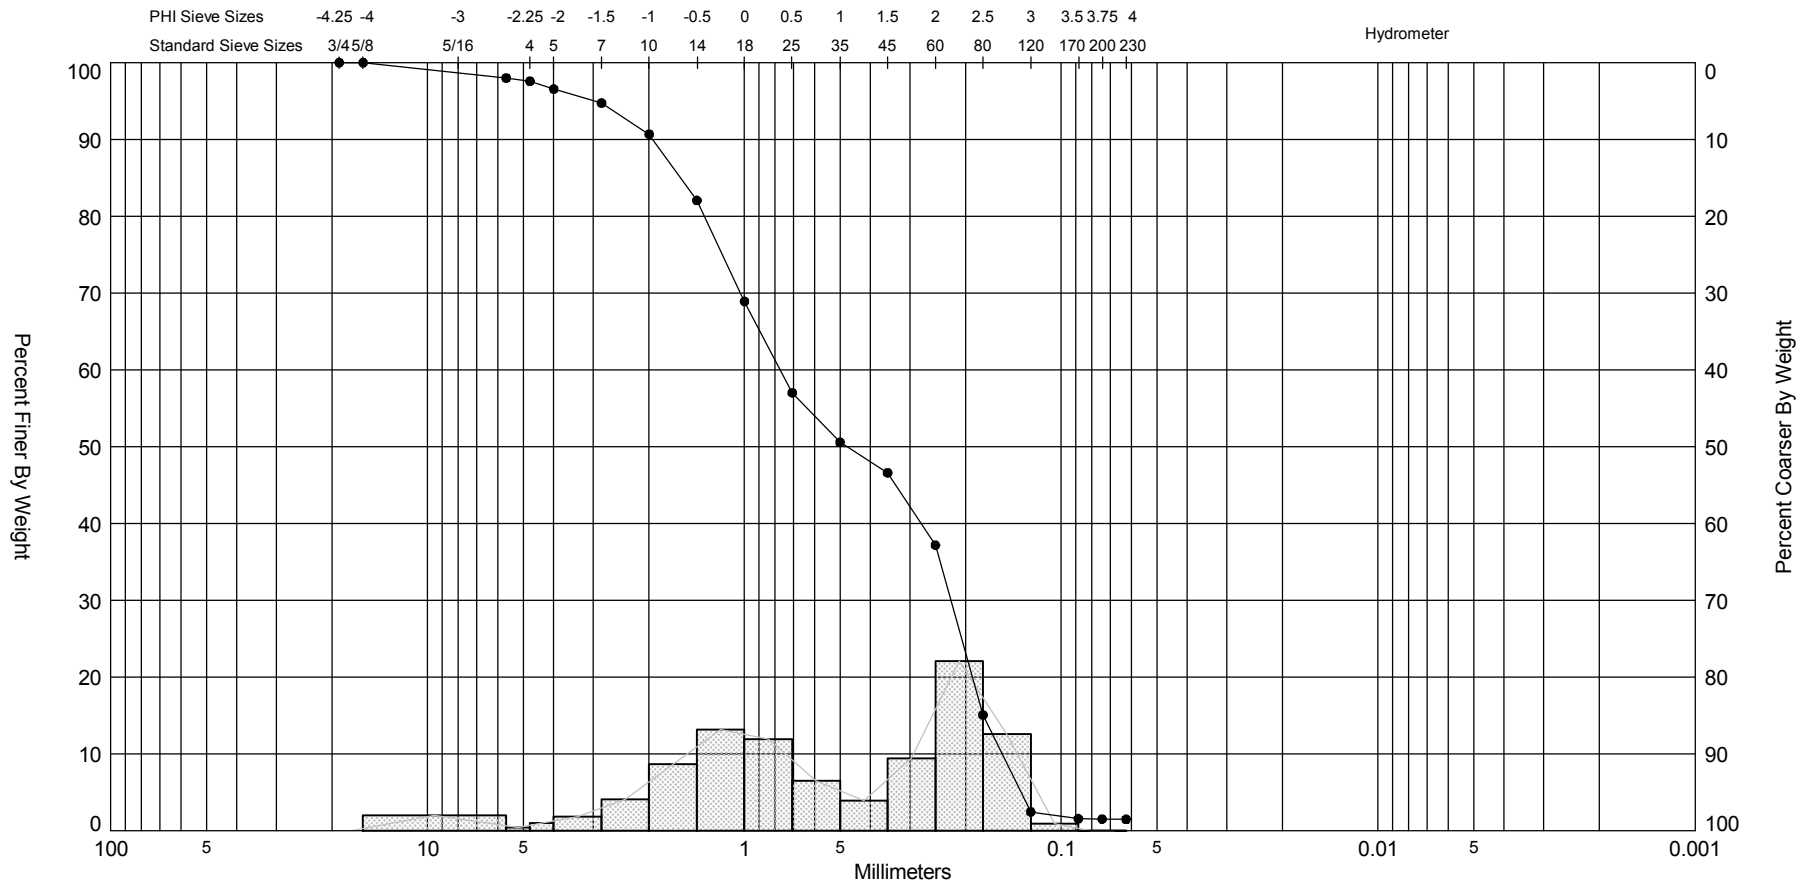
SIEVE ANALYSIS: BALD HEAD CREEK, NC., FEB. '14, GPJ, FL DEP ROSS.GDT 3/3/14

Sample	Symbol	Elev. (ft)	USCS	% Fines	% Organics	% Carbonates	Median	Mean	Skew	Kurt	Sort	Sample Information	
BHC-19 #2	—●—	-7.6	SP	#200 - 1.51 #230 - 1.47		21.30	1.07	0.91	-0.52	2.5	1.5	Project Name:	Village of Bald Head Island
Comments:												Analysis Date:	02-17-14
Depths and elevations based on measured values												Analyzed By:	CRM Sr.

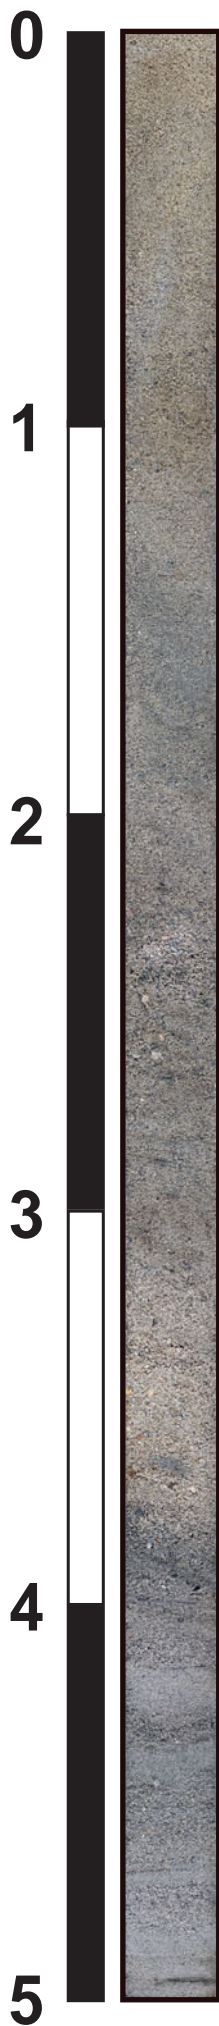
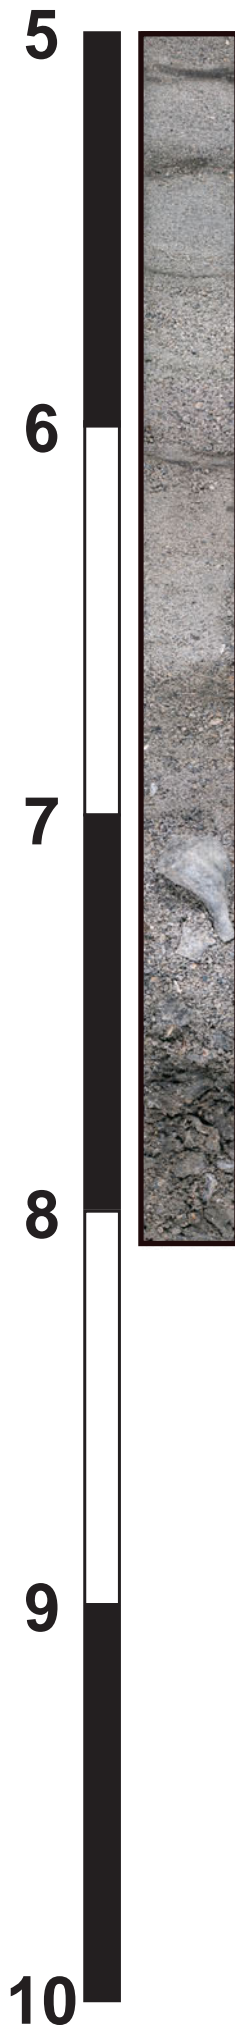
**Bald Head Island
North Carolina
BHC-20**

-9.0	7.6		Medium quartz SAND, little coarse sand size shell, trace silt / gravel size shell, poorly graded, subrounded, gray (2.5Y-6/1), (SP).			
-9.5	8.1		Silty medium quartz SAND, some coarse sand to gravel size shell, little silt, subrounded, dark gray (2.5Y-4/1), (SM).			
			End of Boring

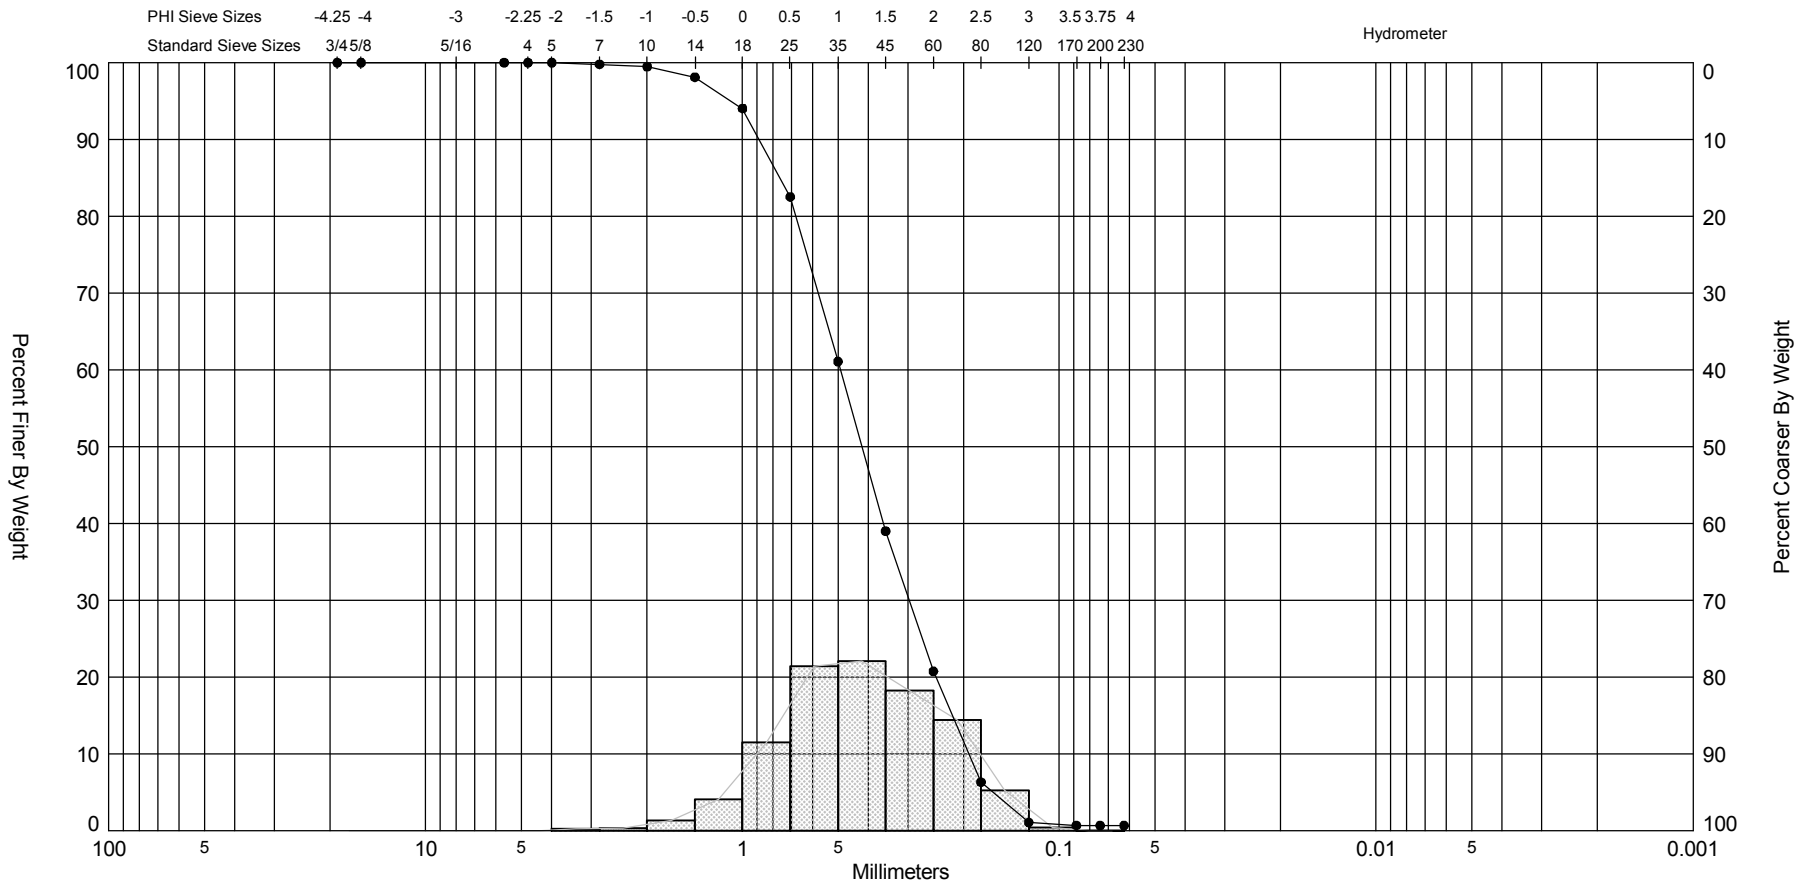
Sample	Symbol	Elev. (ft)	USCS	% Fines	% Organics	% Carbonates	Median	Mean	Skew	Kurt	Sort	Sample Information	
BHC-20 #1	—●—	-1.4	SP	#200 - 0.67 #230 - 0.66		8.30	1.25	1.25	-0.2	2.89	0.83	Project Name:	Village of Bald Head Island
Comments:												Analysis Date:	02-17-14
Depths and elevations based on measured values												Analyzed By:	CRM Sr.
						Athena Technologies, Inc. 1293 Graham Farm Road McClellanville, SC 29458 ph (843) 887-3800 fax (843) 887-3801						Easting (X, ft):	2,305,532
												Northing (Y, ft):	51,170
												Horizontal System:	NAD 1983
												Vertical System:	NGVD 29

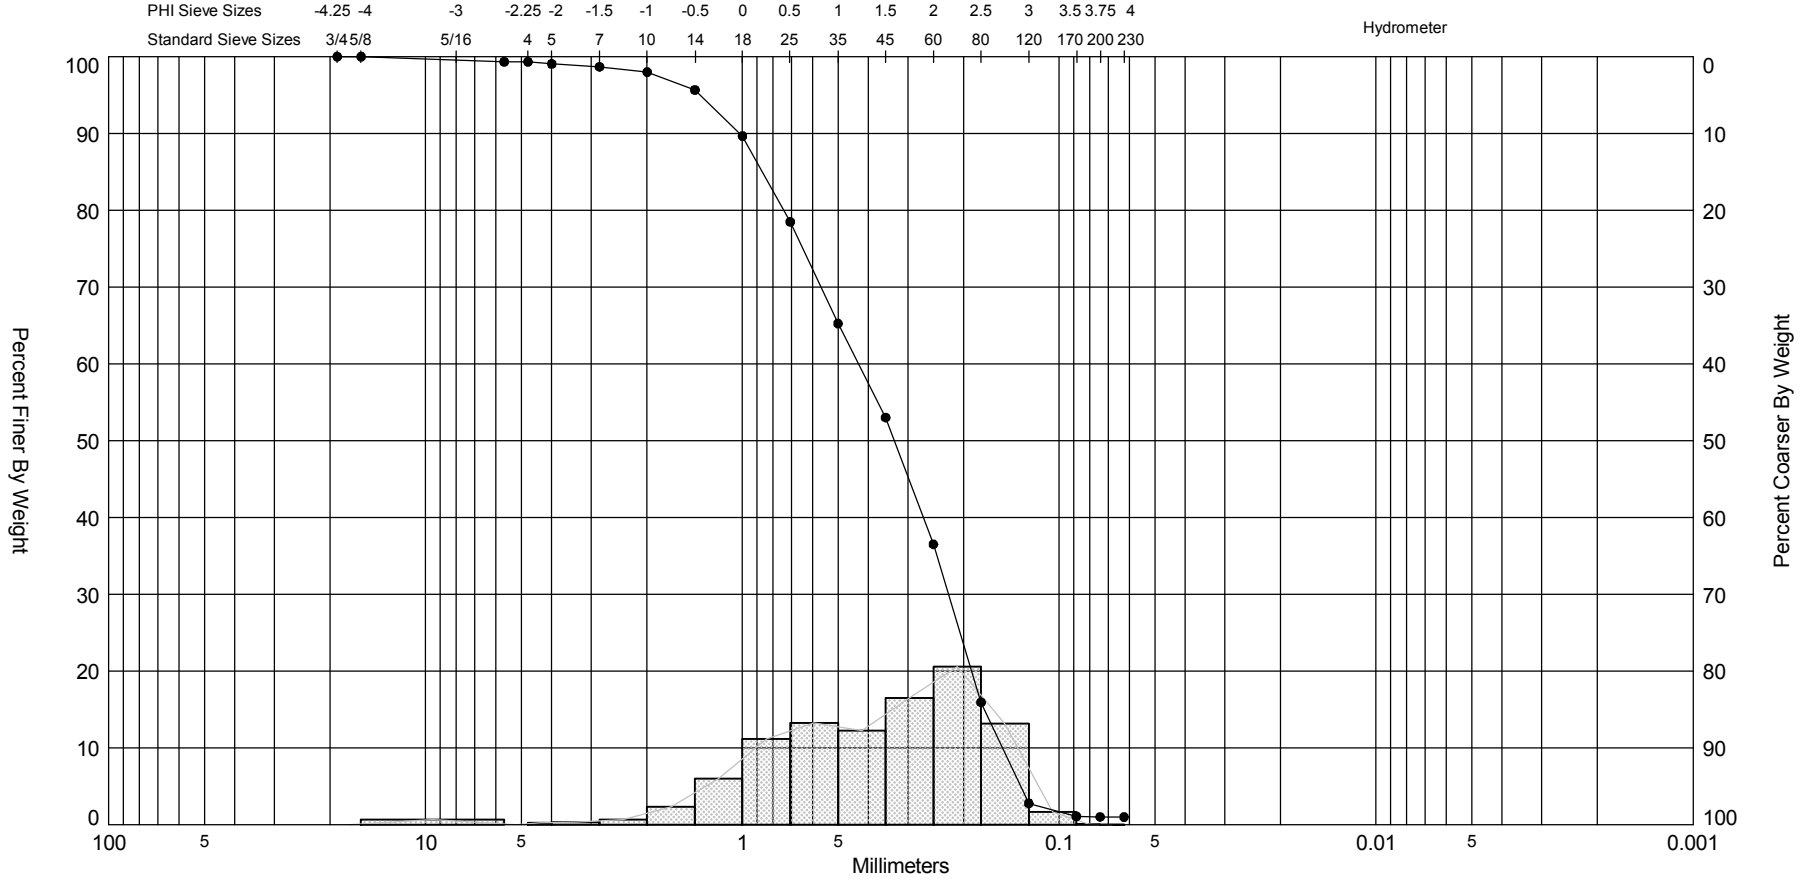
SIEVE ANALYSIS: BALD HEAD CREEK, NC., FEB. '14, GPJ, FL DEP ROSS.GDT 3/3/14

Sample	Symbol	Elev. (ft)	USCS	% Fines	% Organics	% Carbonates	Median	Mean	Skew	Kurt	Sort	Sample Information	
BHC-20 #Comp	—●—	-1.4	SP	#200 - 1.02 #230 - 0.99		11.70	1.59	1.39	-0.84	4.12	1.11	Project Name:	Village of Bald Head Island
Comments:												Analysis Date:	02-17-14
Depths and elevations based on measured values												Analyzed By:	CRM Sr.

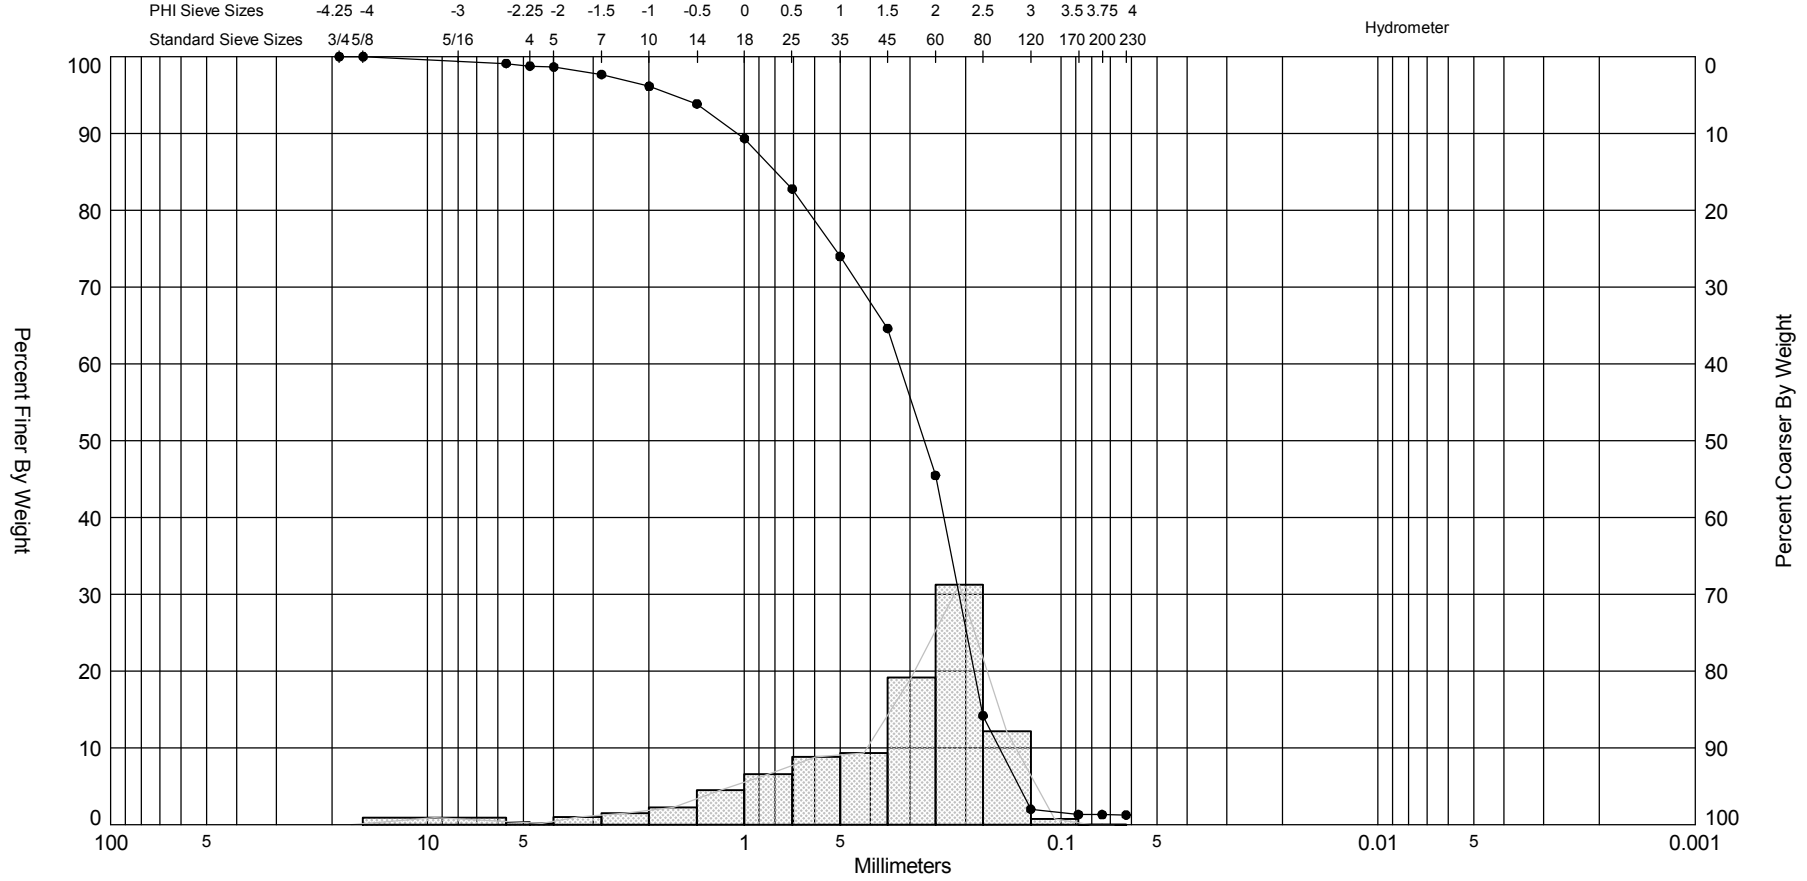
SIEVE ANALYSIS BALD HEAD CREEK, NC., FEB. '14, GPJ, FL DEP ROSS.GDT 3/3/14

Sample	Symbol	Elev. (ft)	USCS	% Fines	% Organics	% Carbonates	Median	Mean	Skew	Kurt	Sort	Sample Information	
BHC-20 #2	—●—	-7.6	SP	#200 - 1.30 #230 - 1.27		12.60	1.88	1.51	-1.45	5.39	1.15	Project Name:	Village of Bald Head Island
Comments:												Analysis Date:	02-17-14
Depths and elevations based on measured values												Analyzed By:	CRM Sr.

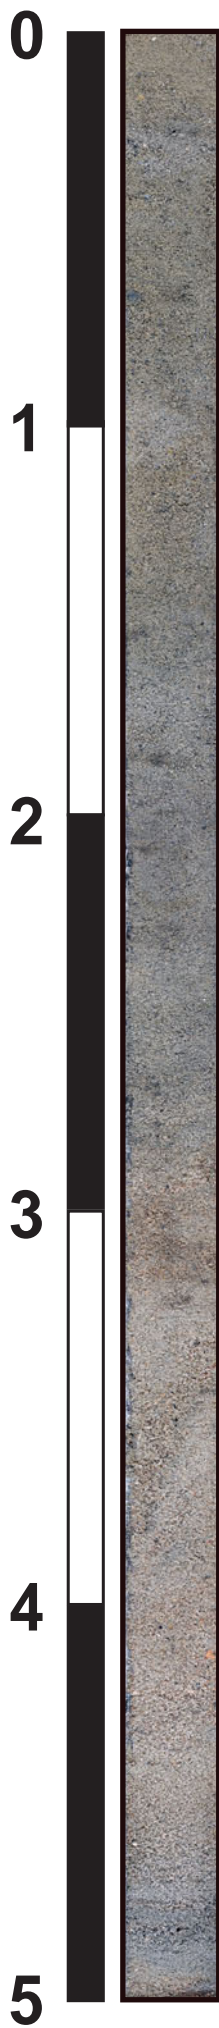
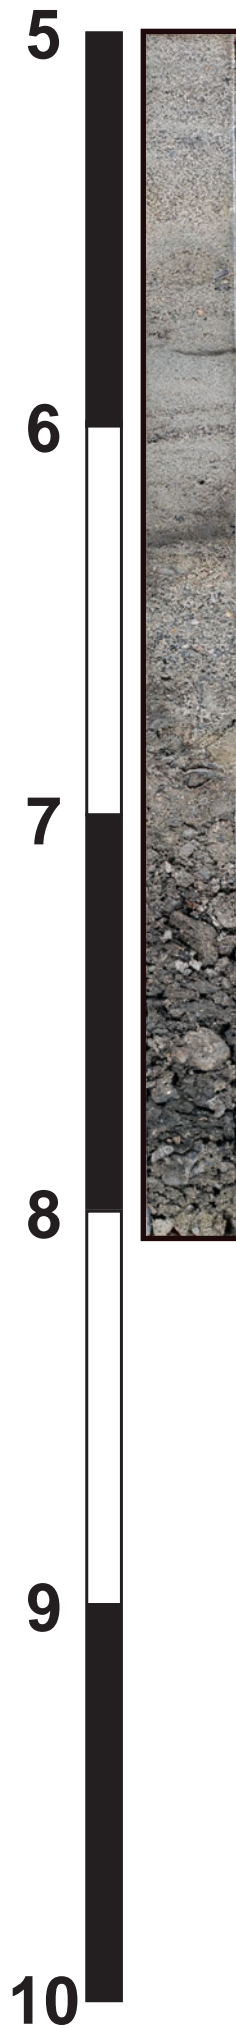
**Bald Head Island
North Carolina
BHC-21**

-9.0	6.4		Medium quartz SAND, little coarse sand to gravel size shell, trace silt, poorly graded, subrounded, gray (2.5Y-6/1), (SP).			
-9.7	7.1		Silty medium quartz SAND, some coarse sand to gravel size shell, little silt, subrounded, dark grayish brown (2.5Y-4/2), (SM).			
-10.7	8.1		End of Boring
