Village of Bald Head Island Terminal Groin Project

Bald Head Creek Borrow Site Expansion Geotechnical Analysis

Bald Head Island, N.C.

**Geotechnical Investigation of Bald Head Creek
Bald Head Island, North Carolina**

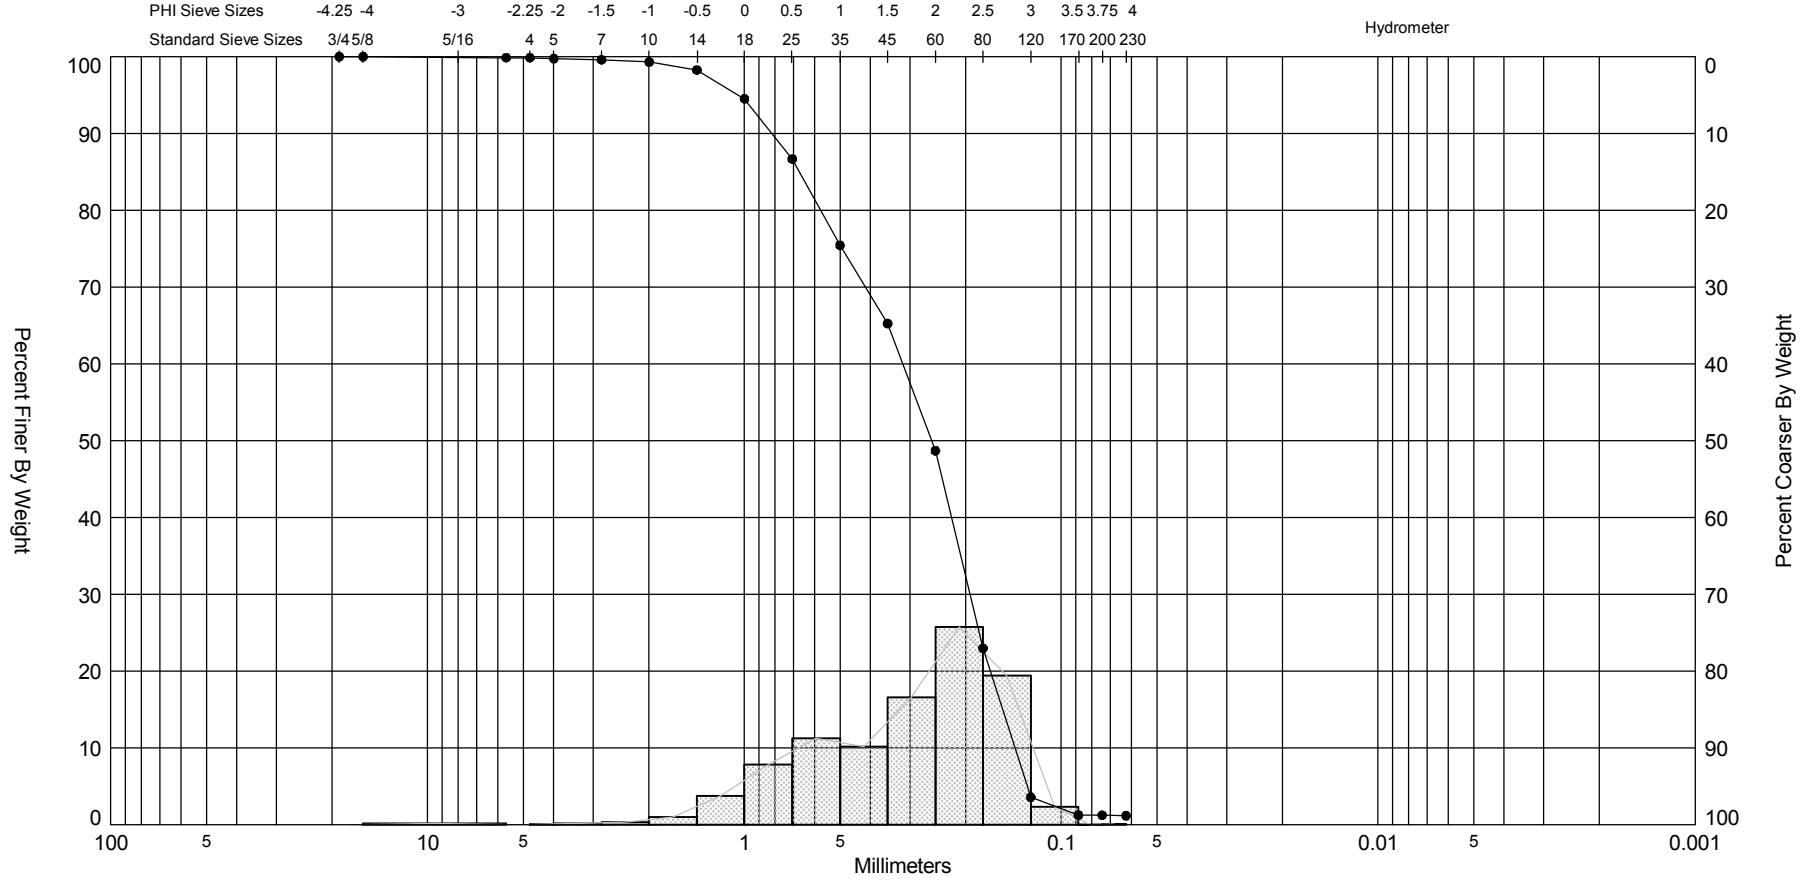
SIEVE ANALYSIS: BALD HEAD CREEK, NC., FEB. '14, GPJ, FL DEP ROSS.GDT 3/3/14

Sample	Symbol	Elev. (ft)	USCS	% Fines	% Organics	% Carbonates	Median	Mean	Skew	Kurt	Sort	Sample Information	
BHC-21 #1	—●—	-2.6	SP	#200 - 1.23 #230 - 1.16		8.90	1.96	1.7	-0.85	3.65	0.97	Project Name:	Village of Bald Head Island
Comments:												Analysis Date:	02-17-14
Depths and elevations based on measured values												Analyzed By:	CRM Sr.

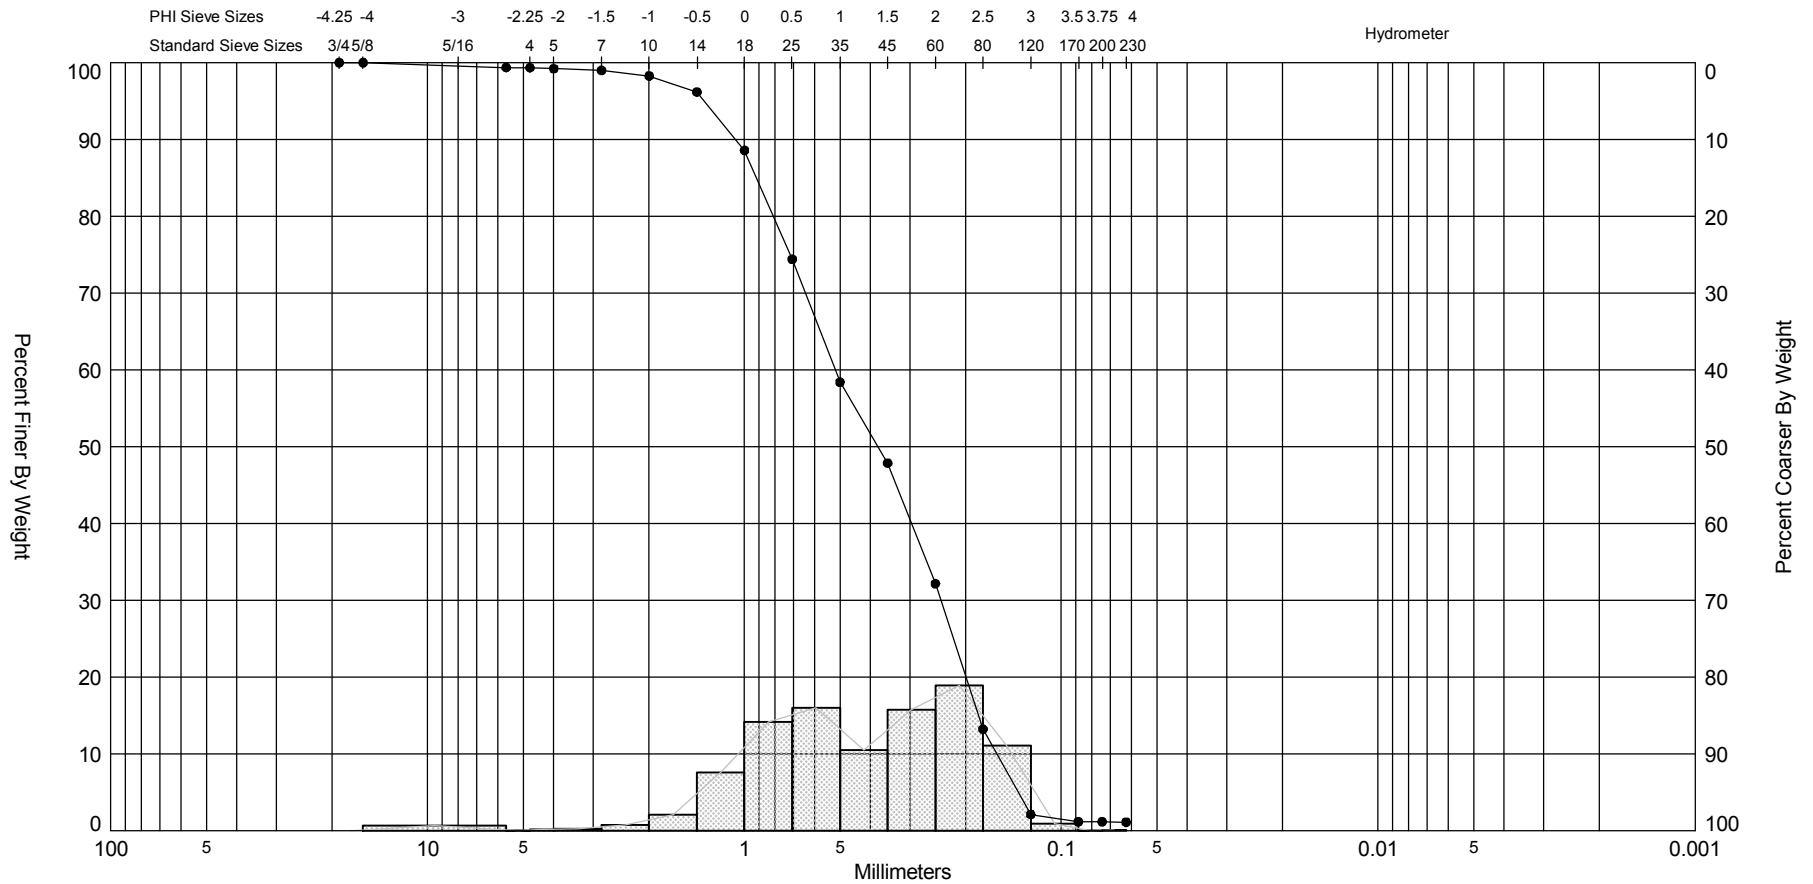
SIEVE ANALYSIS: BALD HEAD CREEK, NC., FEB. '14, GPJ, FL DEP ROSS.GDT 3/3/14

Sample	Symbol	Elev. (ft)	USCS	% Fines	% Organics	% Carbonates	Median	Mean	Skew	Kurt	Sort	Sample Information	
BHC-21 #Comp	—●—	-2.6	SP	#200 - 1.16 #230 - 1.11		10.70	1.4	1.27	-0.62	3.72	1.09	Project Name:	Village of Bald Head Island
Comments:												Analysis Date:	02-17-14
Depths and elevations based on measured values												Analyzed By:	CRM Sr.

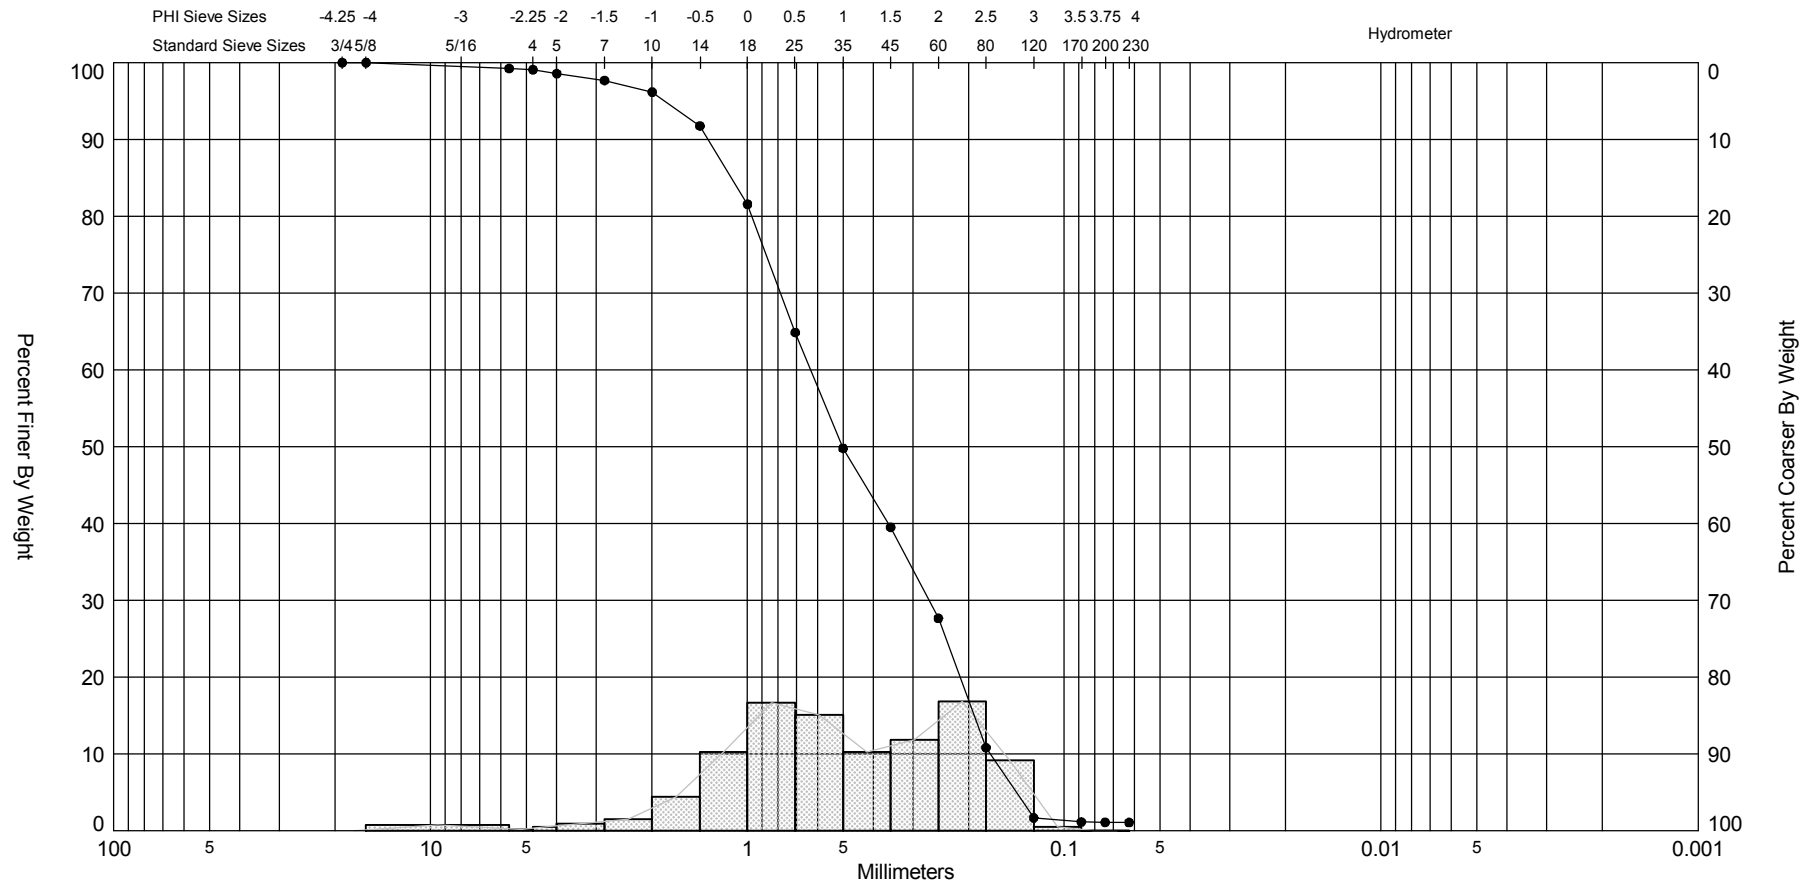
GRANULARMETRIC REPORT BALD HEAD CREEK, NC, FEB. '14.GPJ FL DEP ROSS.GDT 3/3/14

Sample	Symbol	Elev. (ft)	USCS	% Fines	% Organics	% Carbonates	Median	Mean	Skew	Kurt	Sort	Sample Information	
BHC-21 #2	—●—	-7.6	SP	#200 - 1.09 #230 - 1.06		15.30	0.99	1.02	-0.48	3.21	1.19	Project Name:	Village of Bald Head Island
Comments:												Analysis Date:	02-17-14
Depths and elevations based on measured values												Analyzed By:	CRM Sr.

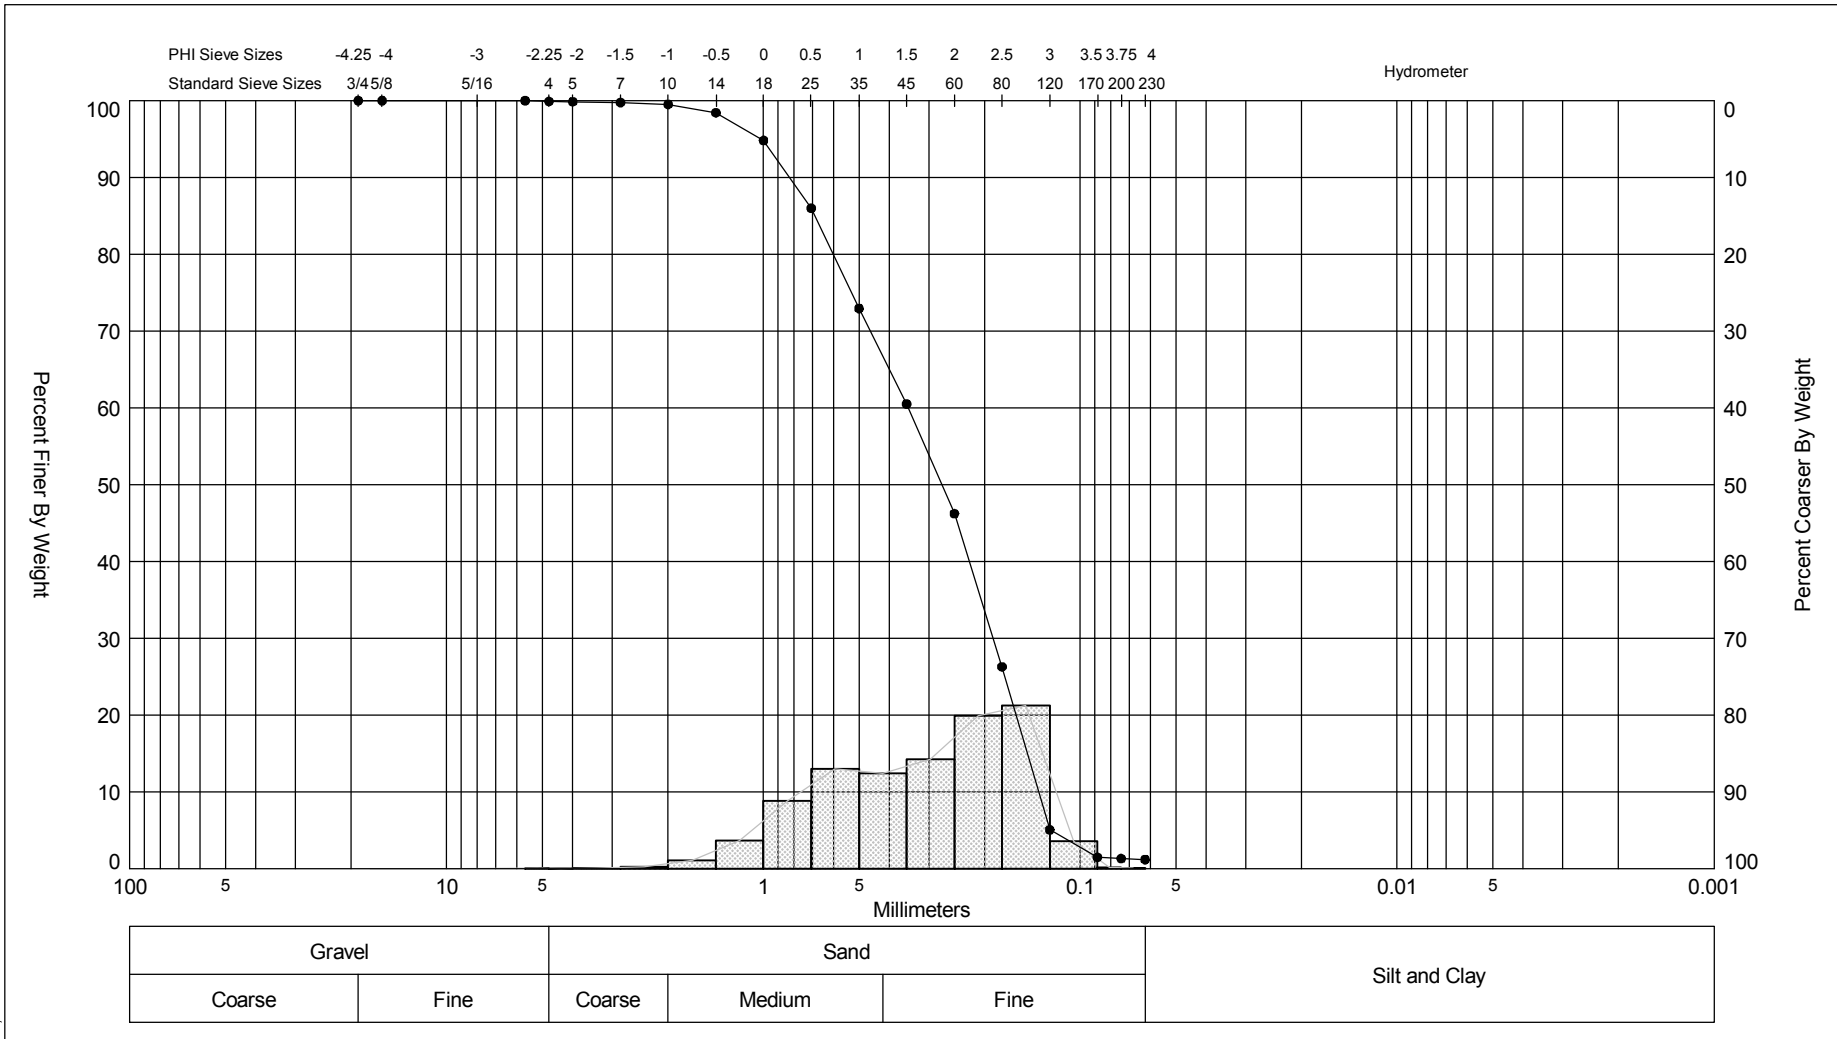
SIEVE ANALYSIS BALD HEAD CREEK, NC., FEB. '14, GPJ, FL DEP ROSS.GDT 3/3/14

Sample	Symbol	Elev. (ft)	USCS	% Fines	% Organics	% Carbonates	Median	Mean	Skew	Kurt	Sort	Sample Information	
BHC-22 #1	—●—	-3.1	SP	#200 - 1.31 #230 - 1.20		8.30	1.87	1.68	-0.53	2.66	0.99	Project Name:	Village of Bald Head Island
Comments:												Analysis Date:	02-17-14
Depths and elevations based on measured values												Analyzed By:	CRM Sr.

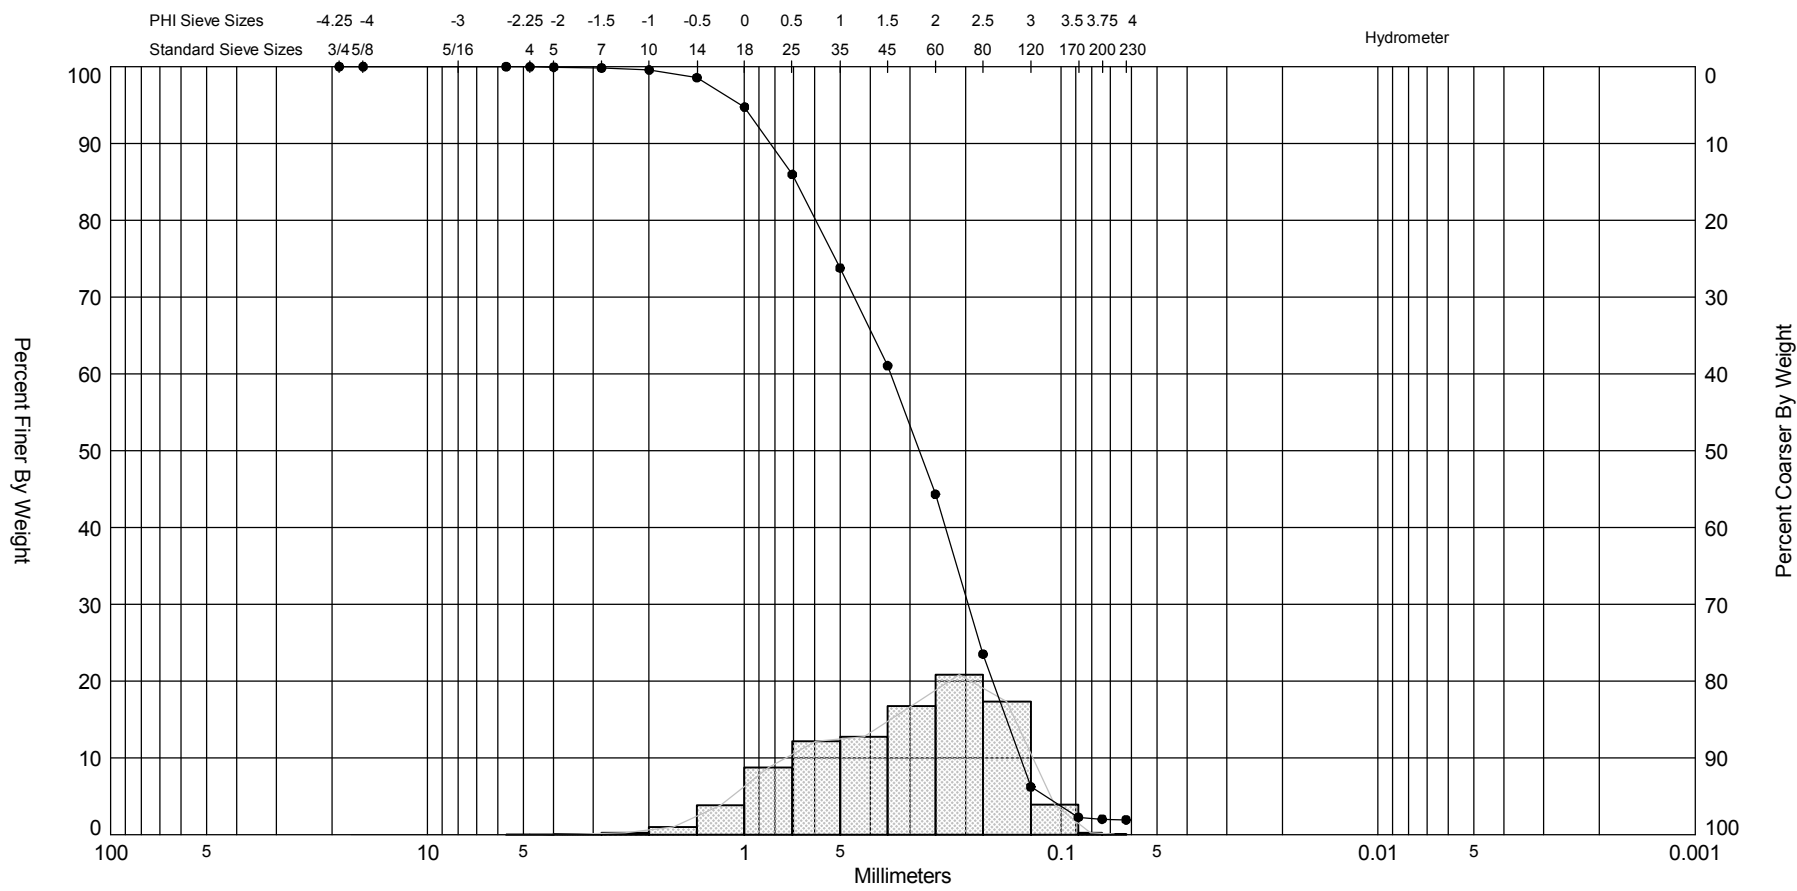
SIEVE ANALYSIS: BALD HEAD CREEK, NC, FEB. '14, GPJ, FL DEP ROSS, GDT 3/3/14

Sample	Symbol	Elev. (ft)	USCS	% Fines	% Organics	% Carbonates	Median	Mean	Skew	Kurt	Sort	Sample Information	
BHC-22 #Comp	●—	-3.1	SP	#200 - 2.03 #230 - 1.94		6.00	1.83	1.66	-0.48	2.63	0.97	Project Name:	Village of Bald Head Island
Comments:												Analysis Date:	02-17-14
Depths and elevations based on measured values												Analyzed By:	CRM Sr.

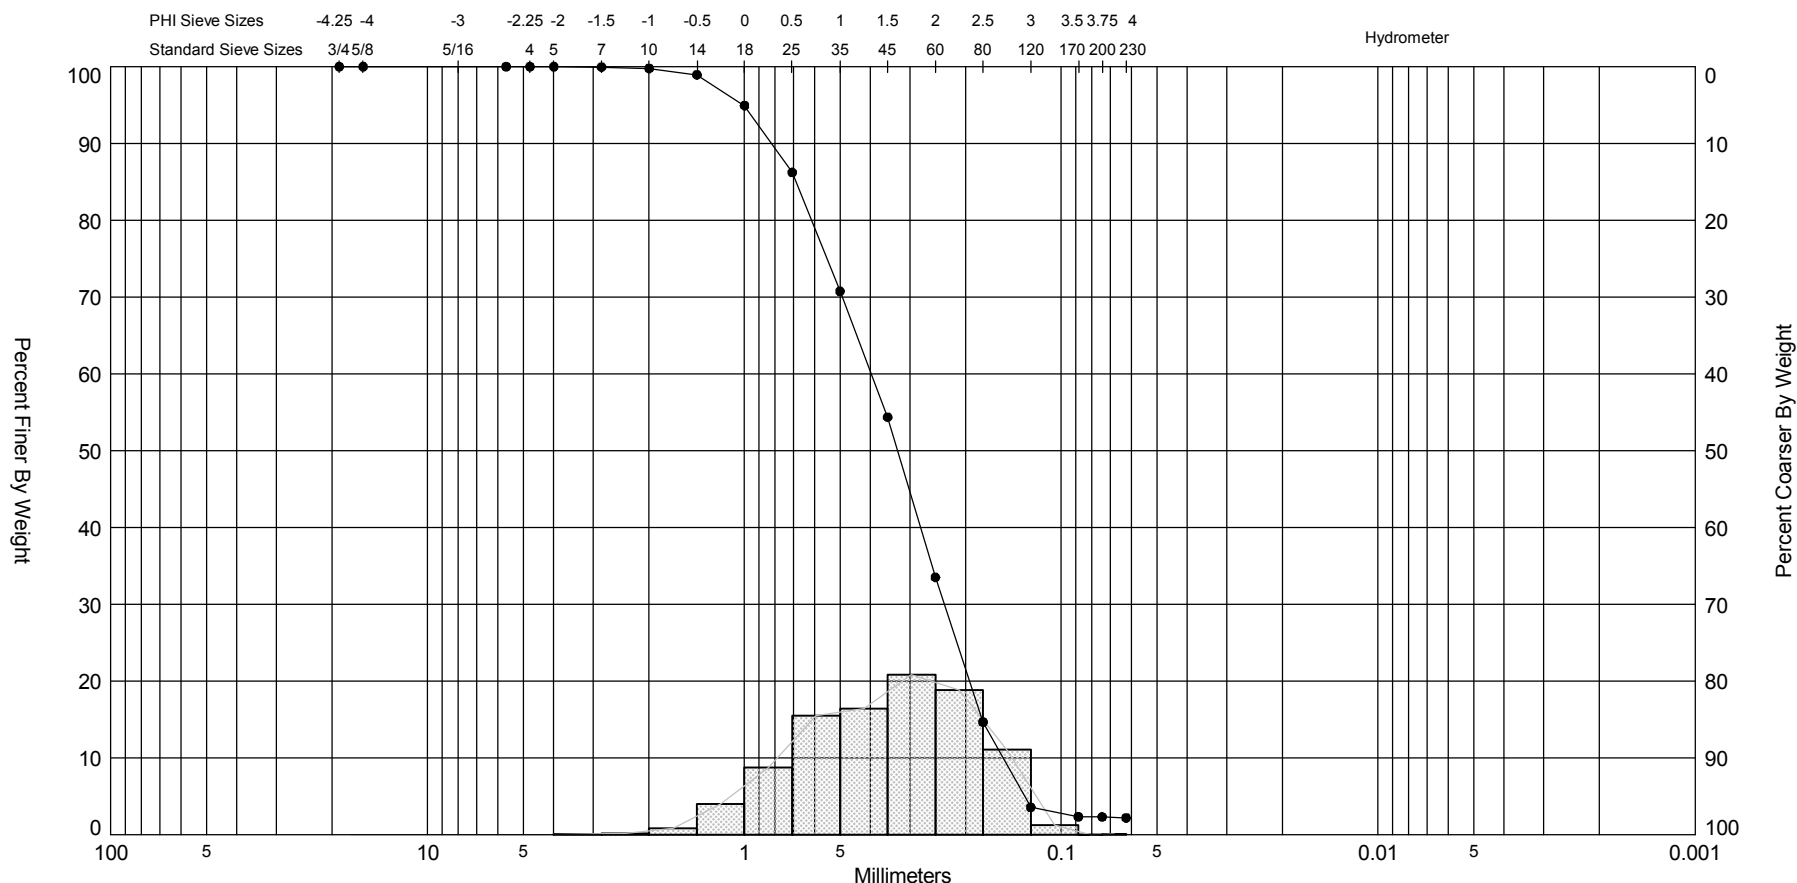
GRANULARMETRIC REPORT BALD HEAD CREEK, NC, FEB. '14.GPJ FL DEP ROSS.GDT 3/3/14

Sample	Symbol	Elev. (ft)	USCS	% Fines	% Organics	% Carbonates	Median	Mean	Skew	Kurt	Sort	Sample Information	
BHC-22 #2	—●—	-7.6	SP	#200 - 2.31 #230 - 2.20		2.70	1.6	1.5	-0.32	2.56	0.88	Project Name:	Village of Bald Head Island
Comments:												Analysis Date:	02-17-14
Depths and elevations based on measured values												Analyzed By:	CRM Sr.
