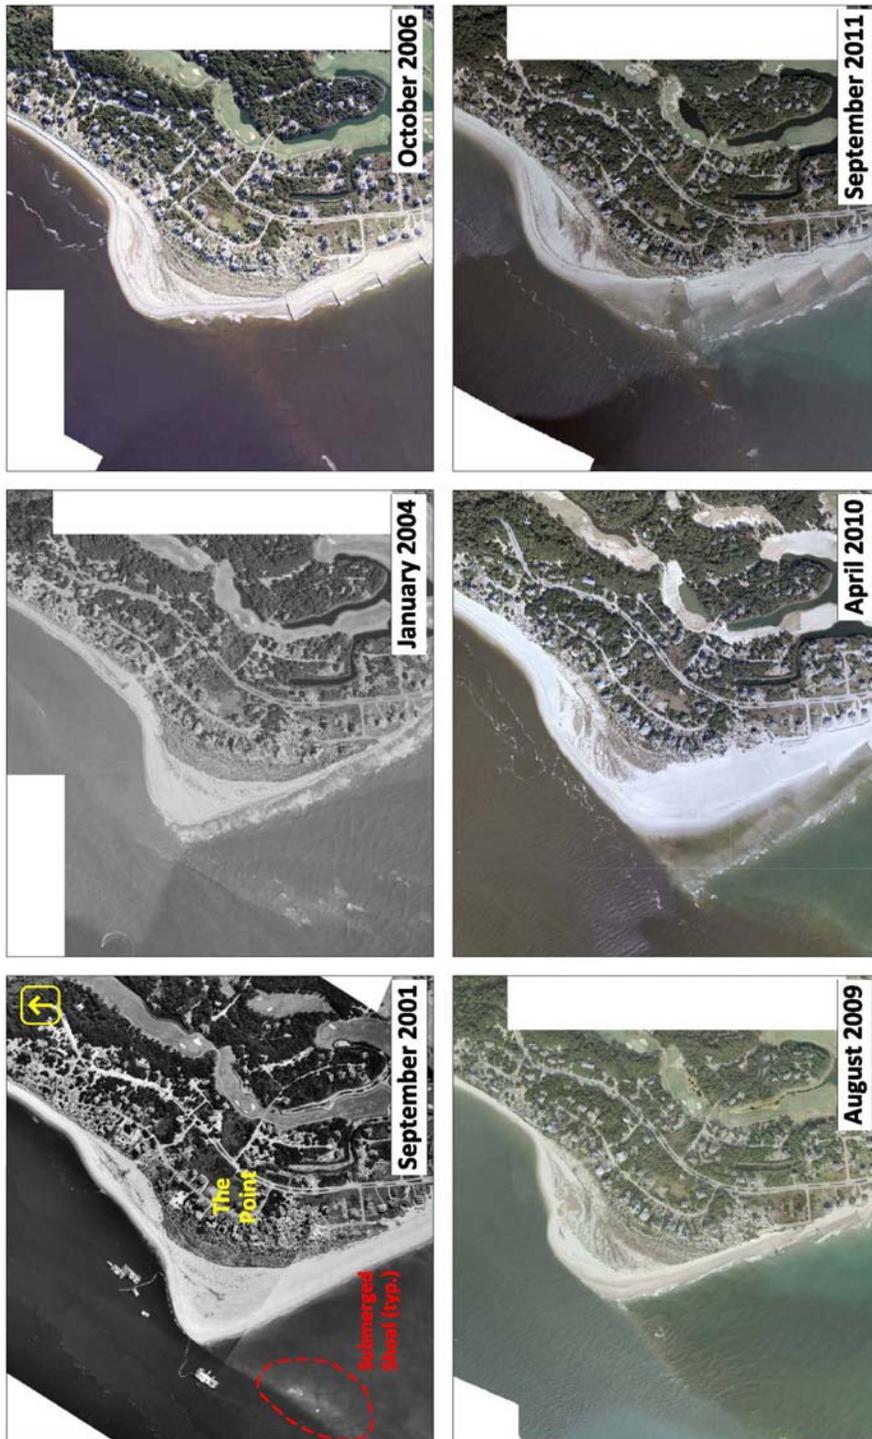
**Figure 4.21.** 2001-2011 Aerial Photographs of Bald Head Island. A persistent submerged spit shoal, resulting from offshore transport is evident off the tip of the island.
