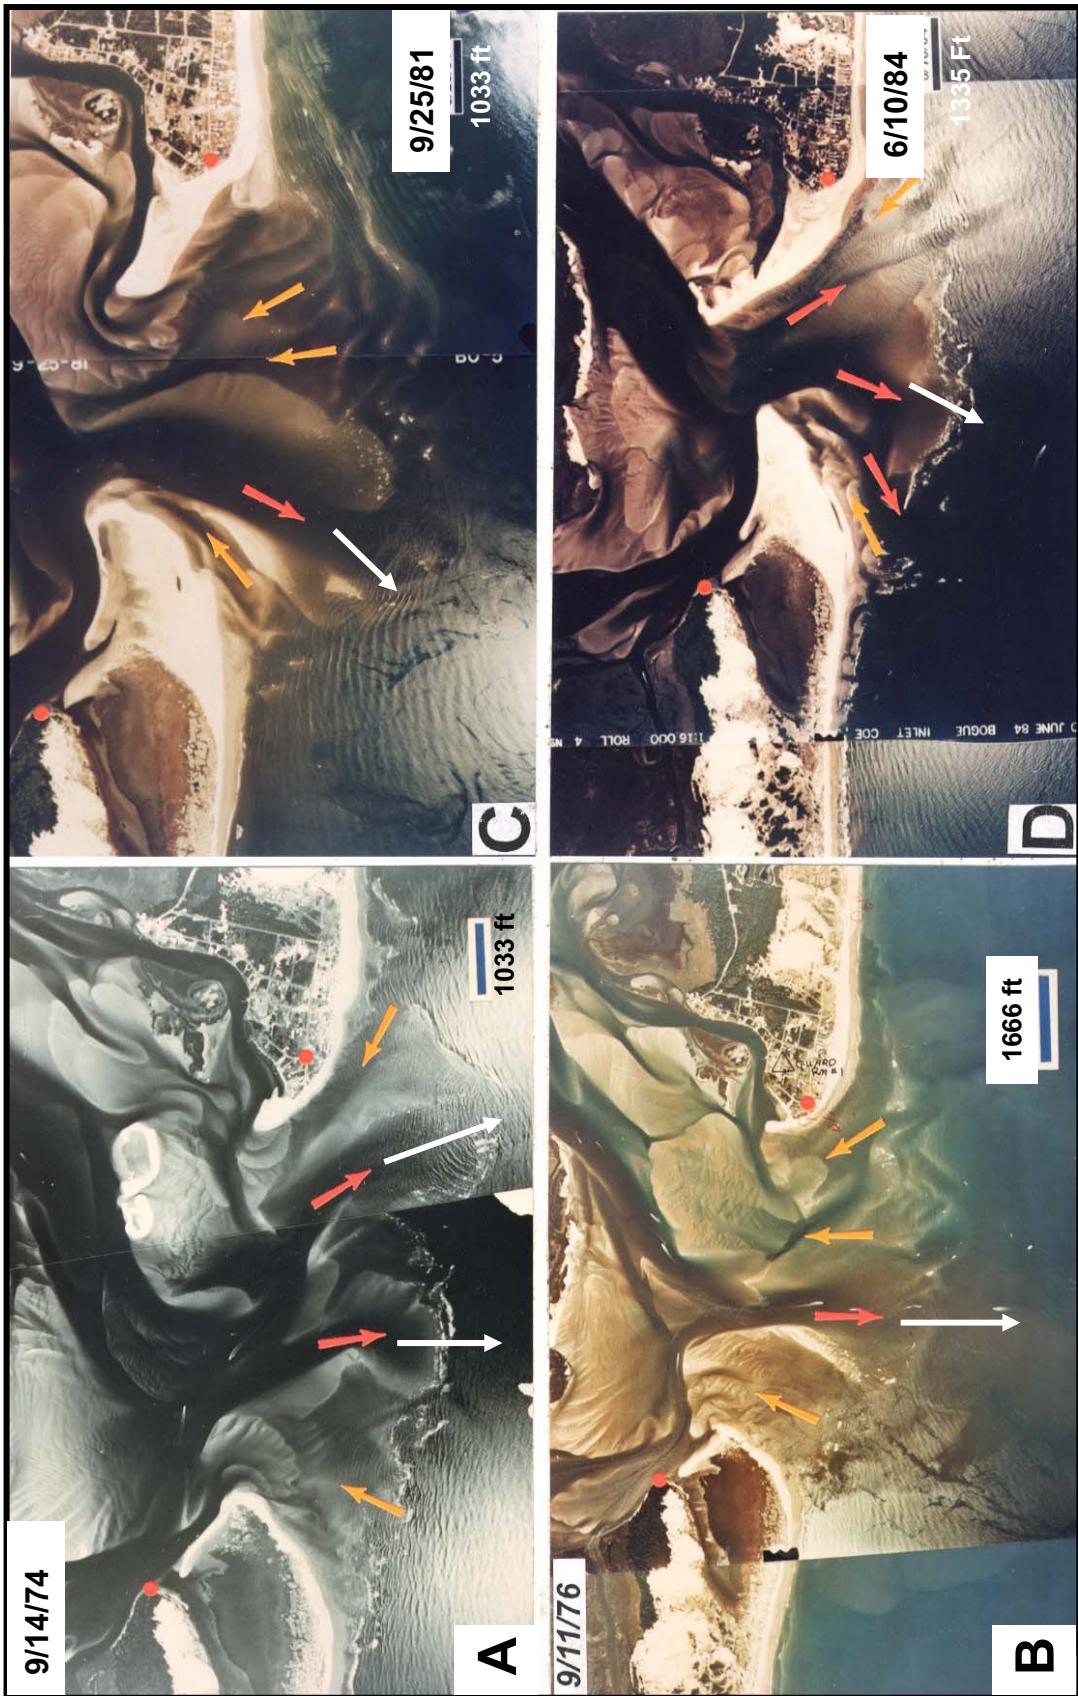
Figure 6. Historic aerial photographs A-D (9/4/74 – 6/10/84) depicting inlet and shoulder configurations. The two ebb channels present in 1974 (A) have merged into a single shore-normal ebb channel by 1976 flanked by relatively wide marginal flood channels. Note elongation of spits on adjacent shoulders has resulted in constriction of the inlet throat. Erosion of the Bogue Banks oceanfront and inlet shorelines between 1974 (A) and 1976 (B) was due primarily due to expansion of the marginal flood channel.
