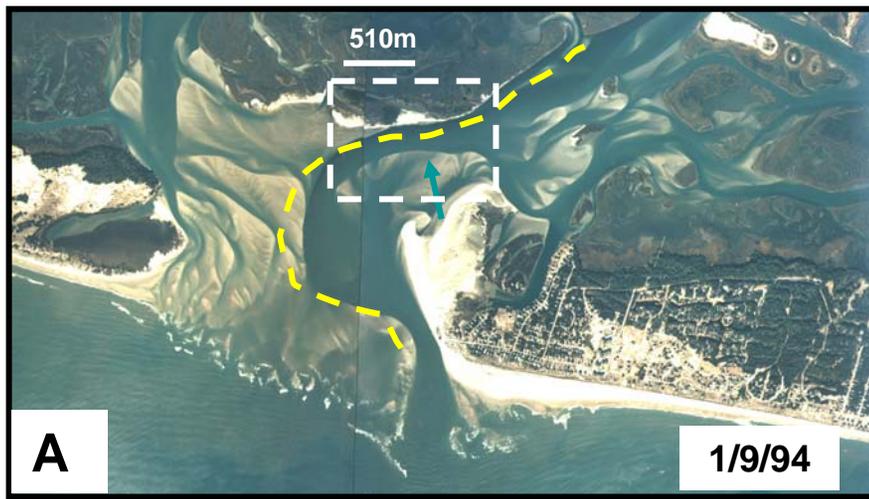
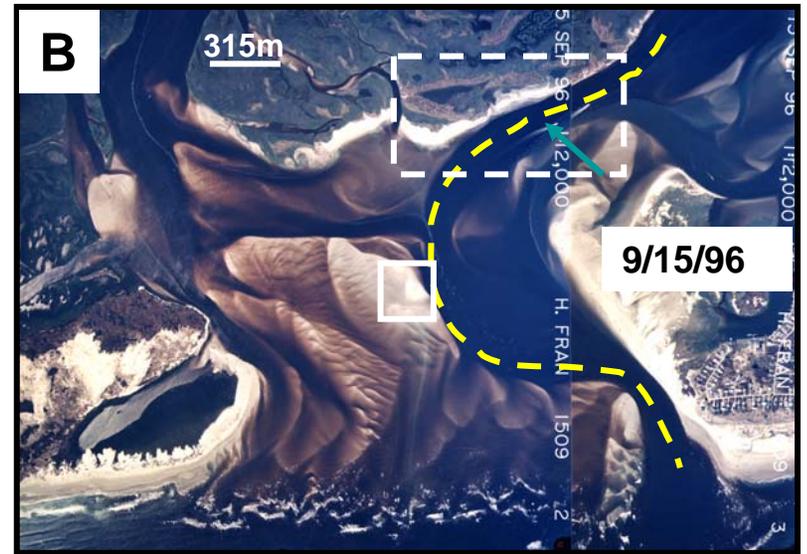
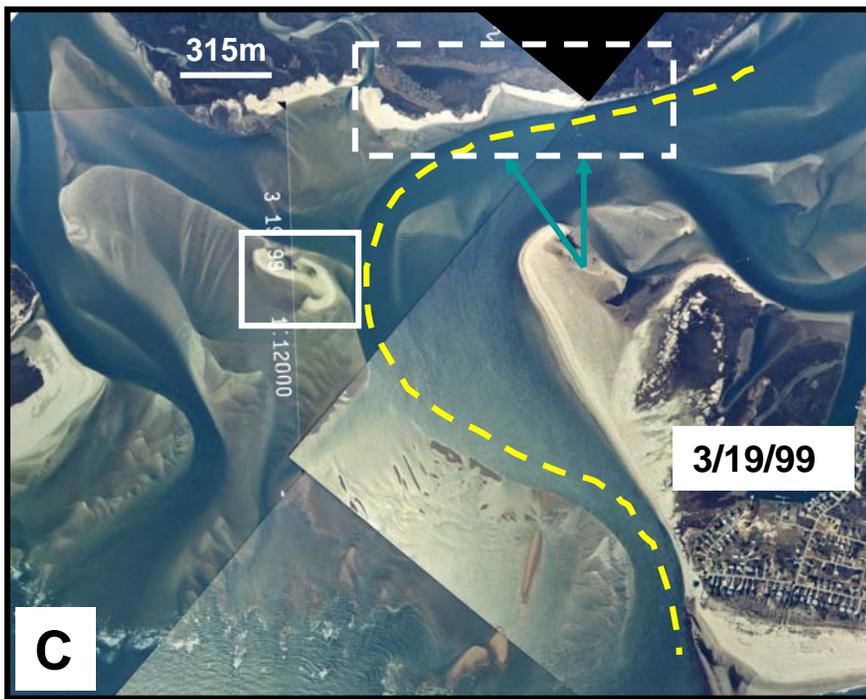
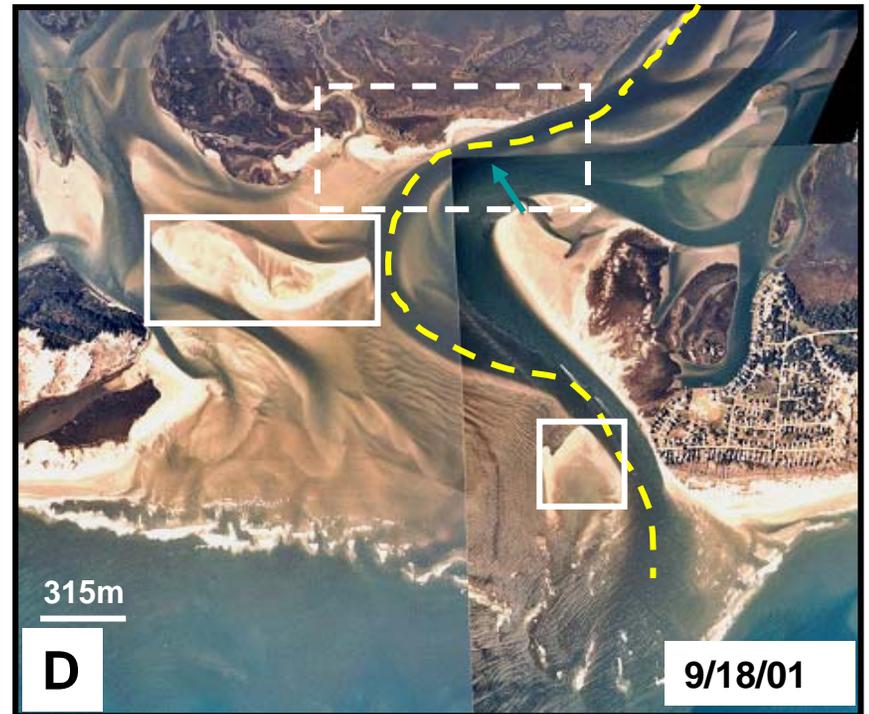
Figure 23. Historic aerial photographs (1/9/94 – 9/18/01) depicting shoreline change along the Dudley Island shoreline and marsh complex. Dotted arrow delineates axis of the main ebb channel (A-D). Note the encroachment of the ebb channel upon the marsh shoreline and the shift of the ebb channel resulting in the erosion of the eastern portion of the flood delta (A and B). Also note the spit shape changes that impact the ebb channel position and the erosion of Dudley Island. Rectangular shaped box delineates Island 1 and 2. Compare to Figures 23 and 24.
