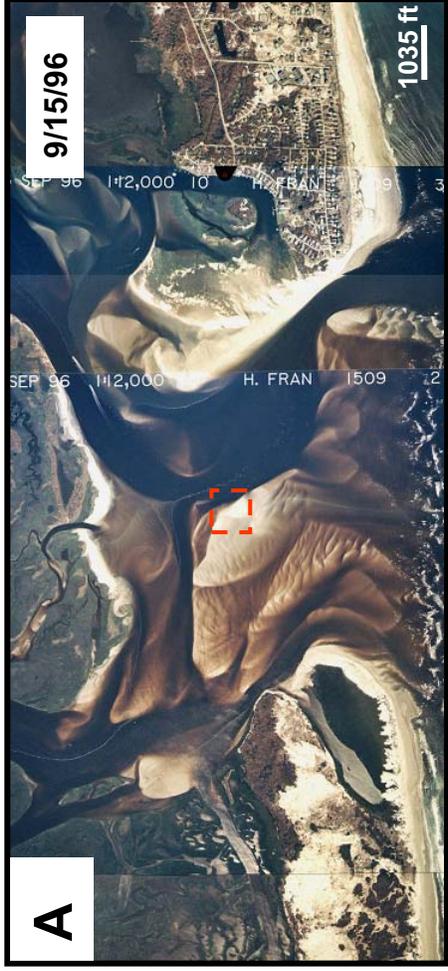
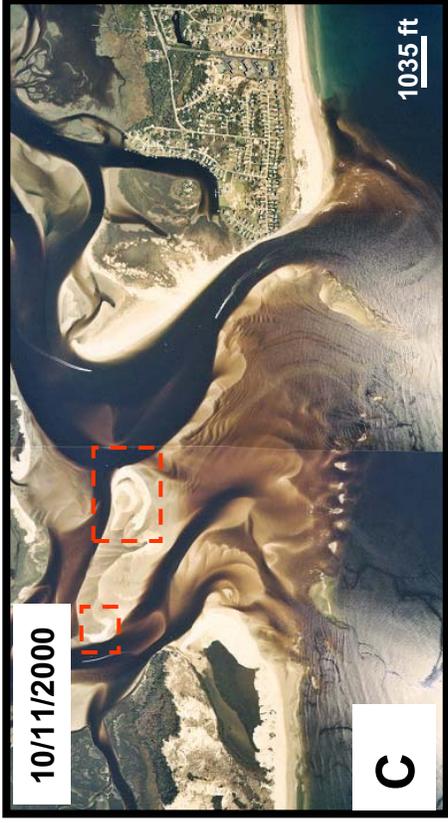
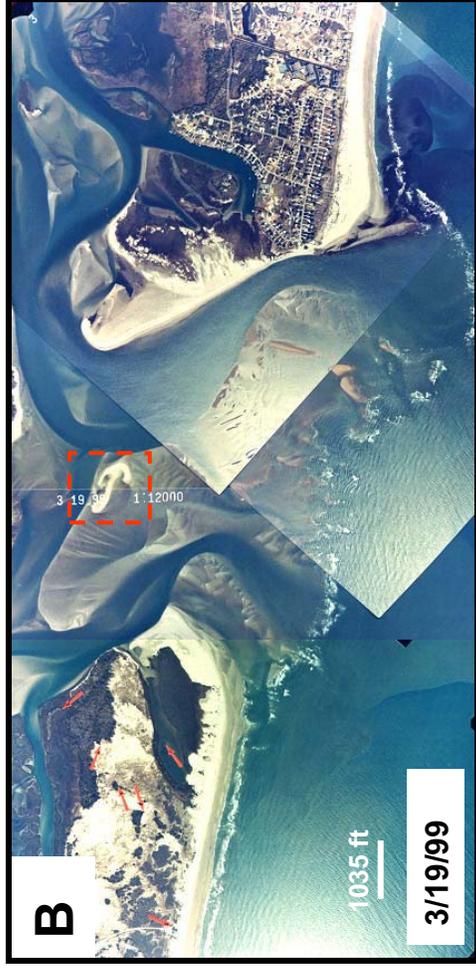
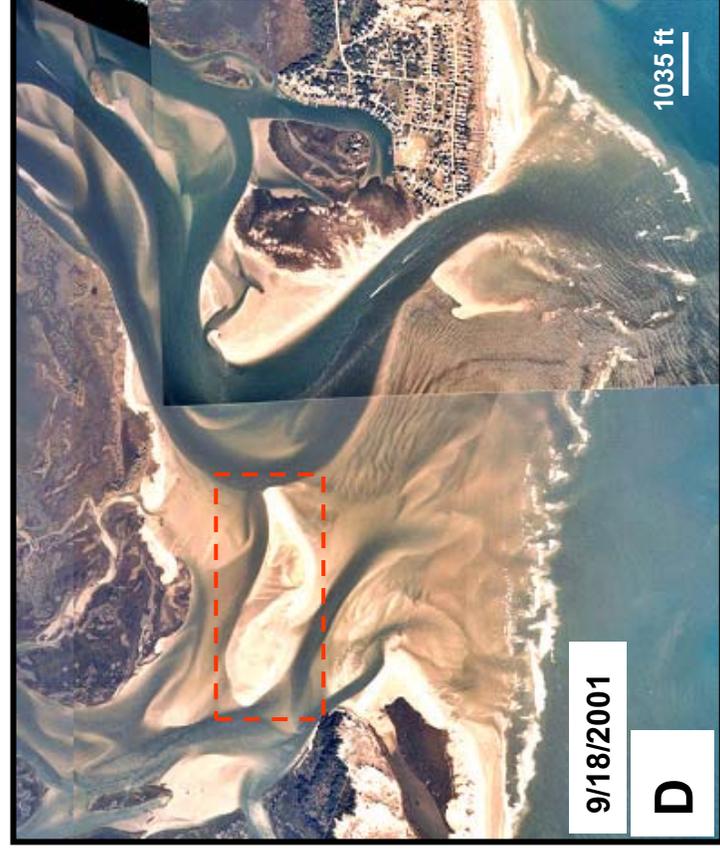
Figure 8. Historic aerial photographs A-D (9/15/95- 9/18/01) depicting inlet and shoulder configurations. The complex interaction of the expanding mid inlet shoal and the continued developments of the Bogue Banks spit complex, within the landward portions of the inlet, led to a shift in the ebb channel and erosion along the Bogue Banks inlet shoreline and accretion along the Bogue Banks oceanfront. Note development of Islands # 1 and # 2 (dashed box) compare Fig. 8 A-D with Fig. 7 D. Also note the growth and decay of a secondary ebb channel near the Bear Island (Hammocks Beach) shoulder.
