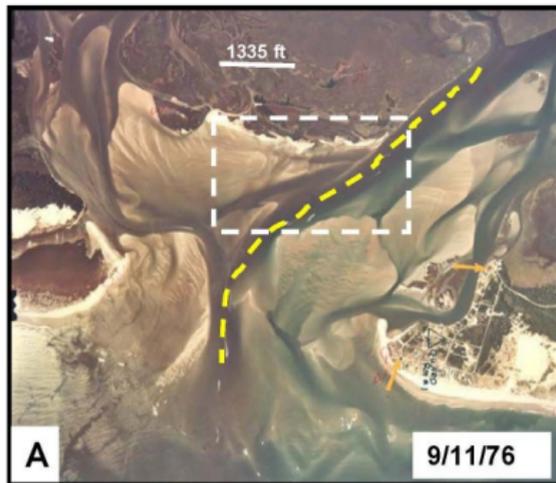
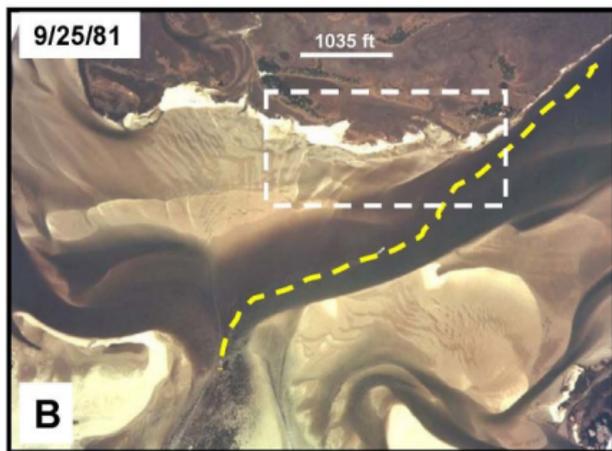
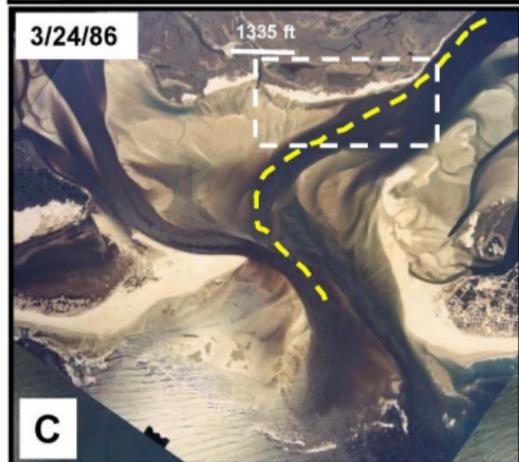
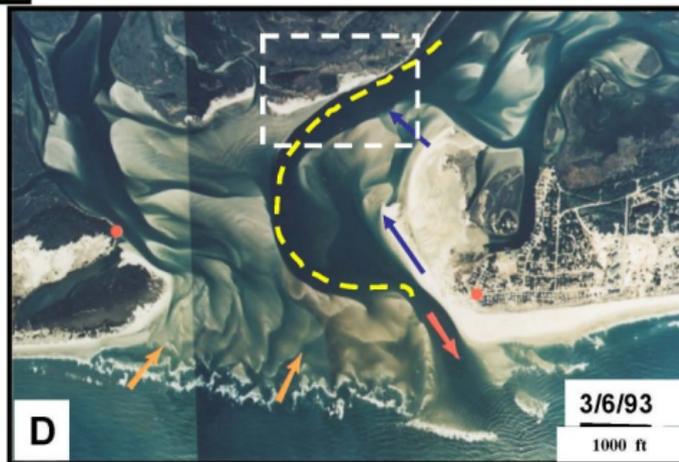
Figure 22. Historic aerial photographs (9/11/76 – 3/6/93) depicting shoreline change along the Dudley Island shoreline and marsh complex. Dotted arrow delineates axis of the main ebb channel (A-D). Note the encroachment of the ebb channel upon the marsh shoreline and the initiation of a shift of the ebb channel resulting in the erosion of the eastern portion of the flood delta (A and B). Compare to Figure 23.
