# MOGENSEN MITIGATION, INC.

## TAR RIVER HEADWATERS STREAM MITIGATION BANK

### FINAL PROSPECTUS

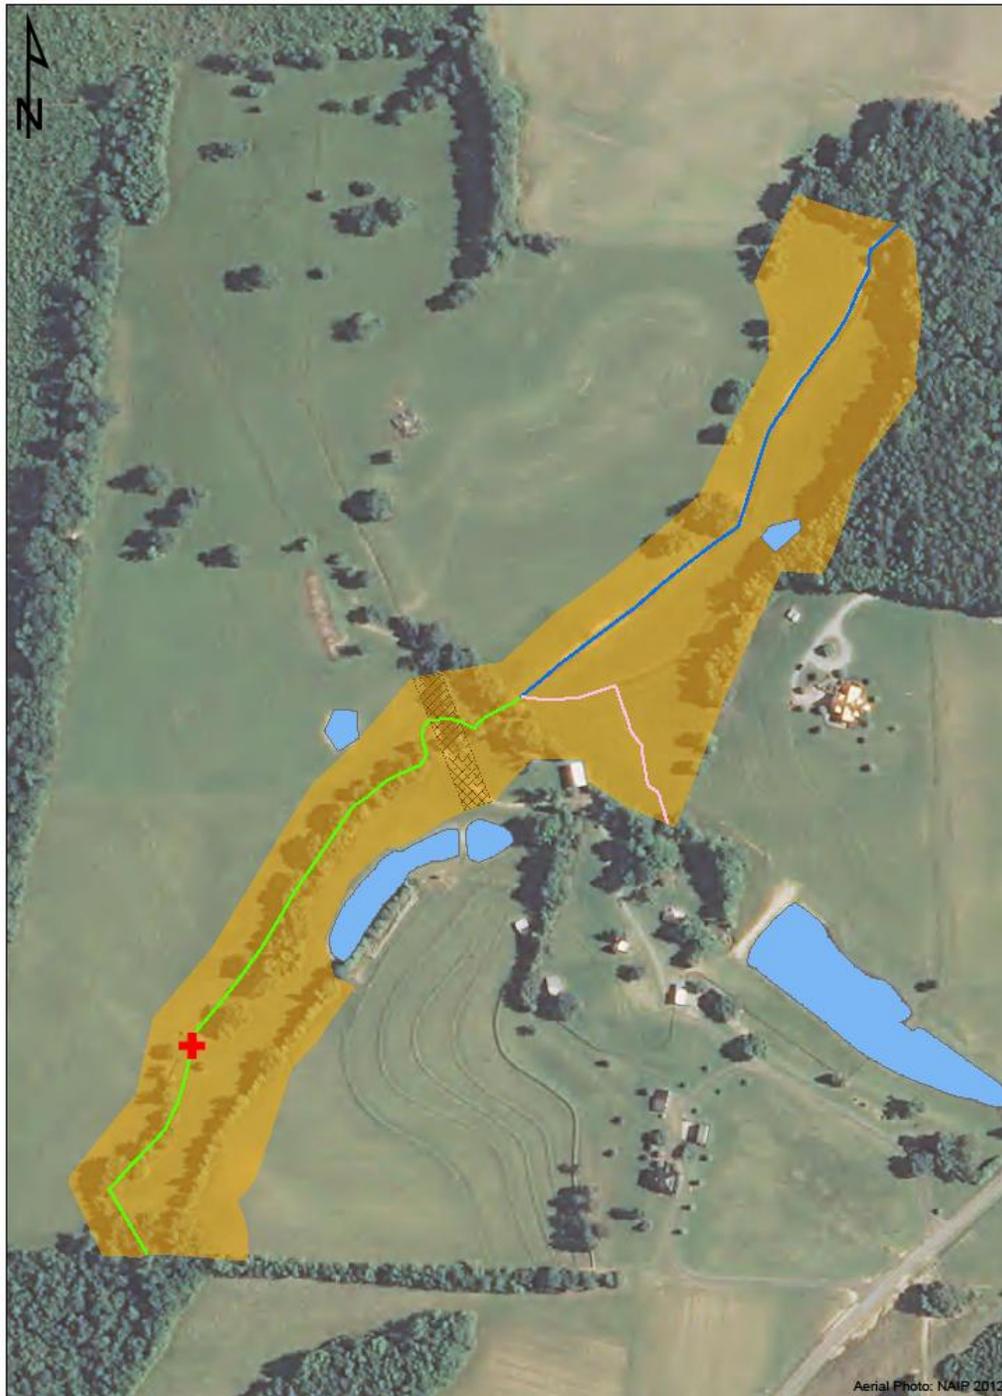
**UT2-R2 Stream Quality Assessment  
Location Map**

- + SQA\_Location
- UT1
- UT2-R1
- UT2-R2
- GPS Farm Ponds
- Easement (19.8 ac)
- Ford Crossing
