**PROSPECTUS**

**Rough Horn Swamp Mitigation Bank  
Columbus County, North Carolina**

**Lumber River Basin  
HUC 03040203**

**September 2016**

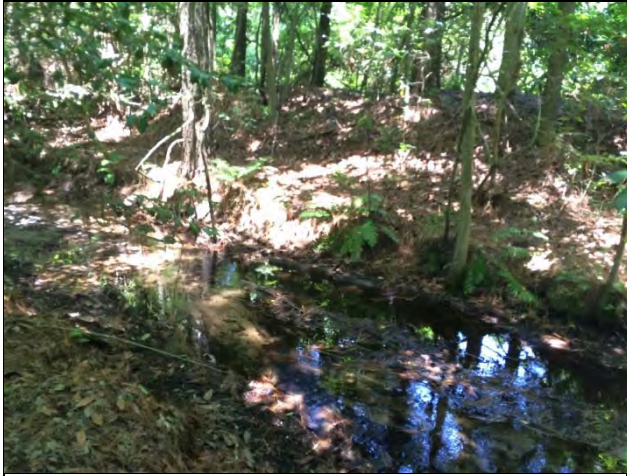
Looking downstream on Long Bay Creek as it enters the project boundary. 7/5/16

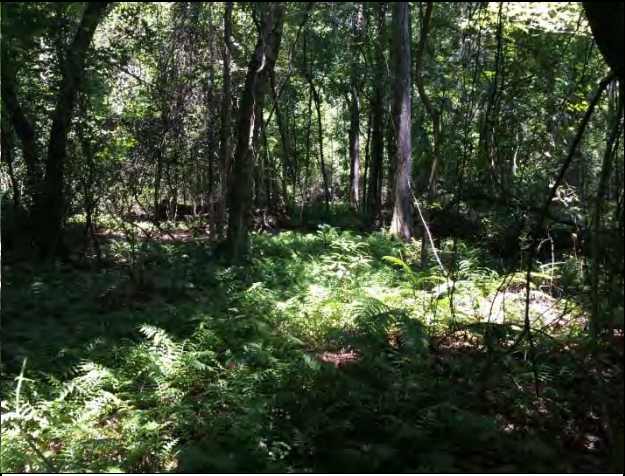
Former stream valley for Long Bay Creek that will be restored. 7/5/16

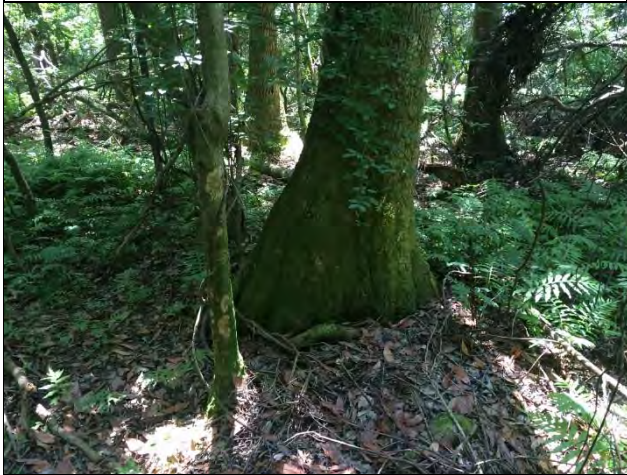
Existing forested wetland. 7/5/16

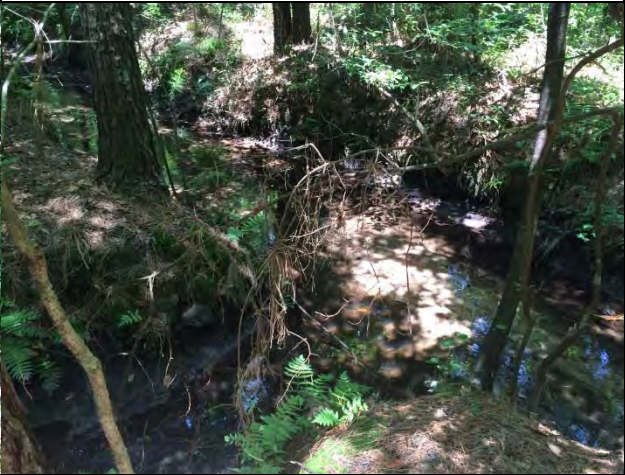
Intersection of ditch flowing south to north and Long Bay Creek flowing west. 7/5/16

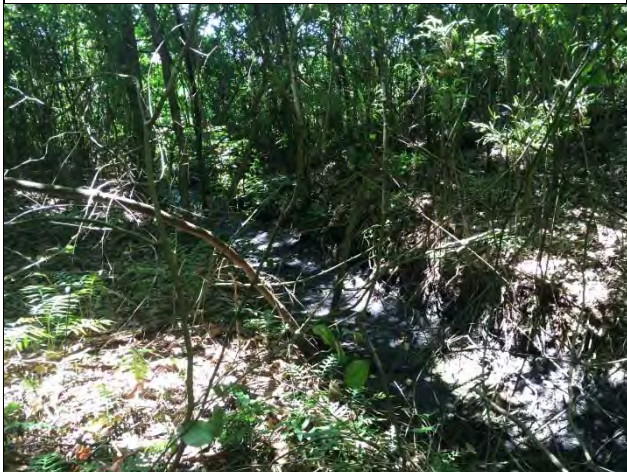
Ditch flowing south to north that currently drains part of the proposed stream valley to be restored. 7/5/16

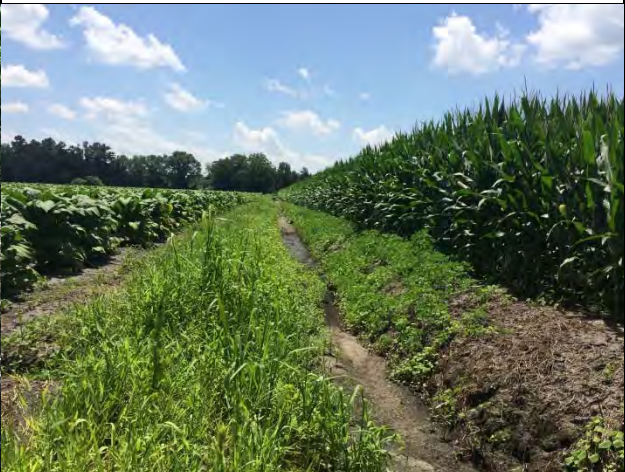
Looking south along furthest ditch to east in non-riparian project area. 7/5/16

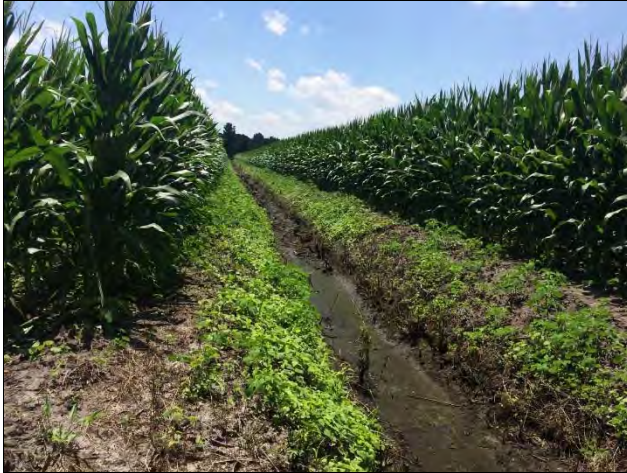
Looking south along second field ditch from the east in non-riparian area. 7/5/16

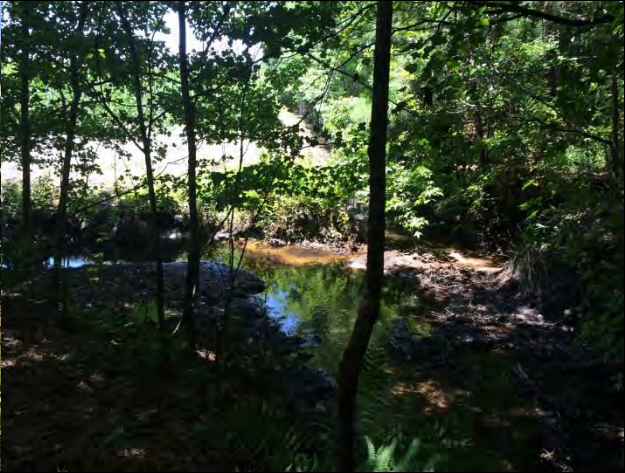
Looking west at current confluence of Long Bay Creek and UTLBC2. 7/5/16

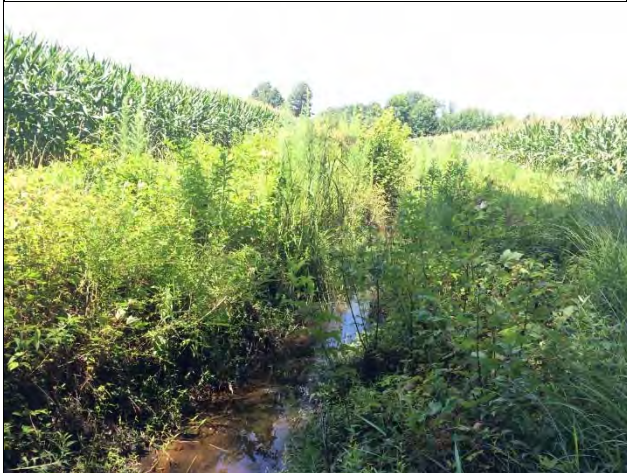
Looking upstream (north) on existing UTLBC2 channel. 7/5/16

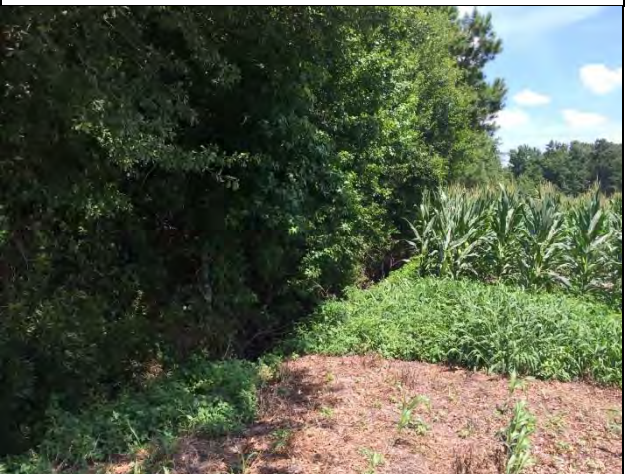
Looking east at ditch flowing along western edge of project along the treeline. 7/5/16

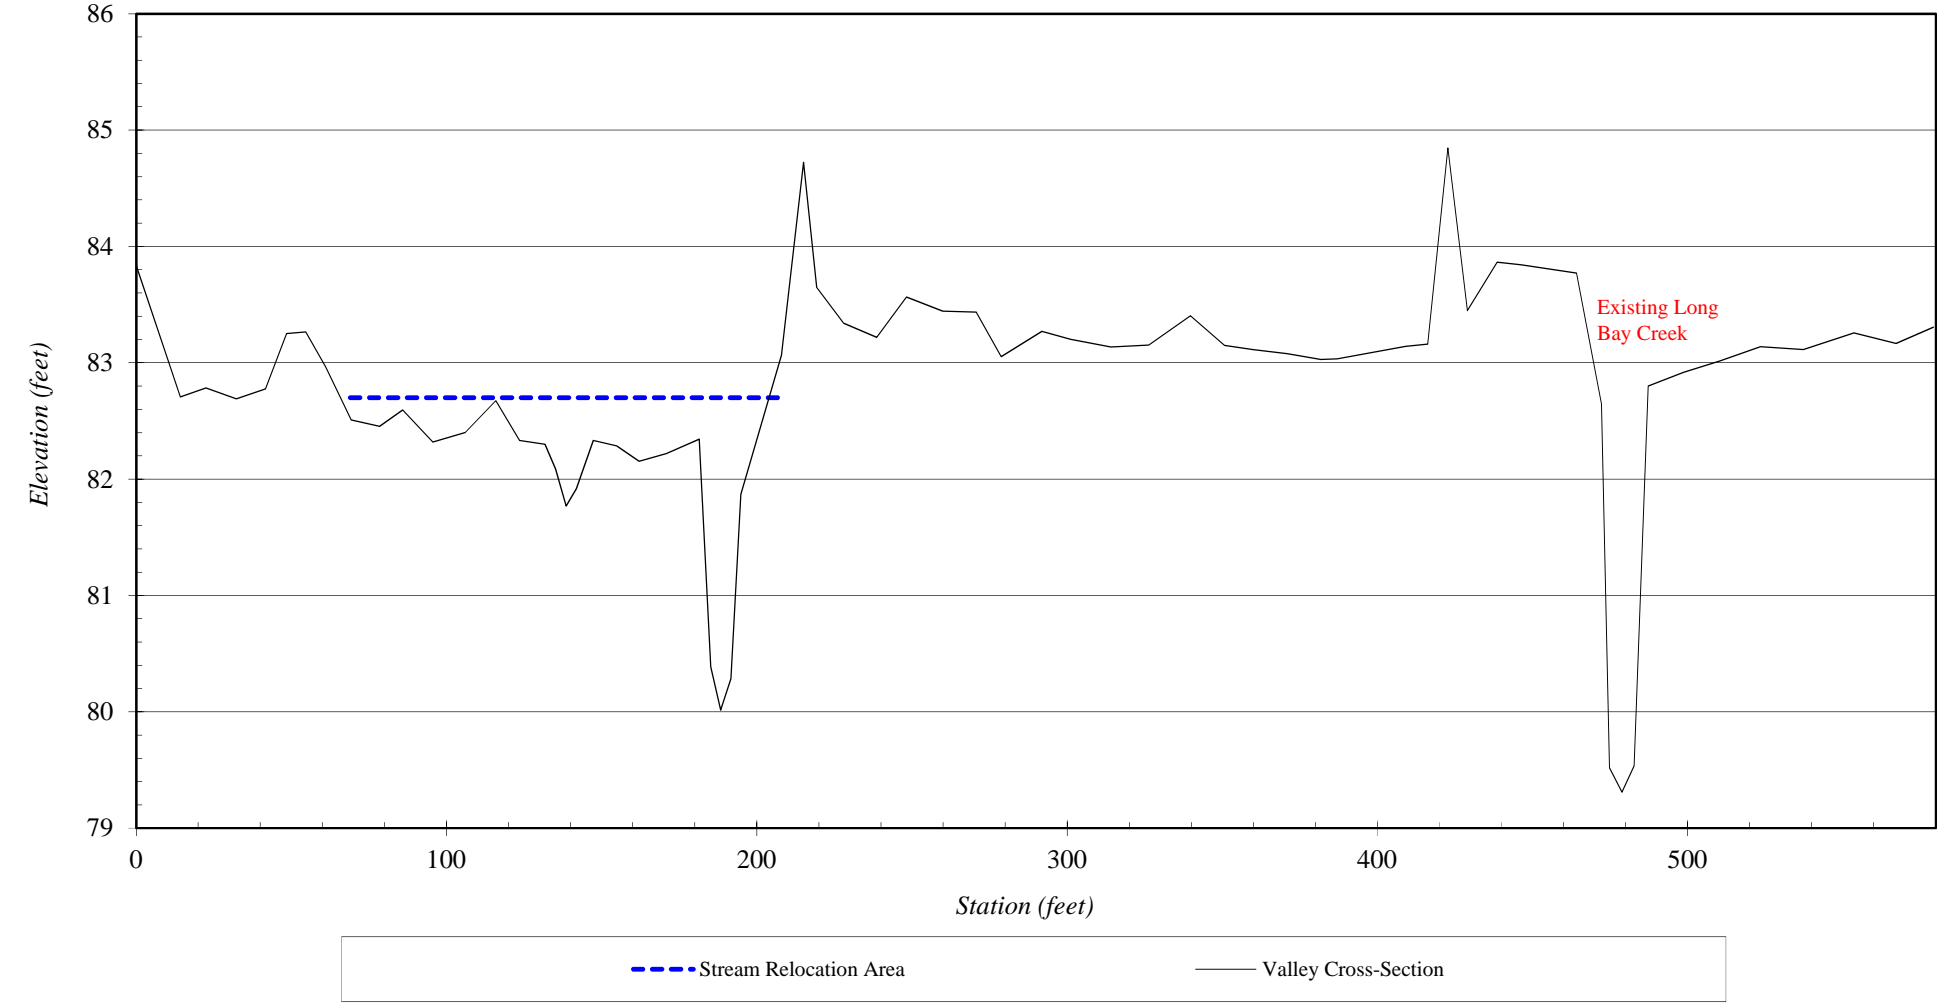
Lumber 03 River Basin, Long Bay Creek, Valley XS 4

<b>River Basin:</b>	Lumber 03
<b>Watershed:</b>	Long Bay Creek
<b>XS ID</b>	Valley XS 4
<b>Drainage Area (sq mi):</b>	2.71 square miles
<b>Date:</b>	March 2016
<b>Field Crew:</b>	KCI

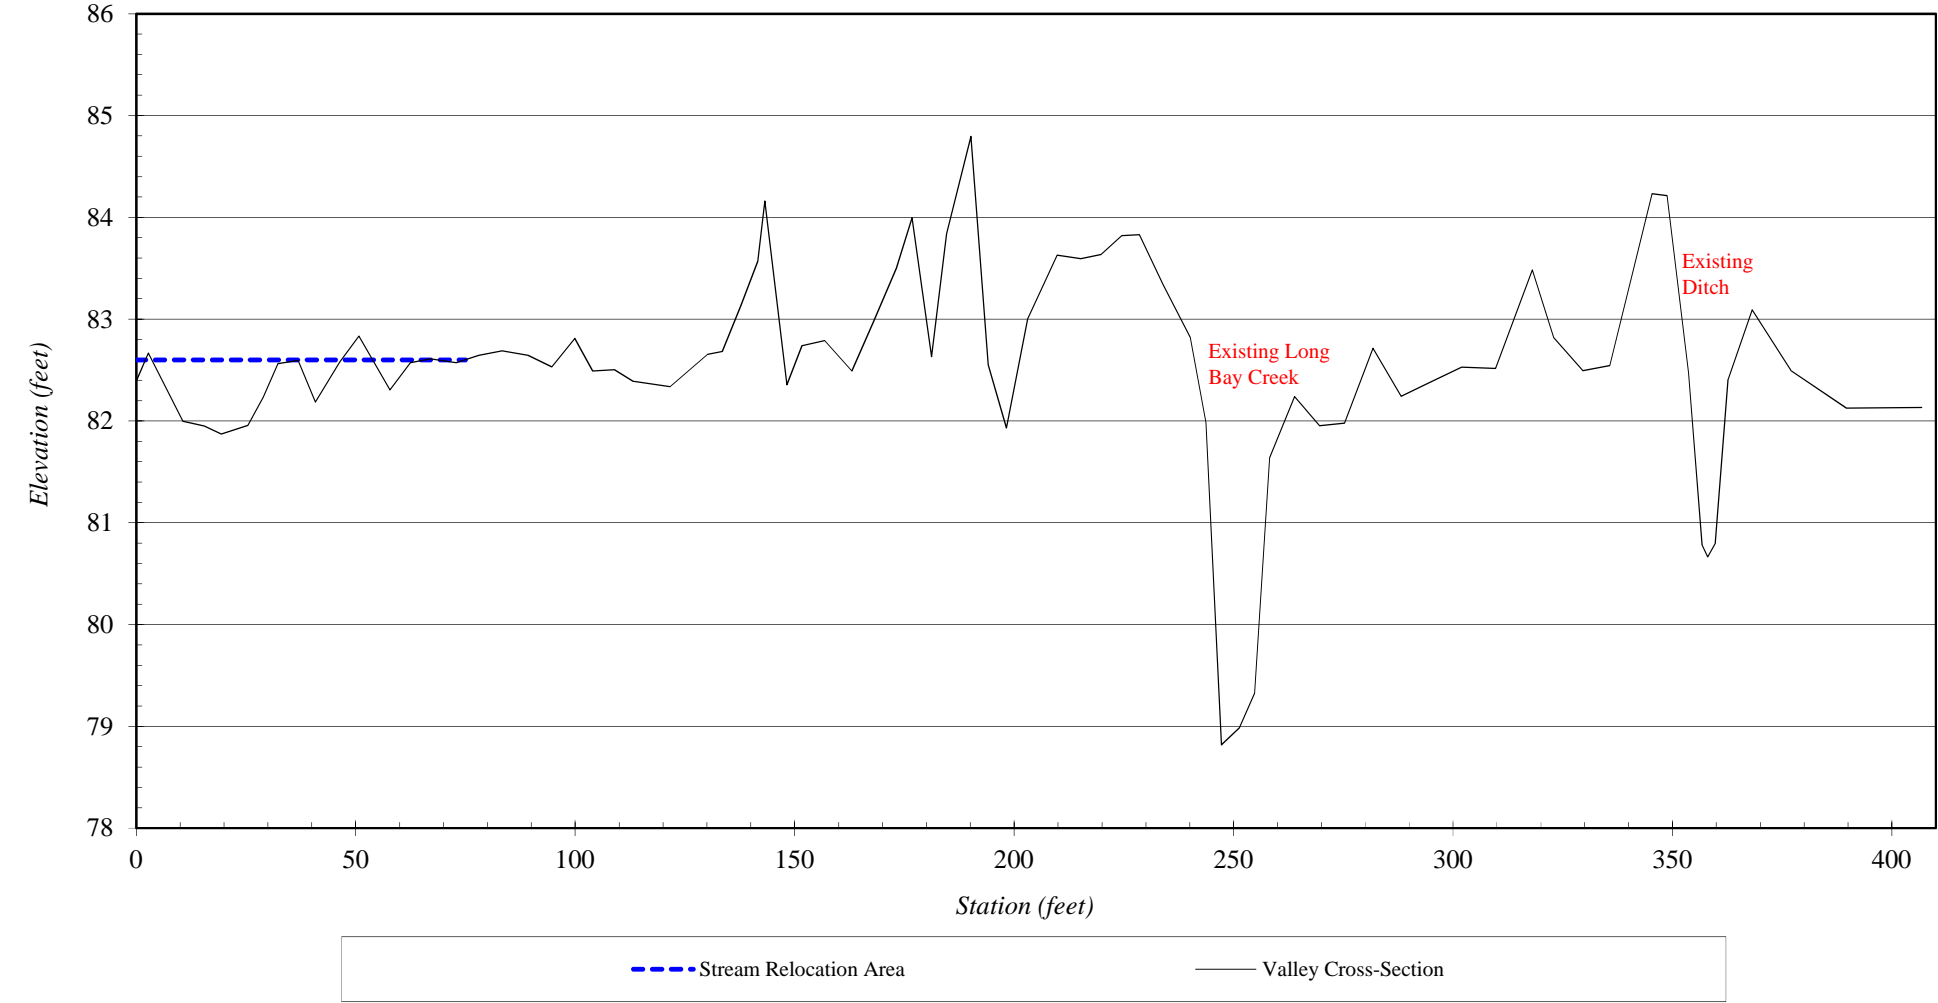
Lumber 03 River Basin, Long Bay Creek, Valley XS 5

<b>River Basin:</b>	Lumber 03
<b>Watershed:</b>	Long Bay Creek
<b>XS ID</b>	Valley XS 5
<b>Drainage Area (sq mi):</b>	2.71 square miles
<b>Date:</b>	March 2016
<b>Field Crew:</b>	KCI
