**VILLAGE OF BALD HEAD ISLAND
SHORELINE PROTECTION PROJECT**

FINAL ENVIRONMENTAL IMPACT STATEMENT

U.S. Army Corps of Engineers
Wilmington District

VOLUME II
(APPENDIX A THROUGH APPENDIX K)

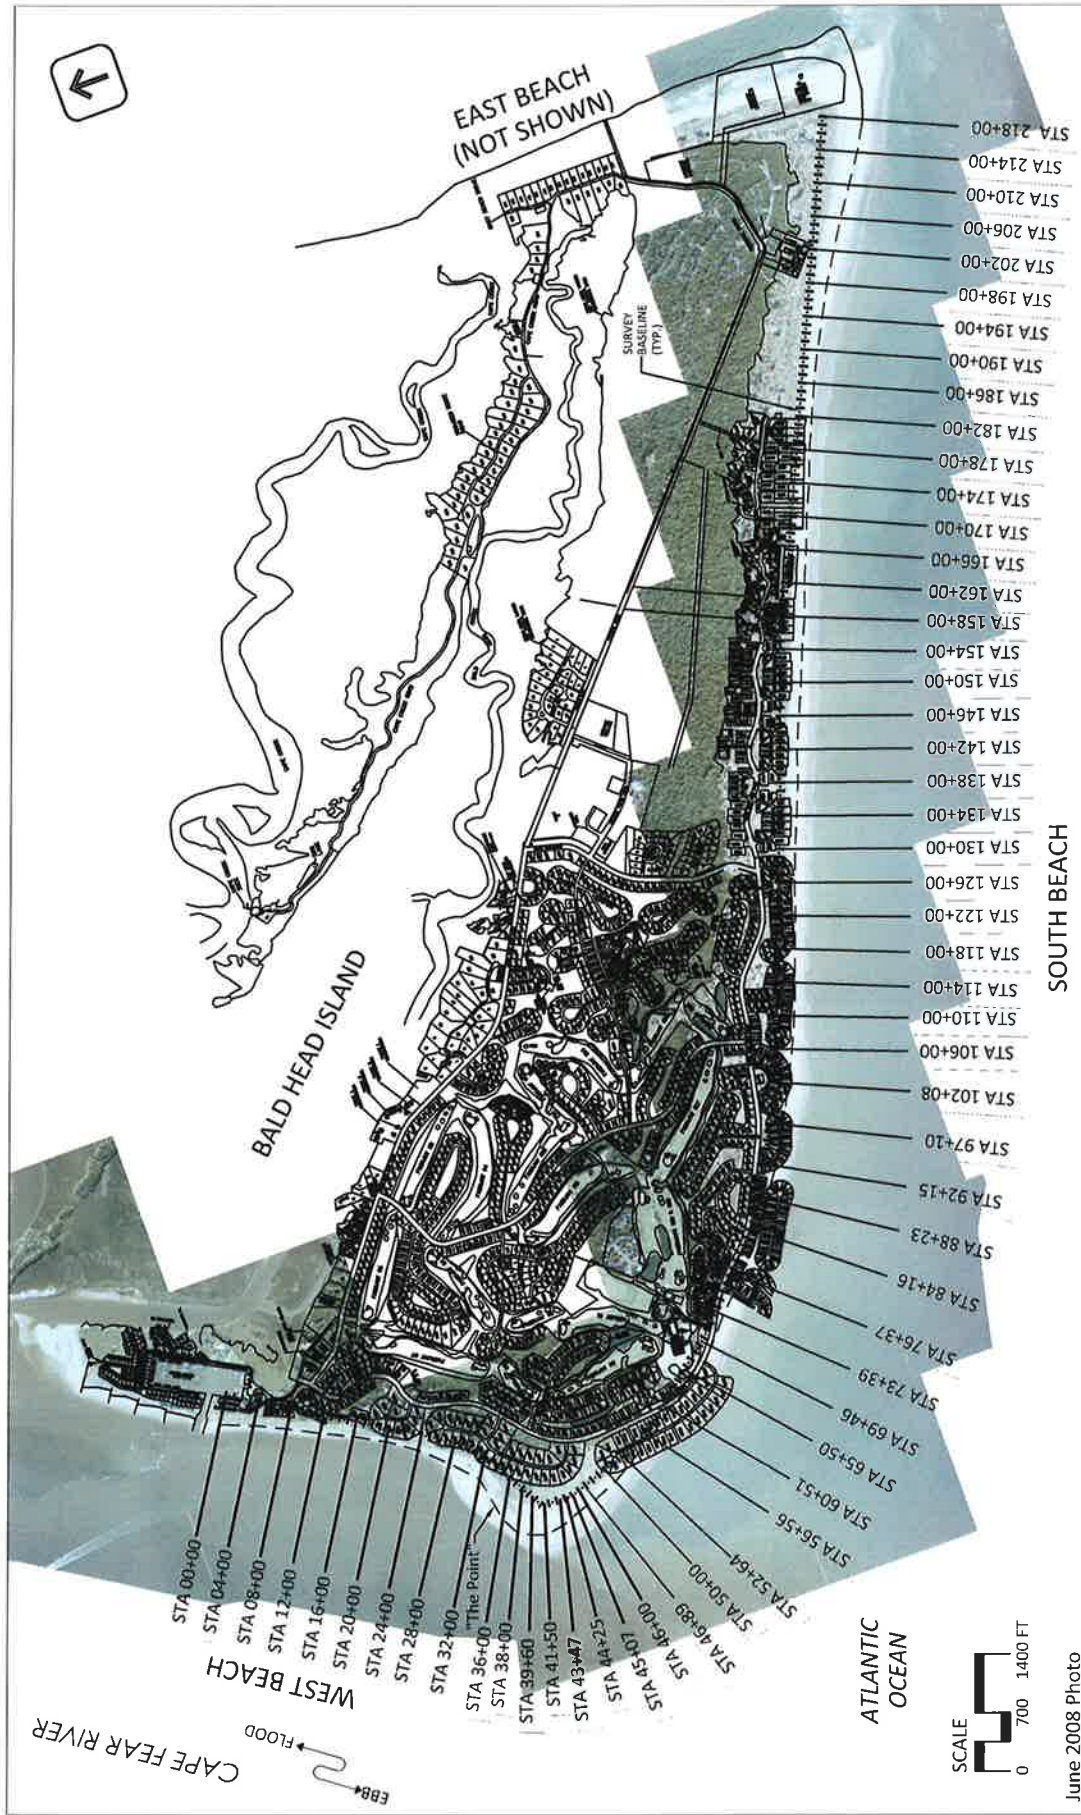
Figure 1: Island-wide beach monitoring baseline.

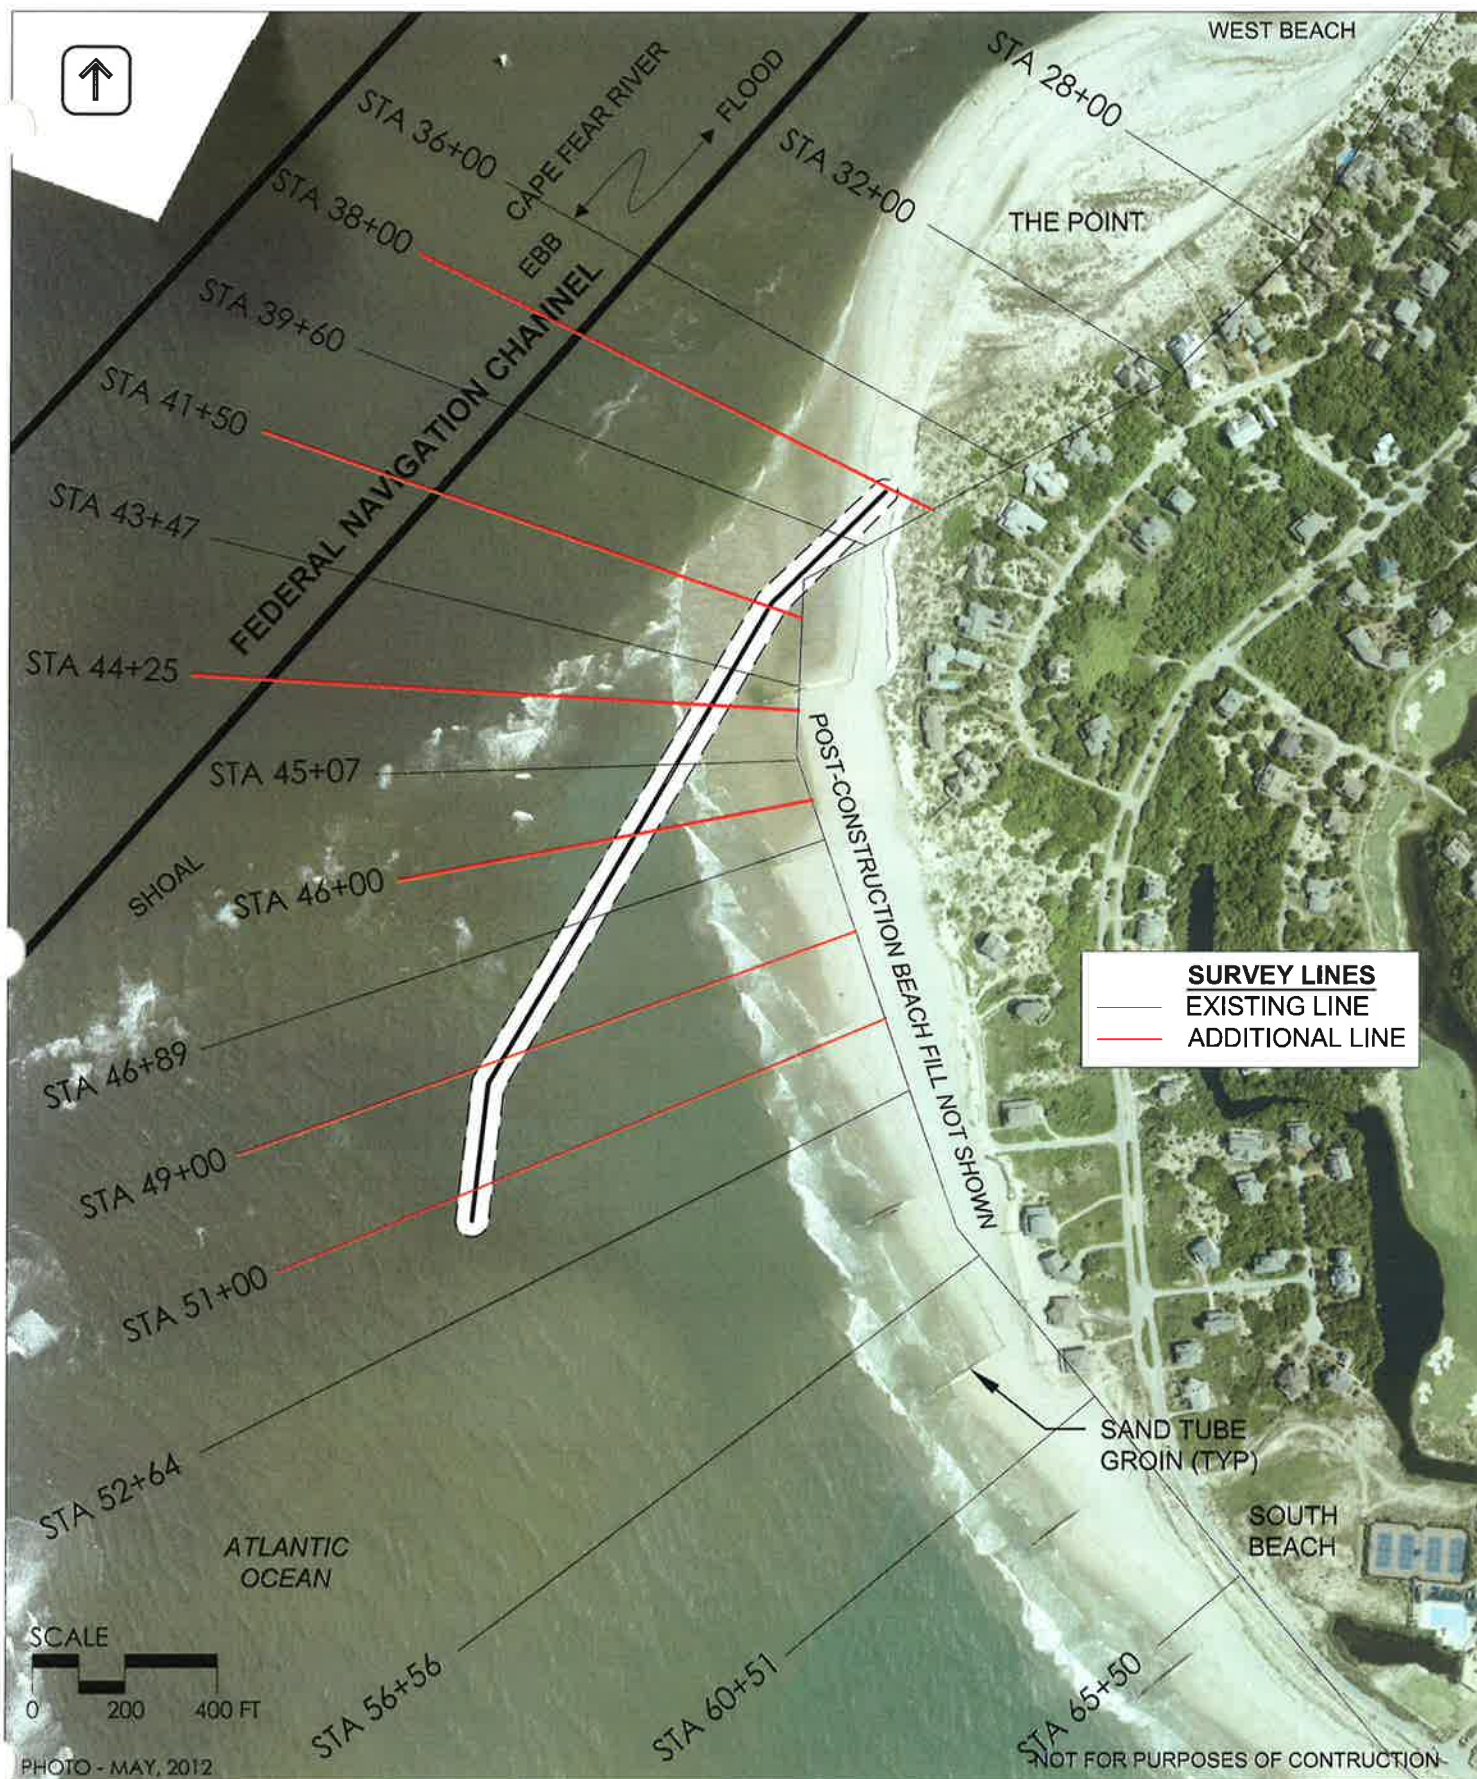
Figure 2: Survey Profile Lines in the Vicinity of the Terminal Structures

Several additional profile lines will be added to the existing survey program in the vicinity of the terminal structure (see **Figure 2**). In addition, the project surveyor will be required to annually perform an approximate MHWL survey between Sta. 0+00 and 75+00 (see **Figure 3**). Each survey will be compared to prior surveys and utilized for trend analysis. Digitally controlled aerial photography taken at approximate 6-month intervals will likewise be used to supplement analysis of the post-terminal groin shoreline condition.

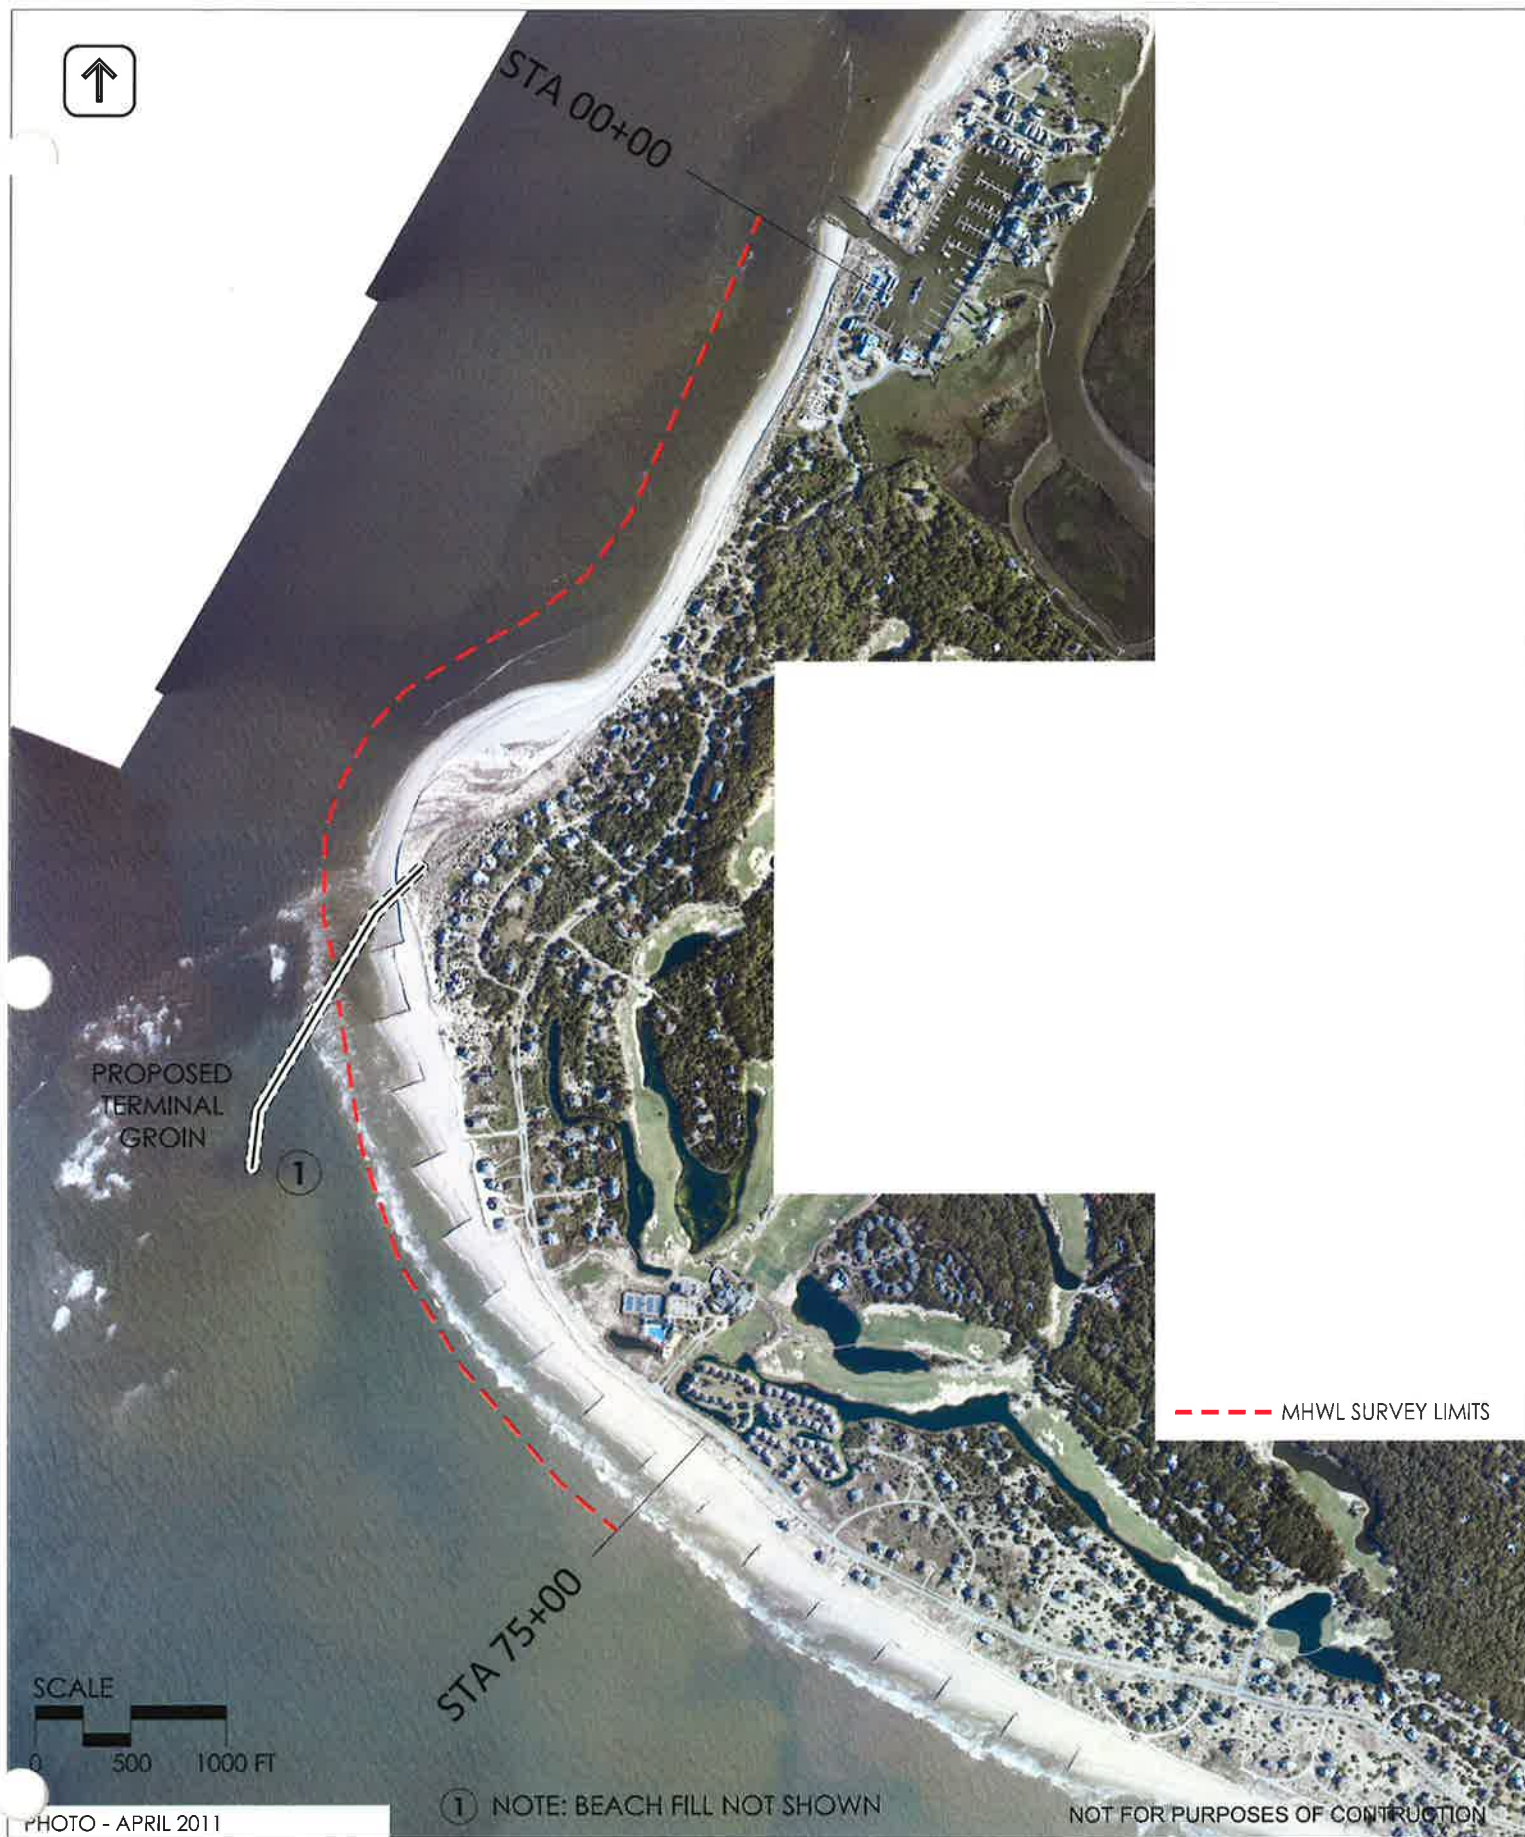
Figure 3: Location of Annual MHWL Surveys

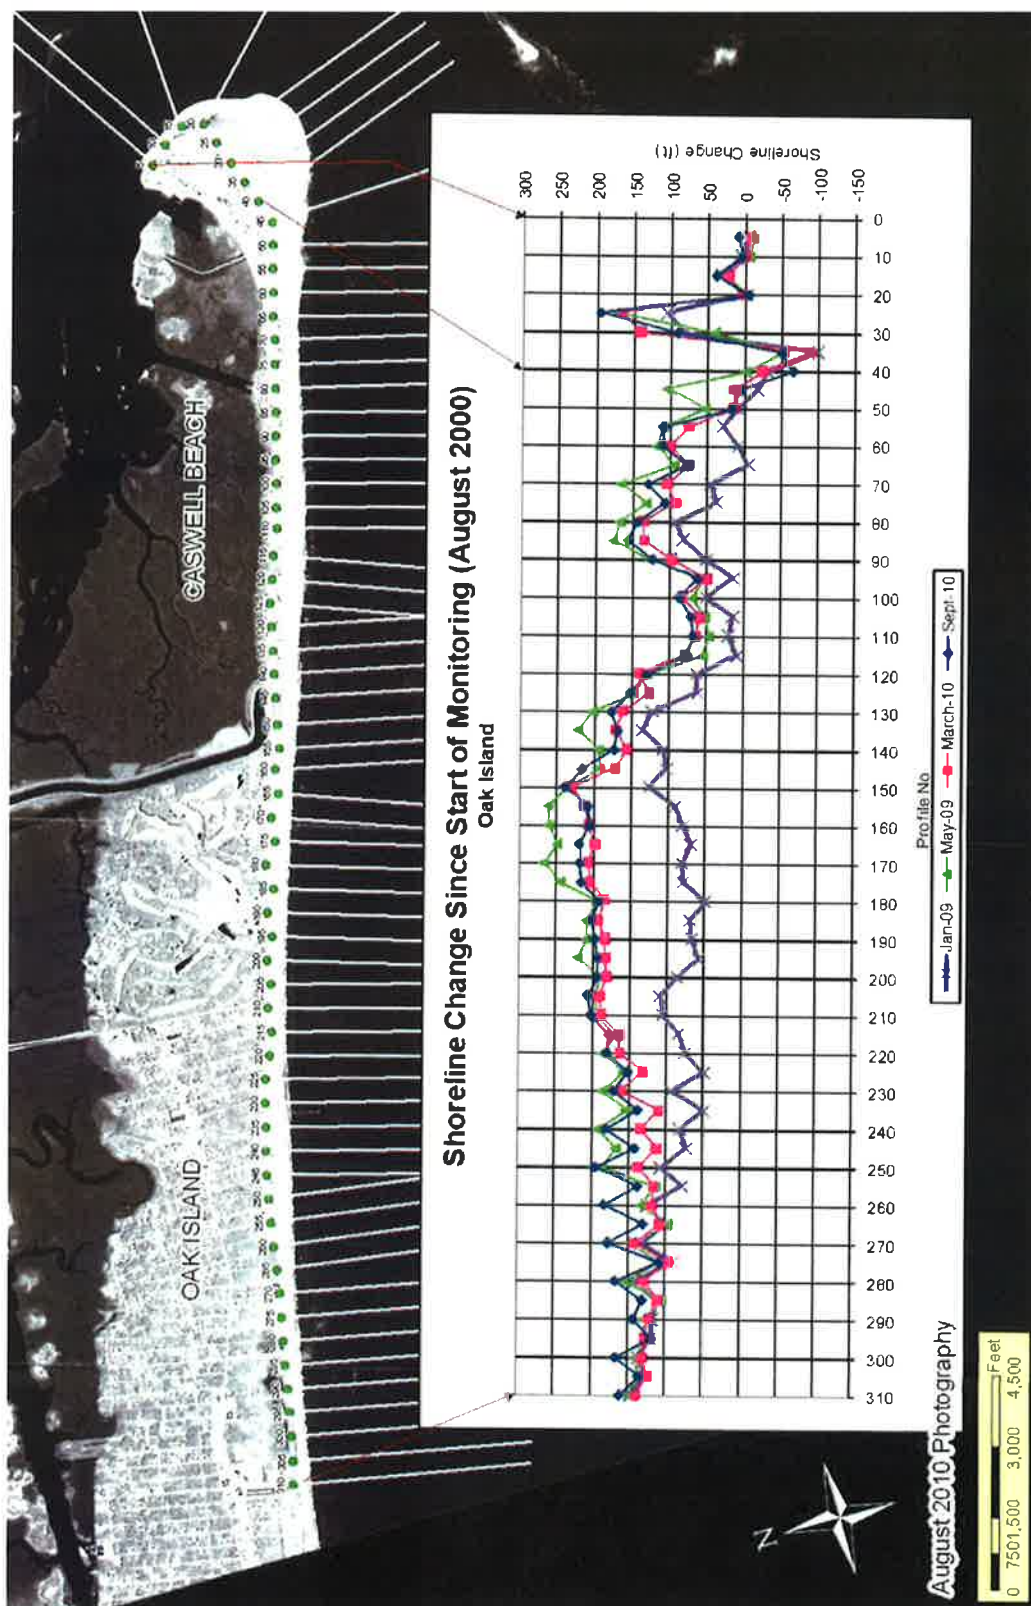
Figure 4: Example -- Federal Monitoring Program for Oak Island.

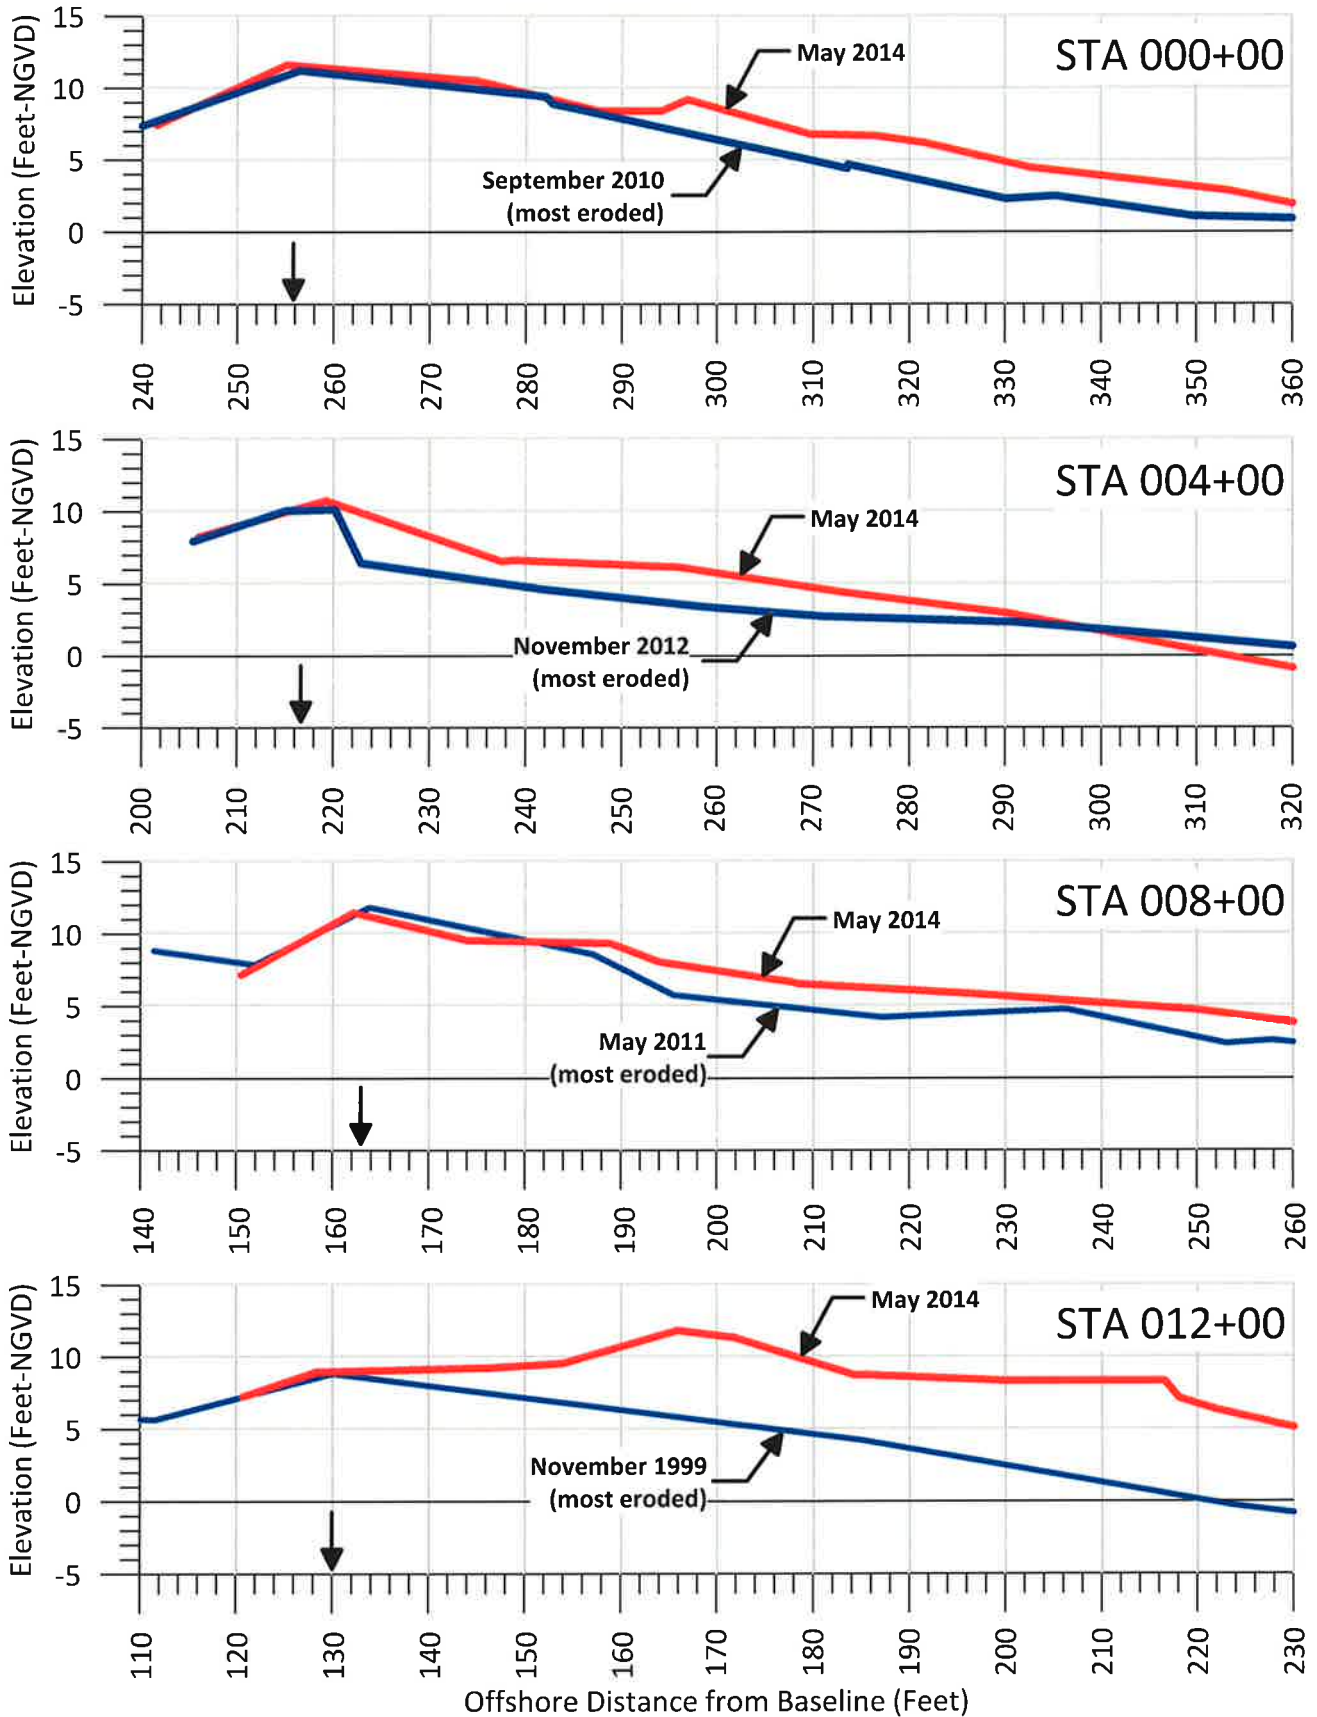
Figure 6: Location of maximum erosion at West Beach (2000-present).

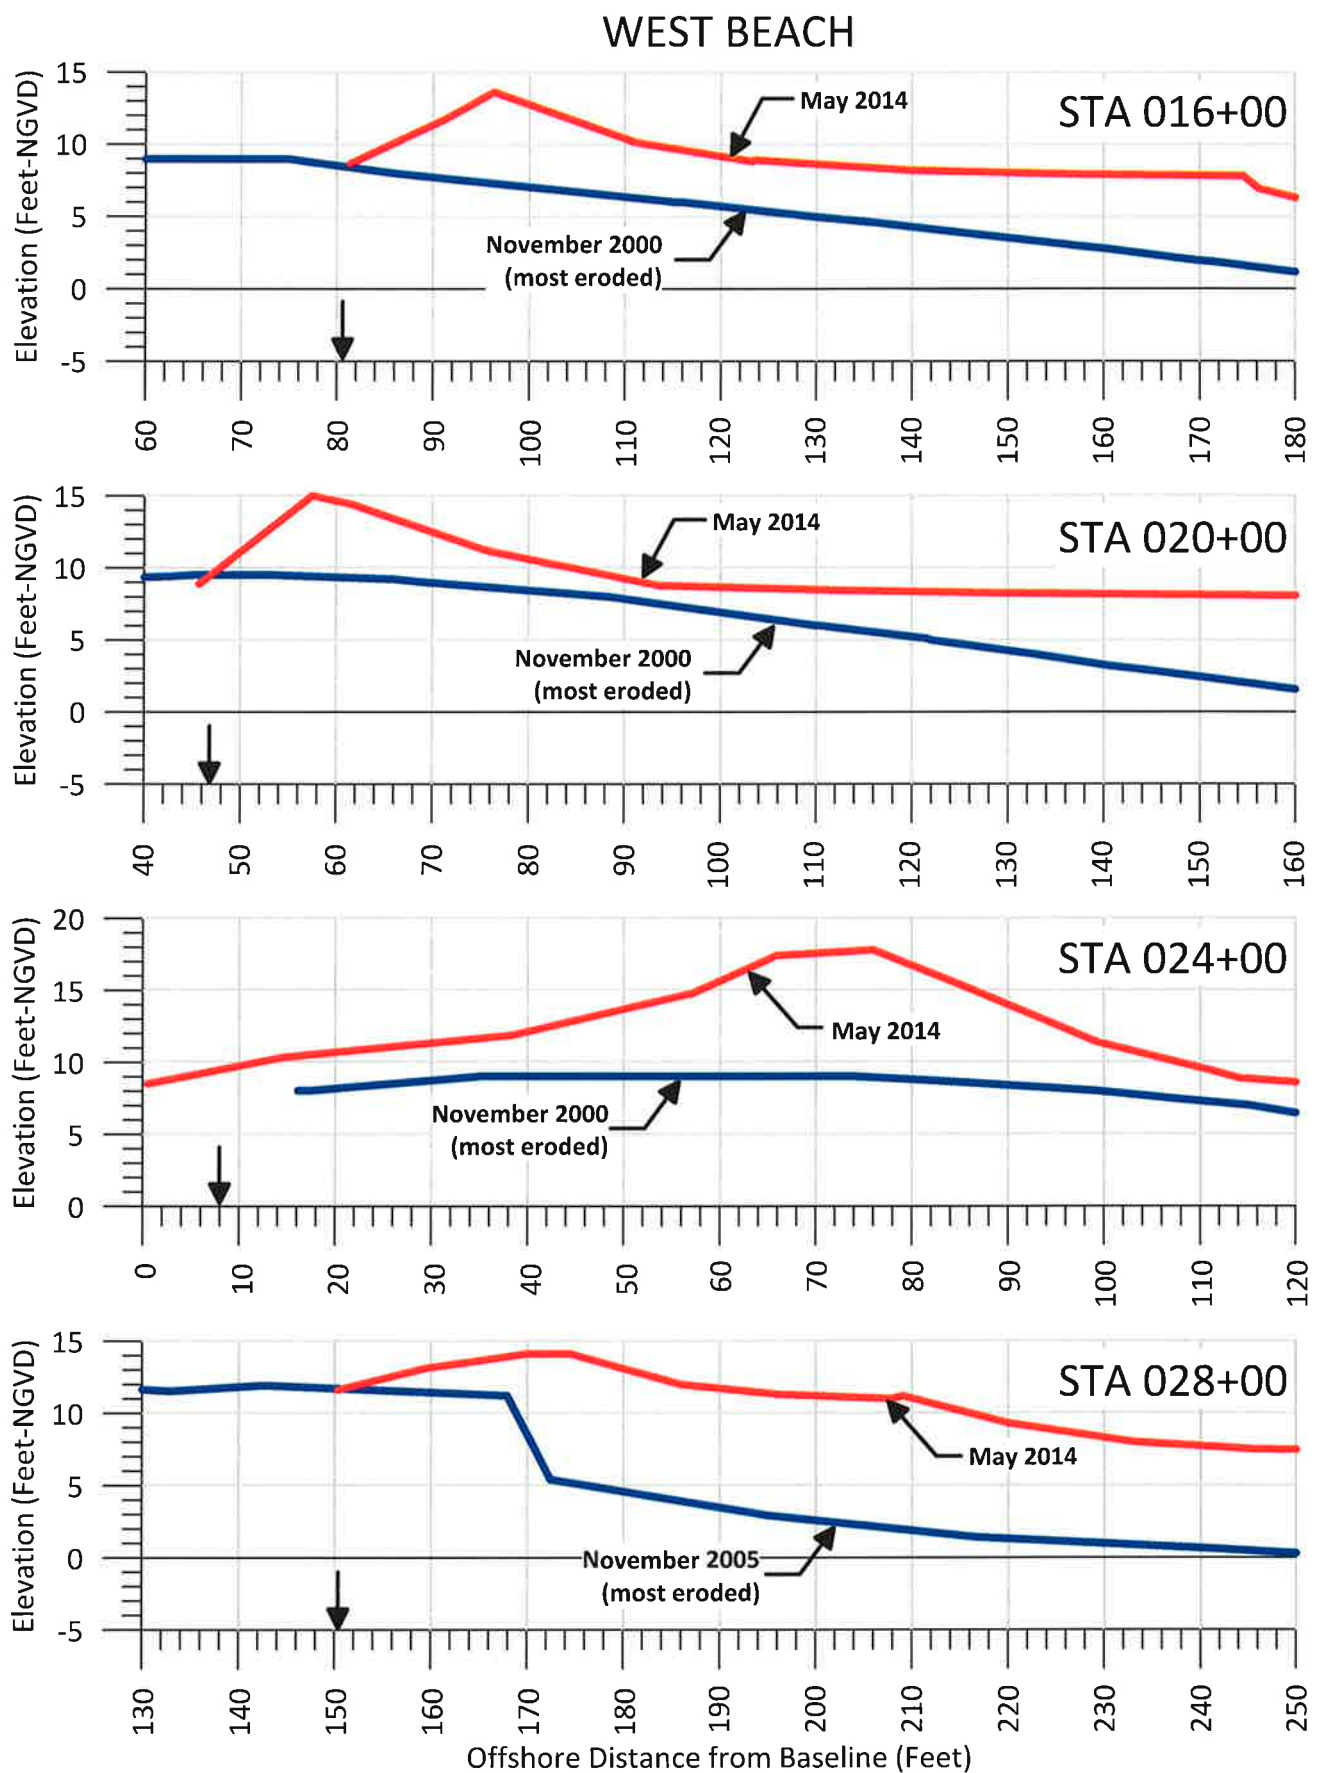
Figure 7: Location of maximum erosion at West Beach (2000-present).

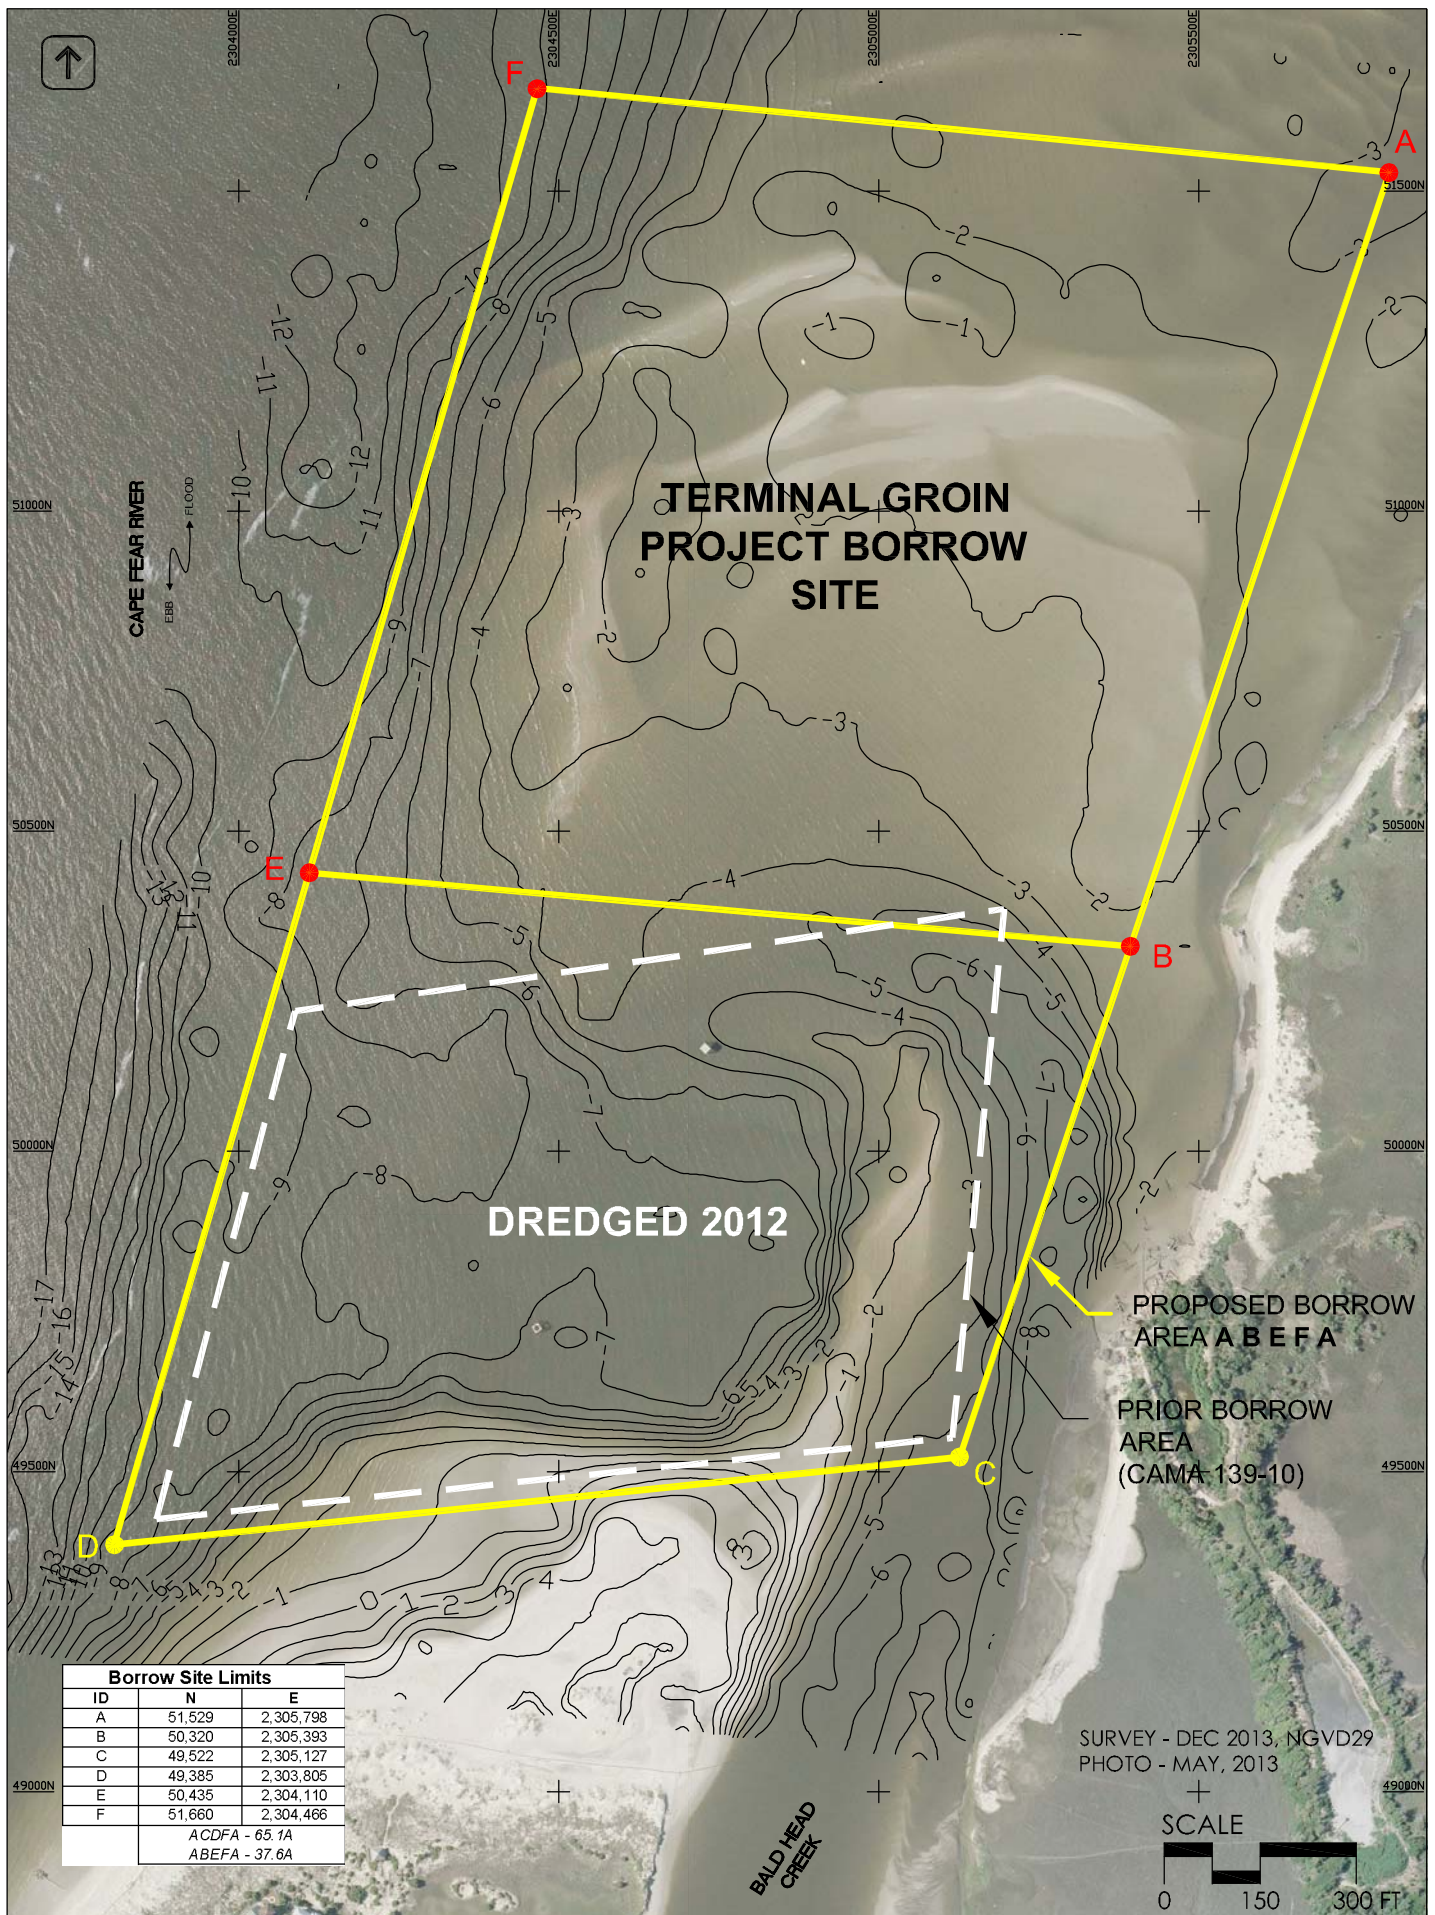
FIGURE 3 - EXPANDED BALD HEAD CREEK BORROW SITE (A,C,D,F,A)

site, many of the same species that were dominant in pre-construction sampling were also dominant in the year-1 and 2 sampling. Diversity and richness were both significantly greater at the borrow site than at the reference sites during both the post- and year-1 and year-2 monitoring events. Physical monitoring surveys of the excavation has shown only limited shoaling (or recovery) resulting from sediment transport from Bald Head Creek, the Row Boat Row shorefront and the adjustment of side slopes. As a result, the 2012 borrow area has been recommended for expansion in a northward direction – with any near term excavation associated with terminal groin post-construction sand requirements being limited to *solely* that area (see **Figure 3**).

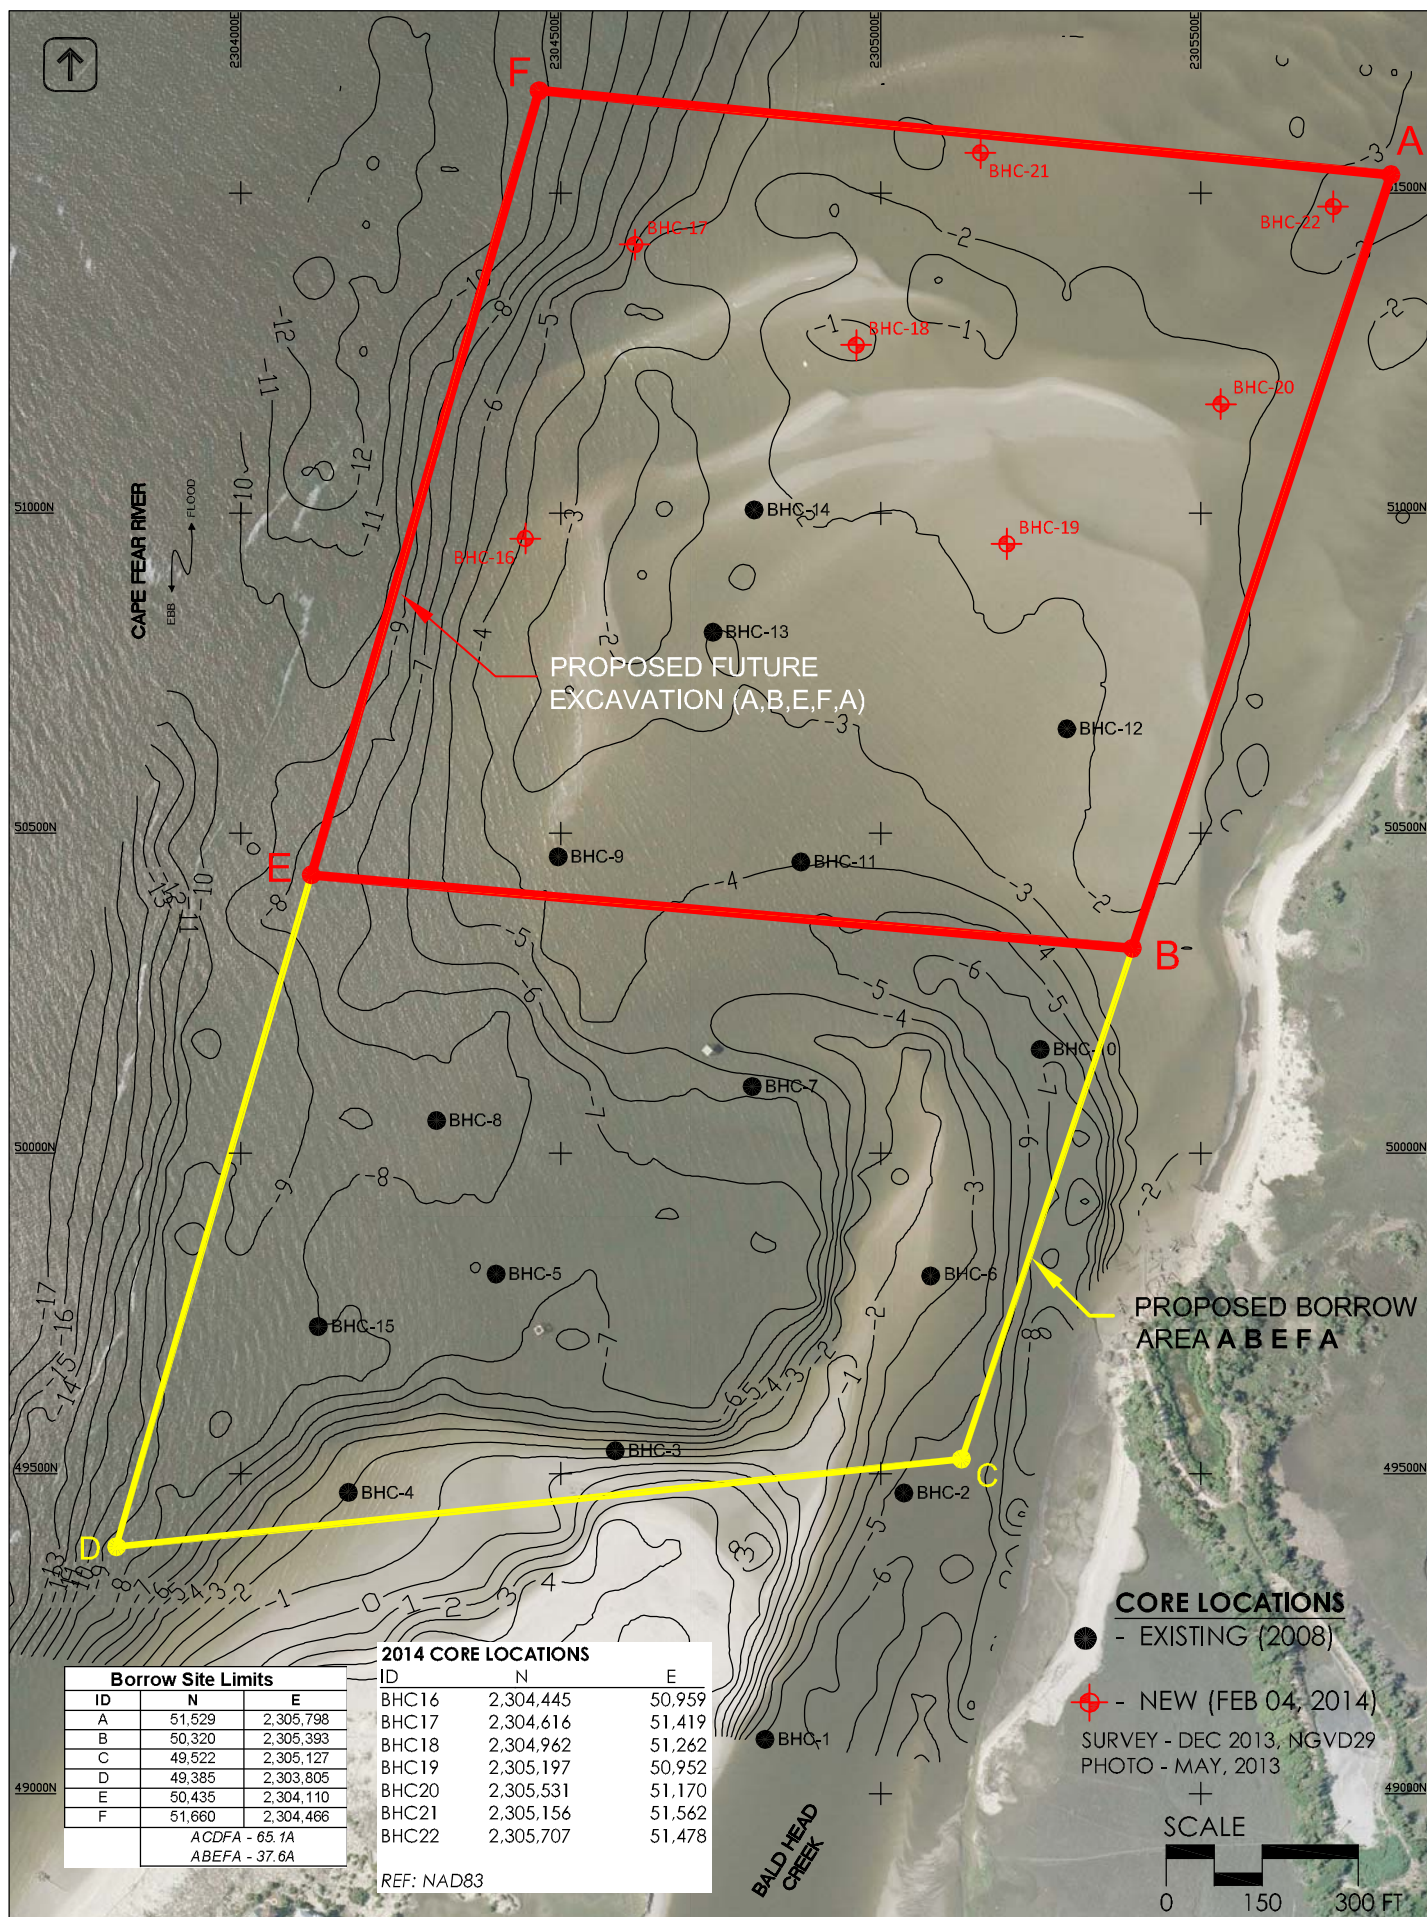
FIGURE 4 - LOCATION OF VIBRACORES

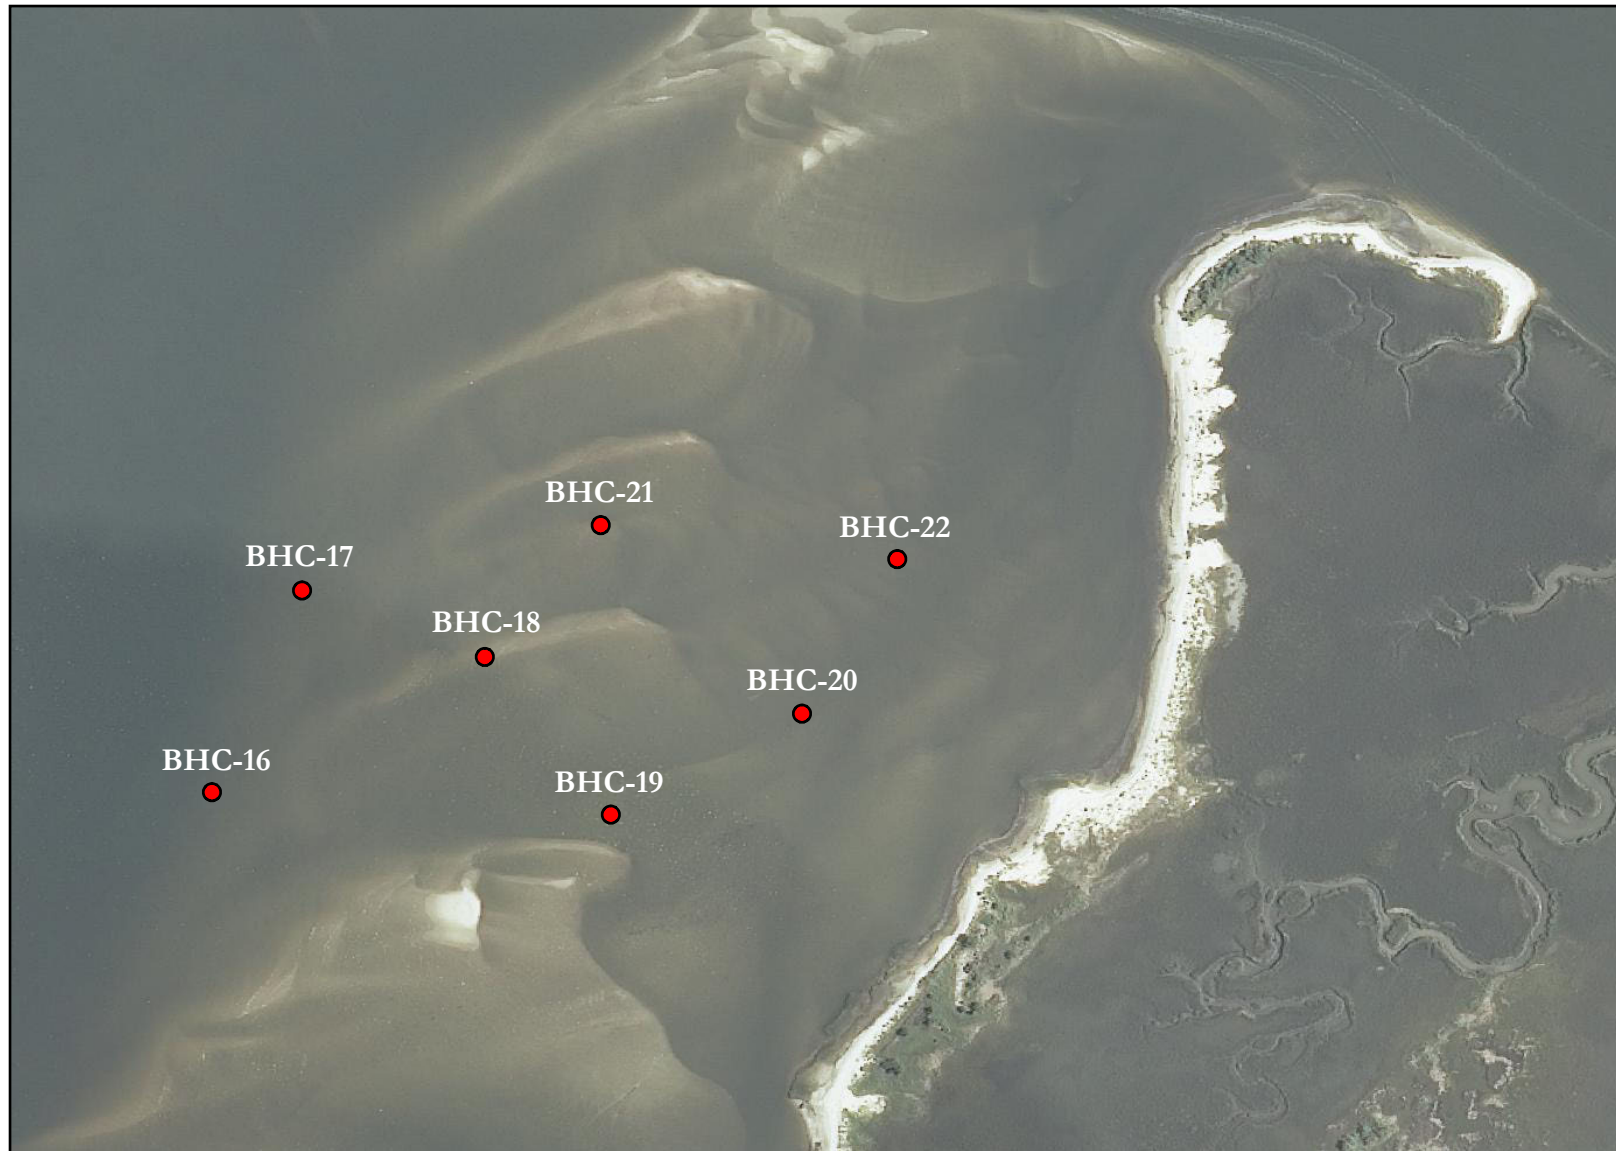
Figure 2: Bald Head Creek Vibracore Location Map

A custom-designed and built vibracore system was utilized in order to collect the geotechnical cores. The system consists of a generator with a mechanical vibrator attached via cable. The vibrator is attached directly to a three-inch (3") diameter, galvanized sample barrel. The sample barrel was lowered until the bottom of the barrel touched the sediment surface, at which point the barrel was raised until directly above the sediment surface. The vibracore machine was turned on and the sample barrel was allowed to penetrate to a depth of ten (10) feet below sediment surface, or to refusal. In certain cases (e.g., BHC-16 and BHC-22), the sample barrel was allowed to penetrate to a deeper depth in an attempt to counteract sediment loss during sample barrel retrieval. Once the sample barrel reached the desired depth, the machine was turned off and the sample barrel was retrieved using an electric winch. Once the sample was on deck, the recovered core length was measured to ensure at least eighty (80) percent recovery. Once recovery was verified, the core was then capped, labeled, and cut into five (5) foot sections. A vibracore summary, outlining penetration, recovery, etc., can be found in **Table 1**.

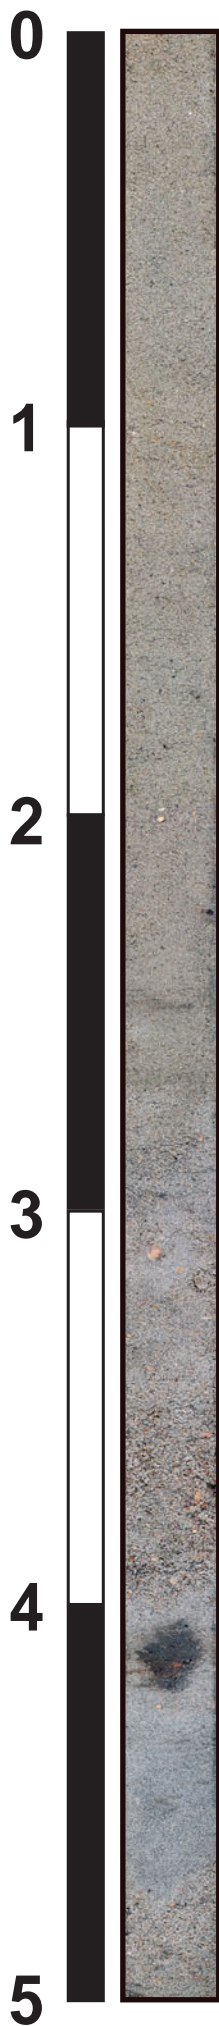
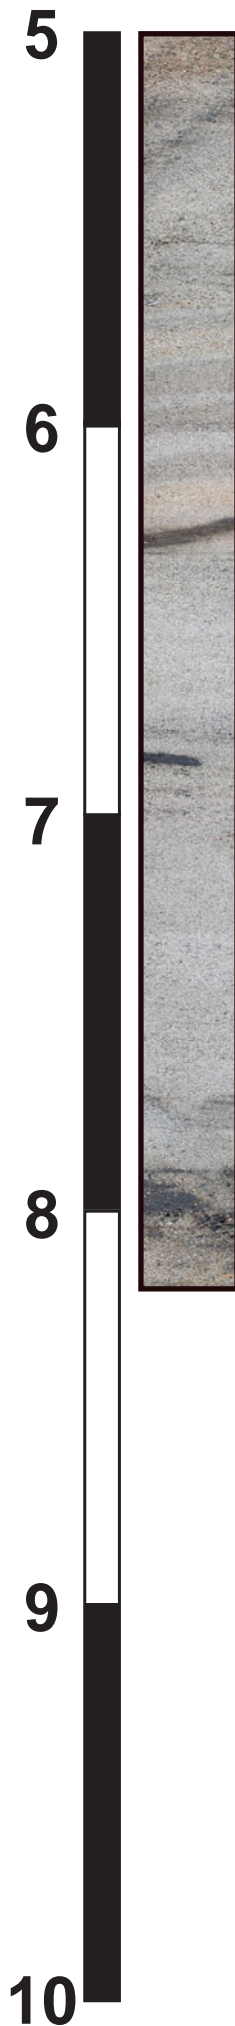
**Bald Head Island
North Carolina
BHC-17**

-9.2	5.2		Medium quartz SAND, little fine sand size shell, trace silt, poorly graded, subrounded, light brownish gray (2.5Y-6/2), (SP).			
-10.3	6.3		Fine to medium quartz SAND, few medium sand and fine sand size shell (in layers), trace silt (in layers/burrows), poorly graded, subrounded, bioturbated, 6.25' = organic SILT (OL) layer, gray (2.5Y-6/1), (SP).			
-11.9	7.9		Fine to medium quartz SAND, trace fine sand size shell, trace silt, poorly graded, subrounded, 6.9' = organic SILT (OL) rip-up, gray (2.5Y-6/1), (SP).			
-12.2	8.2		Silty fine to medium quartz SAND, little silt, trace fine sand size shell, subrounded, bioturbated, gray (2.5Y-5/1), (SM).			
			End of Boring
