**VILLAGE OF BALD HEAD ISLAND
SHORELINE PROTECTION PROJECT**

FINAL ENVIRONMENTAL IMPACT STATEMENT

U.S. Army Corps of Engineers
Wilmington District

VOLUME II
(APPENDIX A THROUGH APPENDIX K)

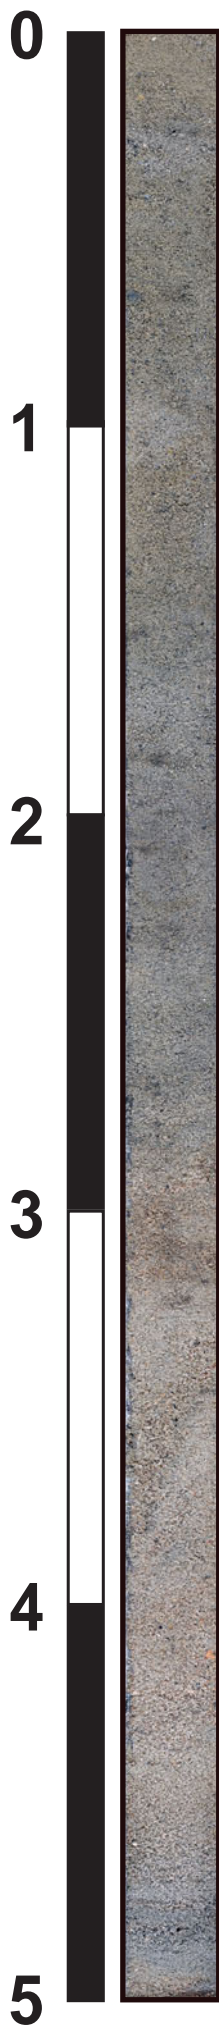
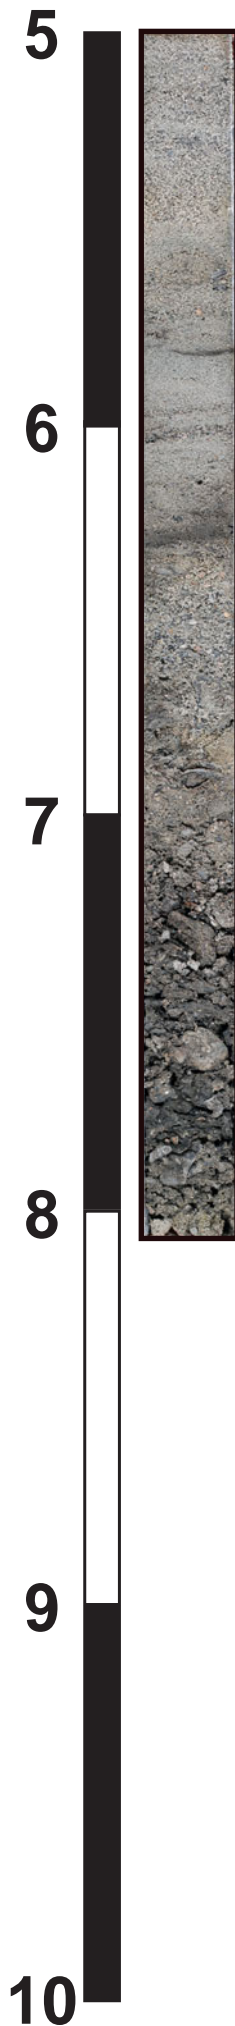
**Bald Head Island
North Carolina
BHC-21**

-9.0	6.4		Medium quartz SAND, little coarse sand to gravel size shell, trace silt, poorly graded, subrounded, gray (2.5Y-6/1), (SP).				
-9.7	7.1		Silty medium quartz SAND, some coarse sand to gravel size shell, little silt, subrounded, dark grayish brown (2.5Y-4/2), (SM).				
-10.7	8.1						
			End of Boring				10

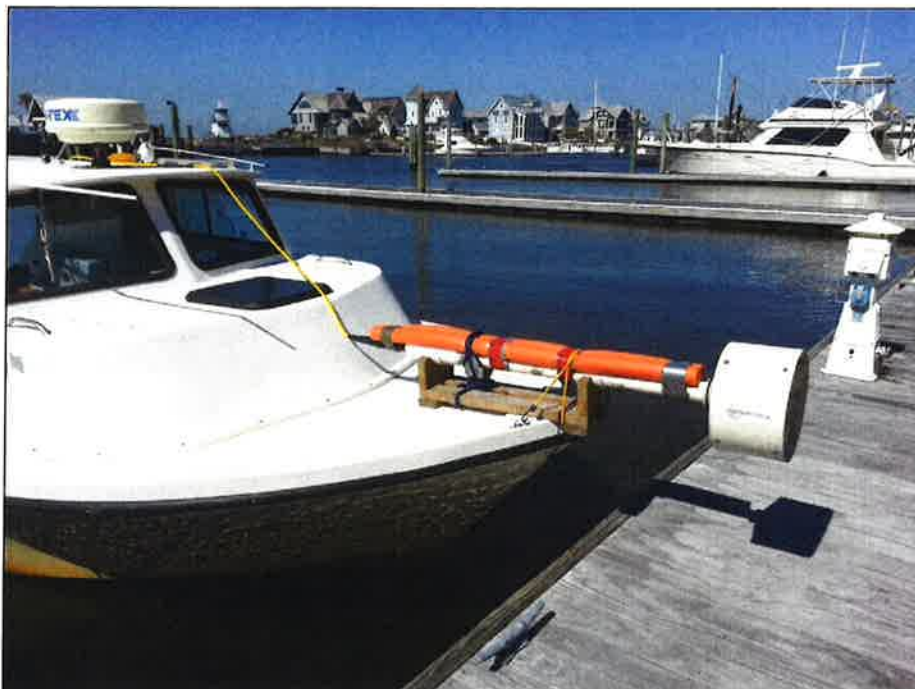
Figure 4. Bow mounting the GEOMETRICS G-881 cesium vapor magnetometer.

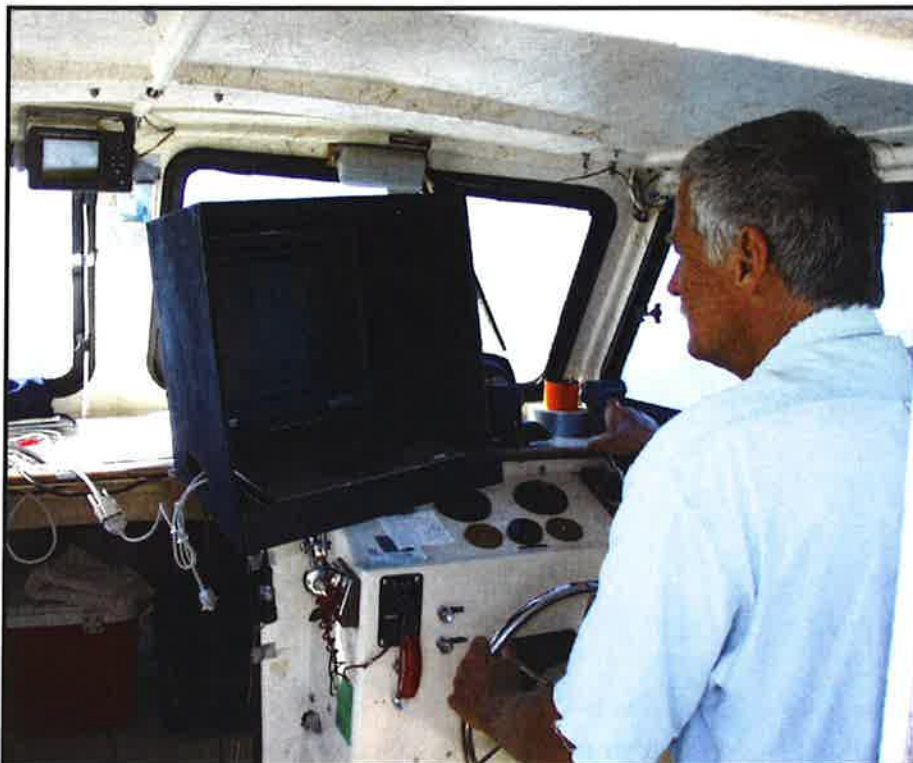
Figure 5. Computer navigation system located at the research vessel helm.

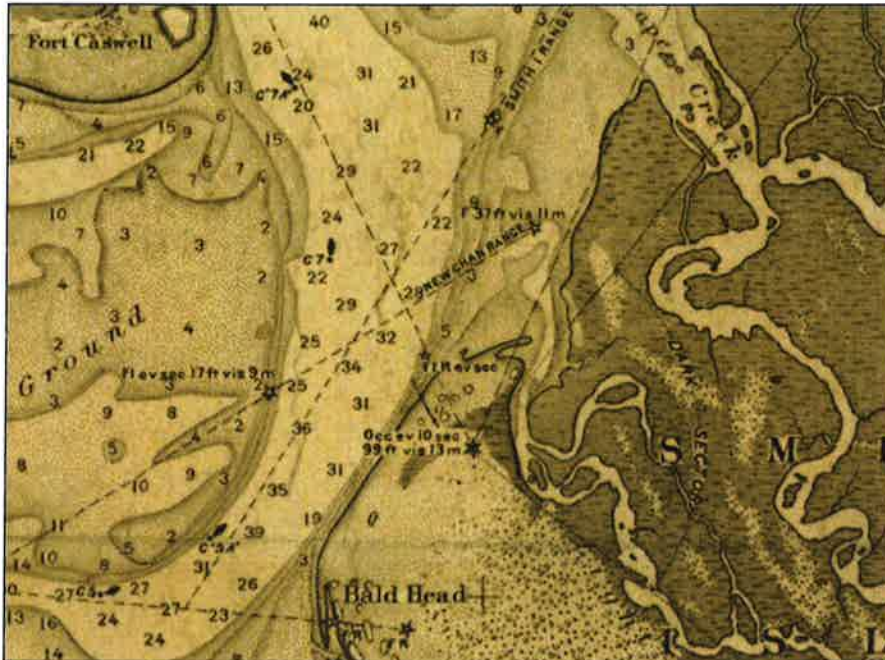
Figure 12. 1923 C&GS chart showing realignment of the Bald Head Channel reach beacon, installation of a front beacon for the Smith Island Channel reach and a front-range beacon for the Southport Channel reach.

The shallow area north of the mouth of Bald Head Creek has been the location of a number of channel range markers. As early as 1884 a front-range marker for the Bald Head Channel reach was located north of the mouth of the creek (Figure 10). By 1911, realignment of the Bald Head Channel required placement of a back-range beacon on the shoal north of Bald Head Creek (Figure 11). Within 12 years the Cape Fear Bar Channel realignment required shifting the Bald Head Channel reach beacon. A front-range beacon was also installed for the Smith Island Channel reach and another beacon was installed northwest of Bald Head Light to serve as front-range for the Southport Channel reach (Figure 12). The 1932 C&GS chart shows that only a front-range beacon for the Bald Head Channel reach was being maintained on the shoal north of the mouth of Bald Head Creek (Figure 13) and the previous range structures had been removed. Although the front-range location shifted in relation to a back range beacon in Cedar Creek that configuration persisted until sometime between 1988 and 1998. During that period the front-range beacon for the Cedar Creek back beacon was moved southwest to a location off the northwest point of Bald Head Island (Figure 14). That configuration remains intact today [2014], as the Bald Head Channel alignment has been stabilized by dredging.

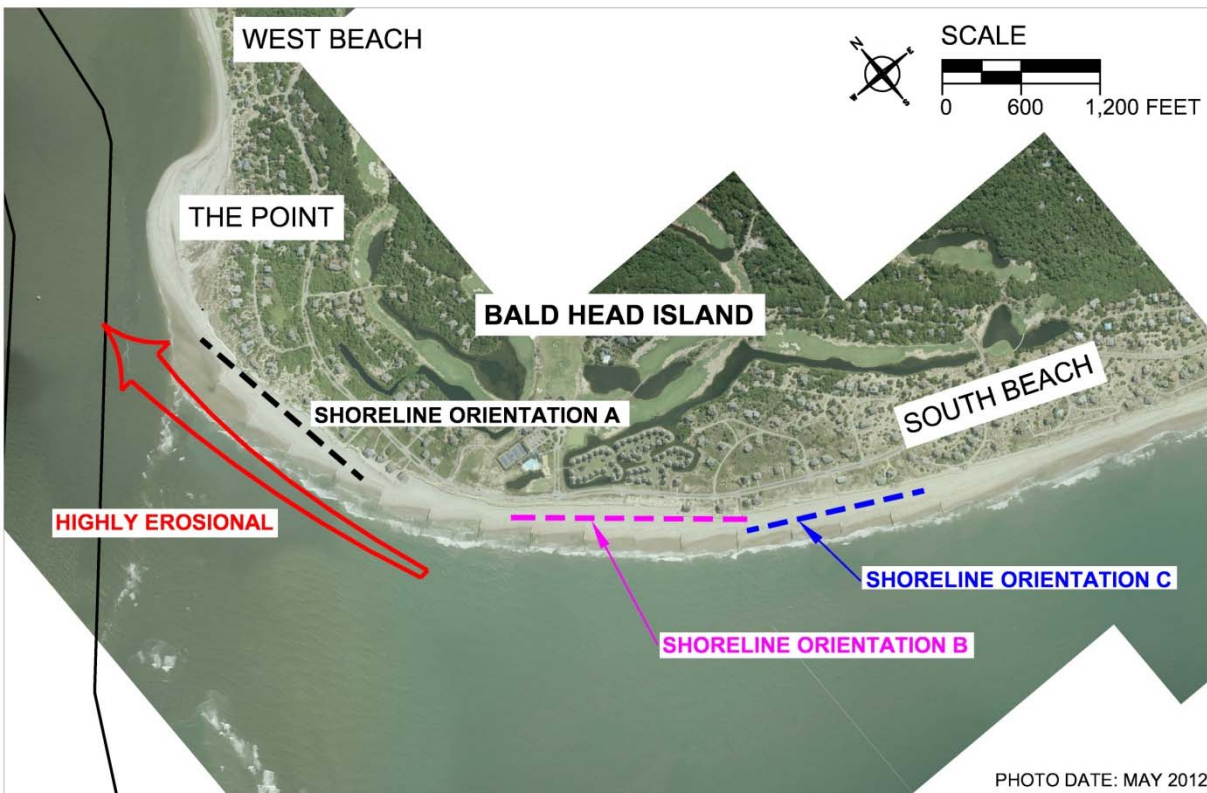
Figure 1: Fundamental shoreline orientations, A, B, and C, observed along western Bald Head Island.

Along westernmost South Beach on Bald Head Island, three fundamental shoreline orientations are currently evident, A, B, and C, as presented in **Figure 1**. Shoreline orientation A, which trends north-to-south, is associated with the aforementioned highest present-day erosional segment of South Beach. Future terminal groin performance will be predicated on developing a stable westerly extension more typical of shoreline orientation B throughout the chronically eroded westernmost reach – thereby essentially reversing the significant negative effects that currently exist with orientation A. Establishing or approaching some variation of orientation B in the long-term, in order to decrease the strong erosional gradient existing along west Bald Head Island, requires large-scale structural stabilization – such as a terminal groin of suitable length.

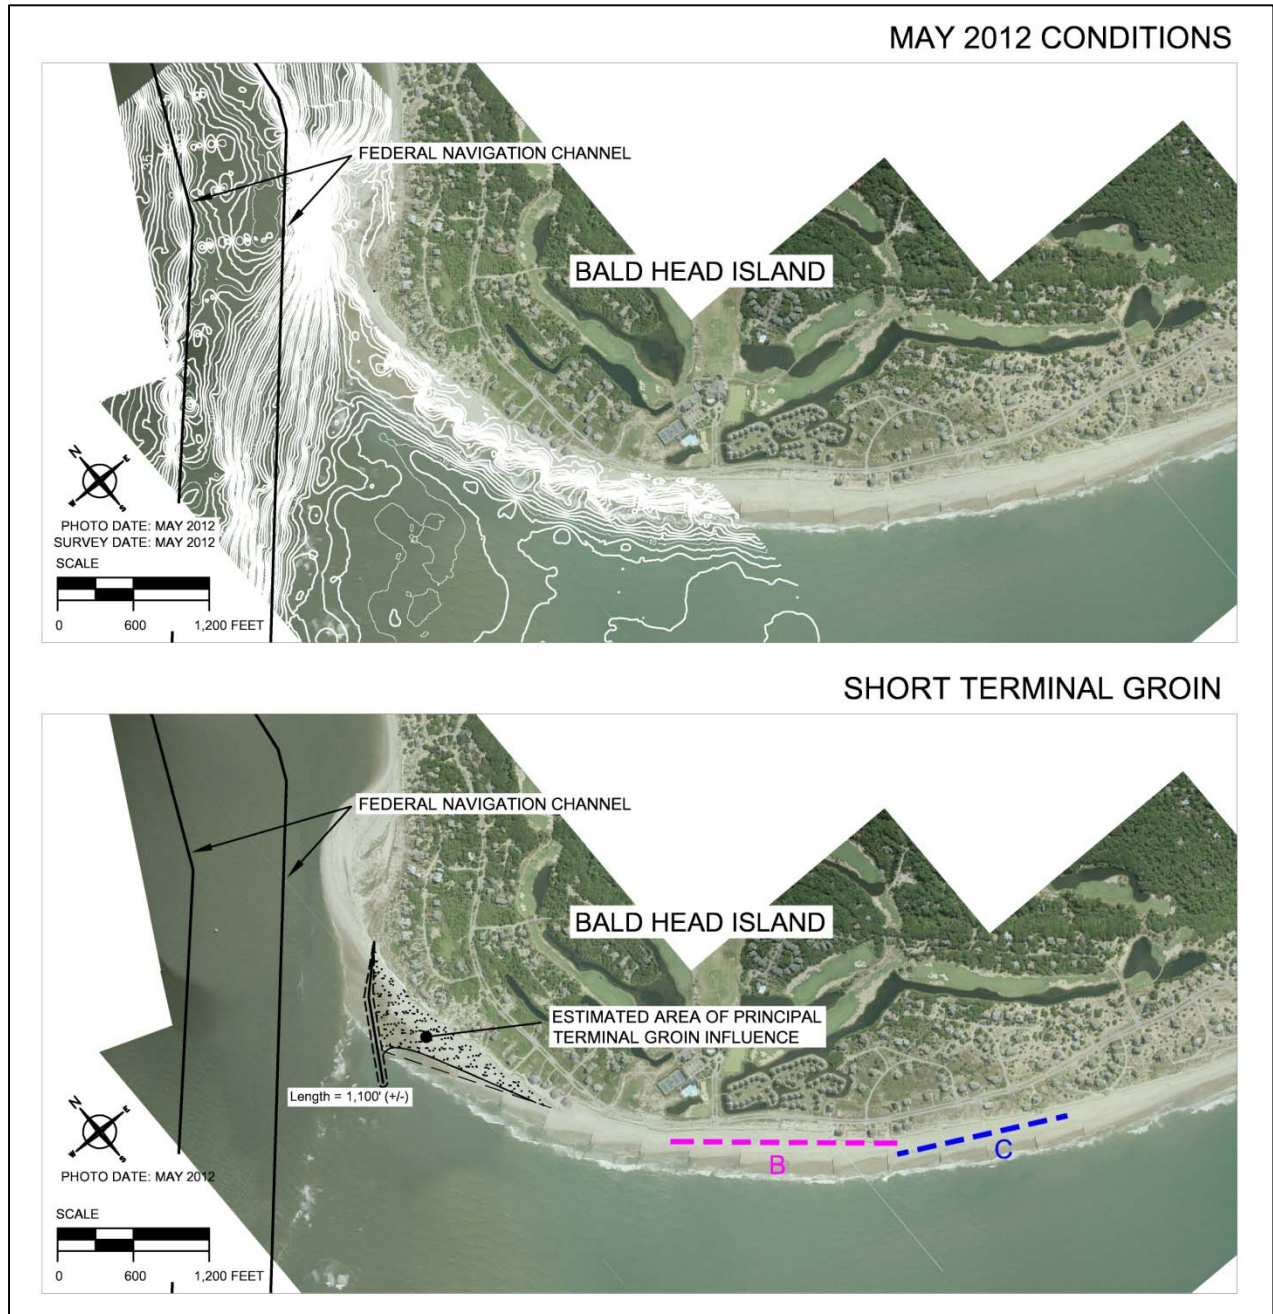
Figure 2: Conceptual illustration of updrift performance of a short terminal groin.

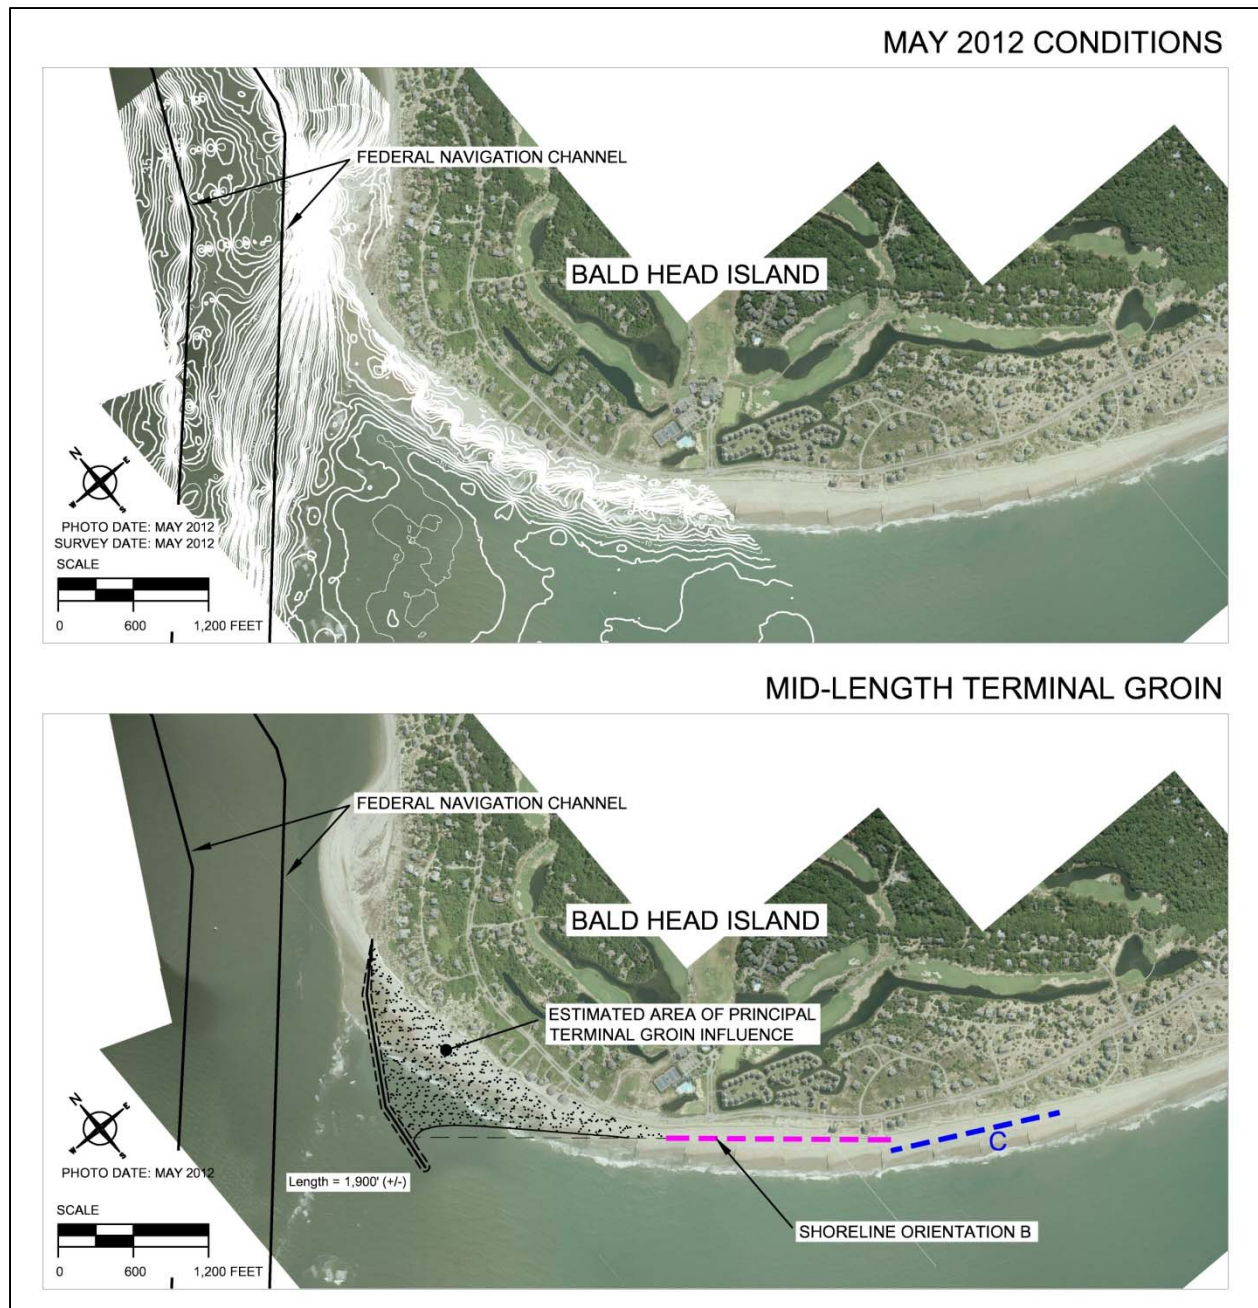
Figure 3: Conceptual illustration of updrift performance of a mid-length terminal groin.

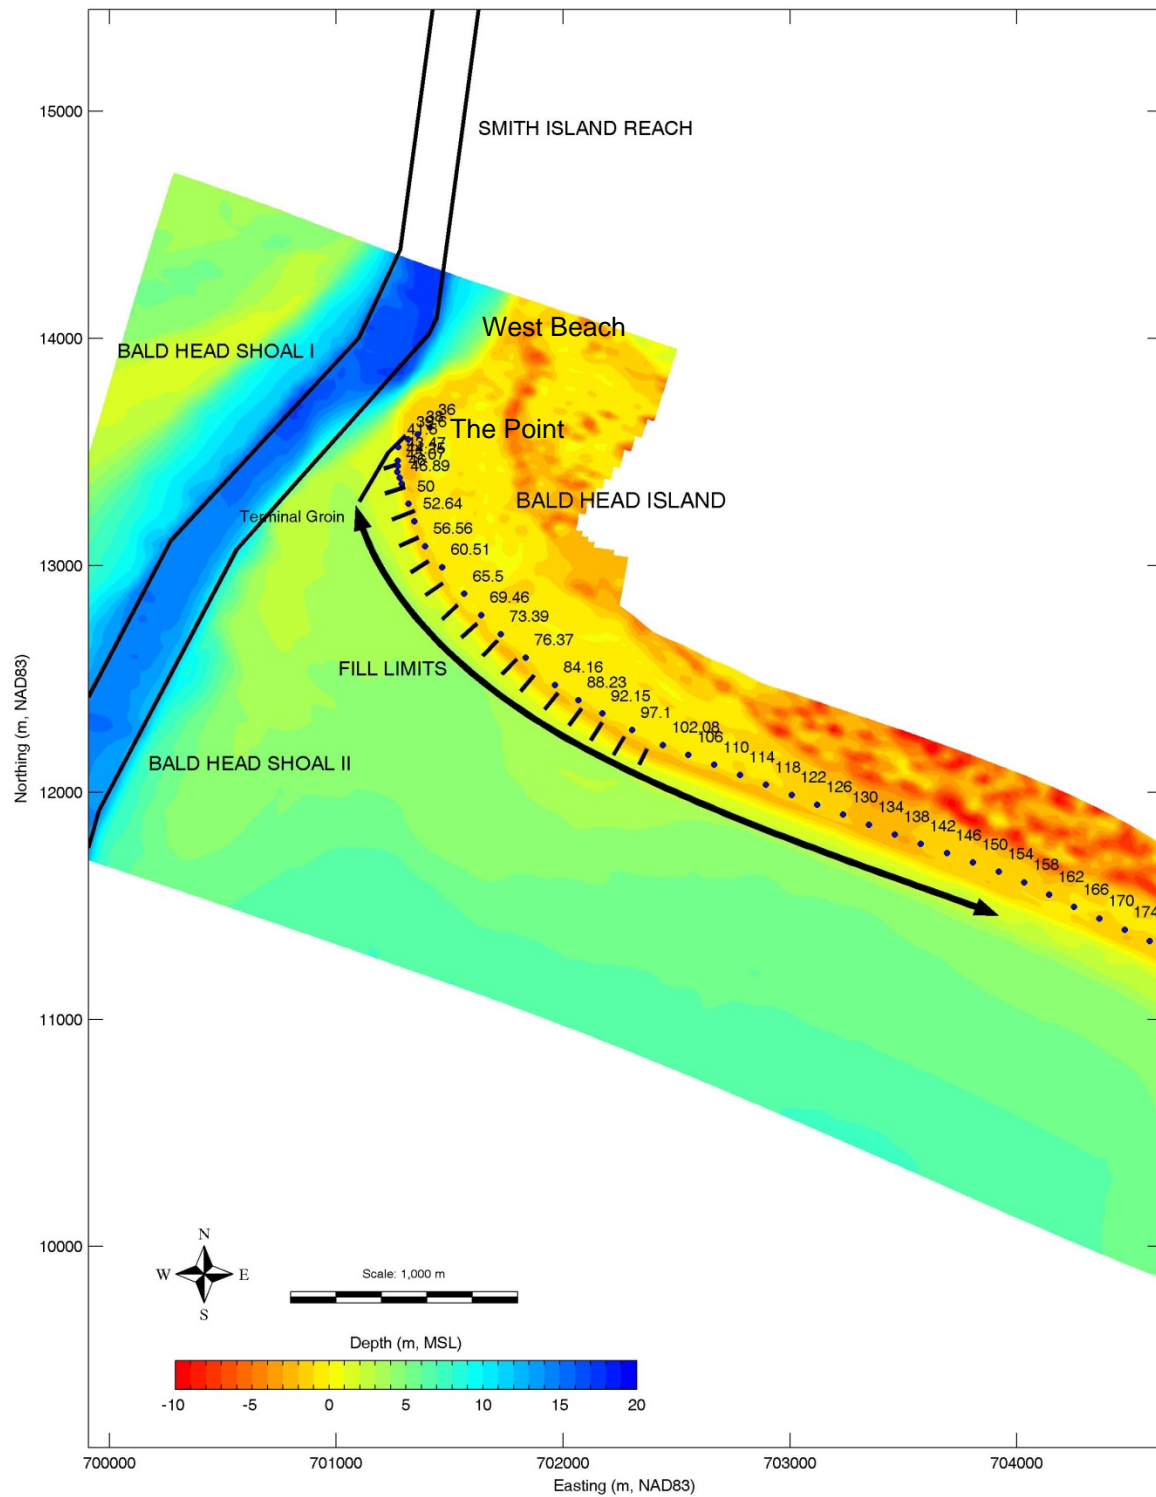
Figure 6: Approximate limits of periodic sand placement for simulation of a Phase I terminal groin. In the model simulations, beach placement occurs every three years and is coincident with channel dredging.

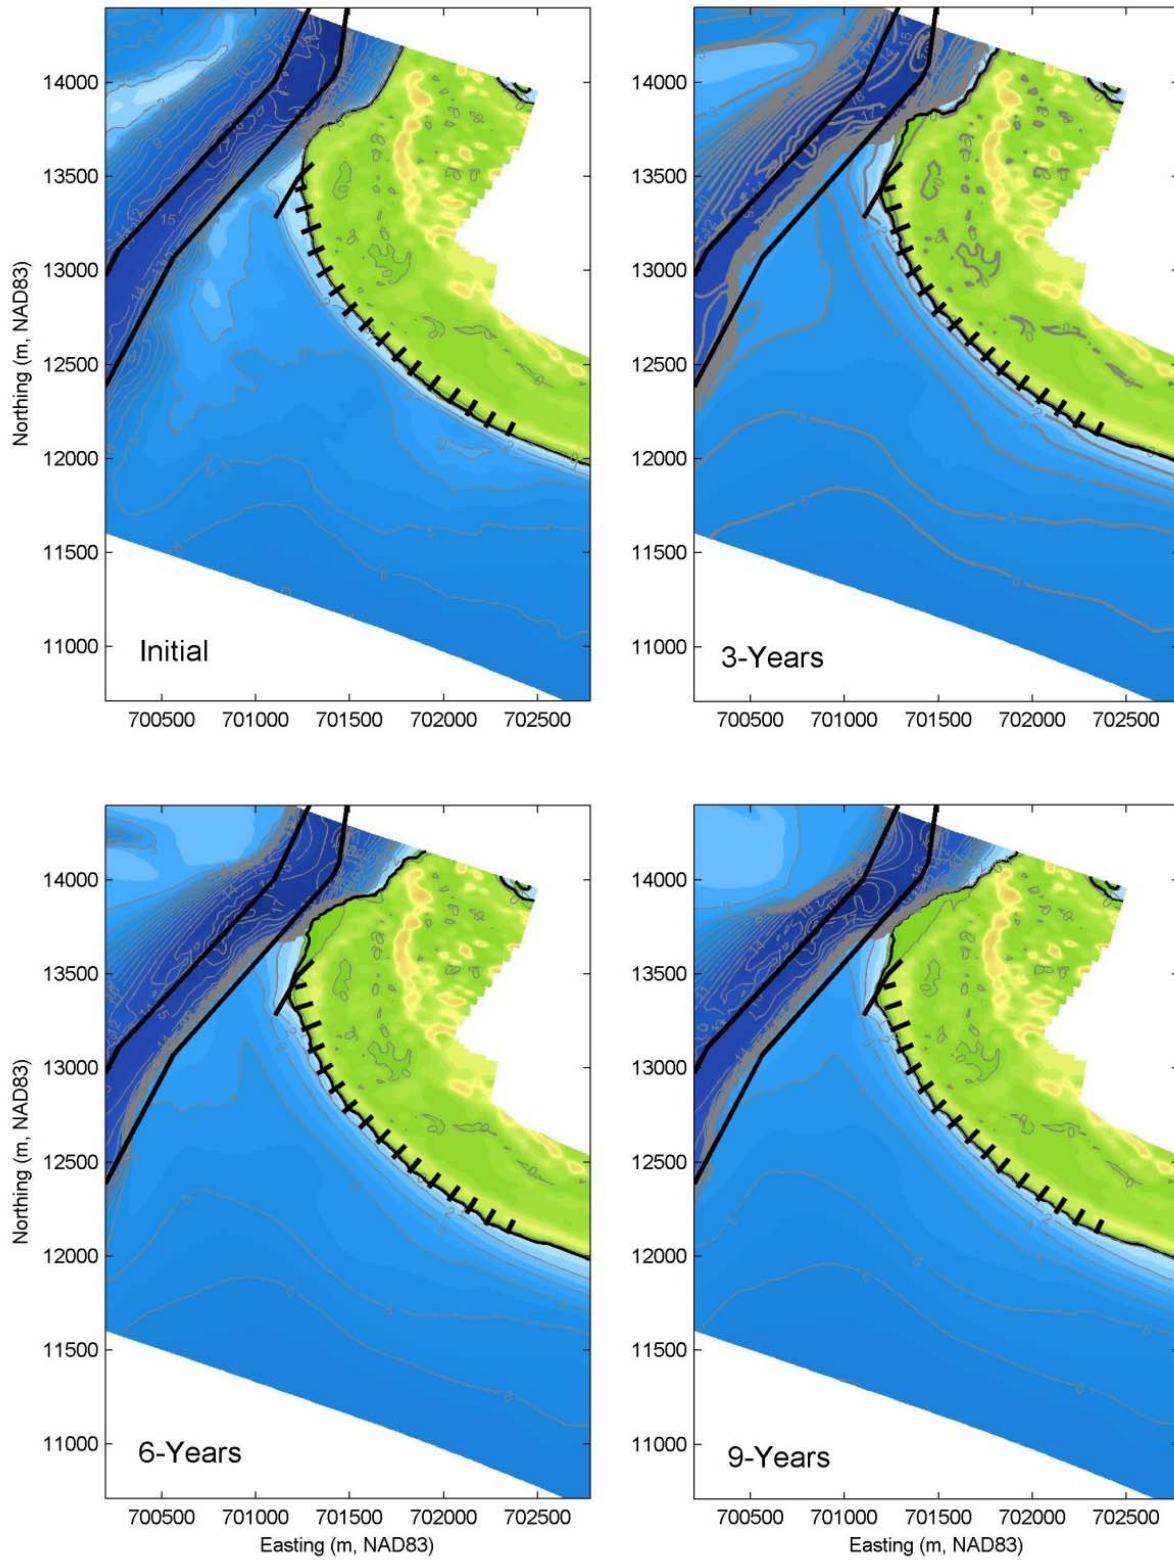
Figure 7: Bathymetry predicted throughout the simulation at years 3, 6, and 9 for a Phase I groin alternative. Each depicts conditions prior to the subsequent sand placement interval.

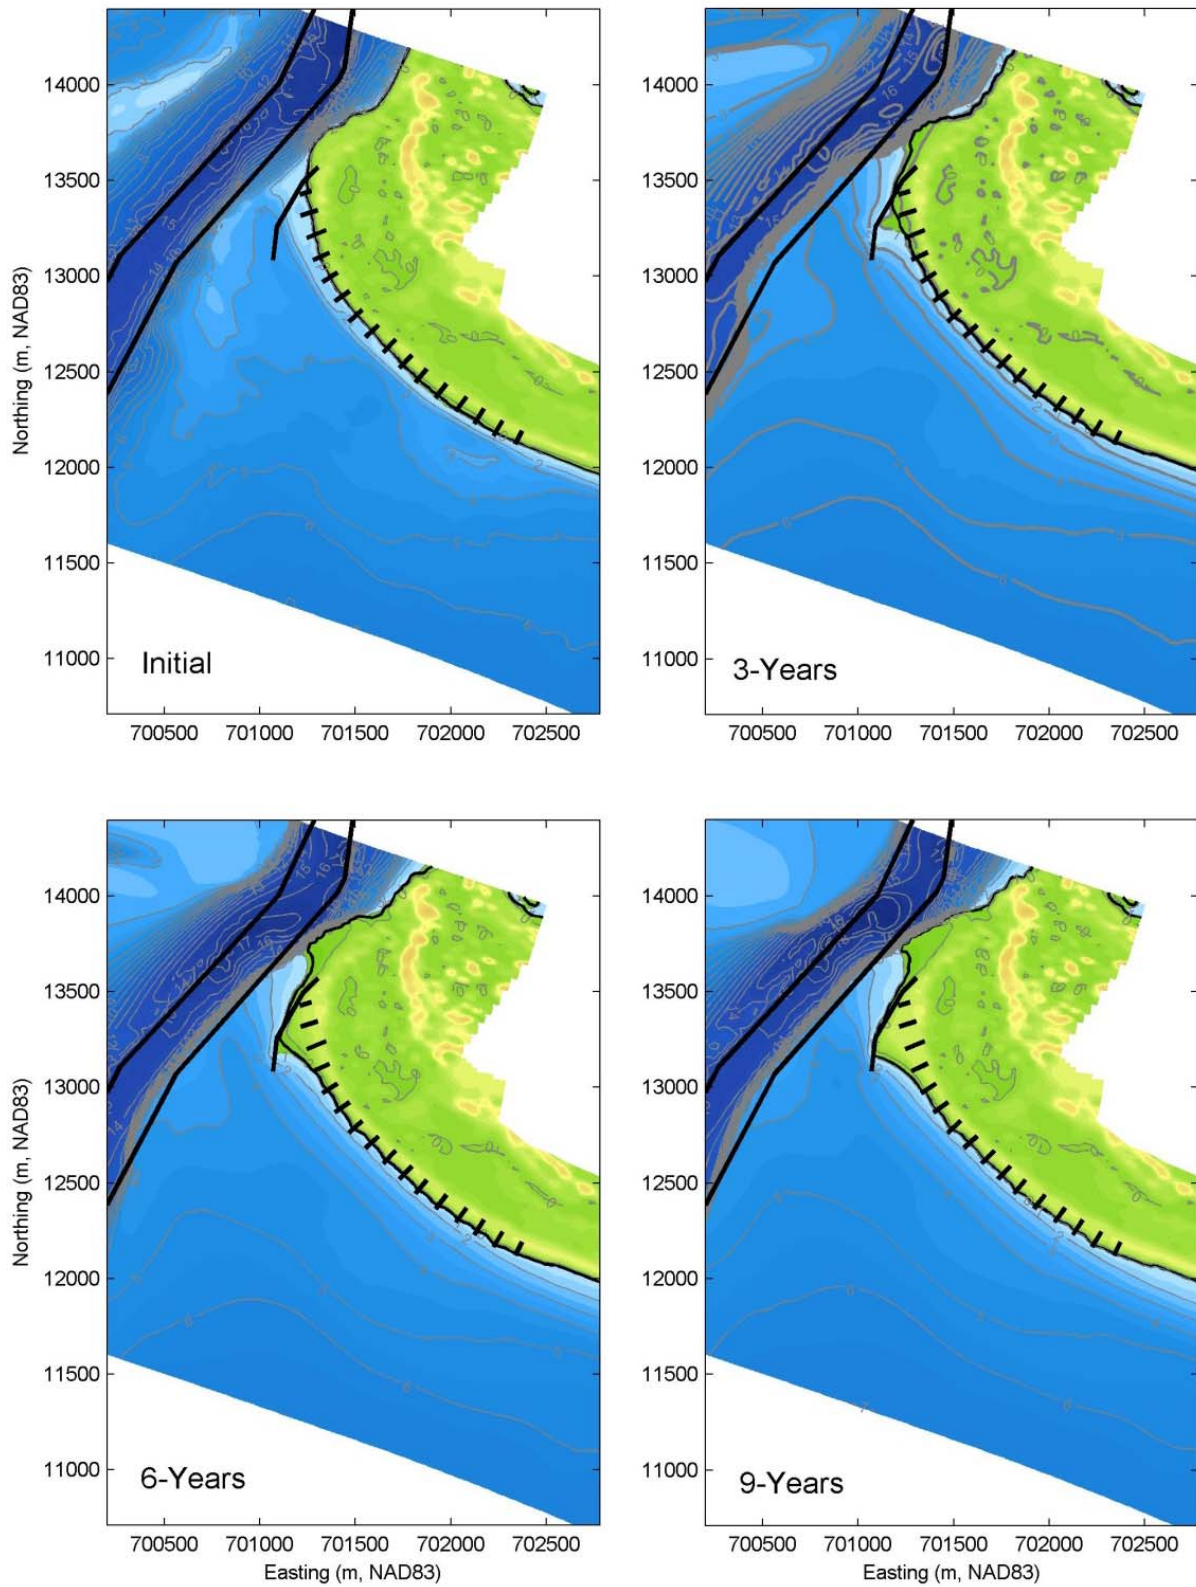
Figure 8: Bathymetry predicted throughout the simulation at years 3, 6, and 9 for a mid-length groin alternative. Each depicts conditions prior to the subsequent sand placement interval.

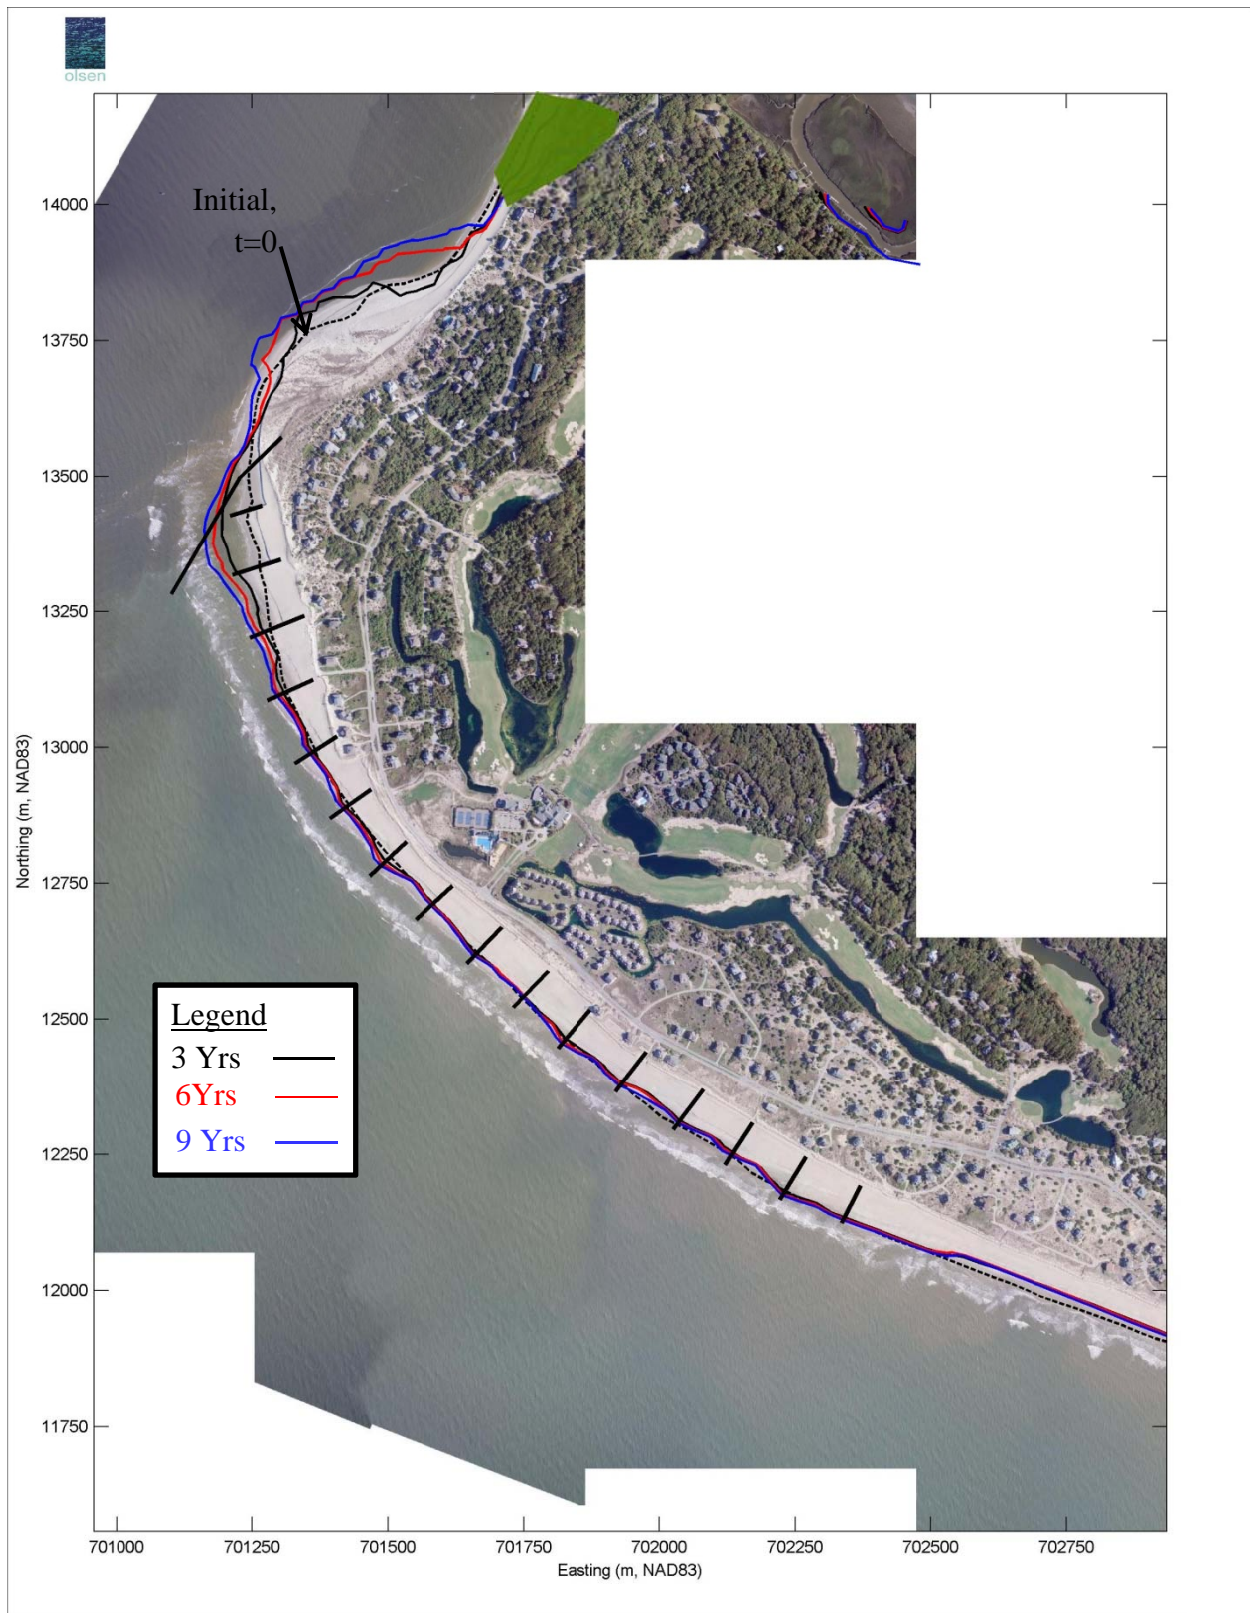
Figure 9: Approximate MLLW contour predicted at years 0, 3, 6, and 9 years for the Phase I groin scenario prior to the subsequent sand placement/dredge event.

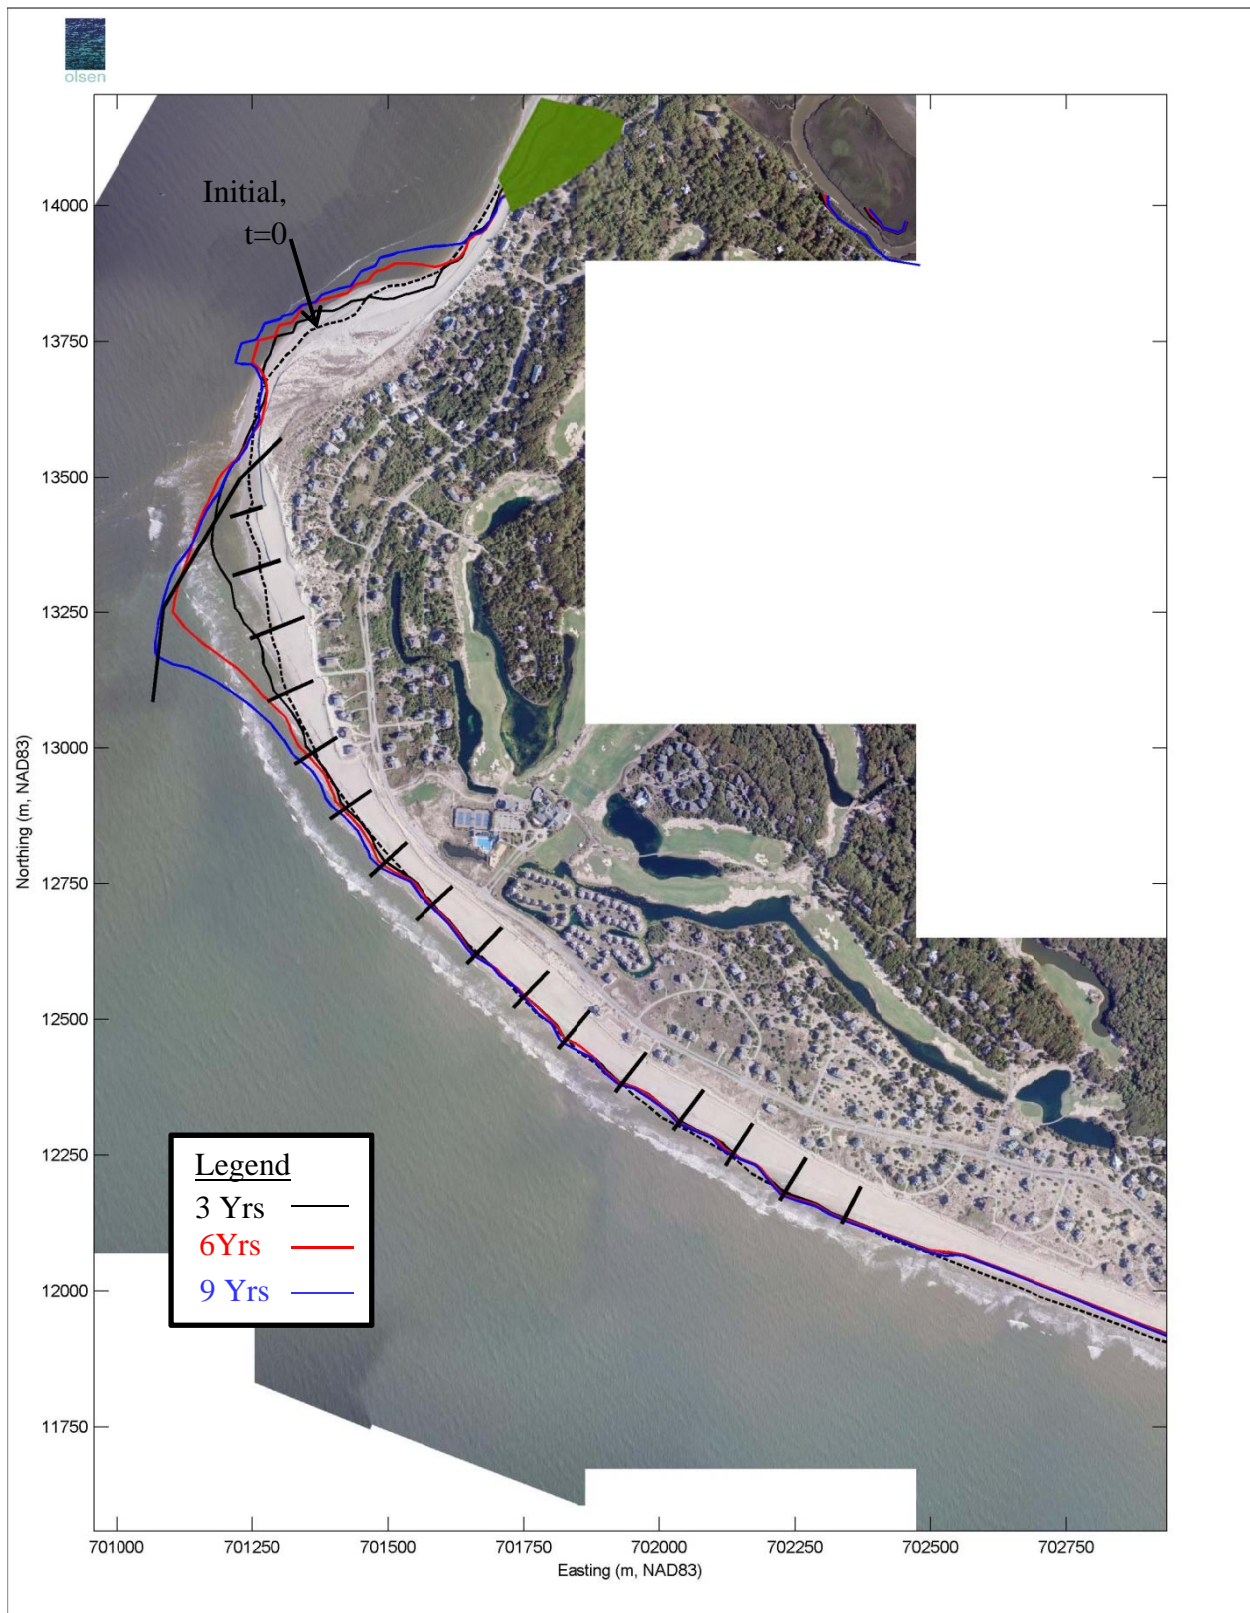
Figure 10: Approximate MLLW contour predicted at years 0, 3, 6, and 9 years for the Phase II groin scenario prior to the subsequent sand placement/dredge event.

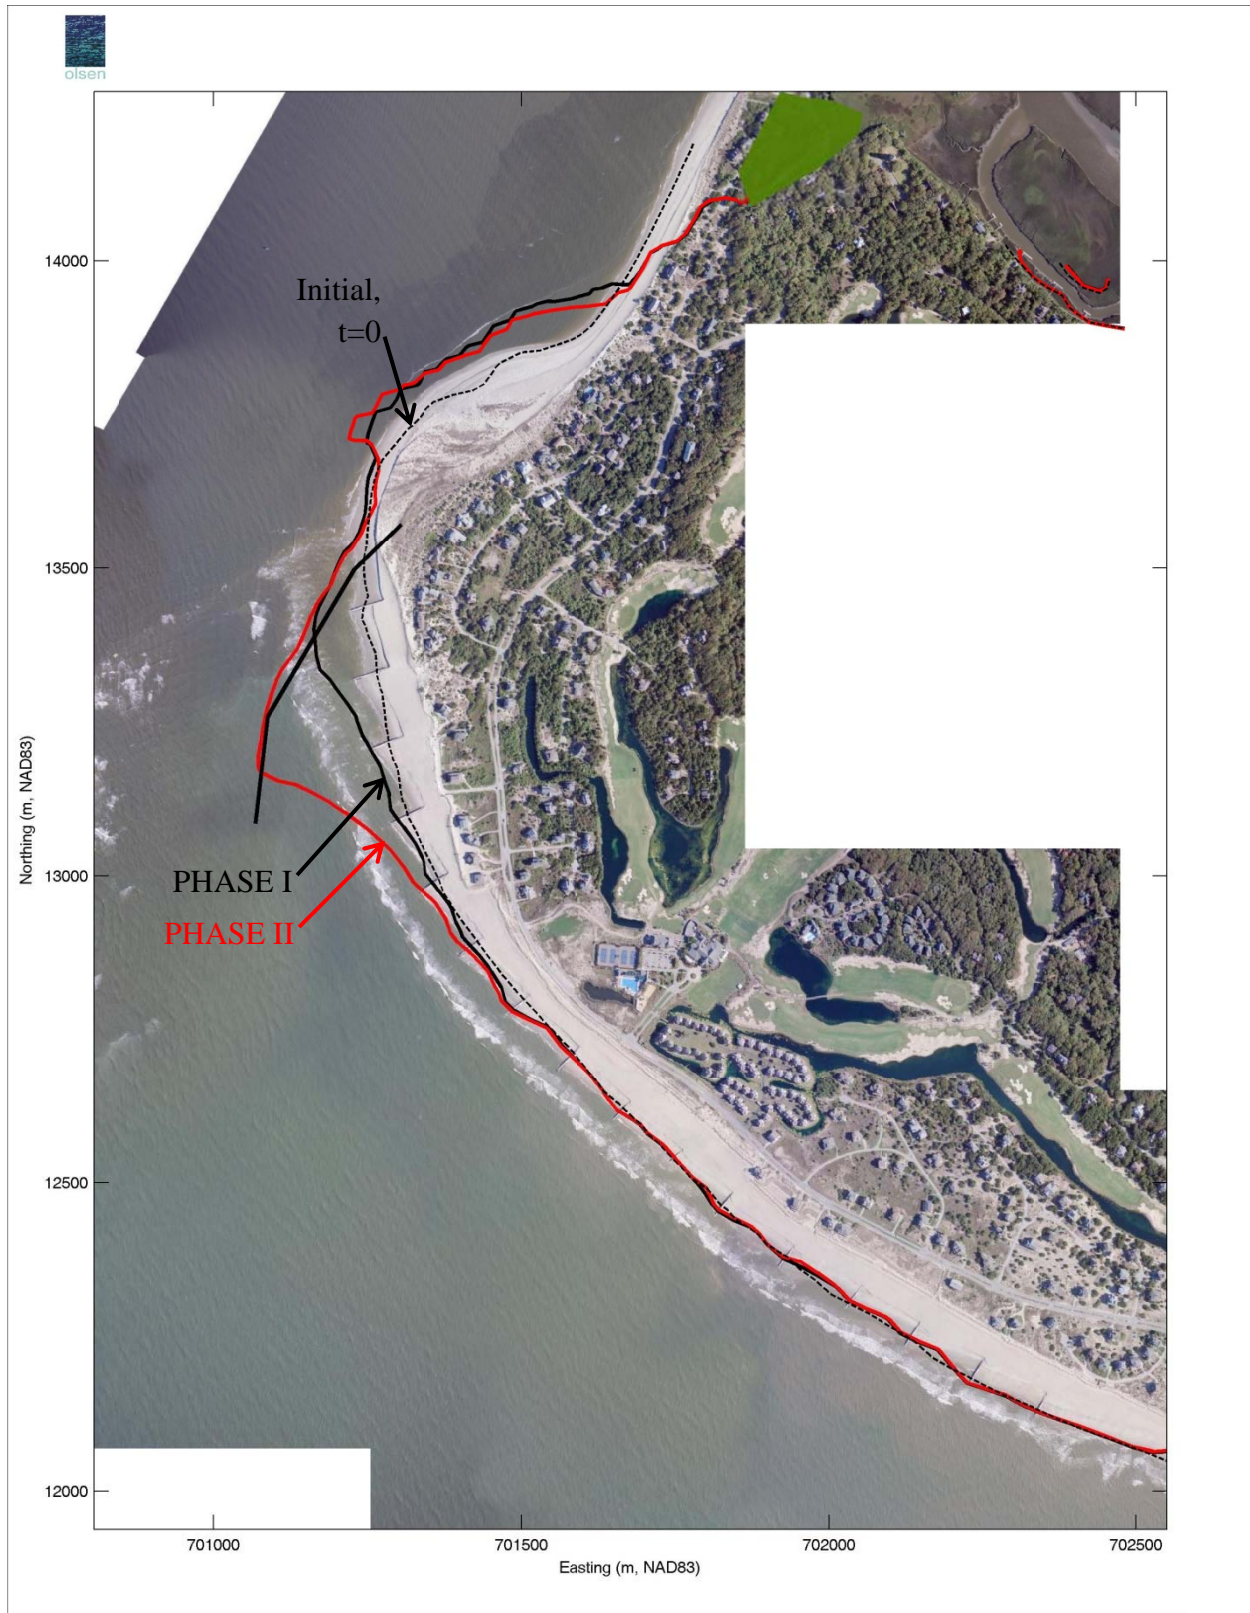
Figure 11: Comparison of MLLW predicted shoreline contours at year 9 for the Phase I and Phase II terminal groin scenarios.

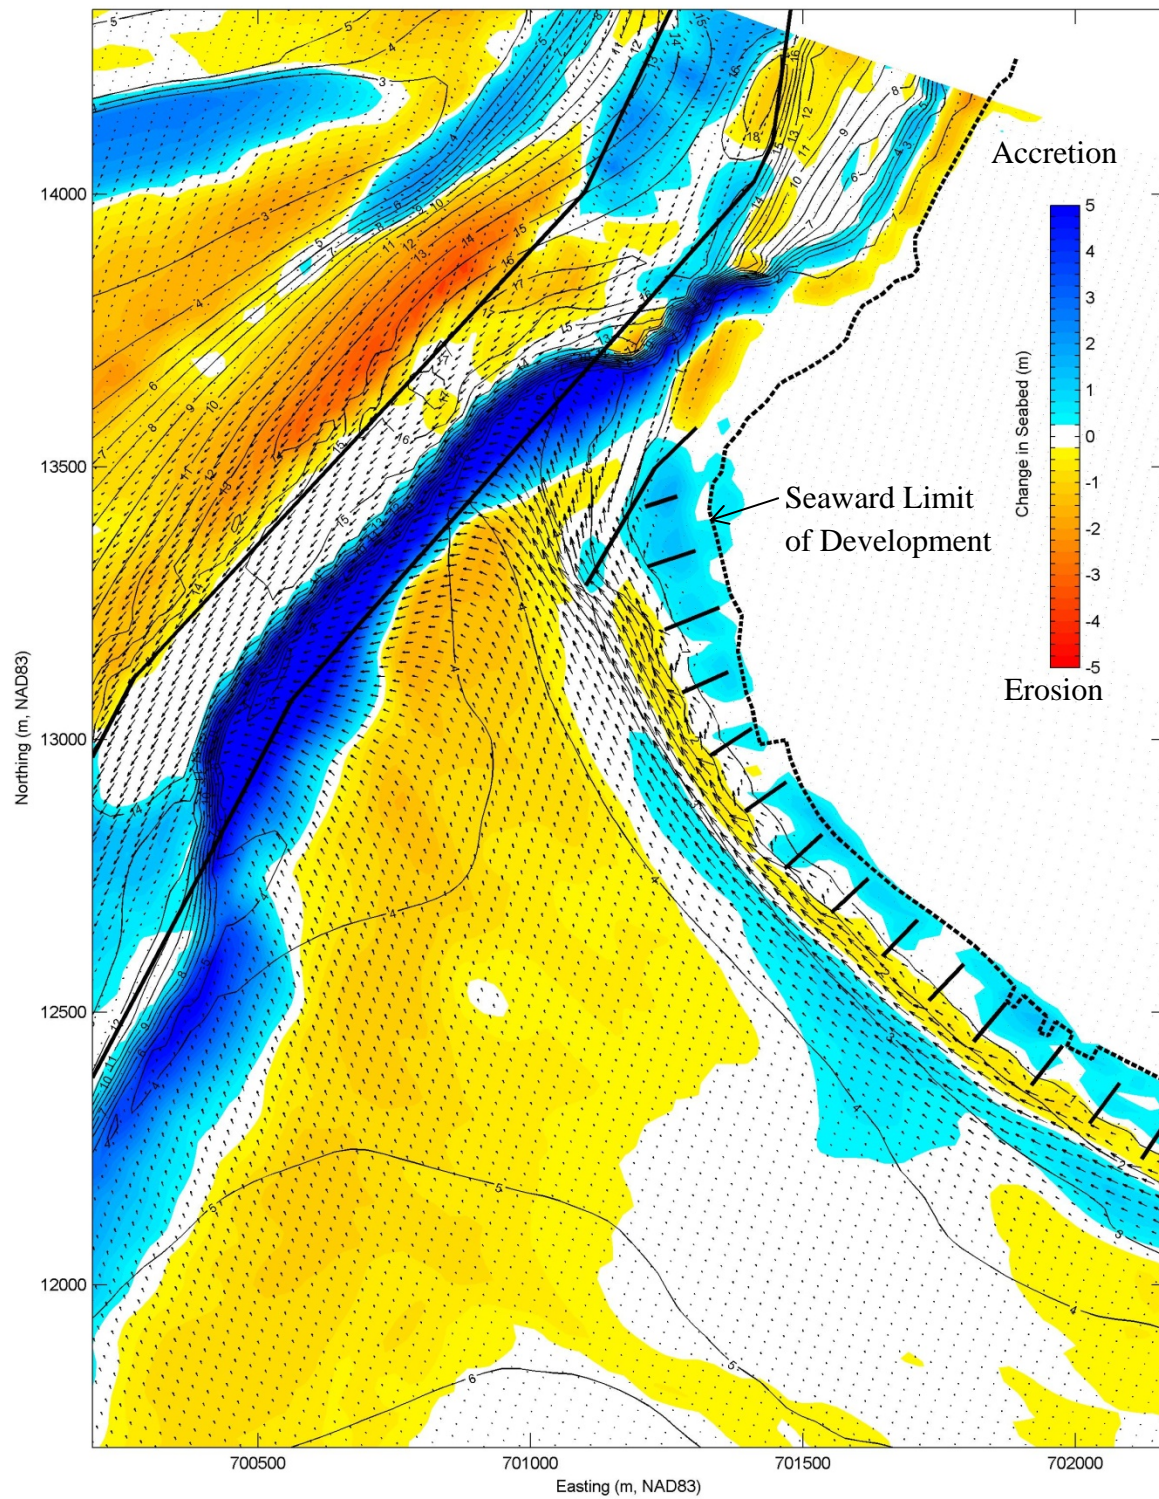
Figure 12: Cumulative sedimentation and erosion after 3 years for a short terminal groin alternative. The effects of repeated sand placement events are included in this result.
