**VILLAGE OF BALD HEAD ISLAND
SHORELINE PROTECTION PROJECT**

FINAL ENVIRONMENTAL IMPACT STATEMENT

U.S. Army Corps of Engineers
Wilmington District

VOLUME II
(APPENDIX A THROUGH APPENDIX K)

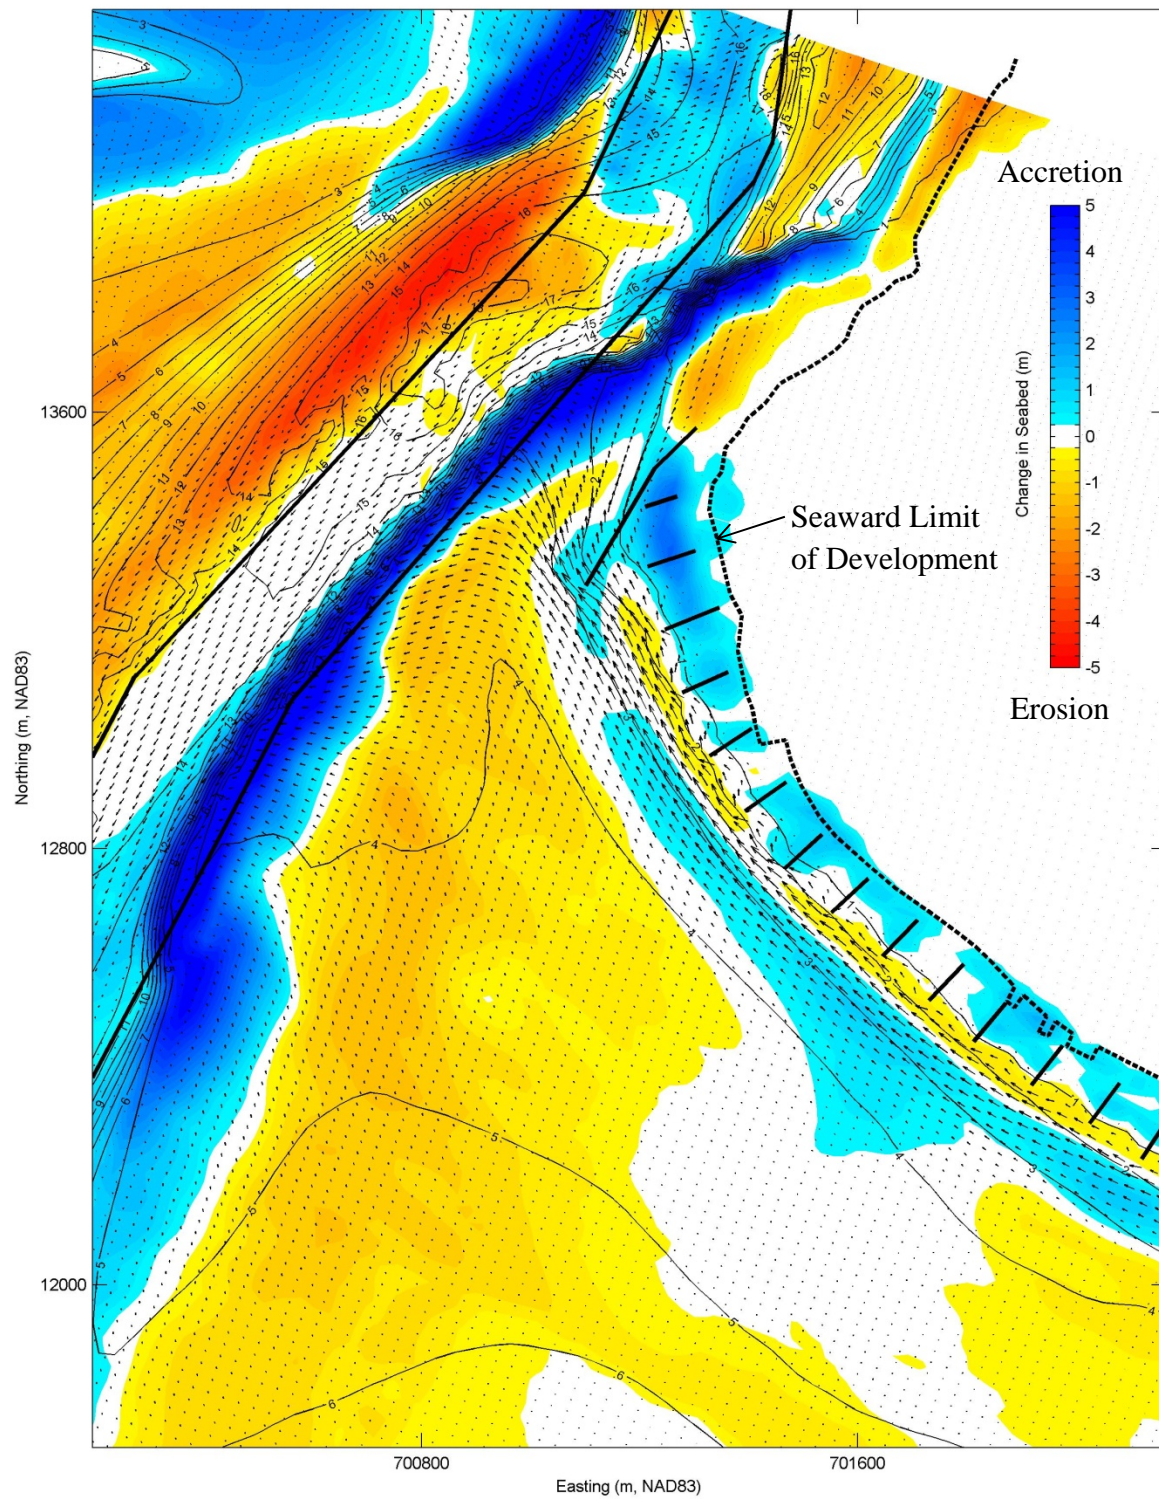
Figure 13: Cumulative sedimentation and erosion after 6 years for a short terminal groin alternative. The effects of repeated sand placement events are included in this result.

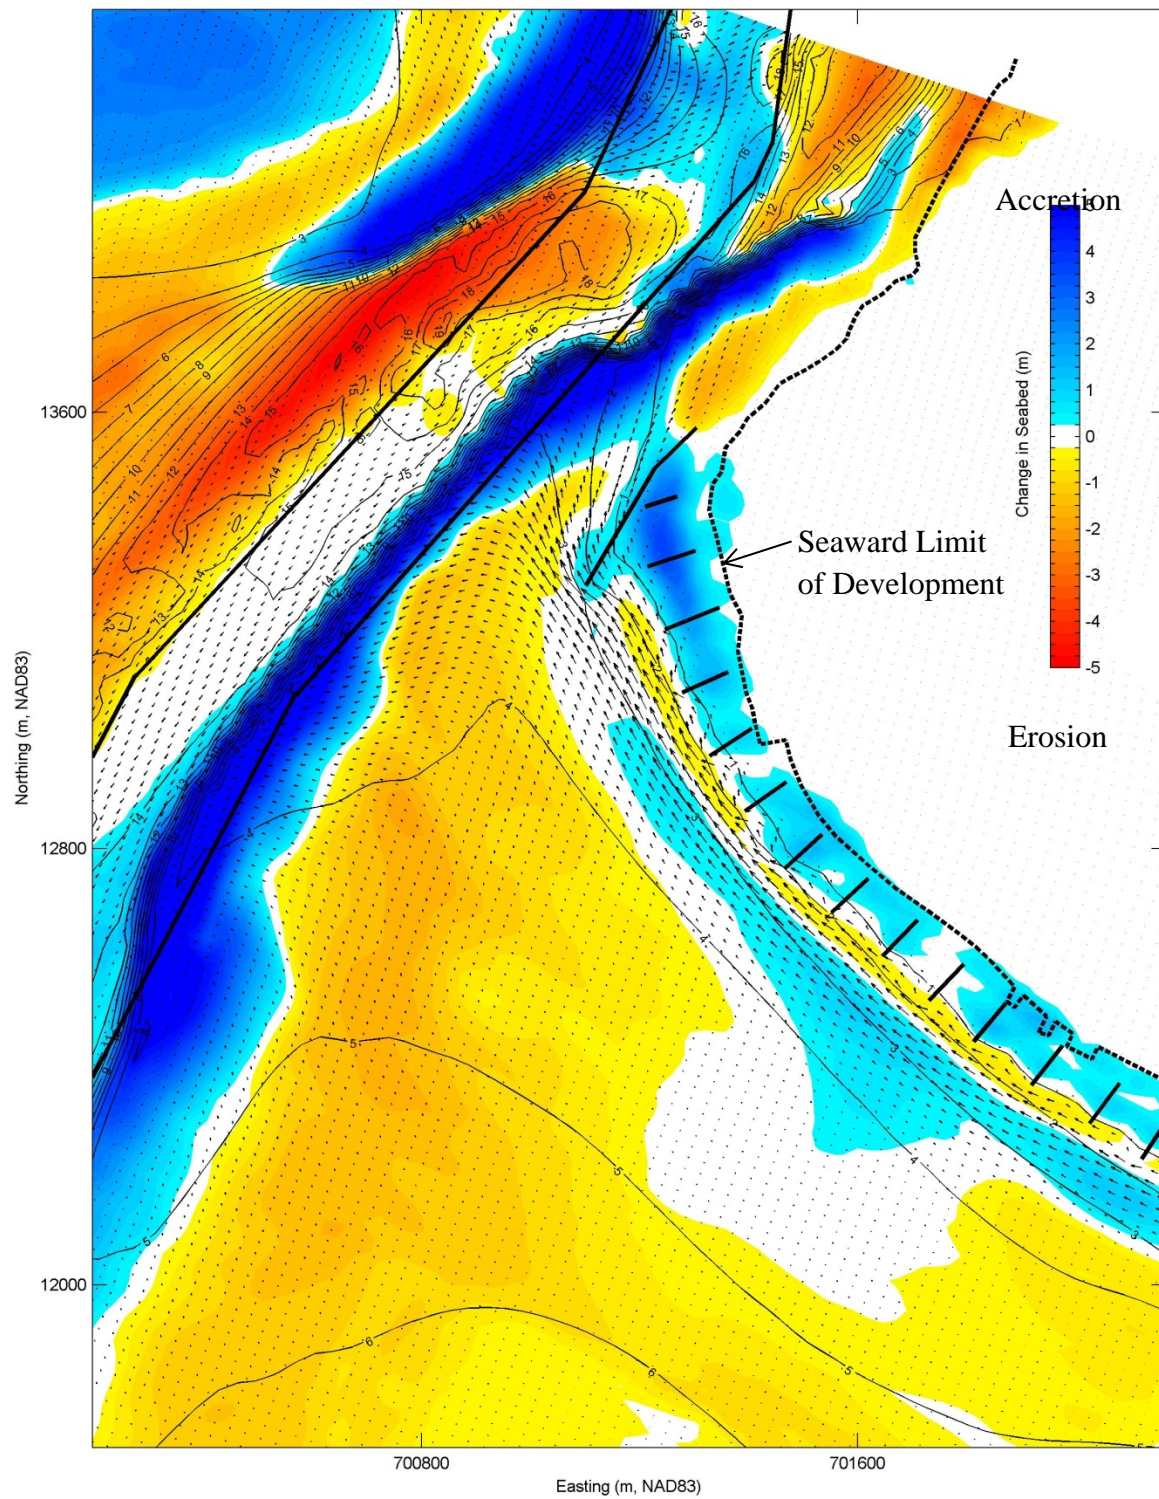
Figure 14: Cumulative sedimentation and erosion after 9 years for a short terminal groin alternative. The effects of repeated sand placement events are included in this result.

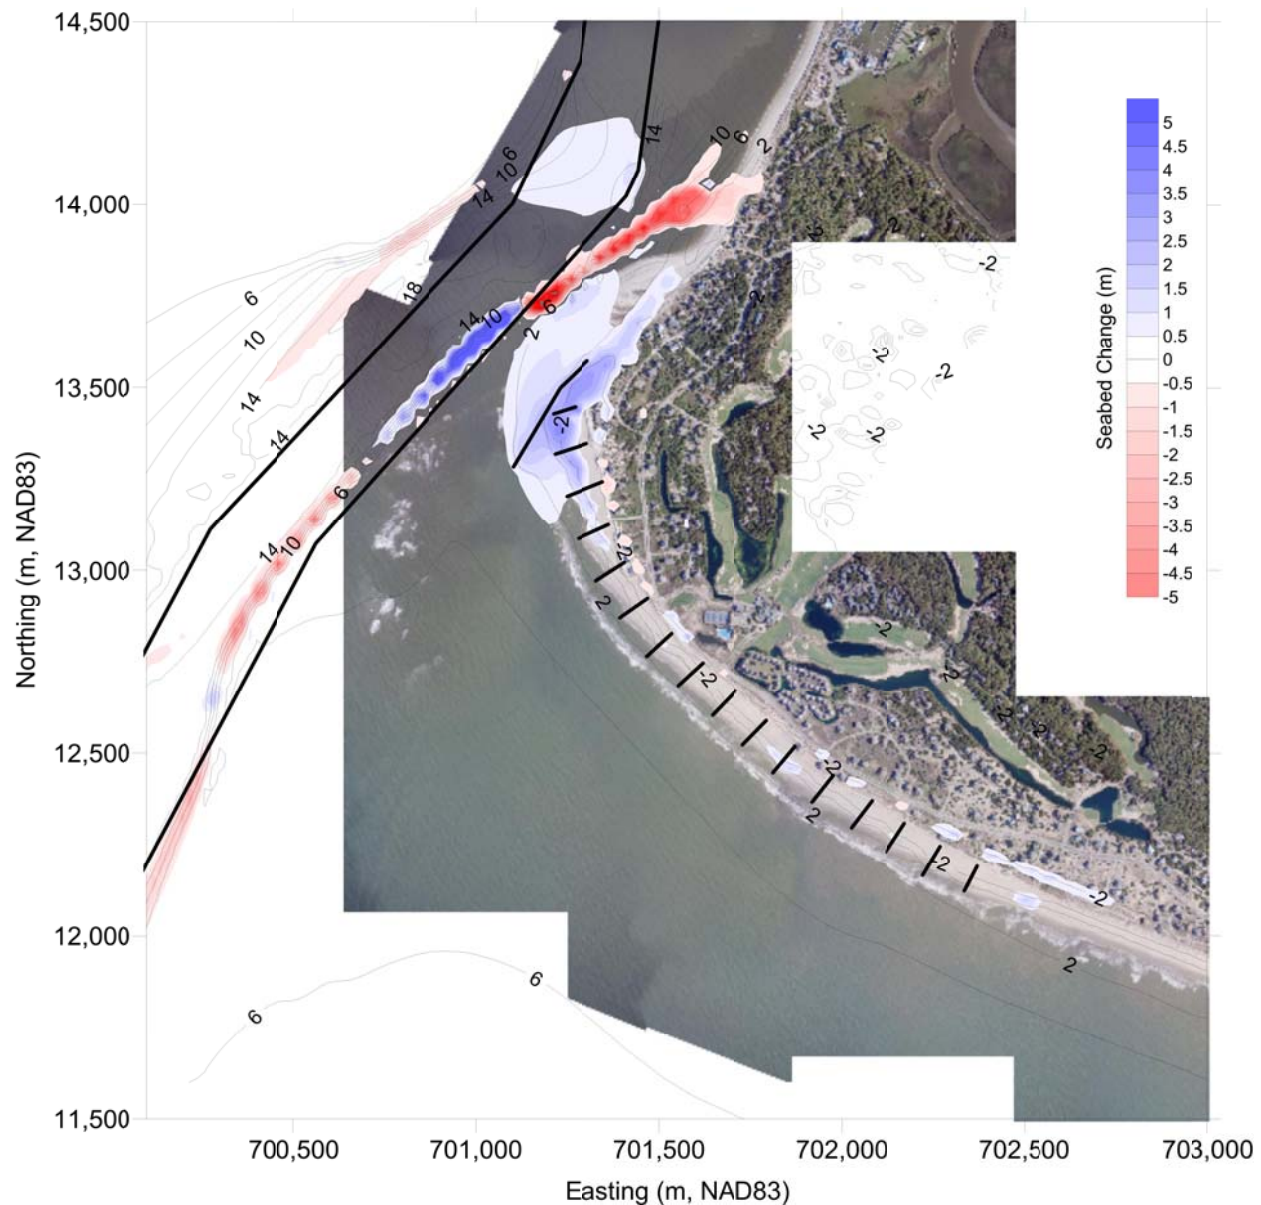
Figure 15: Difference in seabed elevation after 9 years between the Phase I terminal groin and sand-tube groin only (existing condition) scenario. Red shading in the figure indicates areas where the seabed is lower with the Phase I terminal groin while blue shading indicates areas where the seabed is higher with the Phase I terminal groin, relative to the sand-filled tube groin alternative.

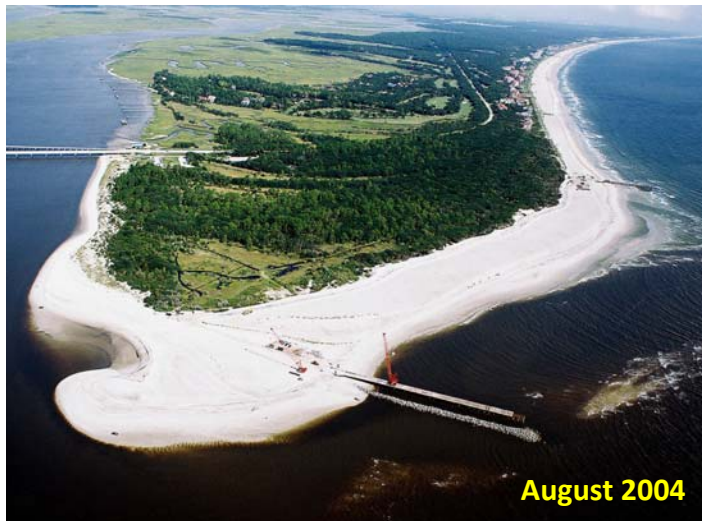
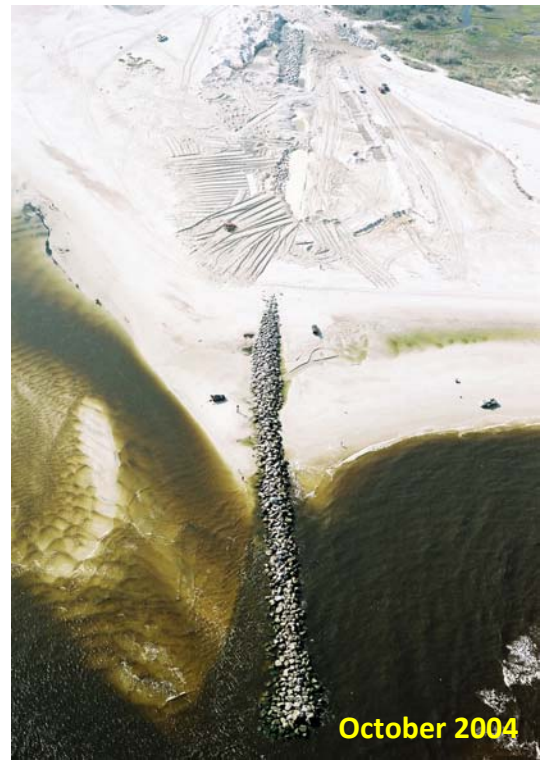
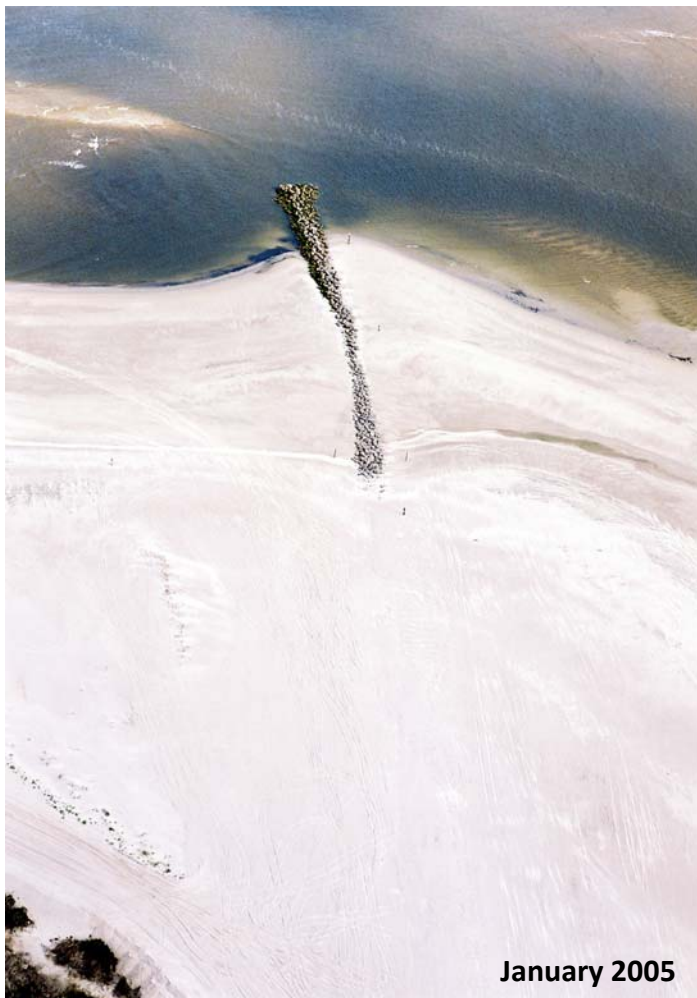
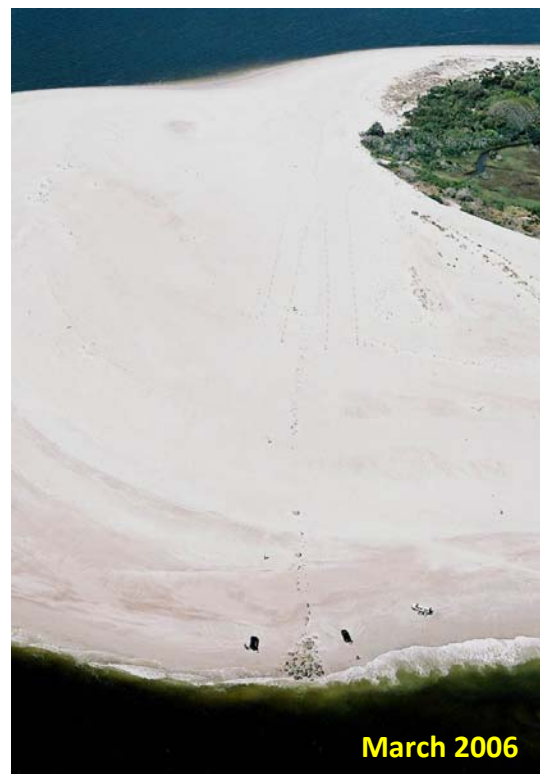
Figure x.x: Chronology of South Amelia Island Leaky Terminal Structure constructed at Amelia Island State Park, Nassau County, Florida.

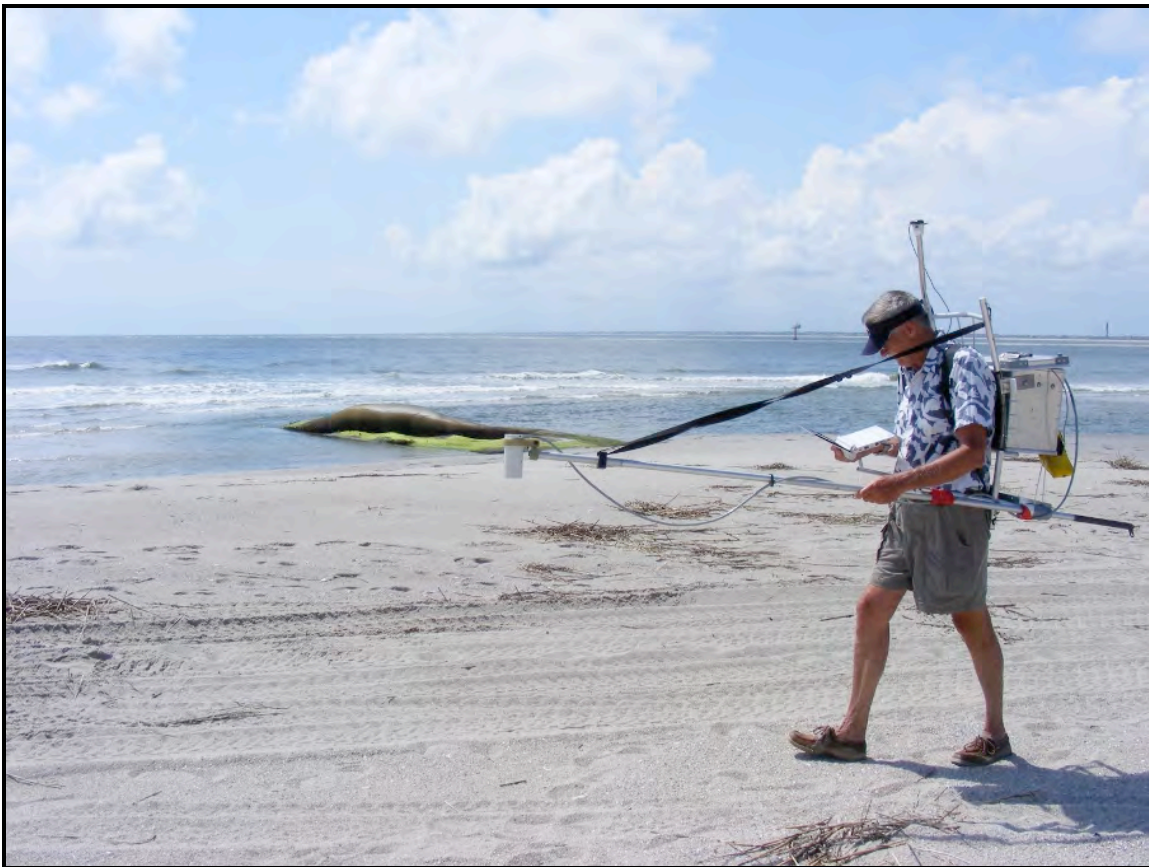
Figure 2. The G-856 magnetometer, Trimble DGPS and PC used for the terrestrial remote sensing survey.

The project terrestrial and inter-tidal areas were examined visually and investigated using a cesium magnetometer at low tide. Where possible, archaeologists walked the shoreline to identify evidence of vessel remains or other cultural features. Magnetic anomalies were located using GPS. A TRIMBLE GeoExplorer Series GeoXT handheld DGPS capable of ± 3 feet was employed to collect positioning data for cultural material located within the survey area. The GeoXT utilizes WAAS satellites to provide differential corrections in the field. A display shows both transects and target locations. The GeoXT was interfaced with a small PC running Hypack survey software to identify survey lanes and collect magnetometer data. A GEOMETRICS 856 cesium vapor magnetometer was used to identify buried ferromagnetic cultural material along each of the terrestrial survey lanes (Figure 2).

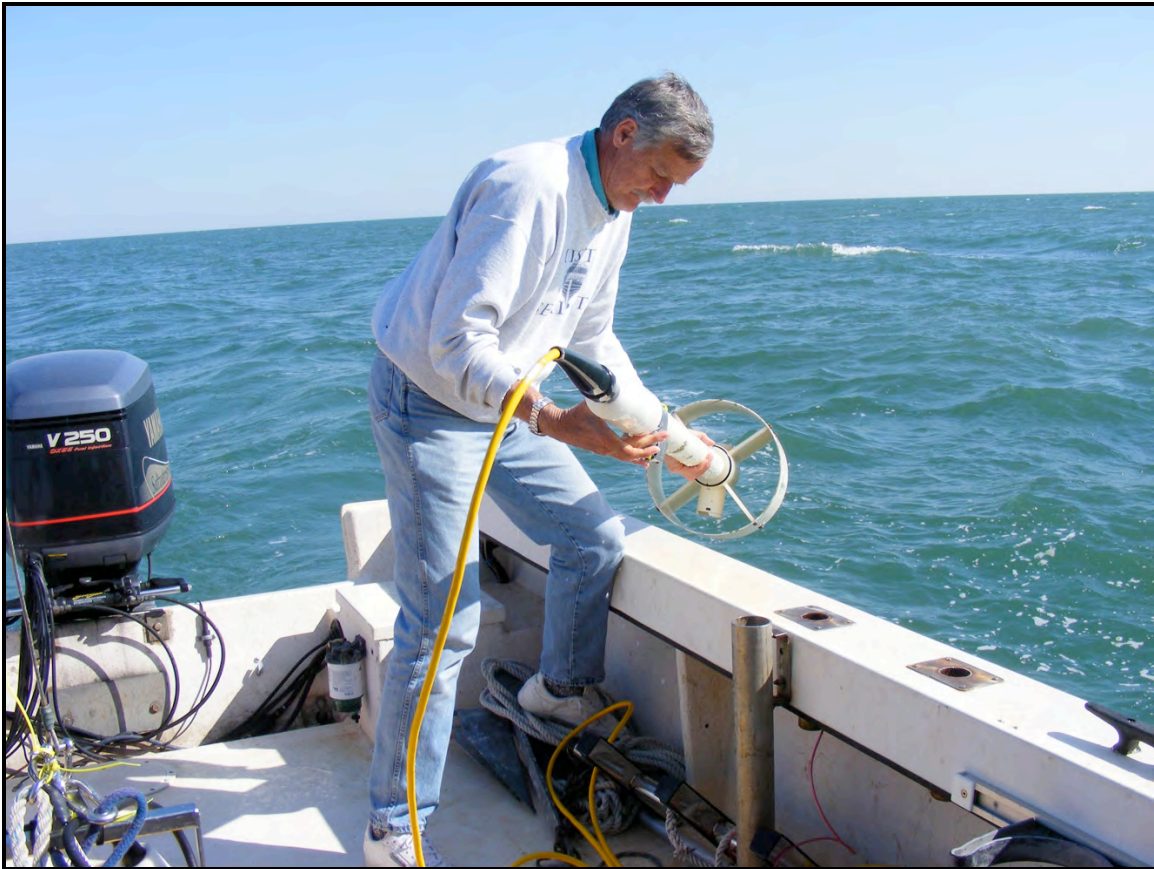
Figure 2. Launching the EG&G GEOMETRICS G-881 magnetometer.

An EG&G GEOMETRICS G-881 marine cesium magnetometer, capable of plus or minus 0.001 gamma resolution, was employed to collect magnetic data in the survey area. To produce the most comprehensive magnetic record, data was collected at 10 samples per second. Due to shoal water within the project area, the magnetometer sensor was towed just below the water surface at a speed of approximately three to four knots. Magnetic data were recorded as a data file associated with the computer navigation system. Data from the survey were contour plotted using QUICKSURF® computer software to facilitate anomaly location and definition of target signature characteristics. All magnetic data were correlated with the acoustic remote-sensing records.

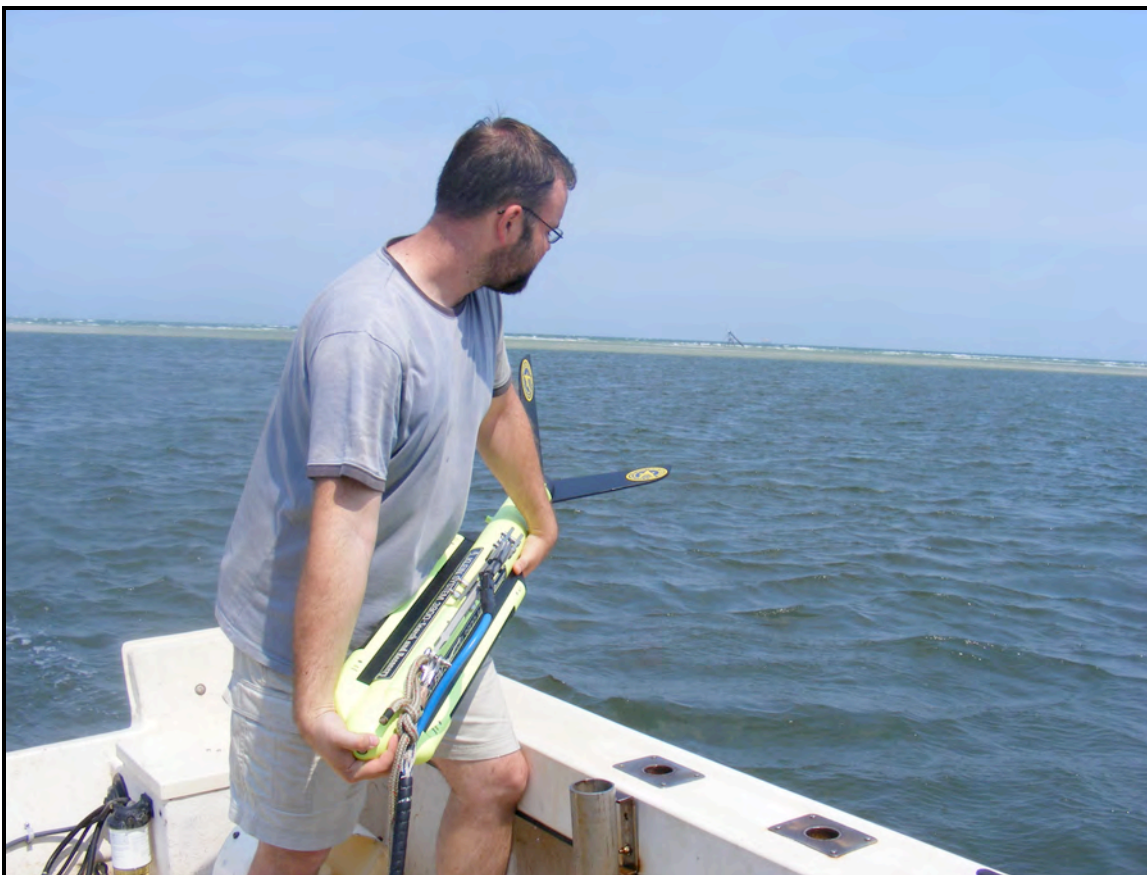
Figure 3. Launching the KLEIN SYSTEM 3900 digital sidescan sonar.

A 445/900 kHz KLEIN SYSTEM 3900 digital sidescan sonar (interfaced with SONARPRO SONAR PROCESSING SYSTEM) was employed to collect acoustic data in the survey area (Figure 3). Due to shoal water within the project area, the sidescan sonar transducer was deployed and maintained between 3 and 5 feet below the water surface. Acoustic data were collected using a range scale of 30 and 50 meters to provide a minimum of 200% coverage and high target signature definition. Acoustic data were recorded as a digital file with SONARPRO and tied to the magnetic and positioning data by the computer navigation system.

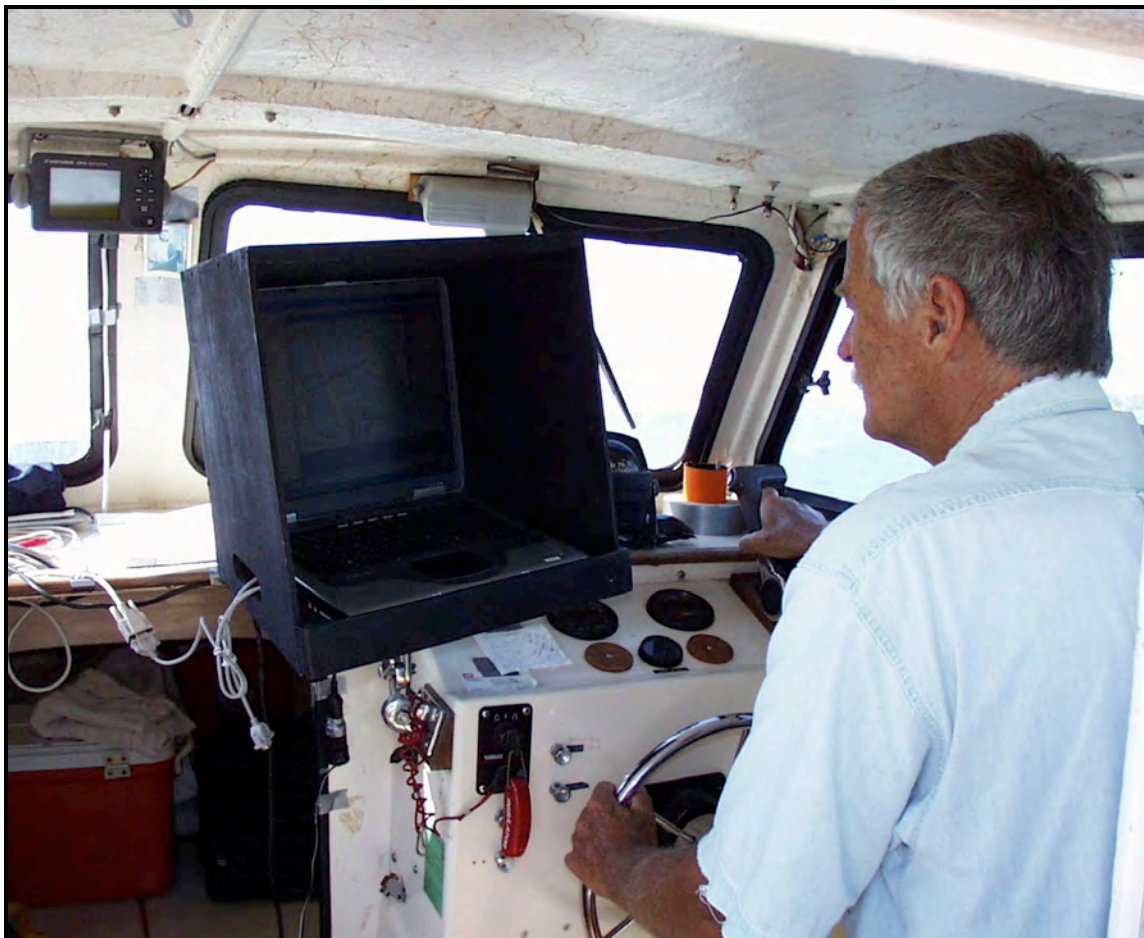
Figure 4. Computer navigation system located at the research vessel helm.

A TRIMBLE AgGPS was used to control navigation and data collection in the survey area. That system has an accuracy of plus or minus three feet, and can be used to generate highly accurate coordinates for the computer navigation system on the survey vessel. The DGPS was employed in conjunction with an onboard laptop loaded with HYPACK navigation and data collection software (Figure 4). Positioning data generated by the navigation system were tied to magnetometer records by regular annotations to facilitate target location and anomaly analysis. All data is related to the North Carolina State Plane Coordinate System, NAD 83.

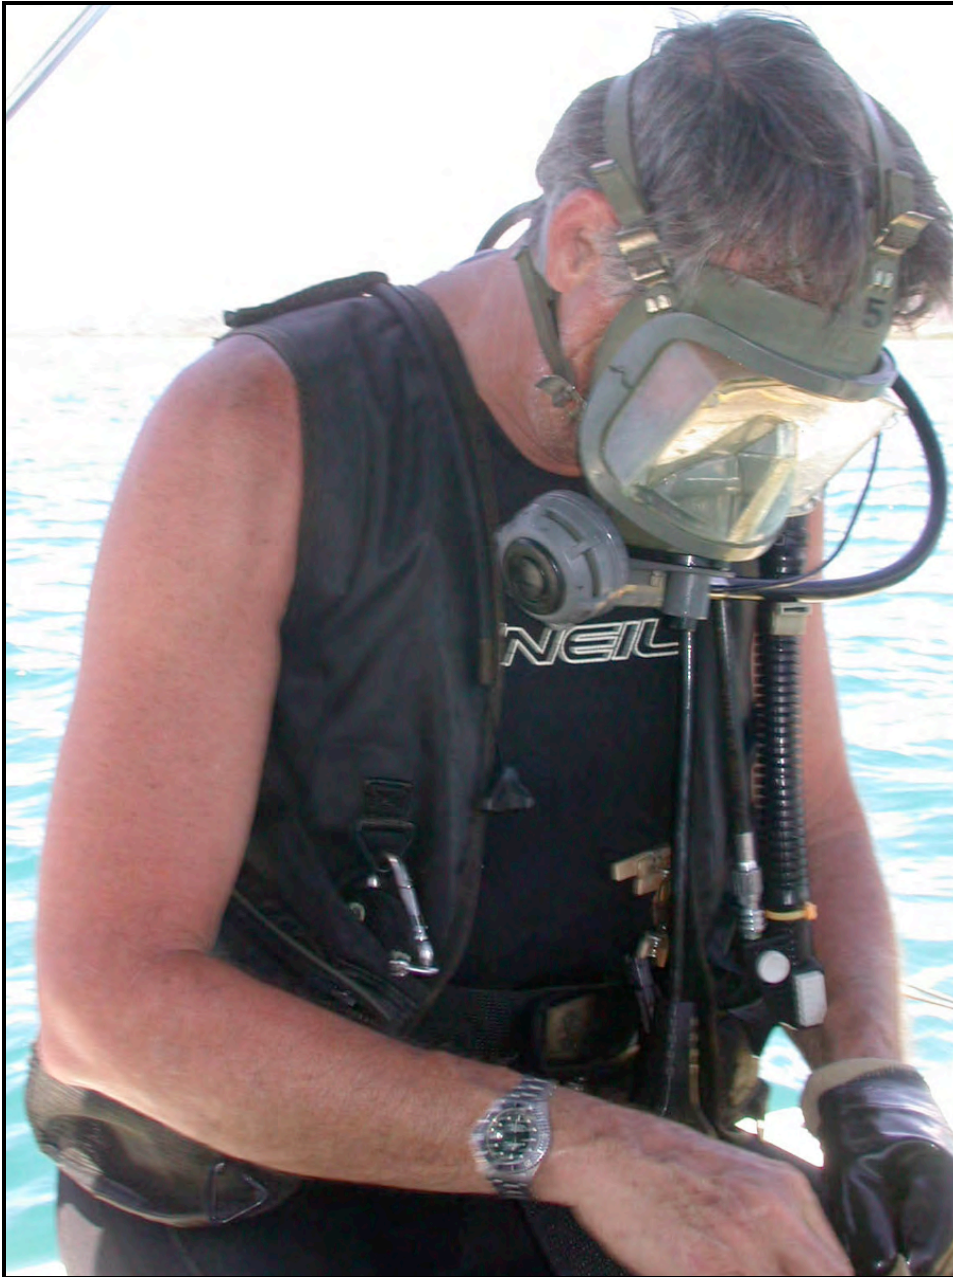
Figure 5. Diver with wireless communications mask suiting up.

precise location of the hull remains. Archaeological divers equipped with wireless communications (Figure 5) recorded the wreck using a baseline web and measured drawings. Once buoys were moved to specific locations on the wreck remains, baseline stations A and F, and DGPS was used to establish those geographical positions.

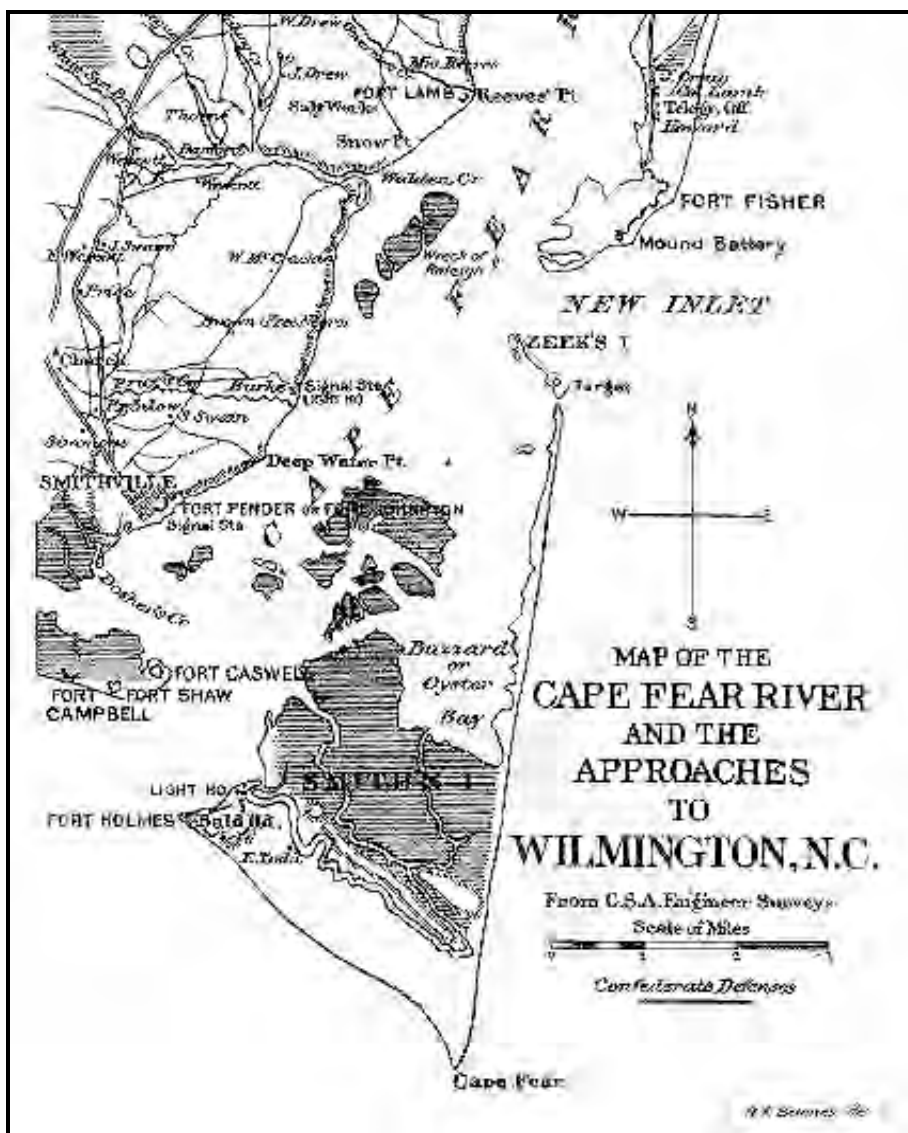
Figure 7. Chart that depicts the two entrances into the Cape Fear River (National Historical Society 1987, I 12:38).

Wilmington became the key port for "runners" largely because of the area's topography. Located 28 miles from the mouth of the Cape Fear River, the port had access to the Atlantic through two separate entrances; eastward through New Inlet and southward through the river mouth (Figure 7). Although the two entrances were only six miles apart, Smith's Island, a strip of sand and shoal, lay in between. Continuing along Cape Fear were the dangerous Frying Pan Shoals, which extended 10 miles further into the Atlantic, making the distance by water between the two entrances a little less than 40 miles (Soley 1883:91).

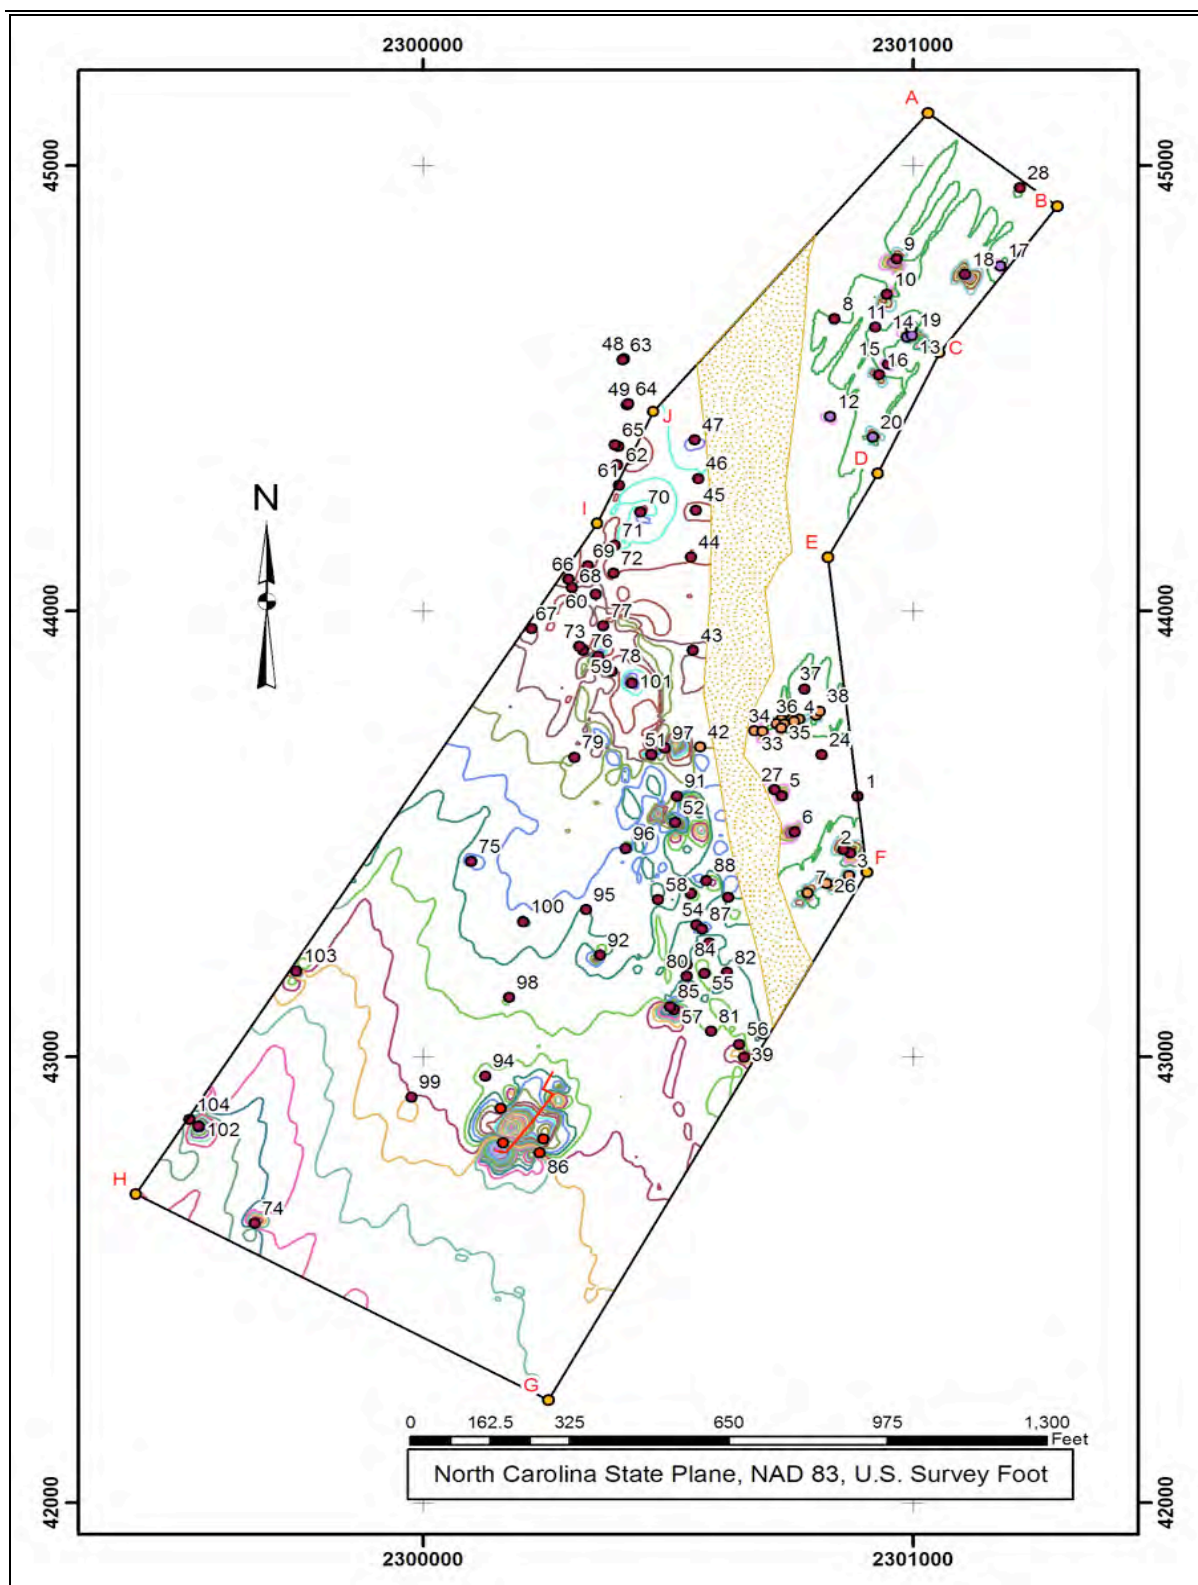
Figure 8. Magnetic contour map with anomalies.

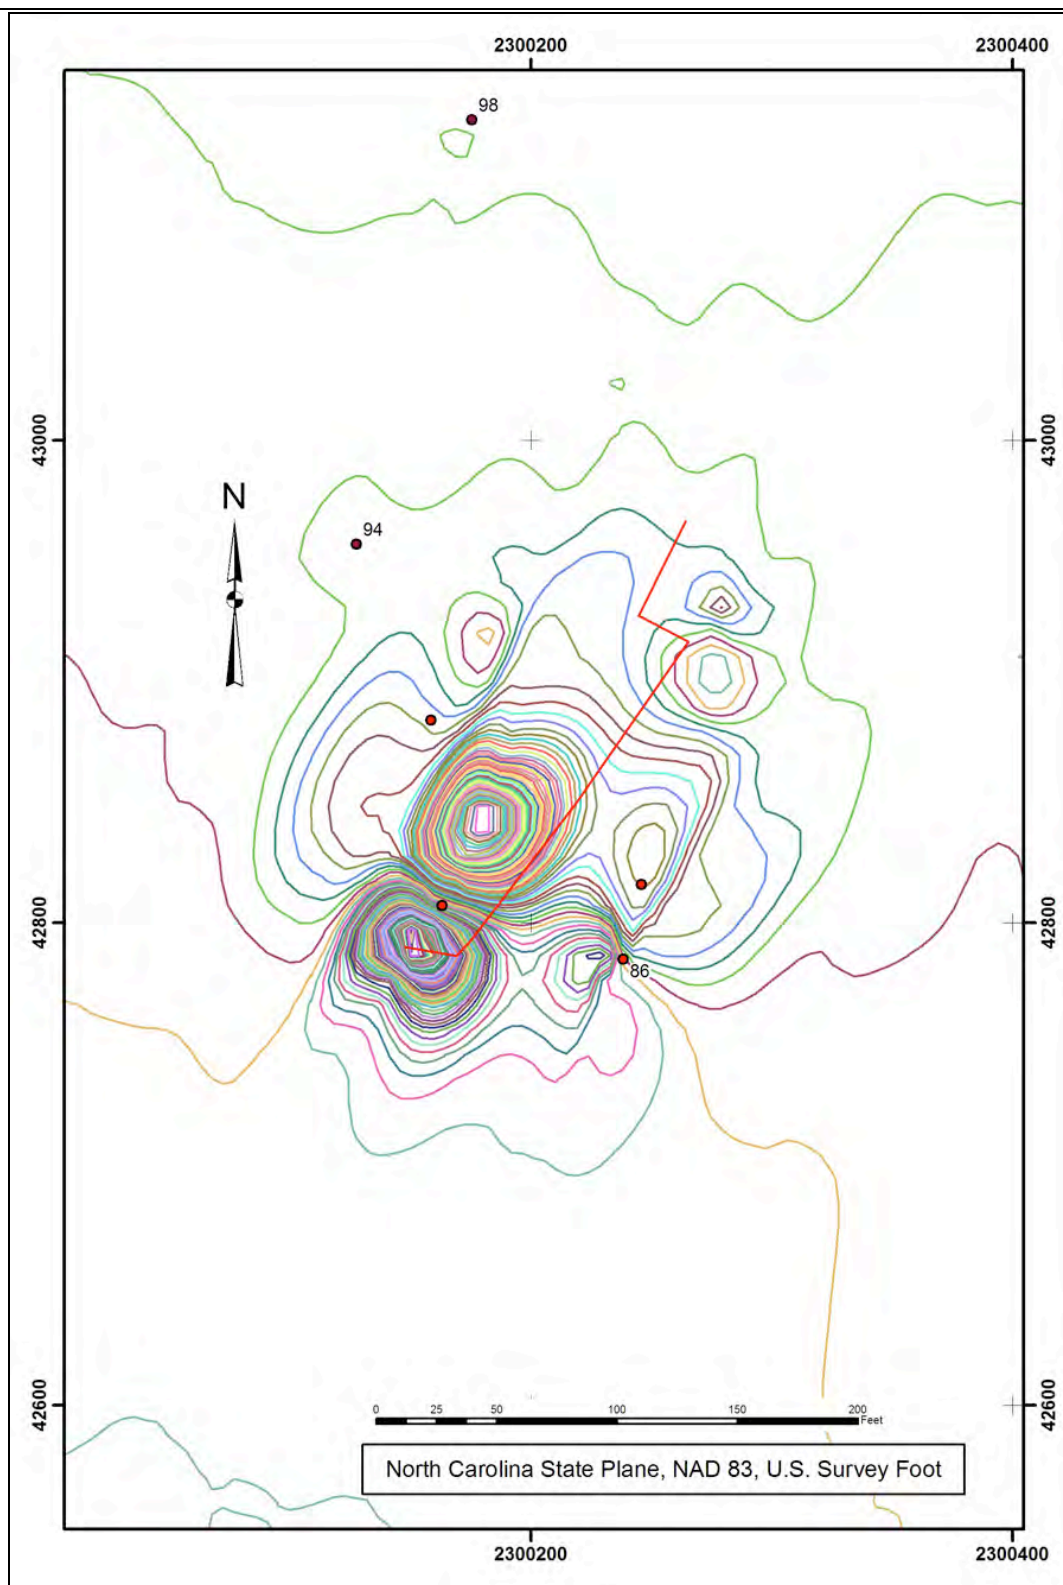
Figure 9. Shipwreck magnetic anomaly with shipwreck baseline.

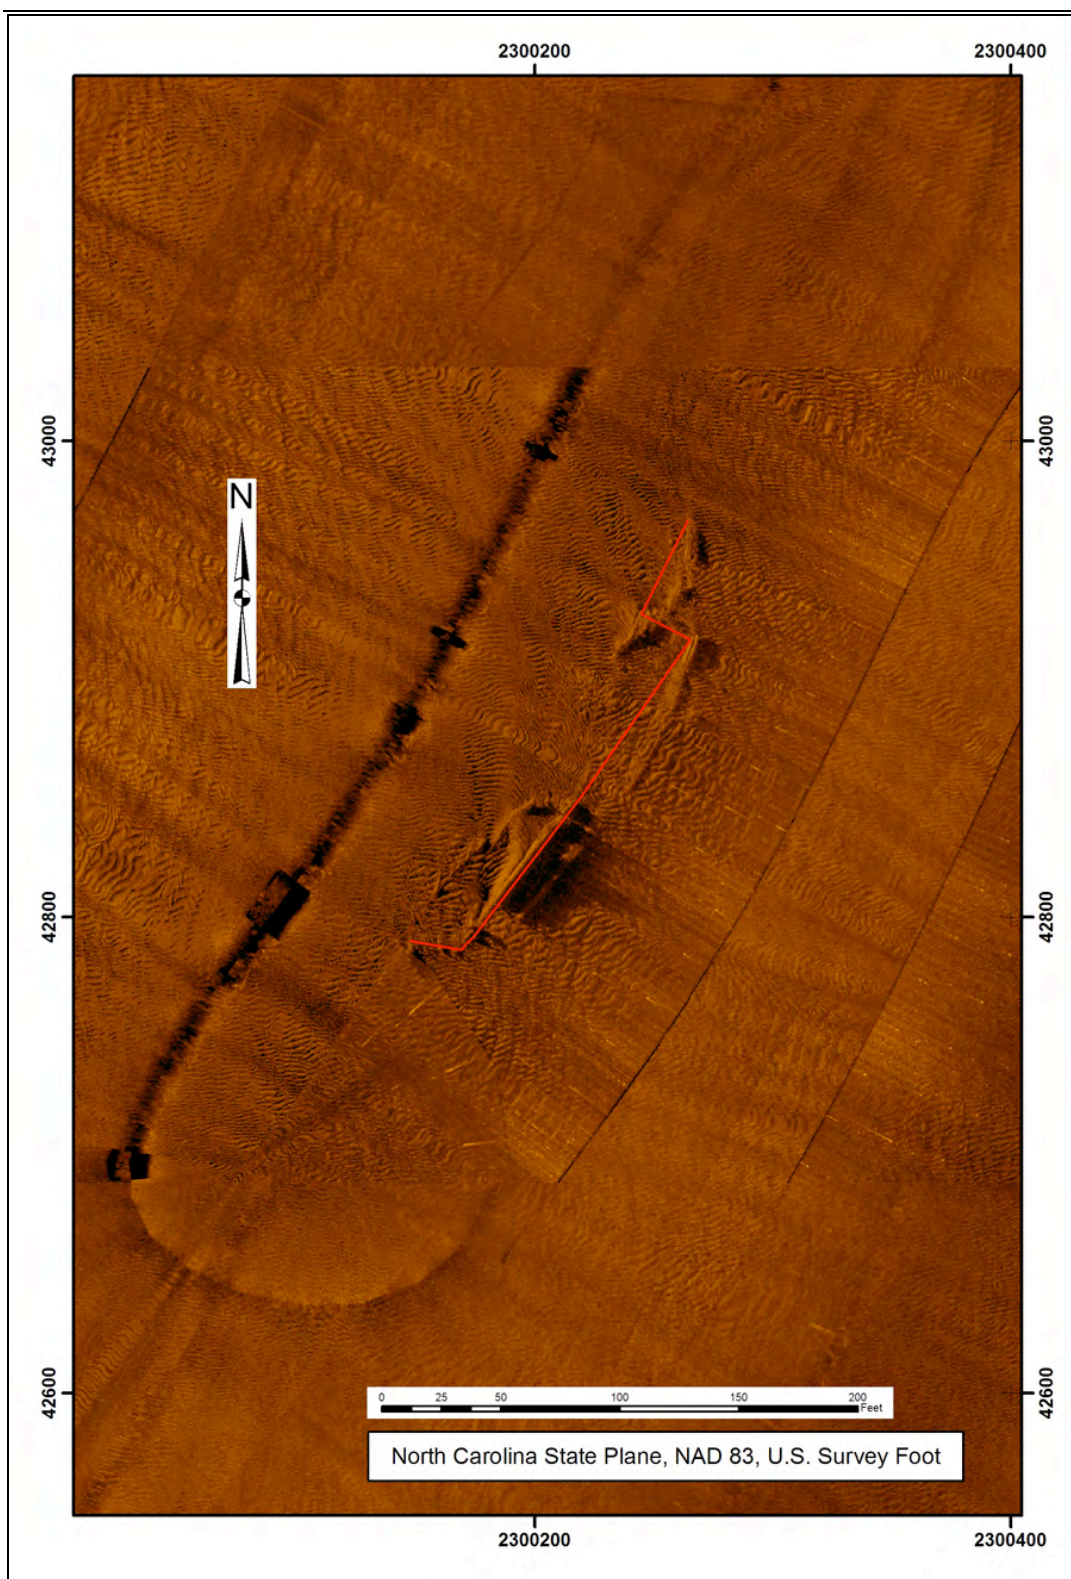
Figure 10. Shipwreck sonar image with baseline.

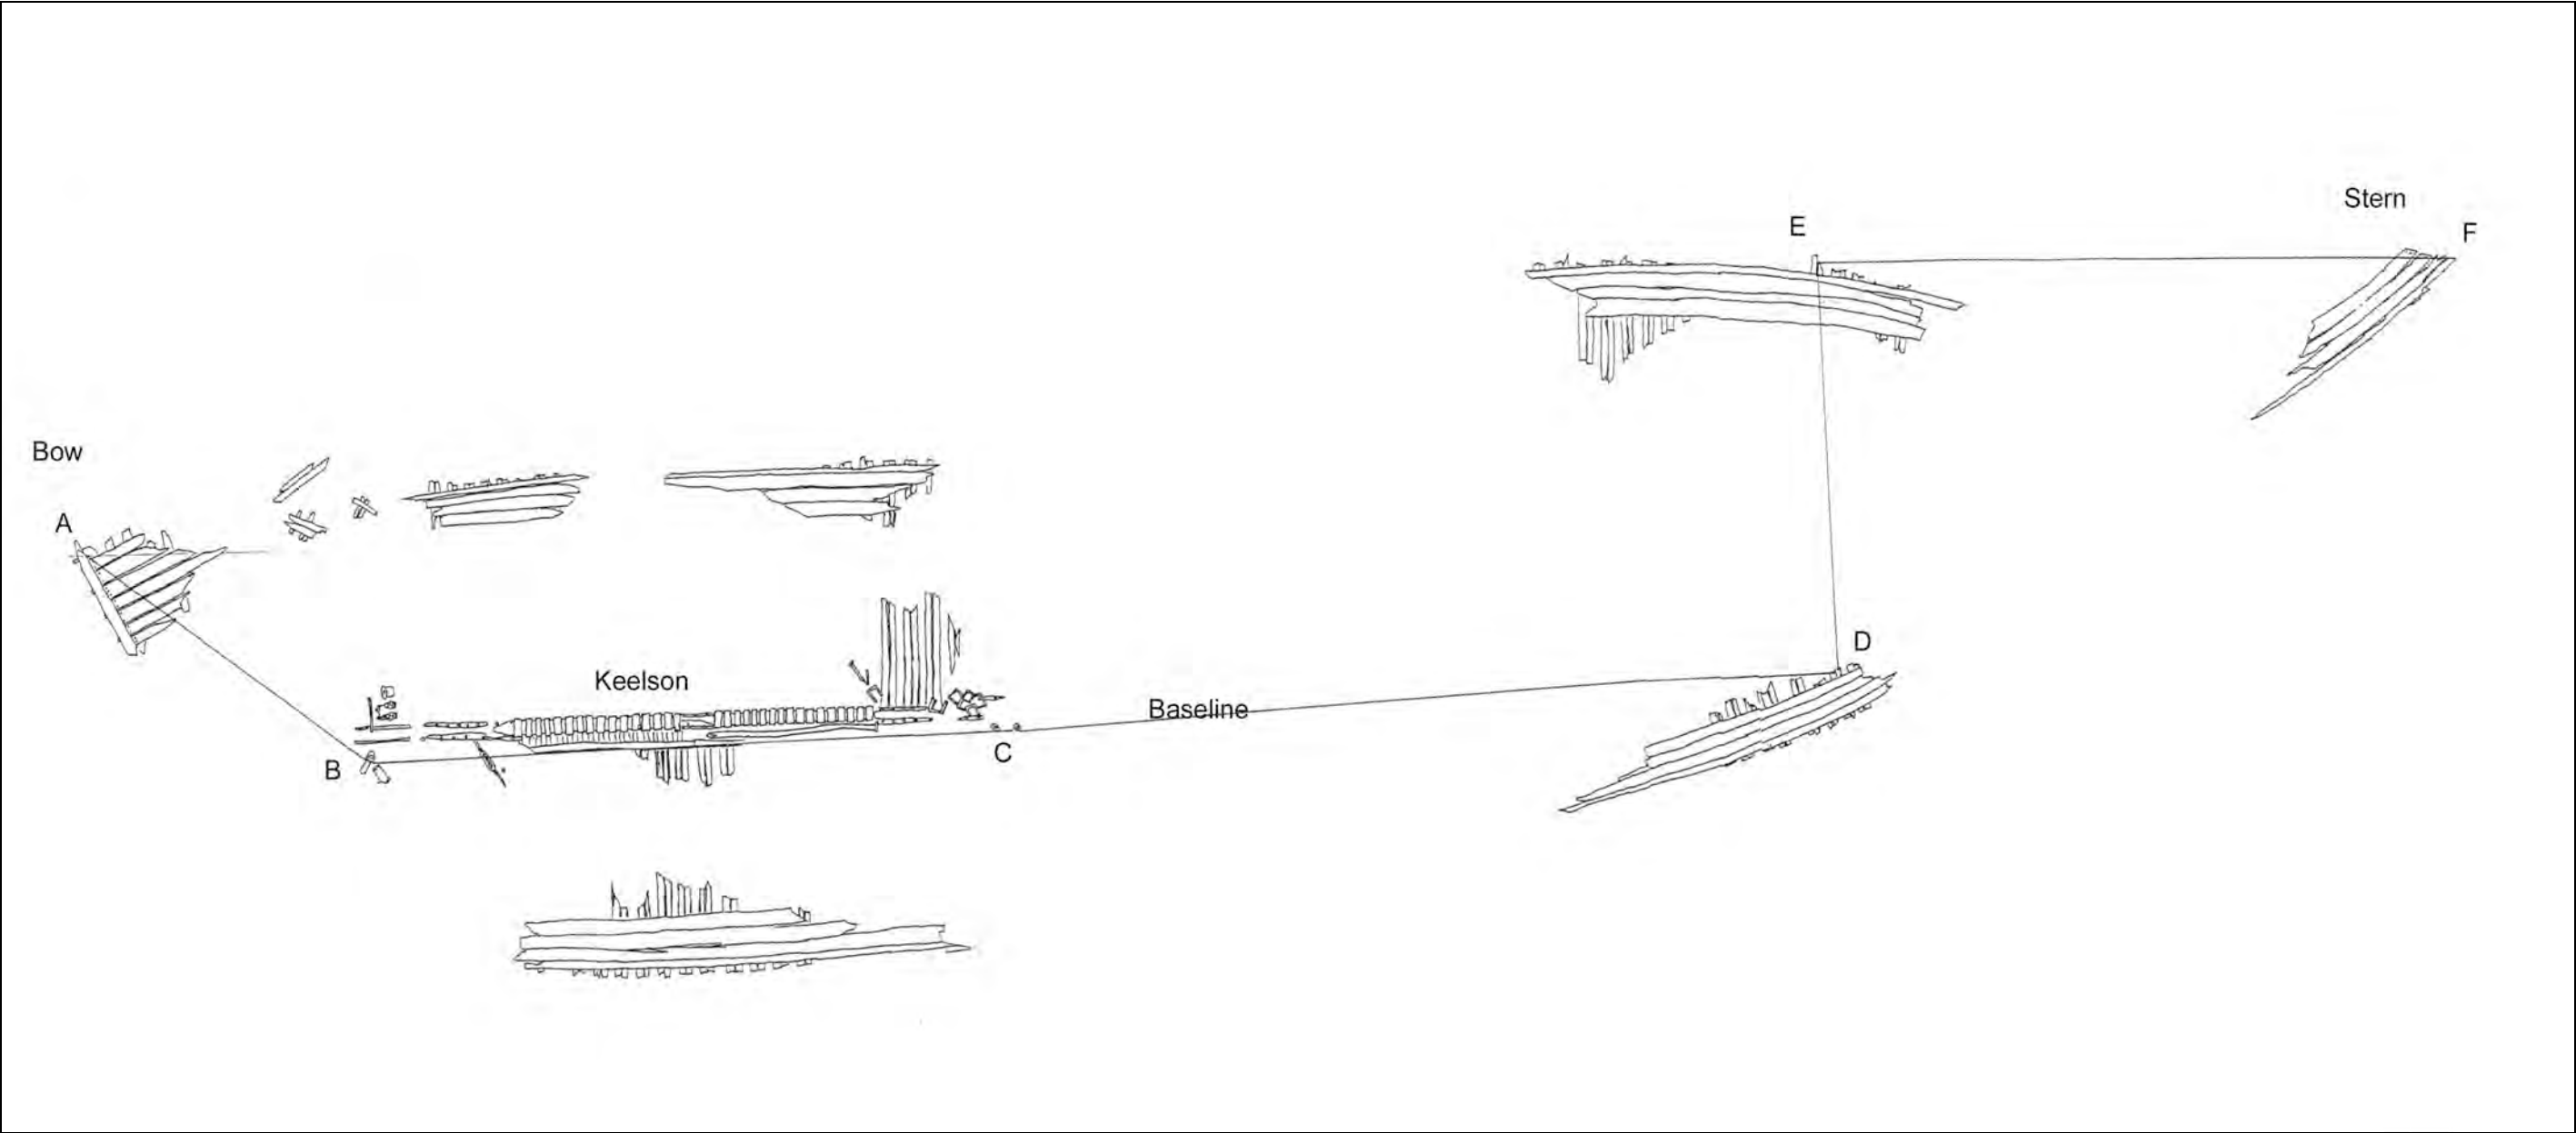
Figure 11. Plan of exposed wreck remains.
