**VILLAGE OF BALD HEAD ISLAND
SHORELINE PROTECTION PROJECT**

FINAL ENVIRONMENTAL IMPACT STATEMENT

U.S. Army Corps of Engineers
Wilmington District

VOLUME II
(APPENDIX A THROUGH APPENDIX K)

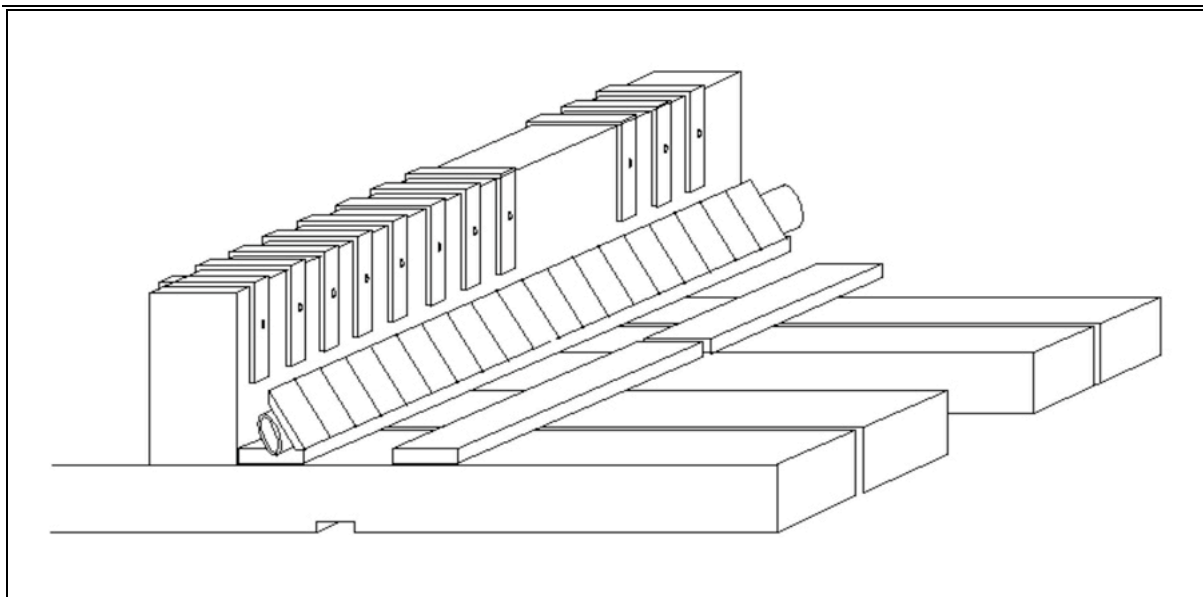
Figure 12. Illustration of the keelson configuration.

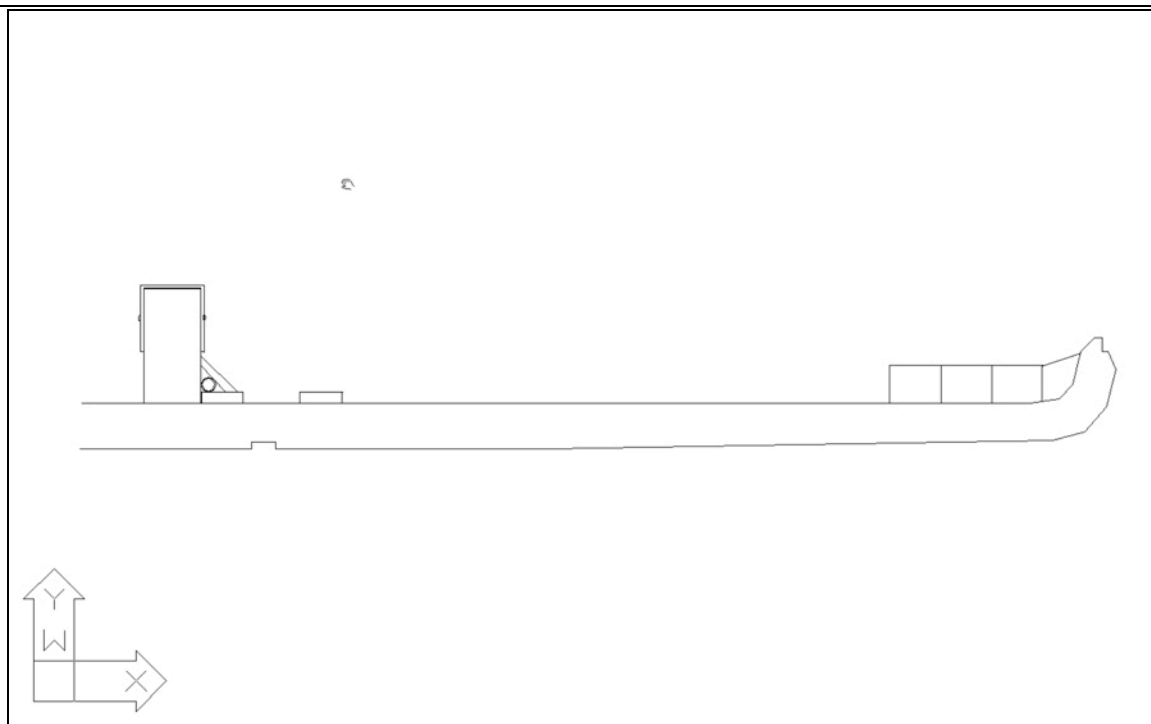
Figure 13. Cross section of the port side of the hull approximately midships (looking aft).

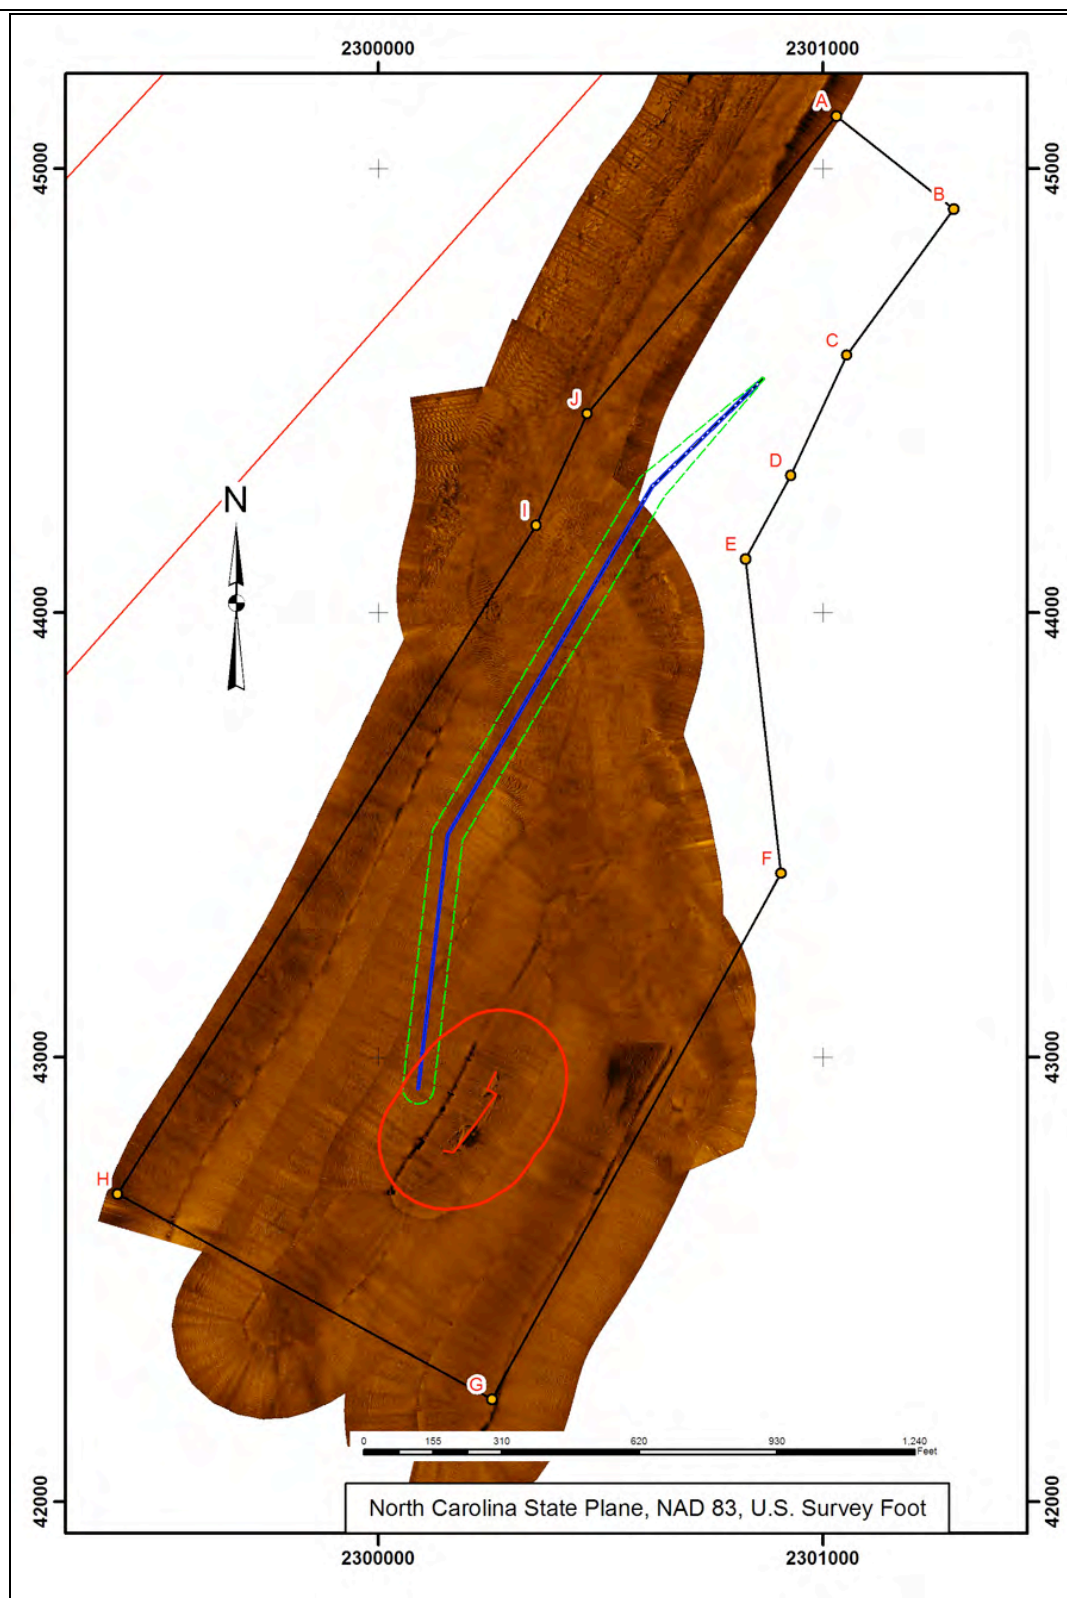
Figure 14. Wreck location with 150-foot buffer on the original groin location.
