**APPENDIX B
ENGINEERING REPORT**

Inlet-Related Shoreline Changes: Rich Inlet, North Carolina

Update Through 2007

William J. Cleary

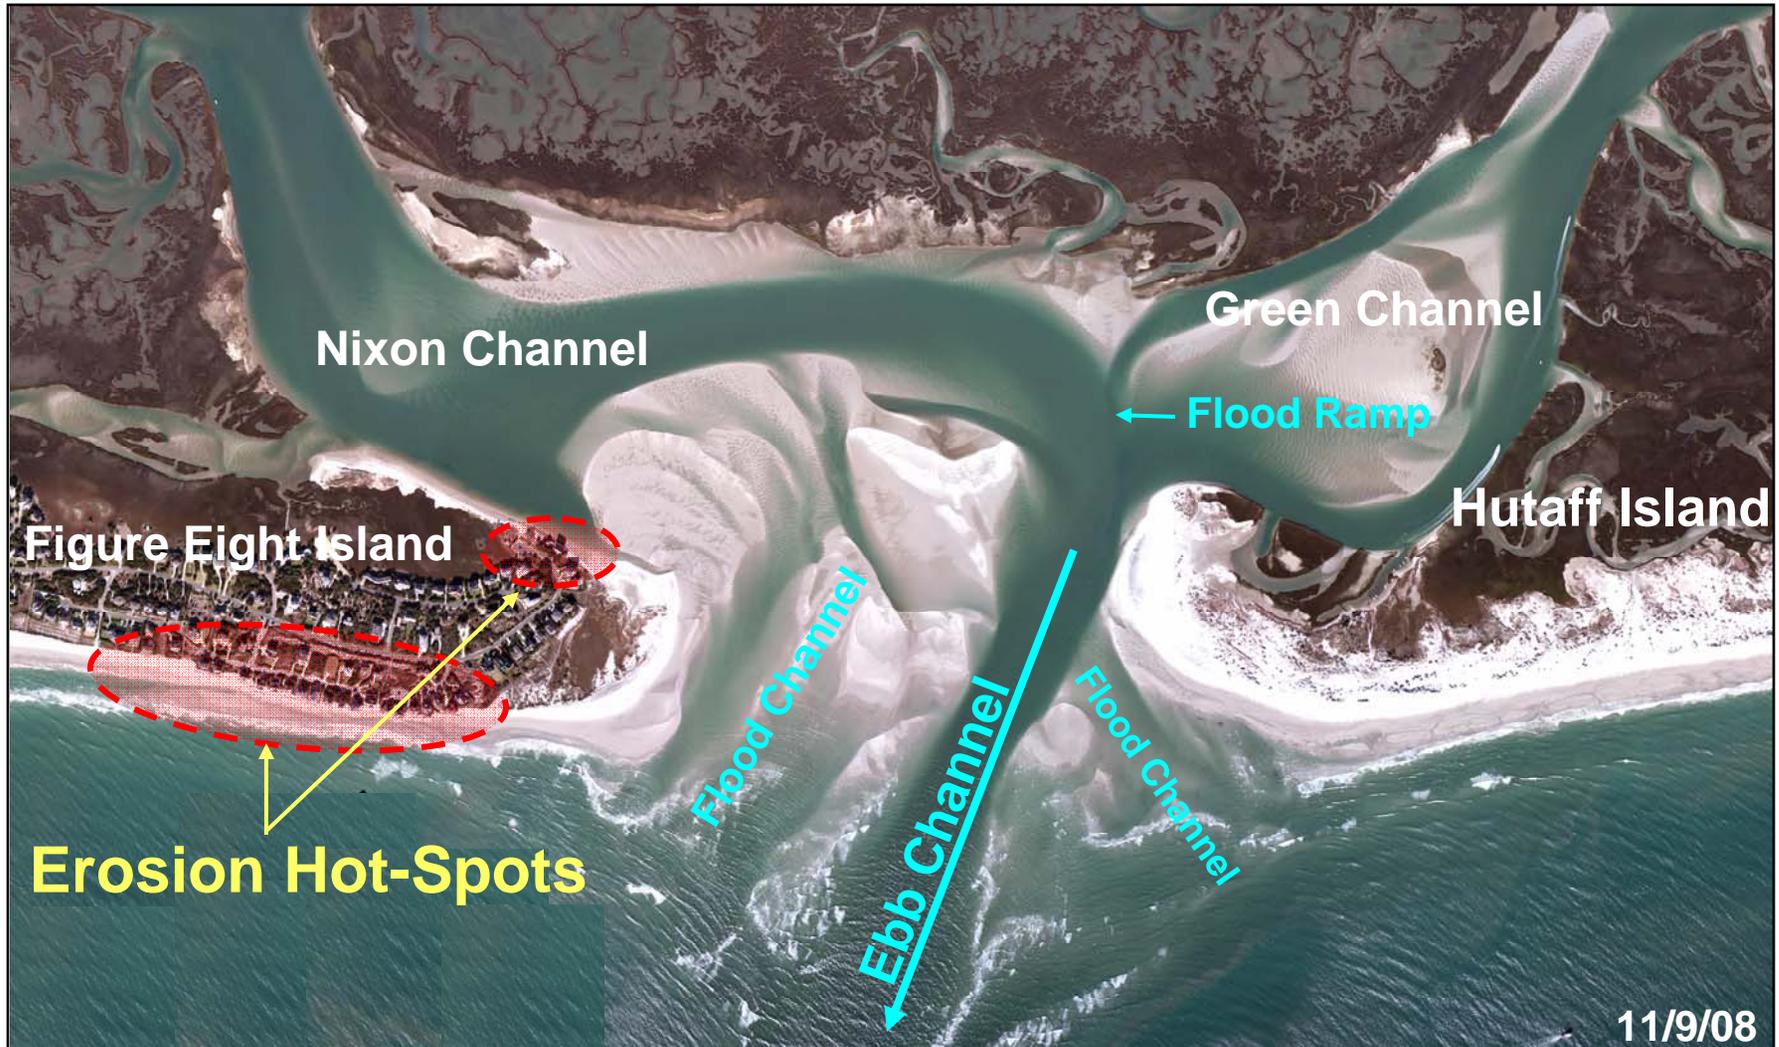
Figure 1. Aerial photograph of Rich Inlet, Figure Eight Island and Hutaff Island depicting conditions as of 11/9/08. Note the expansive marginal flood channel located on the F8I margin that acts as a corridor for the transport of large volumes of sand into the estuary and interior channels. Also note the developing spit along the F8I inlet shoreline. Photograph courtesy of GBA- Wilmington, NC.

In May 2006 a study was authorized by the Figure Eight Beach Homeowners Association, Inc. (F8BHA) to conduct a geomorphic analysis of Rich Inlet and its adjacent oceanfront and estuarine shorelines (Fig.1). The need for the investigation stemmed from a request to update existing data pertaining to the morphological history of Rich Inlet and the historic oceanfront shoreline changes (1938-2007) along 10,000 ft of Figure Eight and Hutaff Islands, as well as the estuarine feeder channel (Green and Nixon Channels) shoreline changes. The primary focus of the investigation was to provide a robust data set that could be utilized to develop a predictive relationship between inlet conditions (primarily bar channel location and orientation) and the response of the oceanfront and interior shorelines (Fig. 1). Data from this study was used in conjunction with engineering oriented investigations to better plan activities associated with the proposed ebb channel realignment effort by CPE.

Contemporary changes in the inlet, along the adjacent oceanfront and interior channel shorelines (Fig. 1), were determined through an analysis of a series of representative historic aerial photographs that date from 1938. Thirty sets of photographs were initially examined for trends; and on the basis of these observations, 10 sets of aerial photographs covering a large spatial and temporal scale (1938–2007) of Rich Inlet, adjacent Figure Eight Island and Hutaff Island were scanned to yield a resolution of 2 ft/pixel or higher. Subsequently, the images were georectified and features were digitized using ArcGIS v.9.2. Ground control points (GCPs) were selected from 1998 digital orthophotos obtained from the North Carolina Division of Coastal Management. A minimum of 15 control points for each 9”x 9” frame were used in the rectification process. The wet/dry line (shoreline), ebb delta, and ebb channel(s) of each newly produced orthophoto were digitized and projected to a common projection of North Carolina State Plane, NAD 83 datum, feet units, and GRS1980 spheroid as ArcView shapefiles.

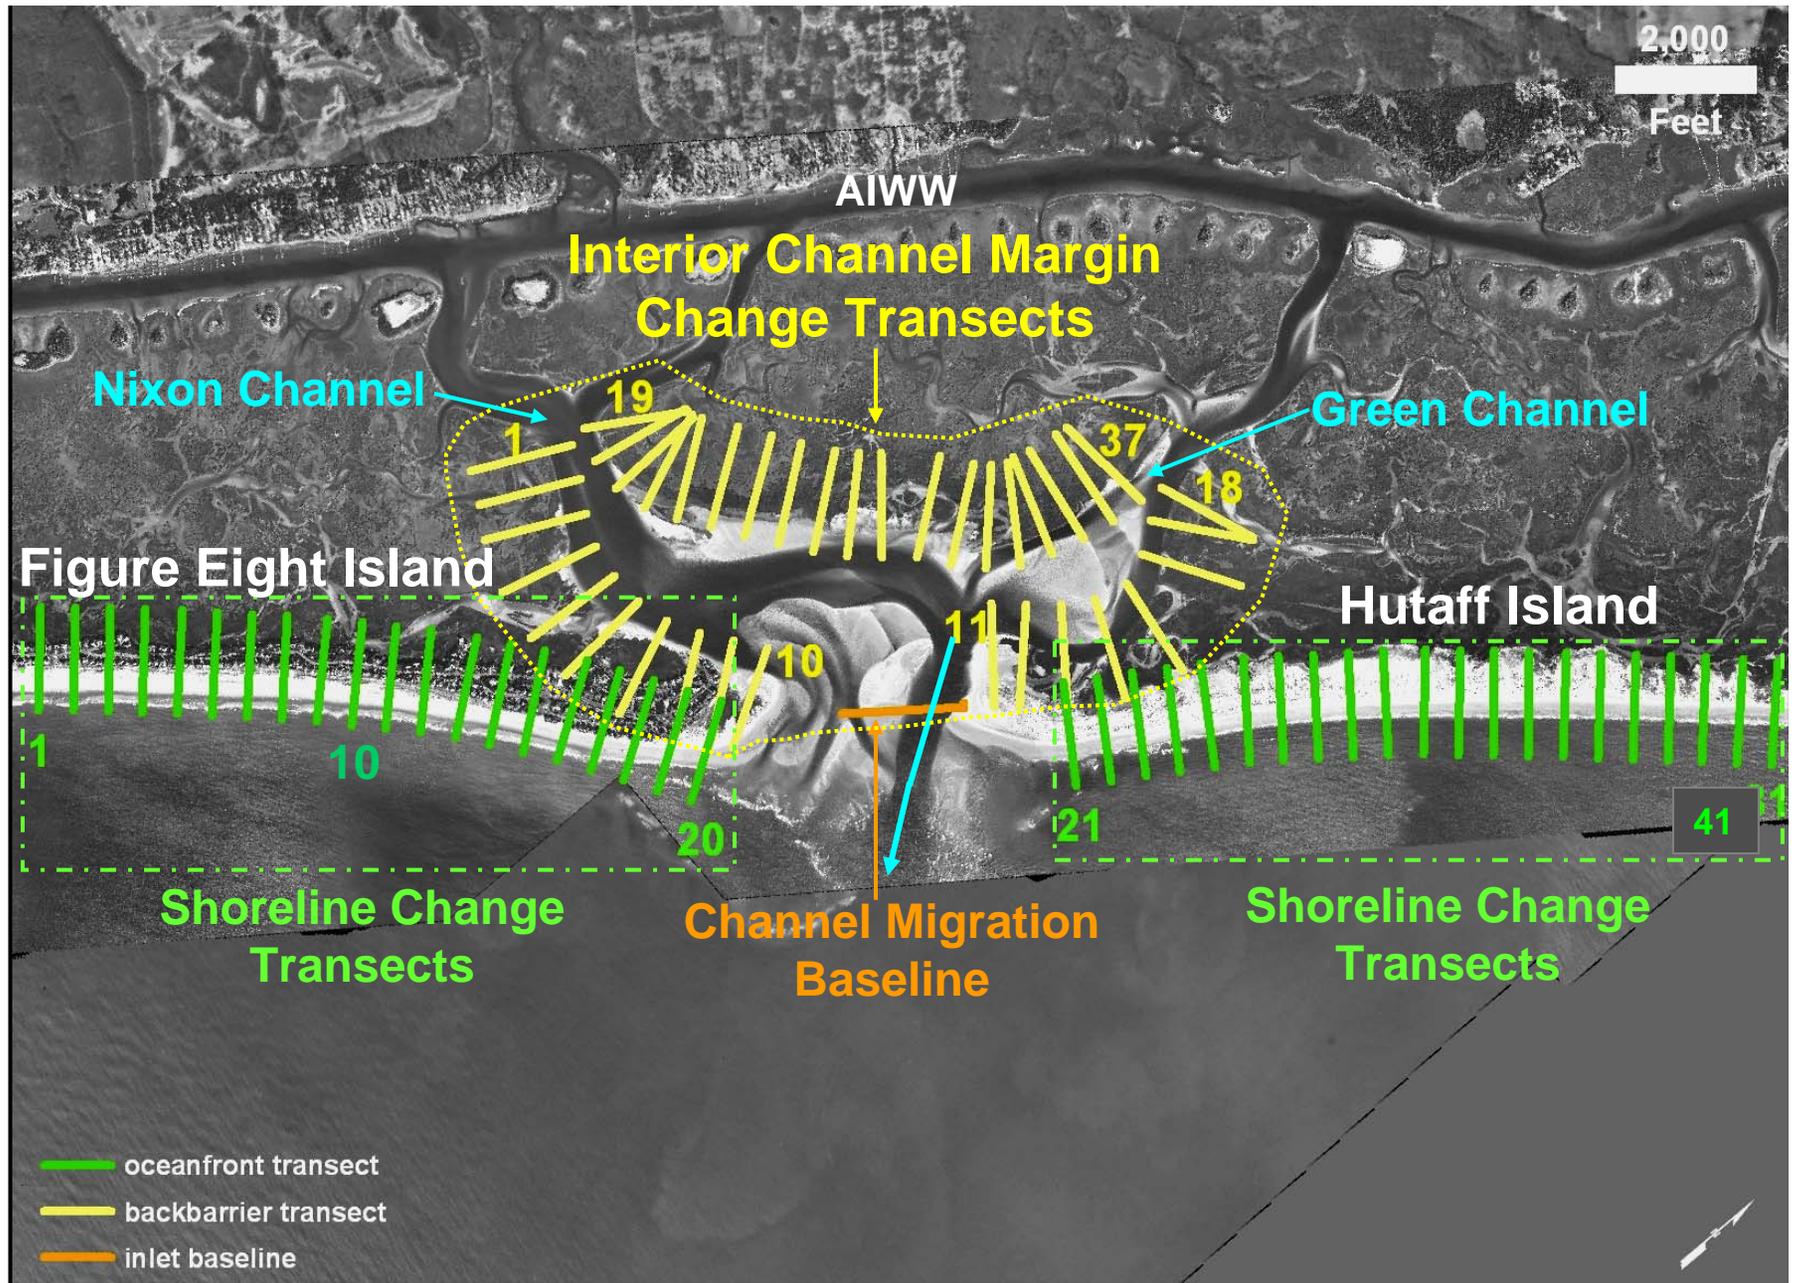
Figure 2. Aerial mosaic (2006) depicting the ebb channel baseline position and the estuarine and oceanfront shoreline transect locations.

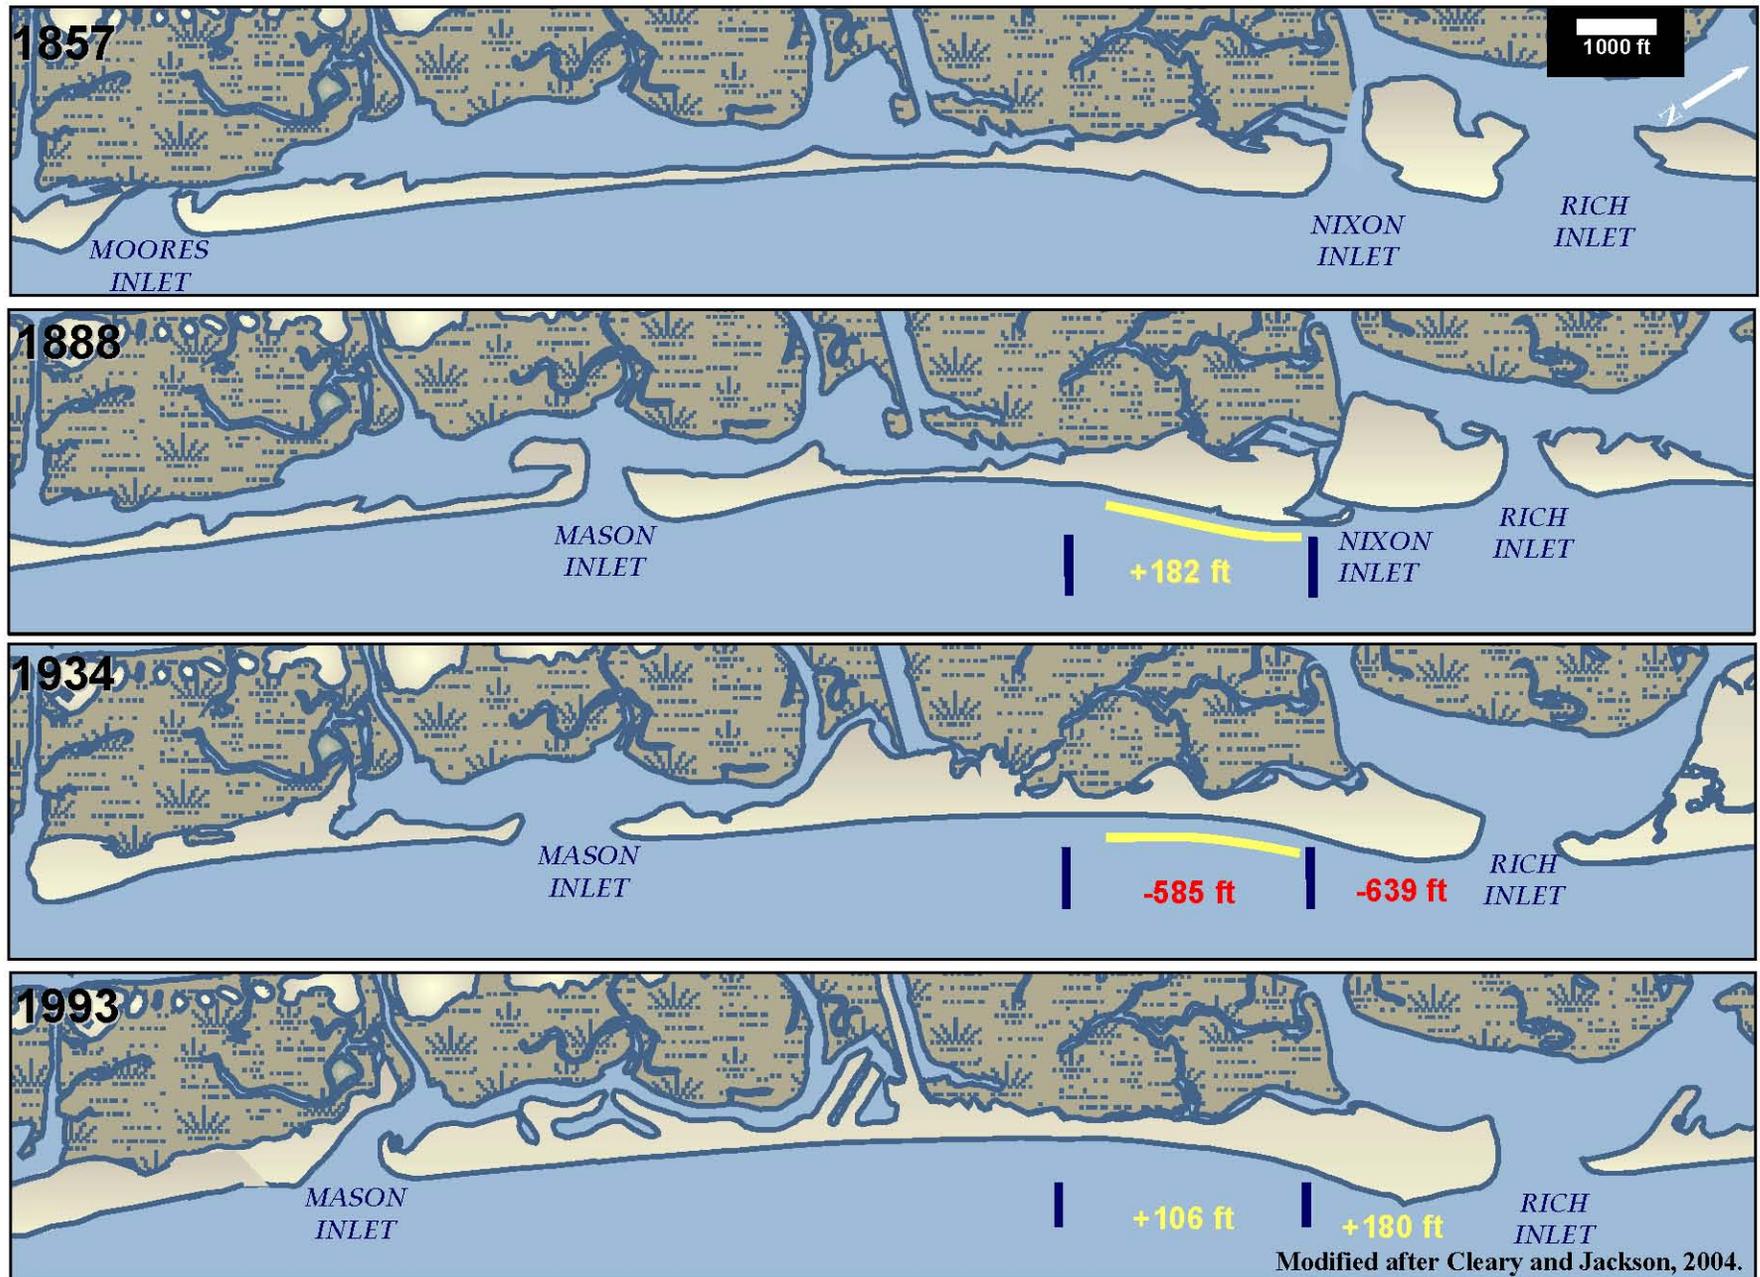
Figure 3. Cartoon based on historic maps and a 1993 aerial photograph depicting position of historic Nixon Inlet along the northern portion of F8I. Note the large bulbous shape of the shoreline (yellow line) with the northward extending spit imaged on the 1888 map. By 1934 the incorporated shoreline segment eroded an average of 585 ft while the shoreline reach nearest the inlet eroded an average of 639 ft since inlet closure. Since 1934 the two reaches have prograded an average than ranged from 106 to 180 ft.

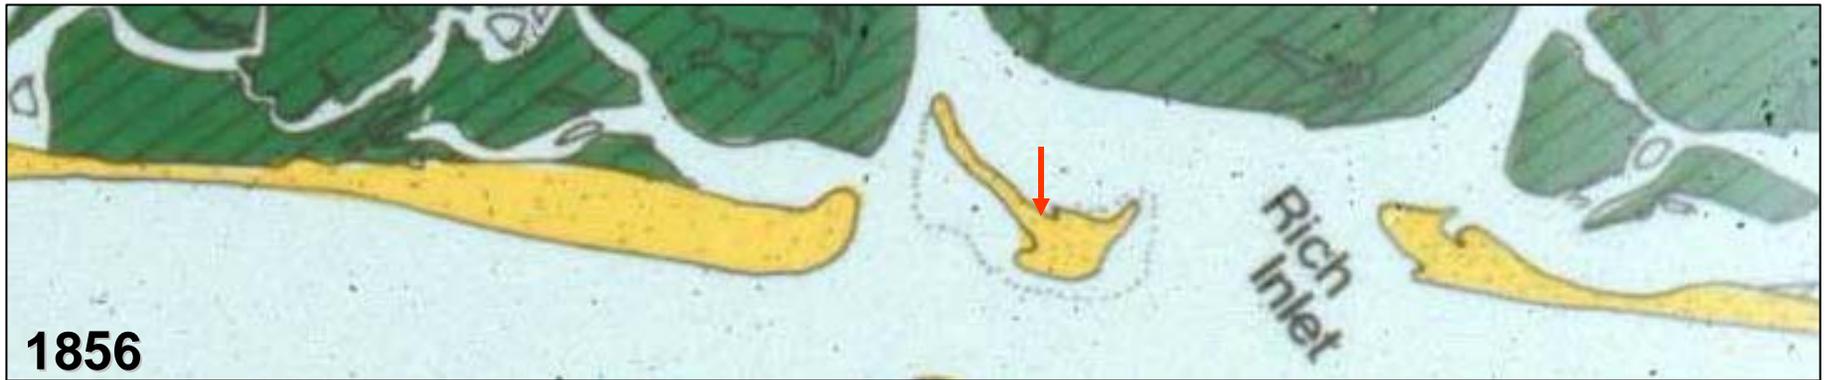
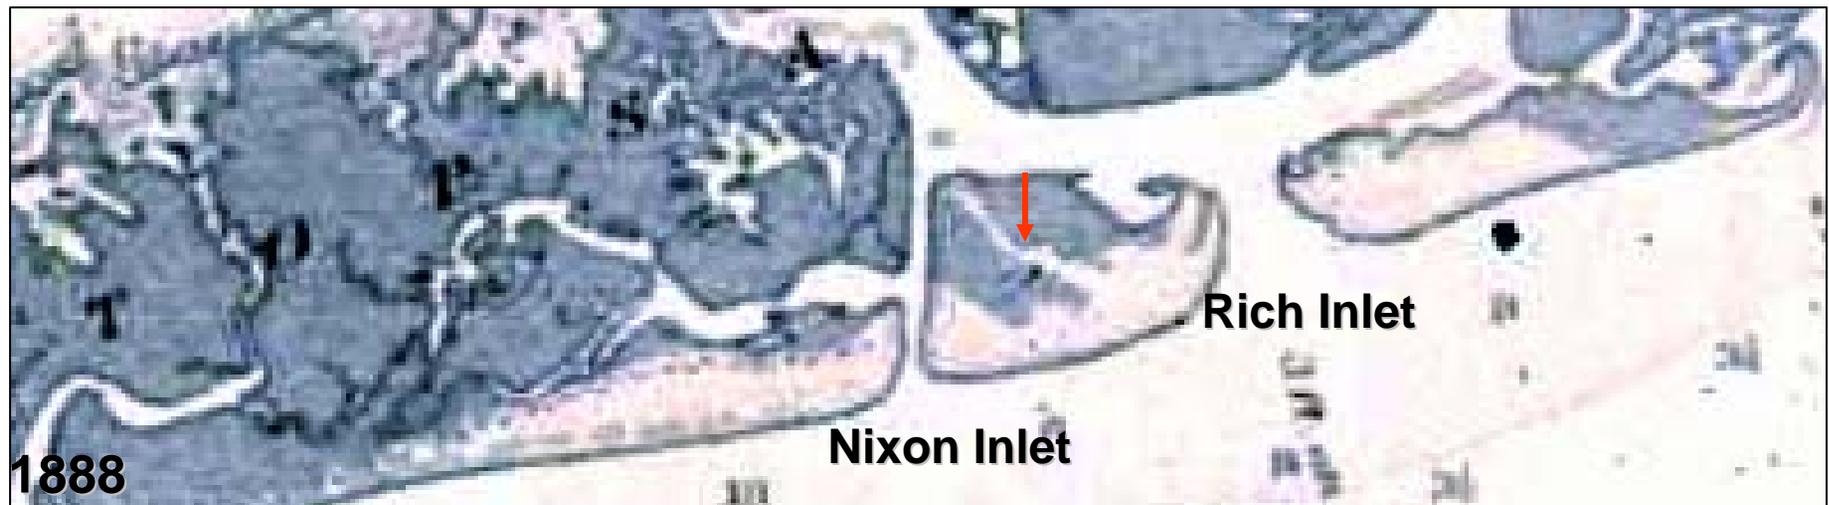
Figure 4. Cartoon depicting position of historic Nixon and Rich inlets along the northern portion of F8I in 1856 and 1888. Arrows delineate morphologic features imaged on an 1938 aerial photograph.

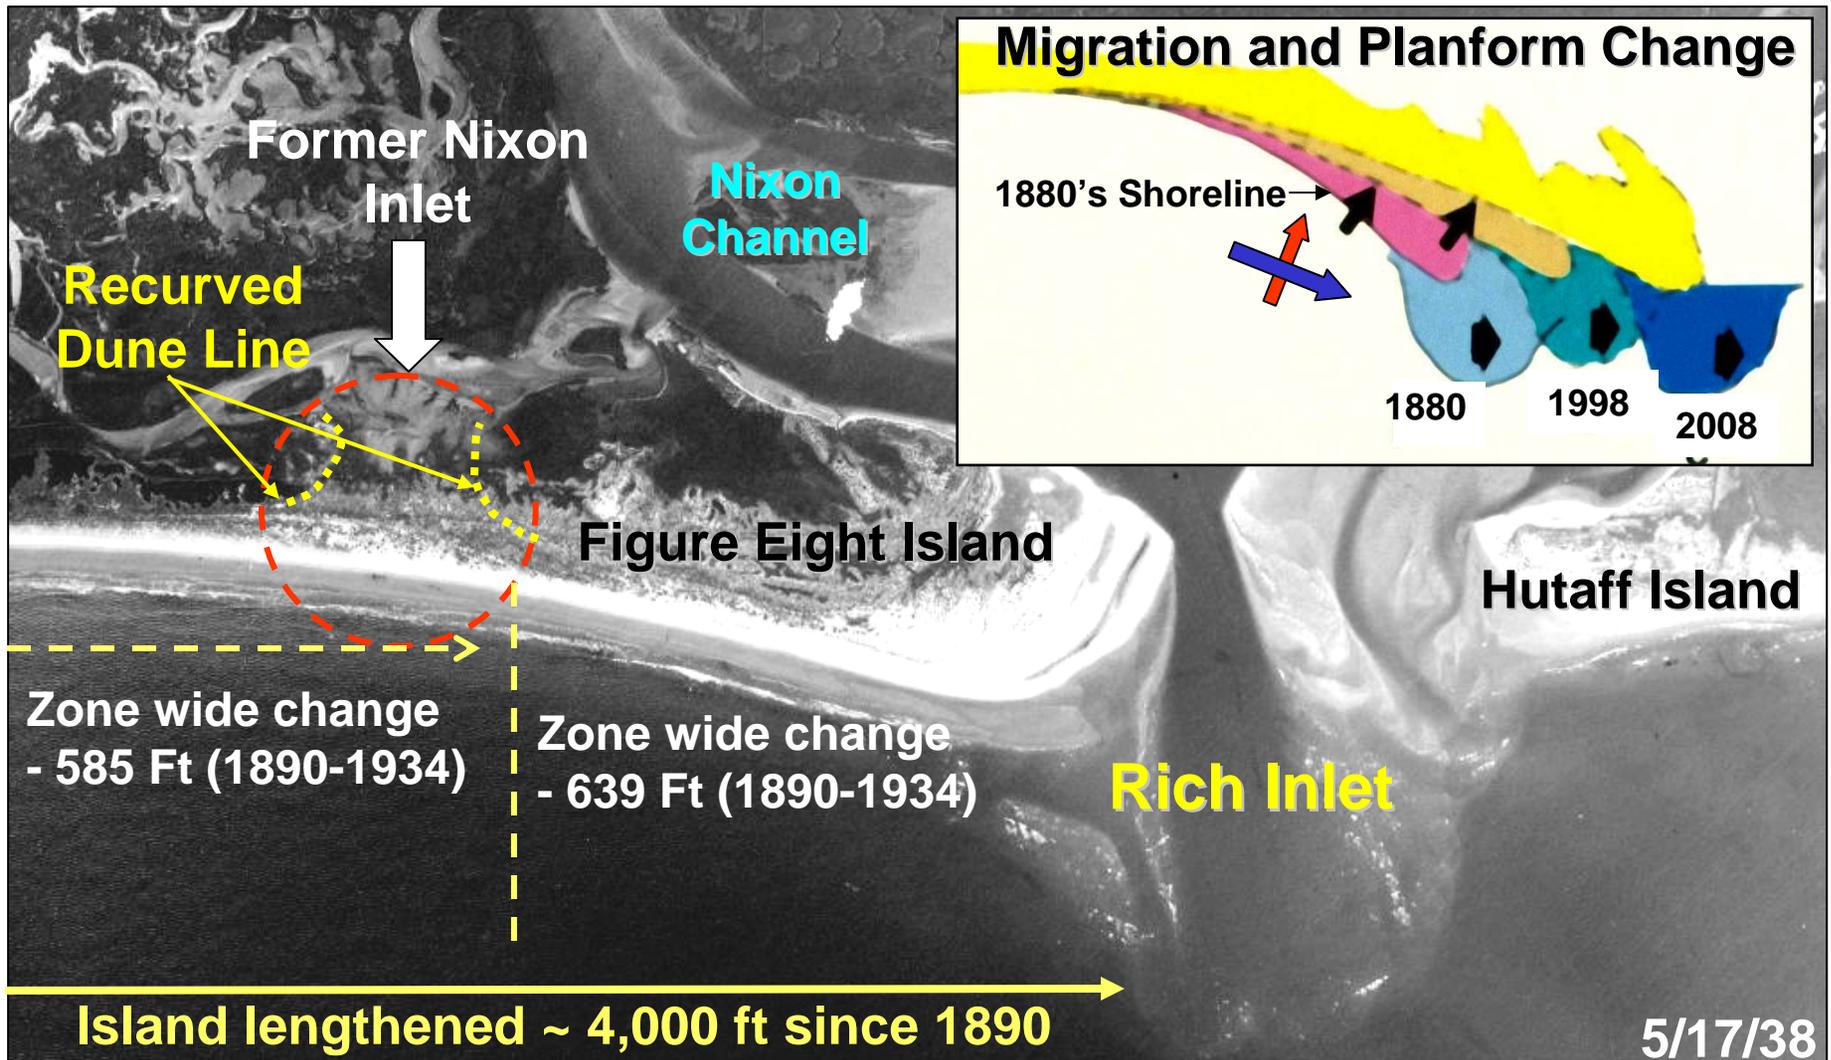
Figure 5. Historic aerial photograph (1938) depicting the historic late 19th C. position of Nixon Inlet and the inlet shoreline features. Insert depicts shoreline planform changes that occurred subsequent to the closure of Nixon Inlet and the attendant lengthening of F8I. Shoreline erosion along the northern portion of the island averaged 585 to 639 ft. See Figure 4 for morphologic features preserved and identified on 1938 photograph. Modified after Cleary and Jackson 2004.

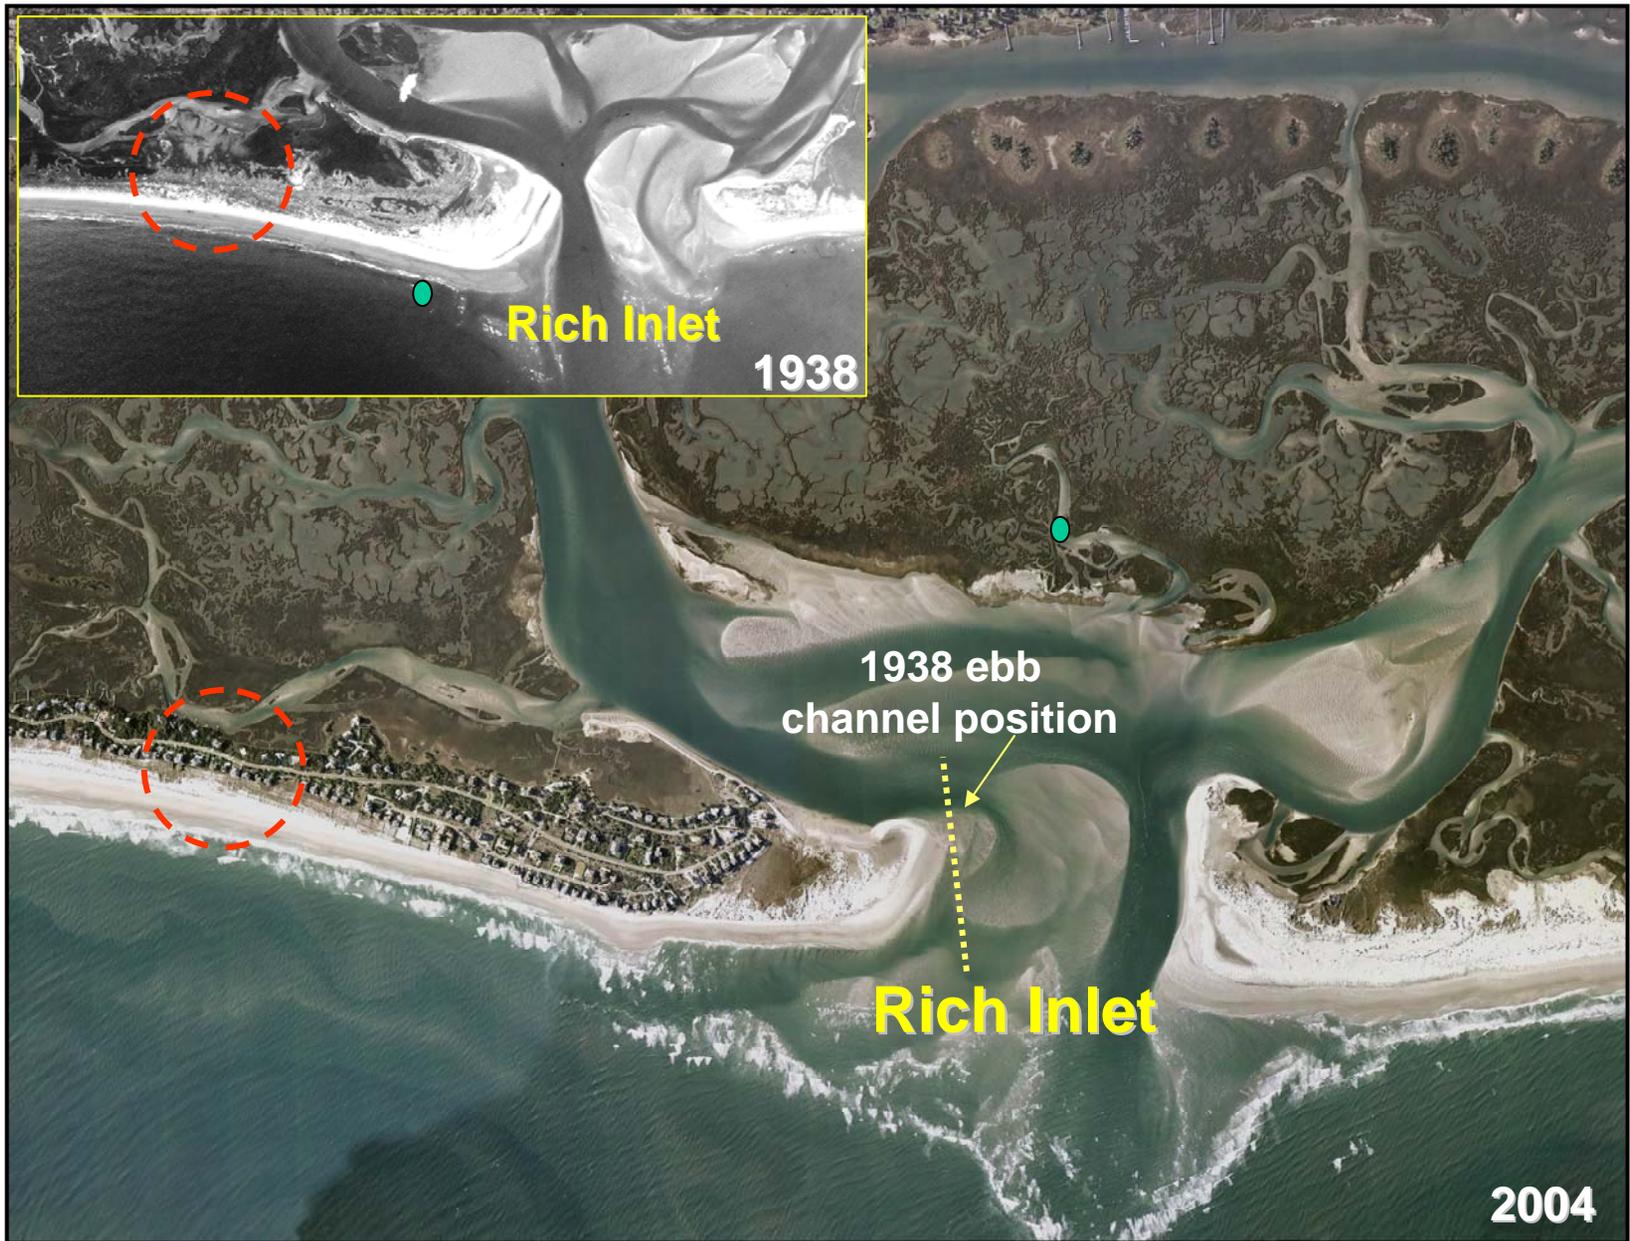
Figure 6. Recent aerial photograph (2004) depicting the location of historic Nixon Inlet and the shoreline conditions downdrift of Rich Inlet. Insert is a 1938 photograph of the area and the location of Nixon Inlet and the bulbous shape of the shoreline downdrift of Rich Inlet.

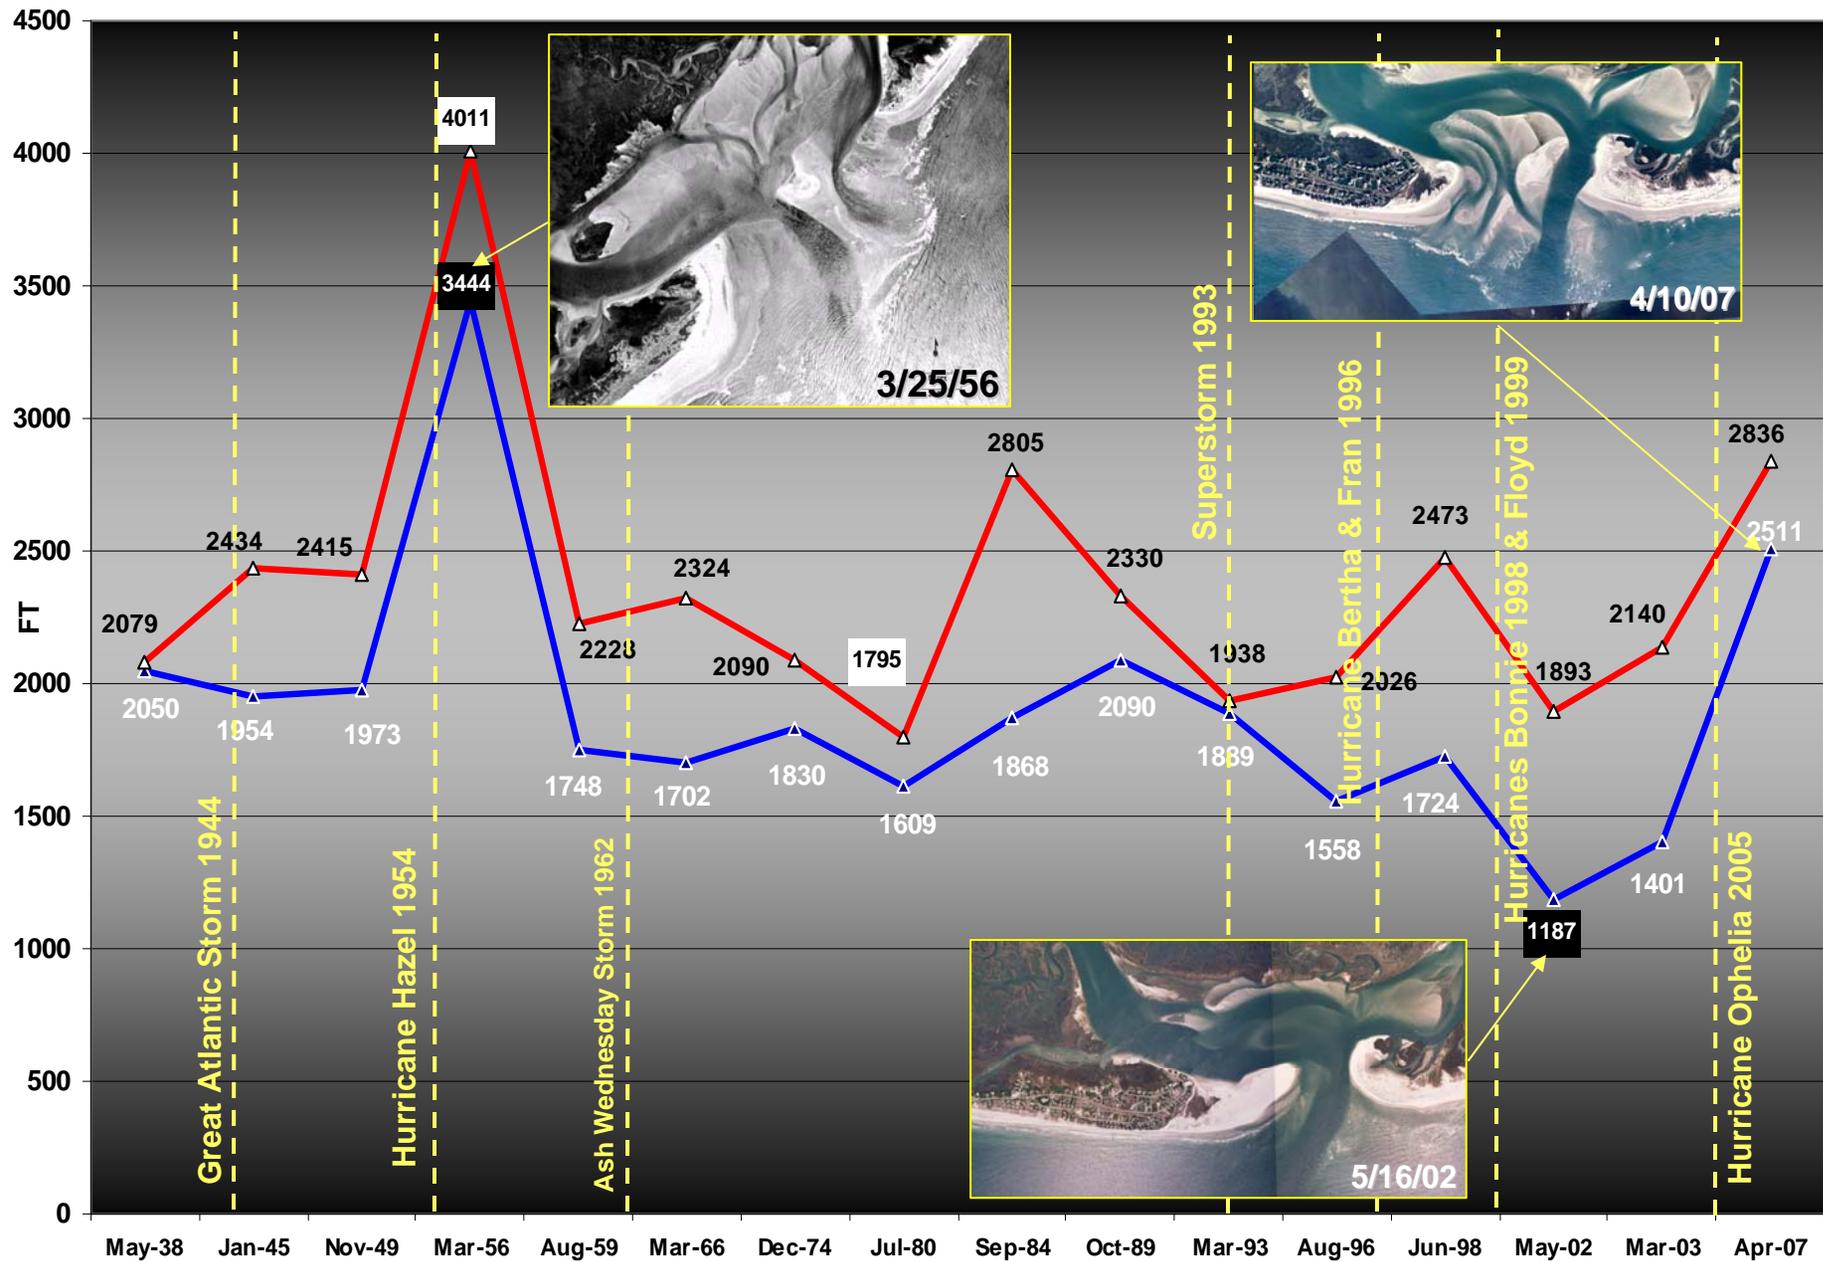
Figure 7. Line graphs depicting the inlet’s minimum width (IMW) and baseline width since 1938. See Figure 2 for location of inlet baseline. The inserts are historical aerial photographs that depict the current (2007) and minimum (2002) IMW as well as the storm-related widening of the inlet (3/25/56) due to Hurricane Hazel in October 1954.

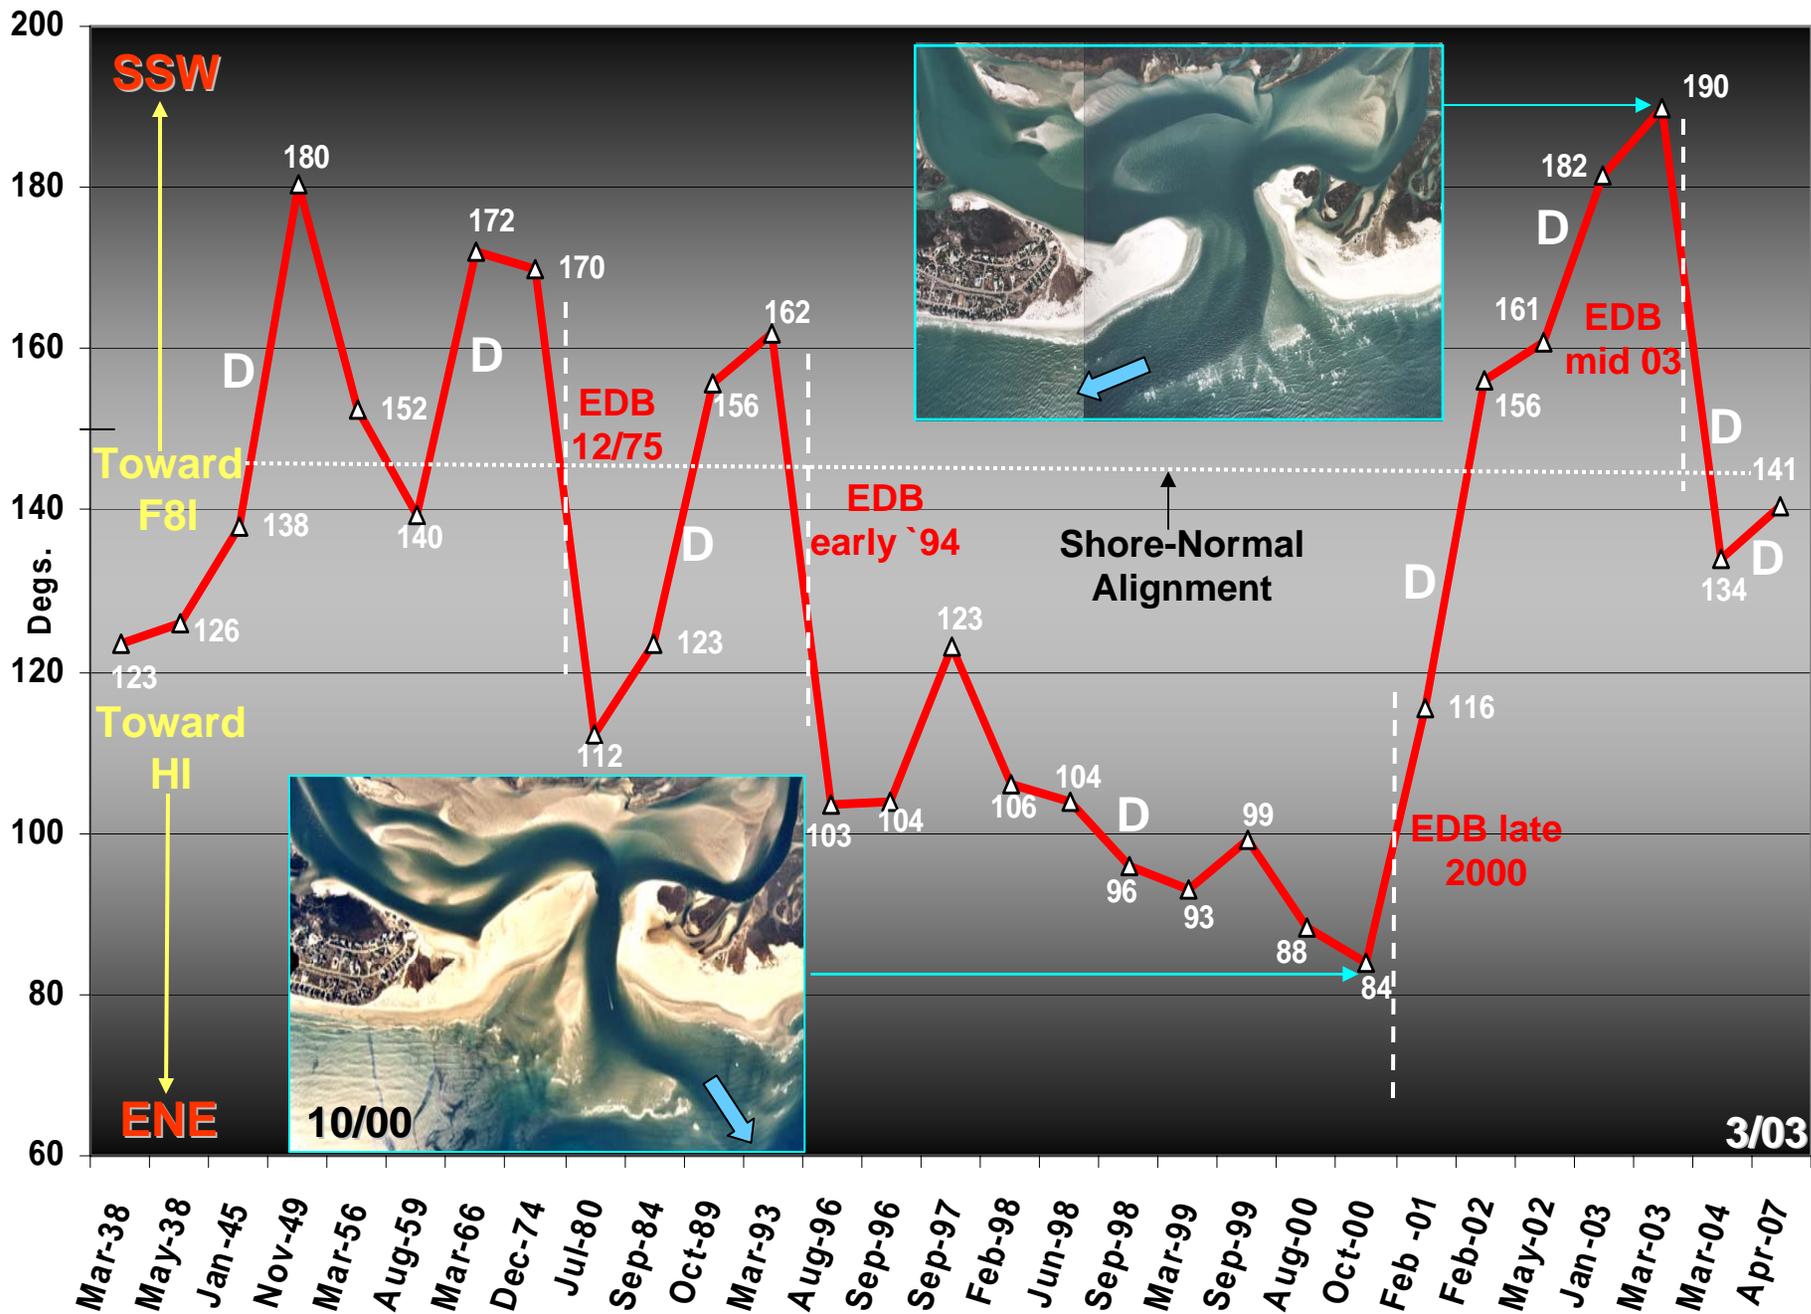
Figure 8. Line graph depicting the orientation (azimuth) of the outer portion of the ebb channel since 1938. The inserts are historical aerial photographs that depict the maximum (2003) and minimum (2000) azimuths of the ebb channel. Ebb delta breaching events that occurred between 1938 and 2007 are labeled “EDB” while channel deflection is labeled by a white colored “D”.

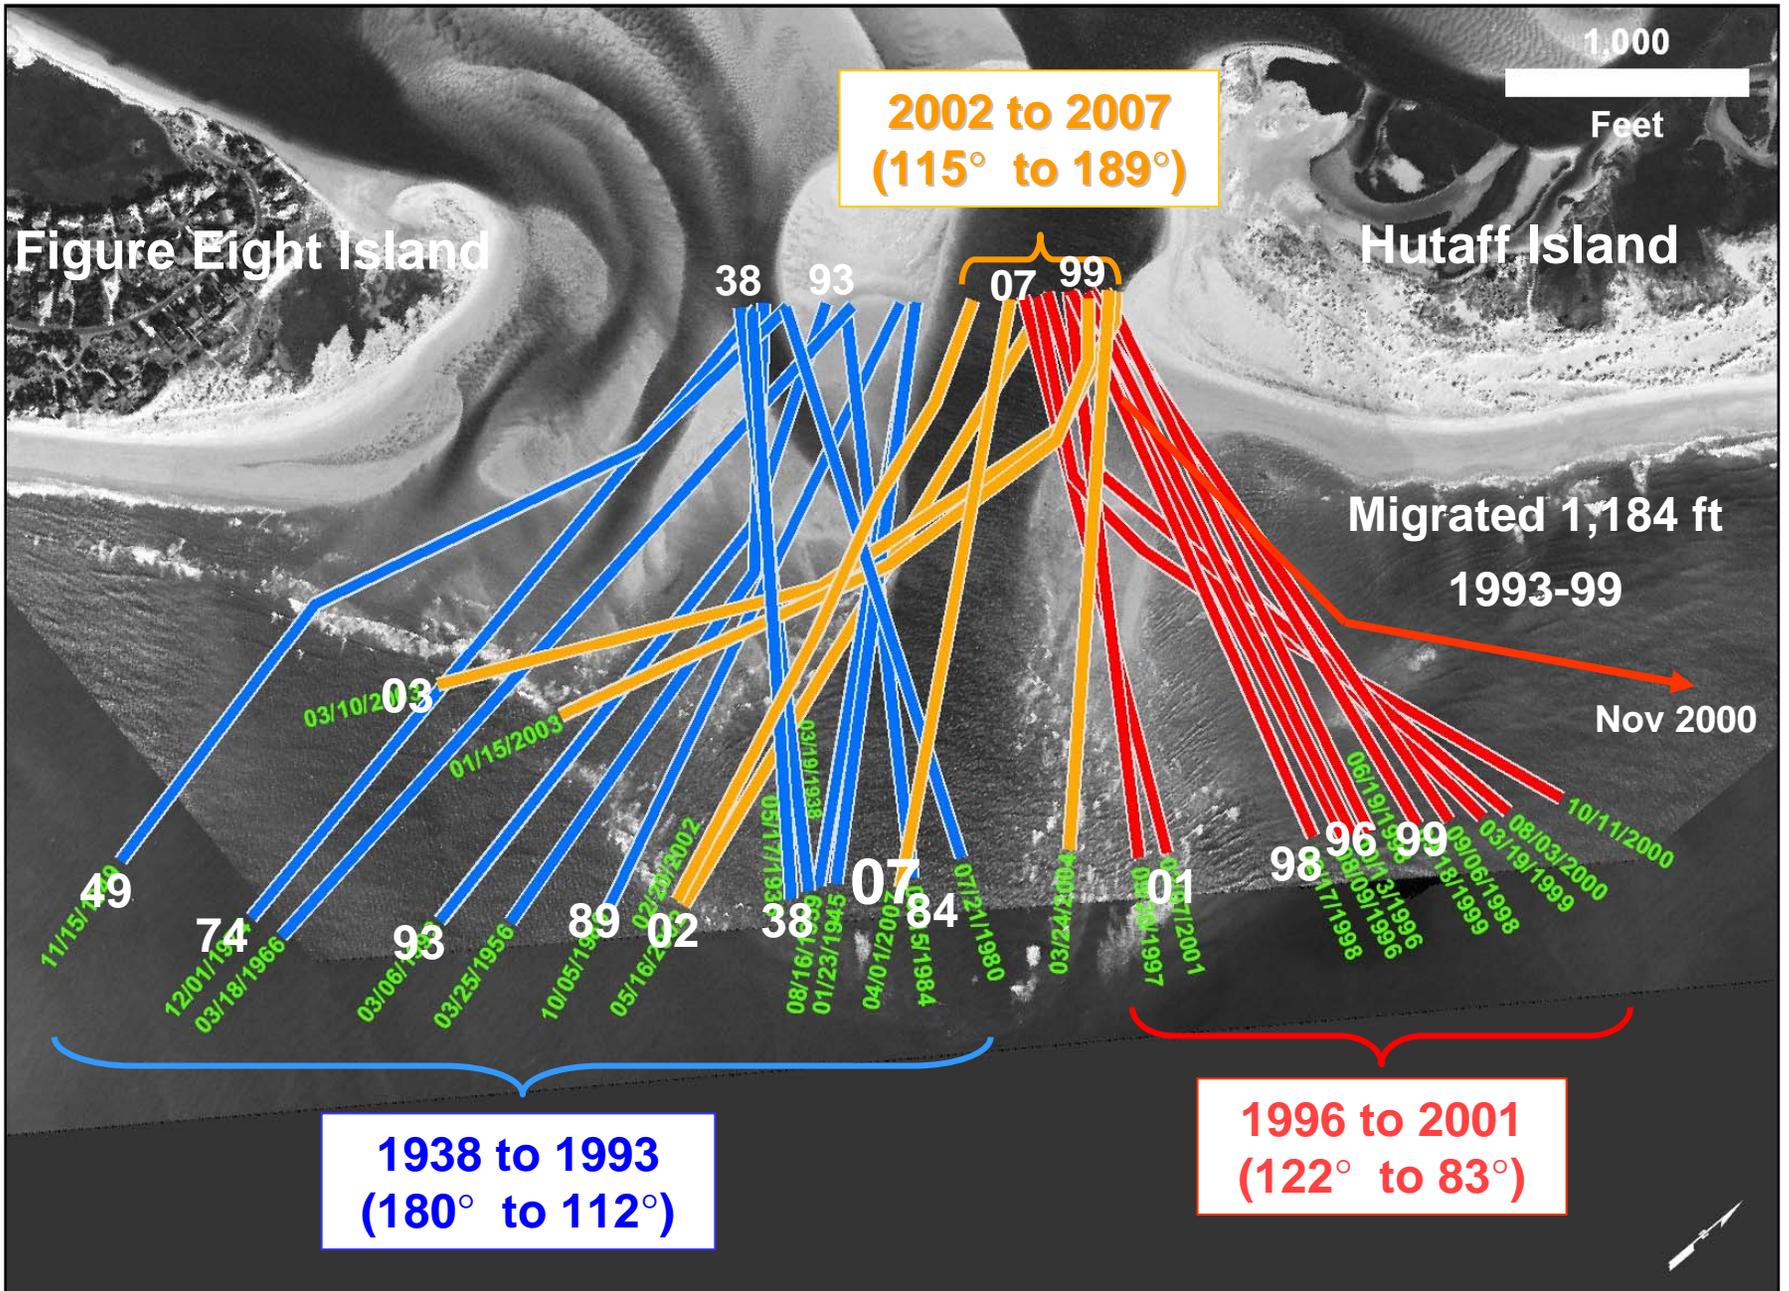
Figure 9. Aerial photograph mosaic (2006) depicting position of the ebb channel between 1938 and 2007. During the mid 1990s the ebb channel shifted to the NE ~1,184 ft and has remained in same general location. Note the changing alignment of outer portion of the ebb channel.

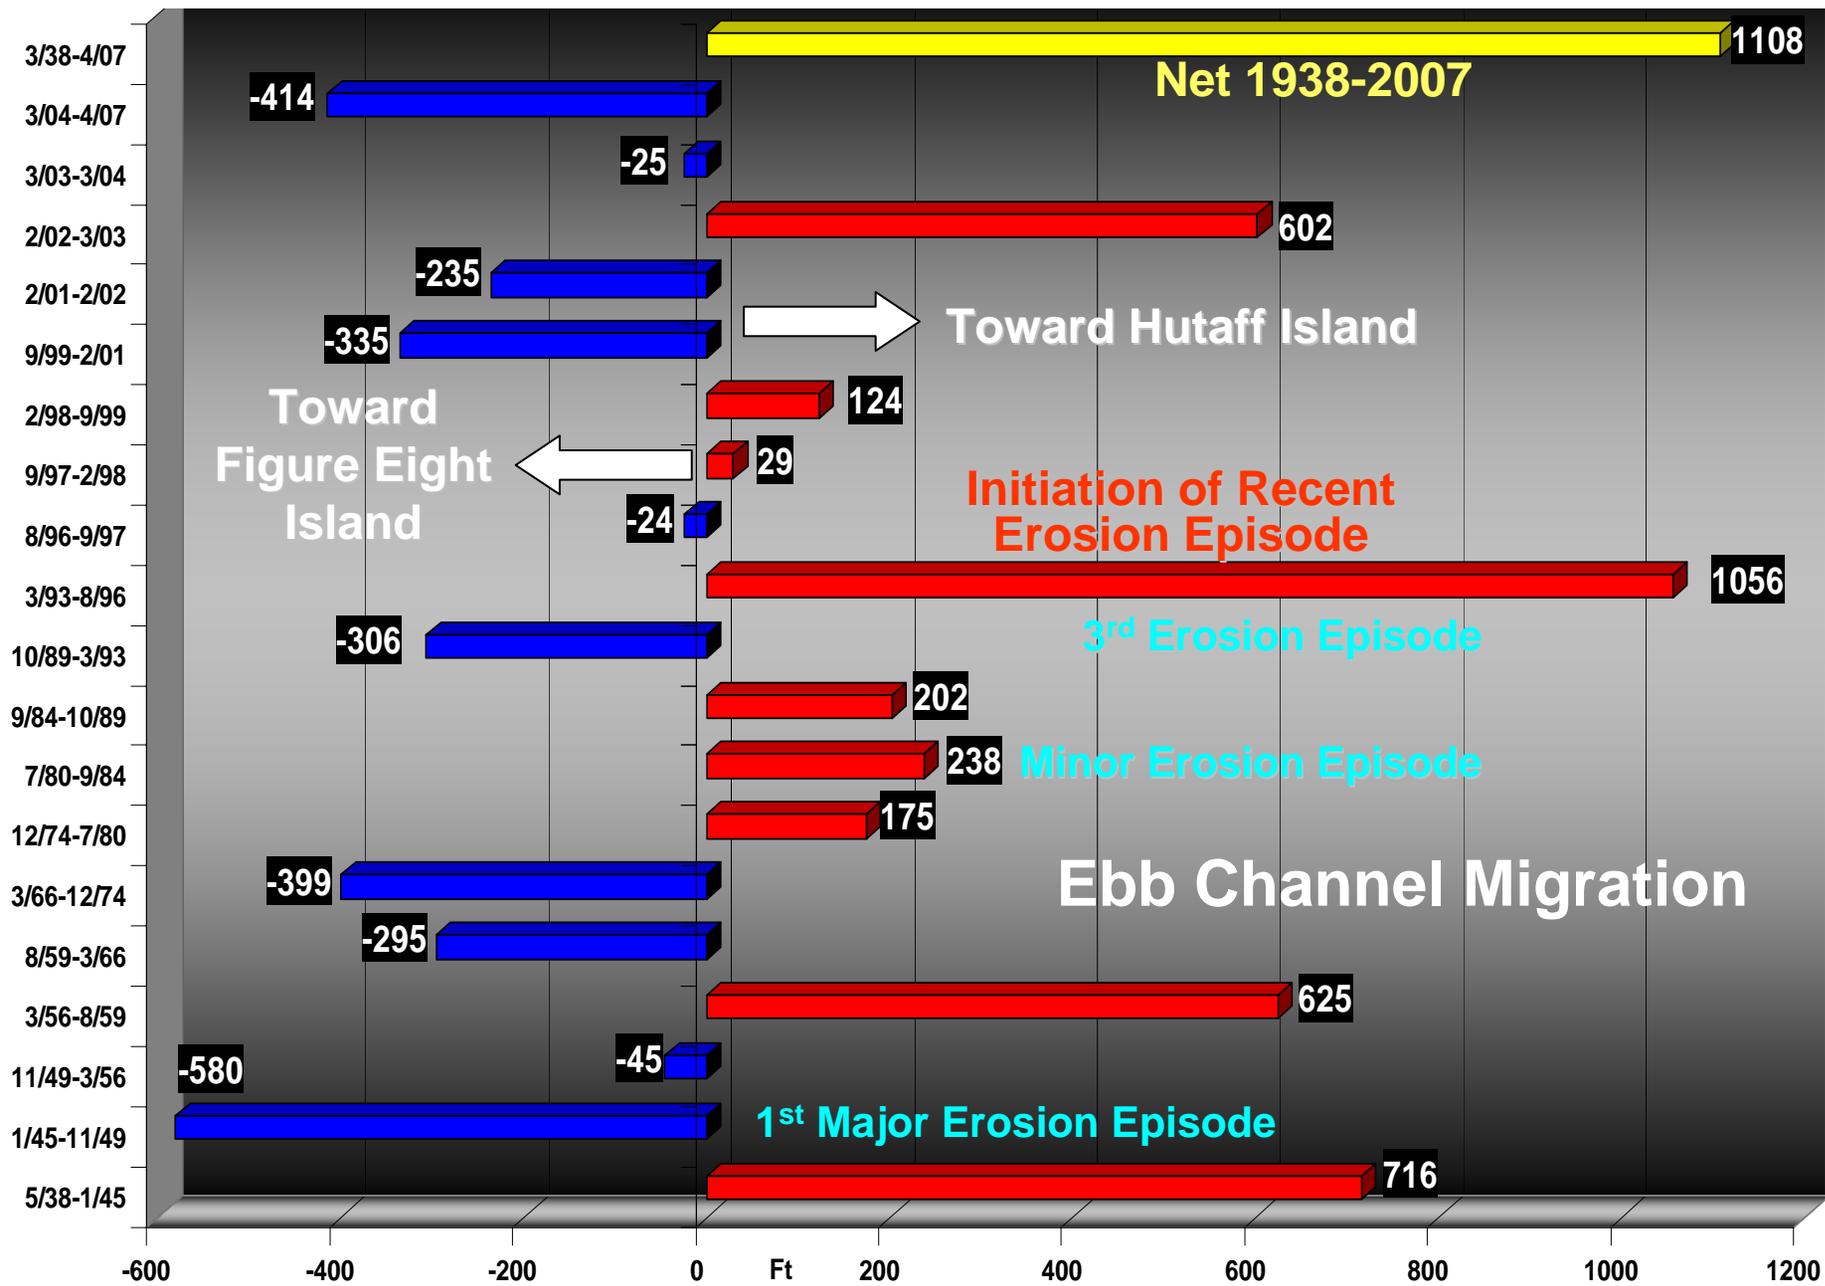
Figure 10. Bar graph depicting migration of Rich's Inlet ebb channel (throat segment) between March 1938 and April 2007.

early 1980s when development of the oceanfront began along the north end of the island (Fig. 10 H). The periodic deterioration and progradation of this shoreline segment is a result of a number of variables that act in concert to produce the complex erosion/accretion patterns. Several major erosion episodes of varying duration have occurred along the oceanfront in this area both prior to and subsequent to development. The mechanism that dictated the erosion was and is related to inlet process, but in each episode, the cause of the erosion, while related to Rich Inlet, was different. This section of the report describes each of the three erosion events and details the inlet-induced shoreline changes.
