**APPENDIX B
ENGINEERING REPORT**

Inlet-Related Shoreline Changes: Rich Inlet, North Carolina

Update Through 2007

William J. Cleary

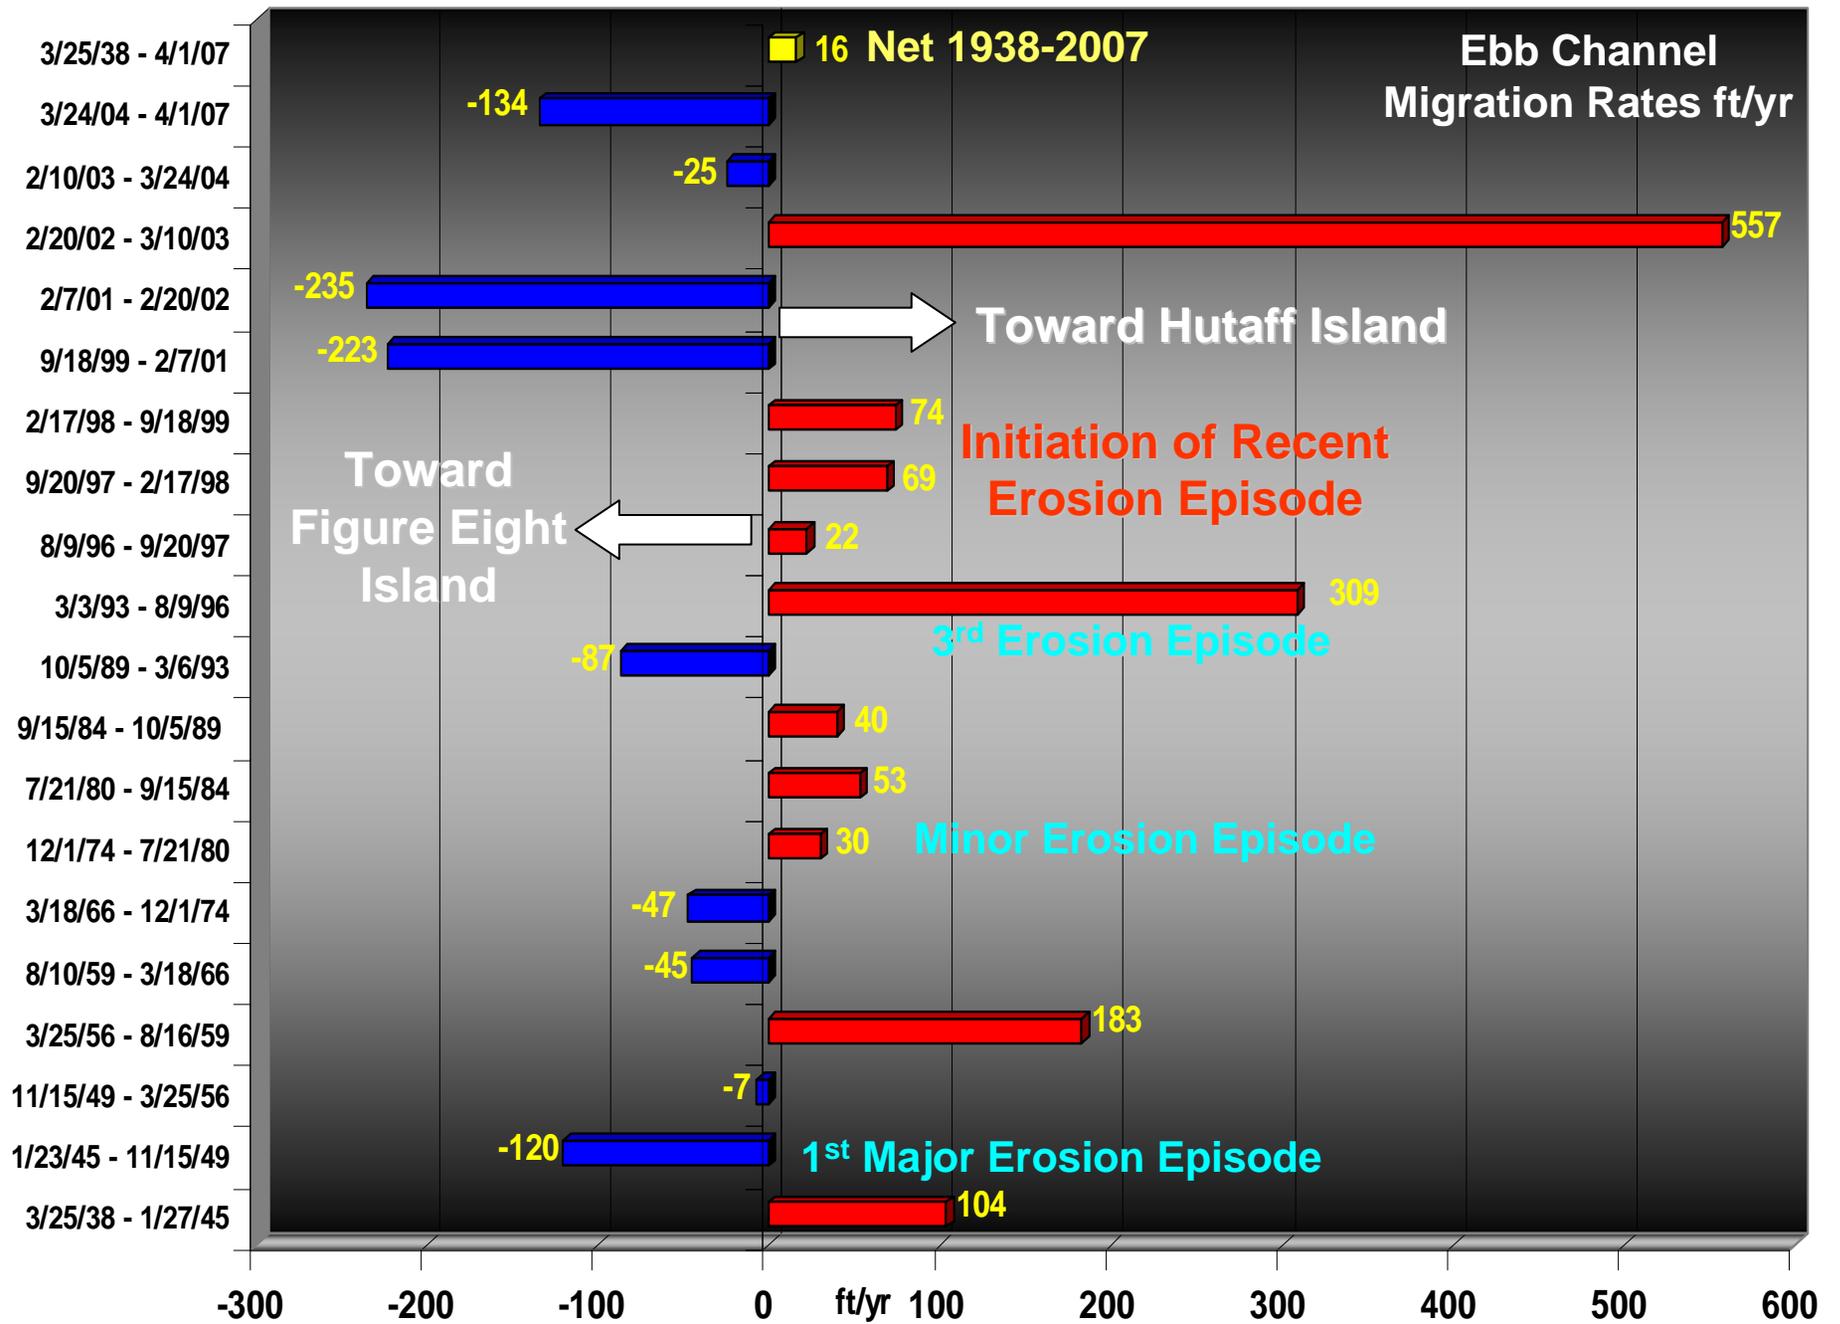
Figure 11. Graph depicting ebb channel migration rates for various time intervals between 1938 and 2007.

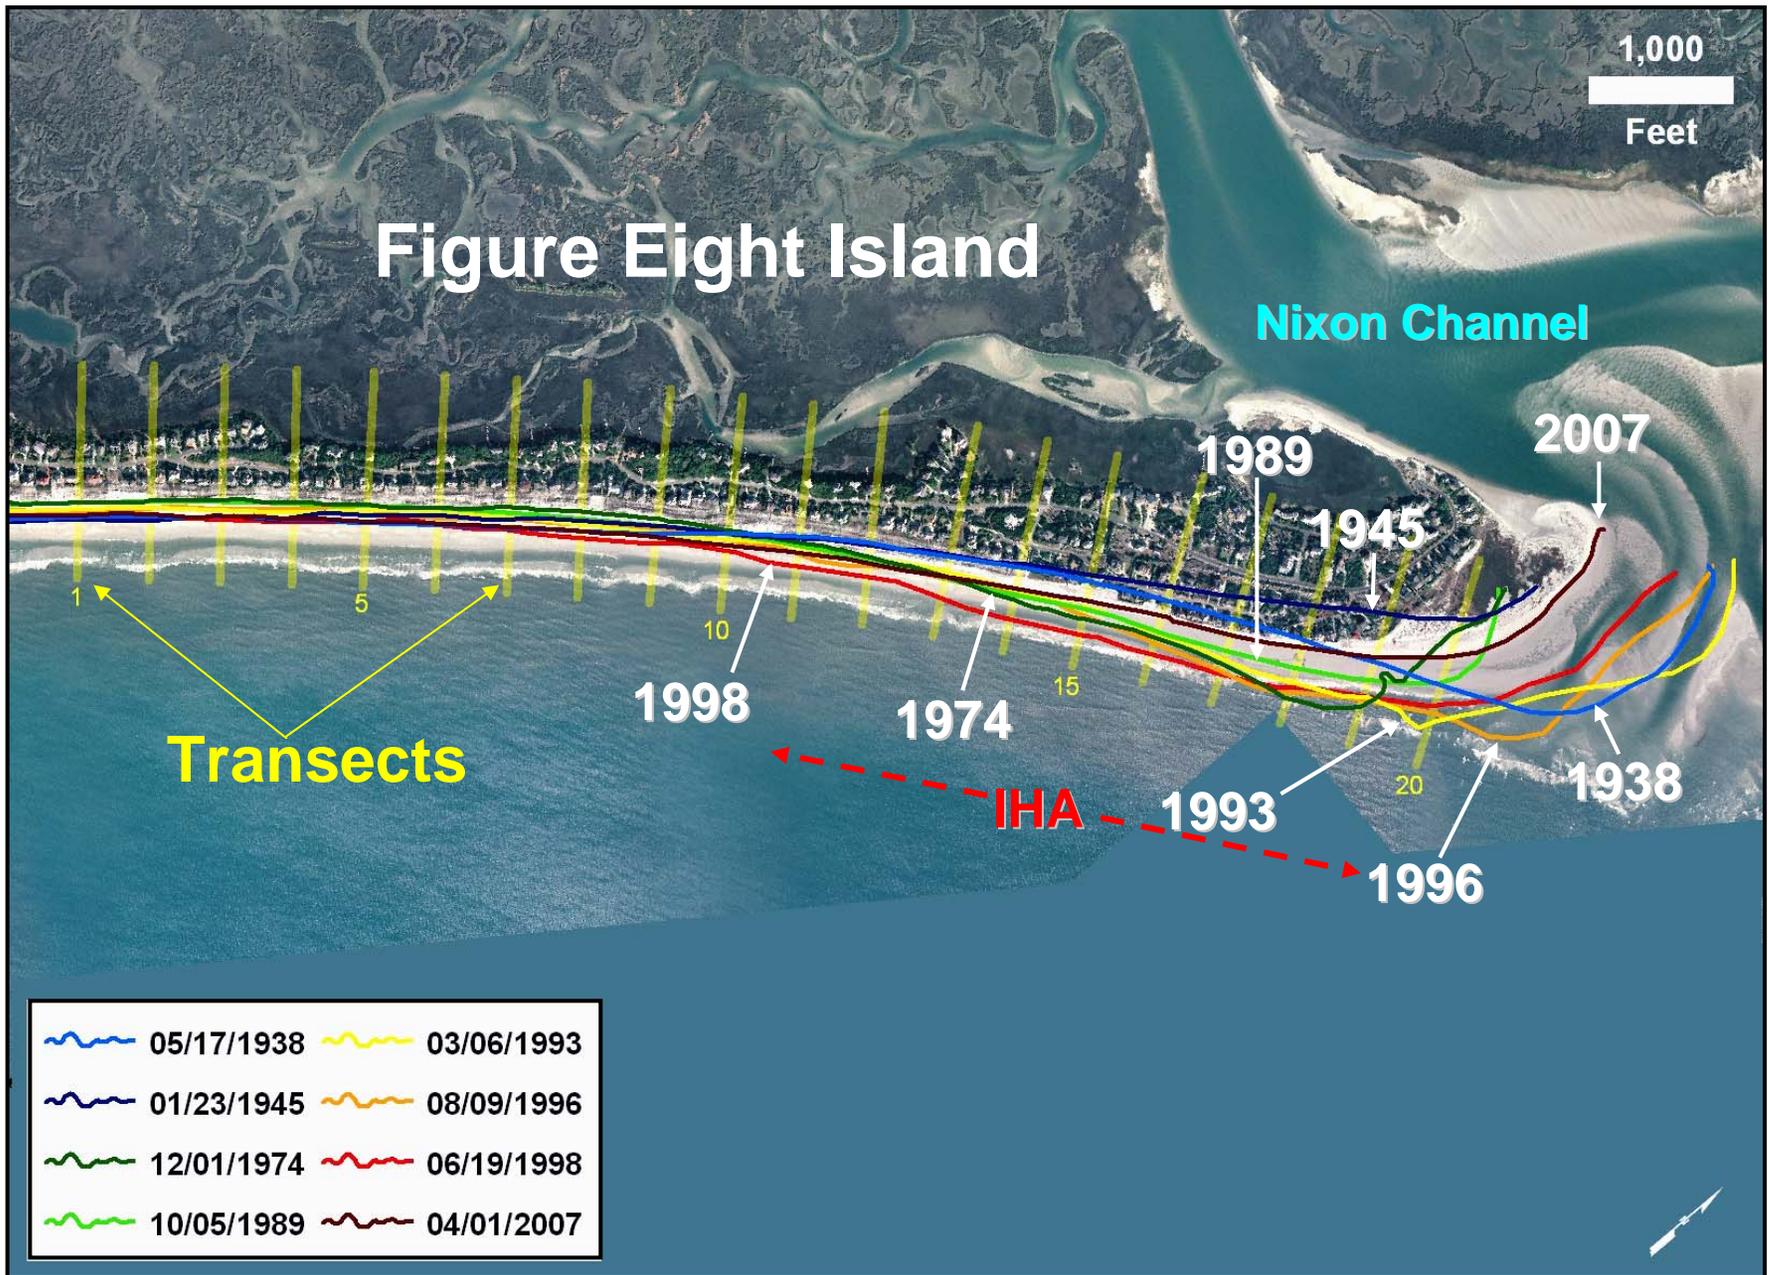
Figure 12. Aerial photograph (2007) depicting selected (8) shoreline positions along F8I since 1938 and transect locations (T1-20). The F8I Rich Inlet IHA includes the shoreline reach between Transects 11 and 20. Note that the 1945 shoreline position is the most landward positioned shoreline. Also note a significant number of homes lie seaward of the 1945 shoreline position

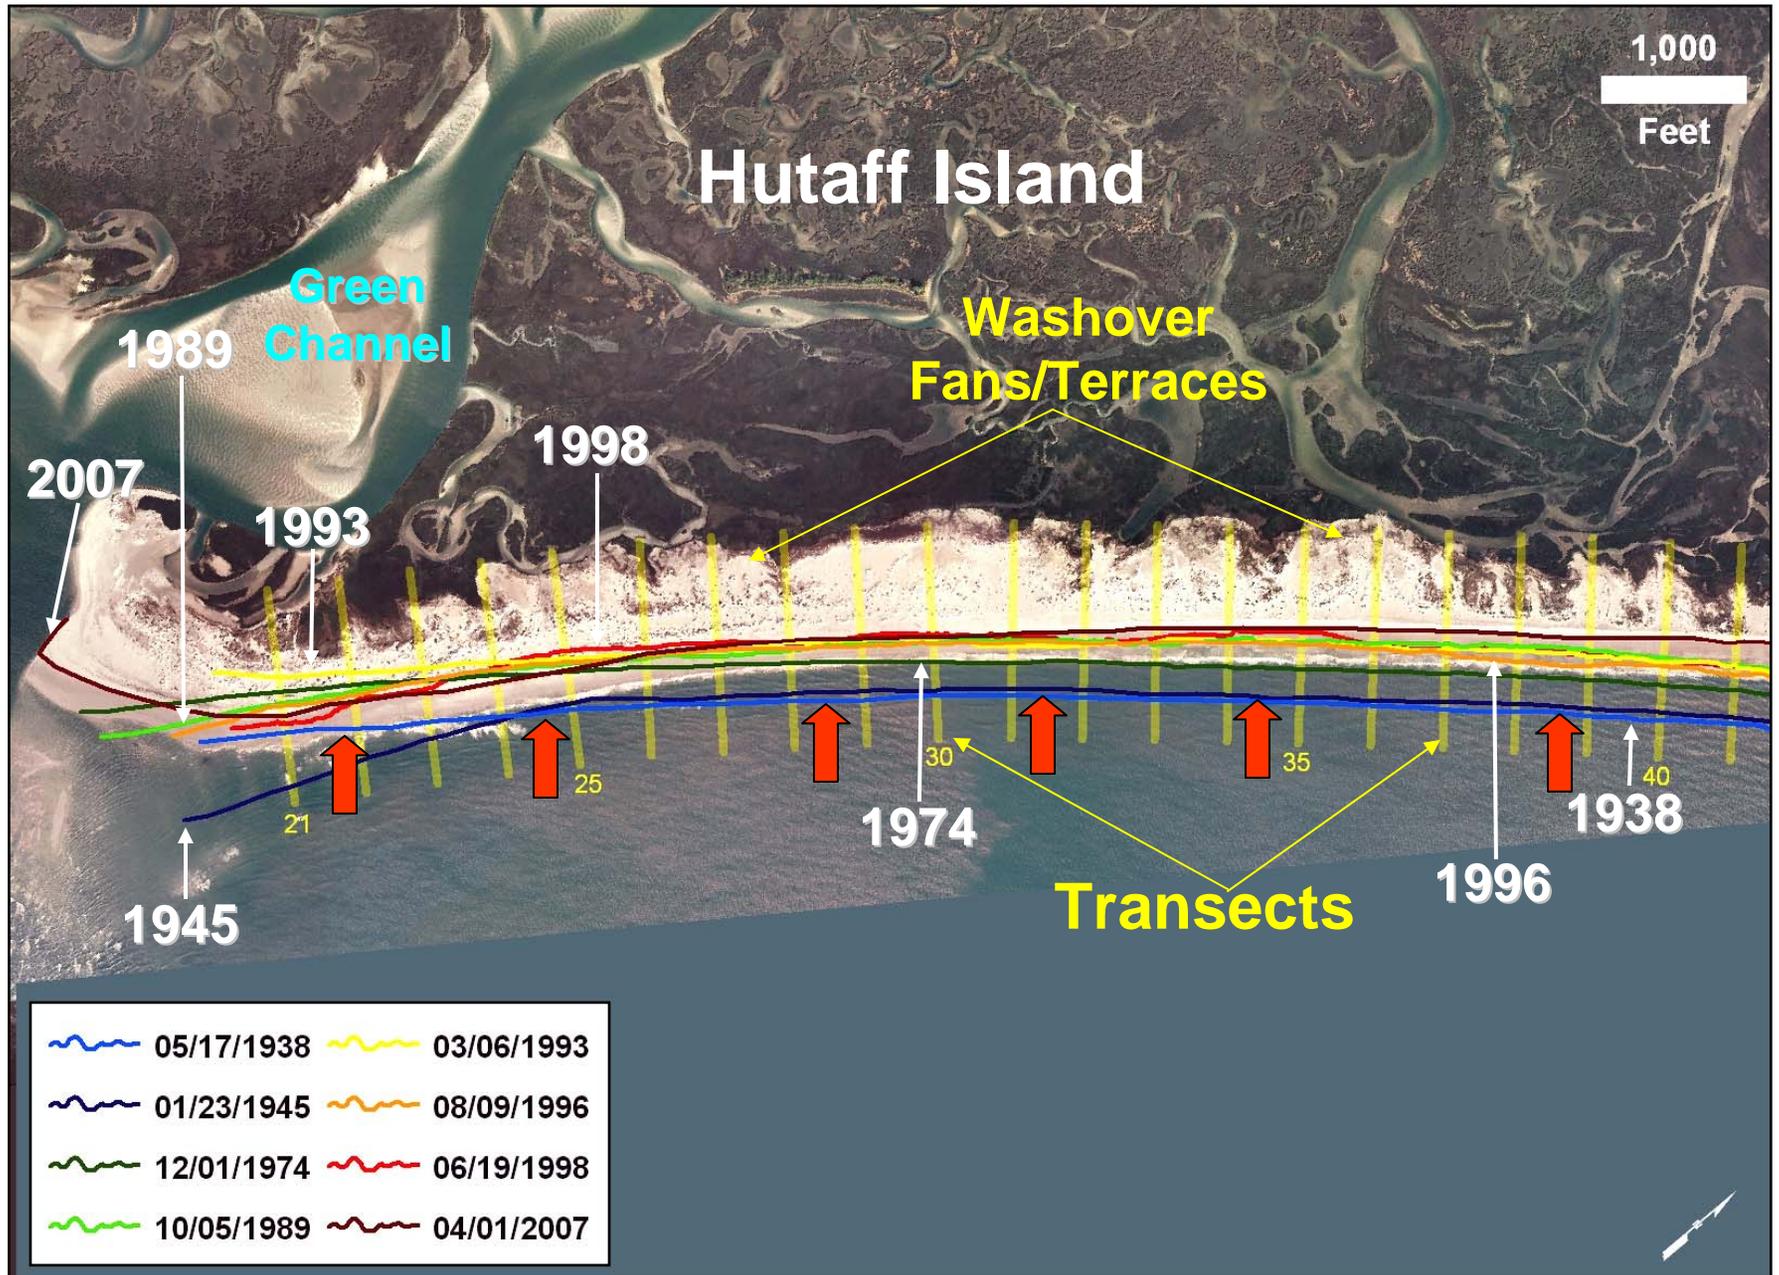
Figure 13. Aerial photograph (2007) depicting selected (8) shoreline positions along HI since 1938 and transect locations (T21-41). The entirety of Hutaff Island is included within an IHA. For purposes of comparison and discussion this study has designated the Rich Inlet zone of influence to include the shoreline reach between Transect 21 and 30. Note that the relative positions of the 1938 and 1945 shorelines along the barrier. Also note the continuous retreat of the shoreline since 1938 north of T 26.

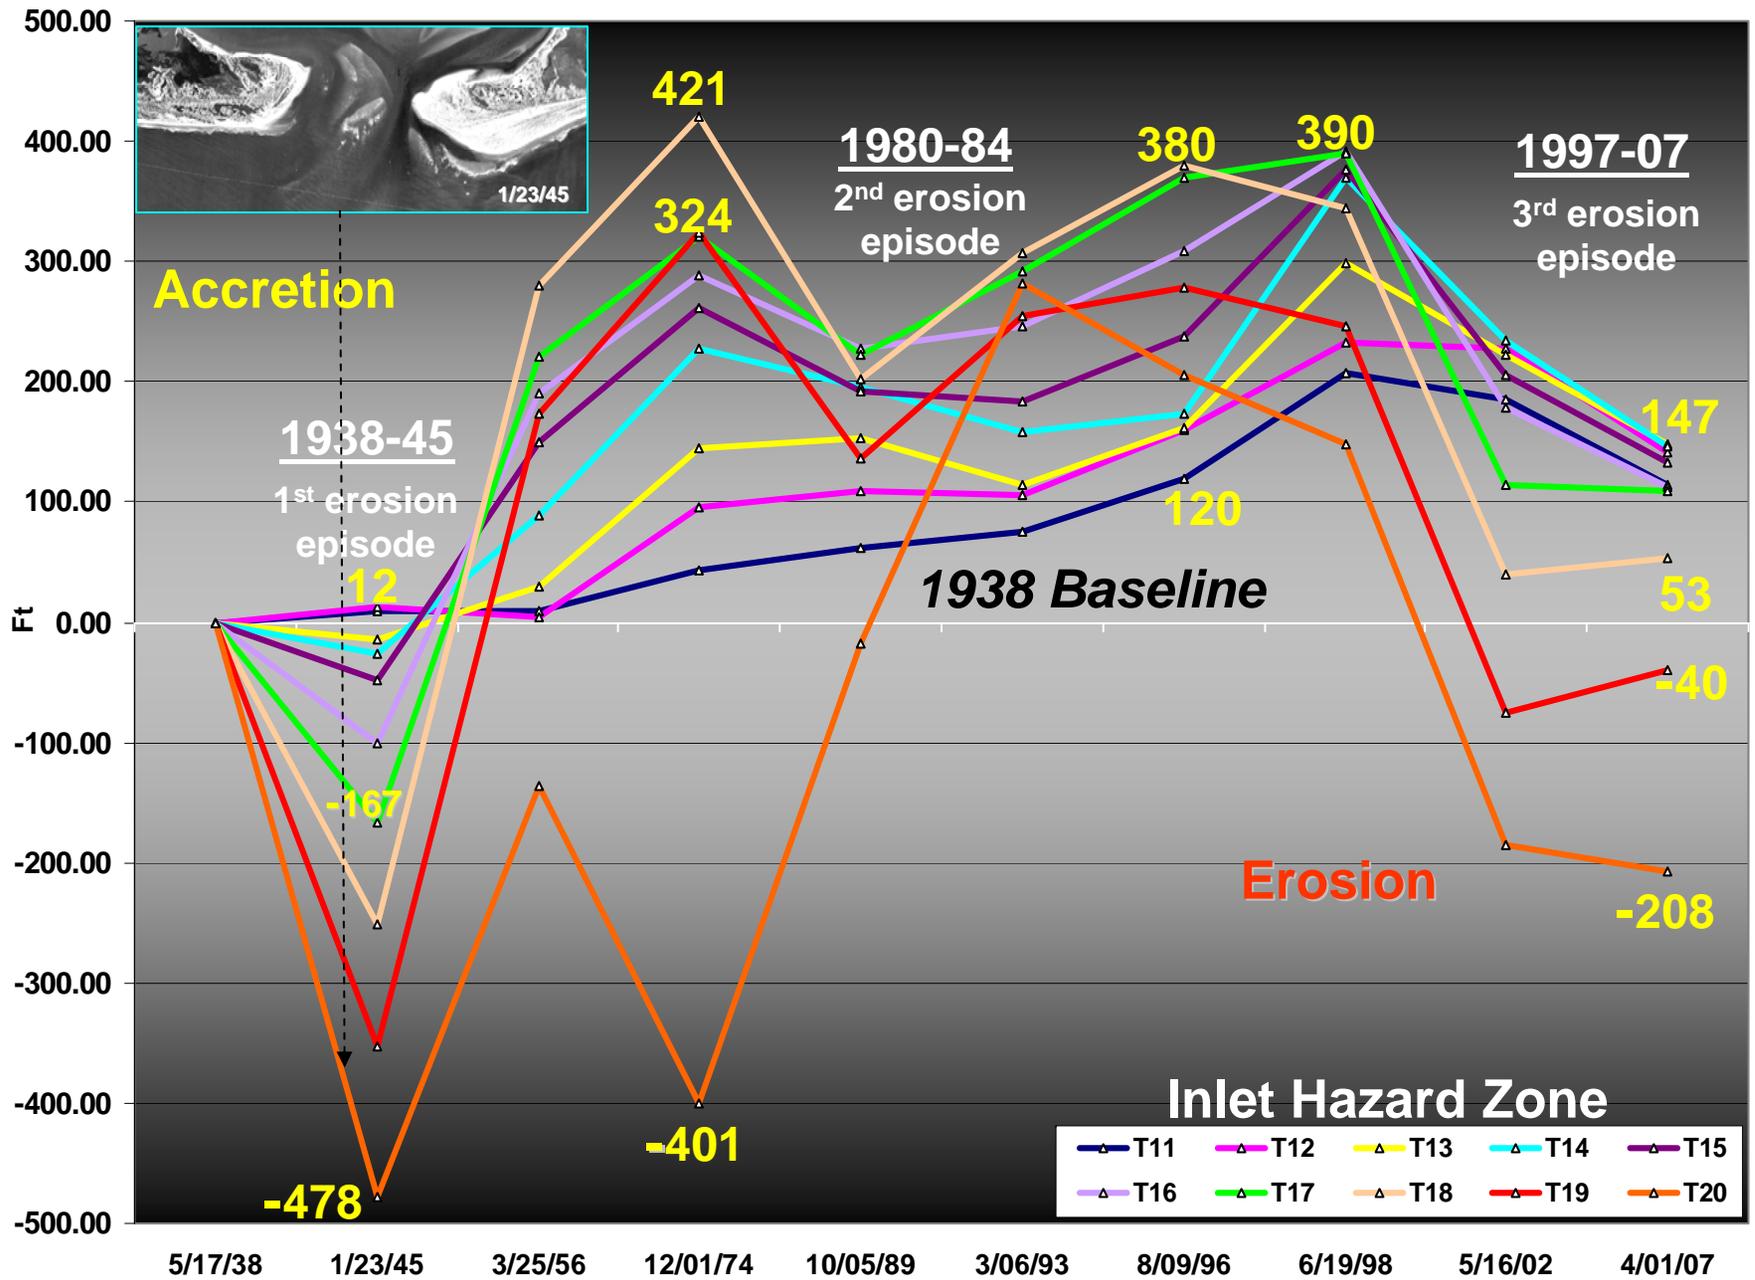
Figure 14. Graph depicting the cumulative shoreline change along transects located within the IHA (T11 to T20) on F8I. Photograph inserts depict condition of the shoreline during the 1st erosion episode.

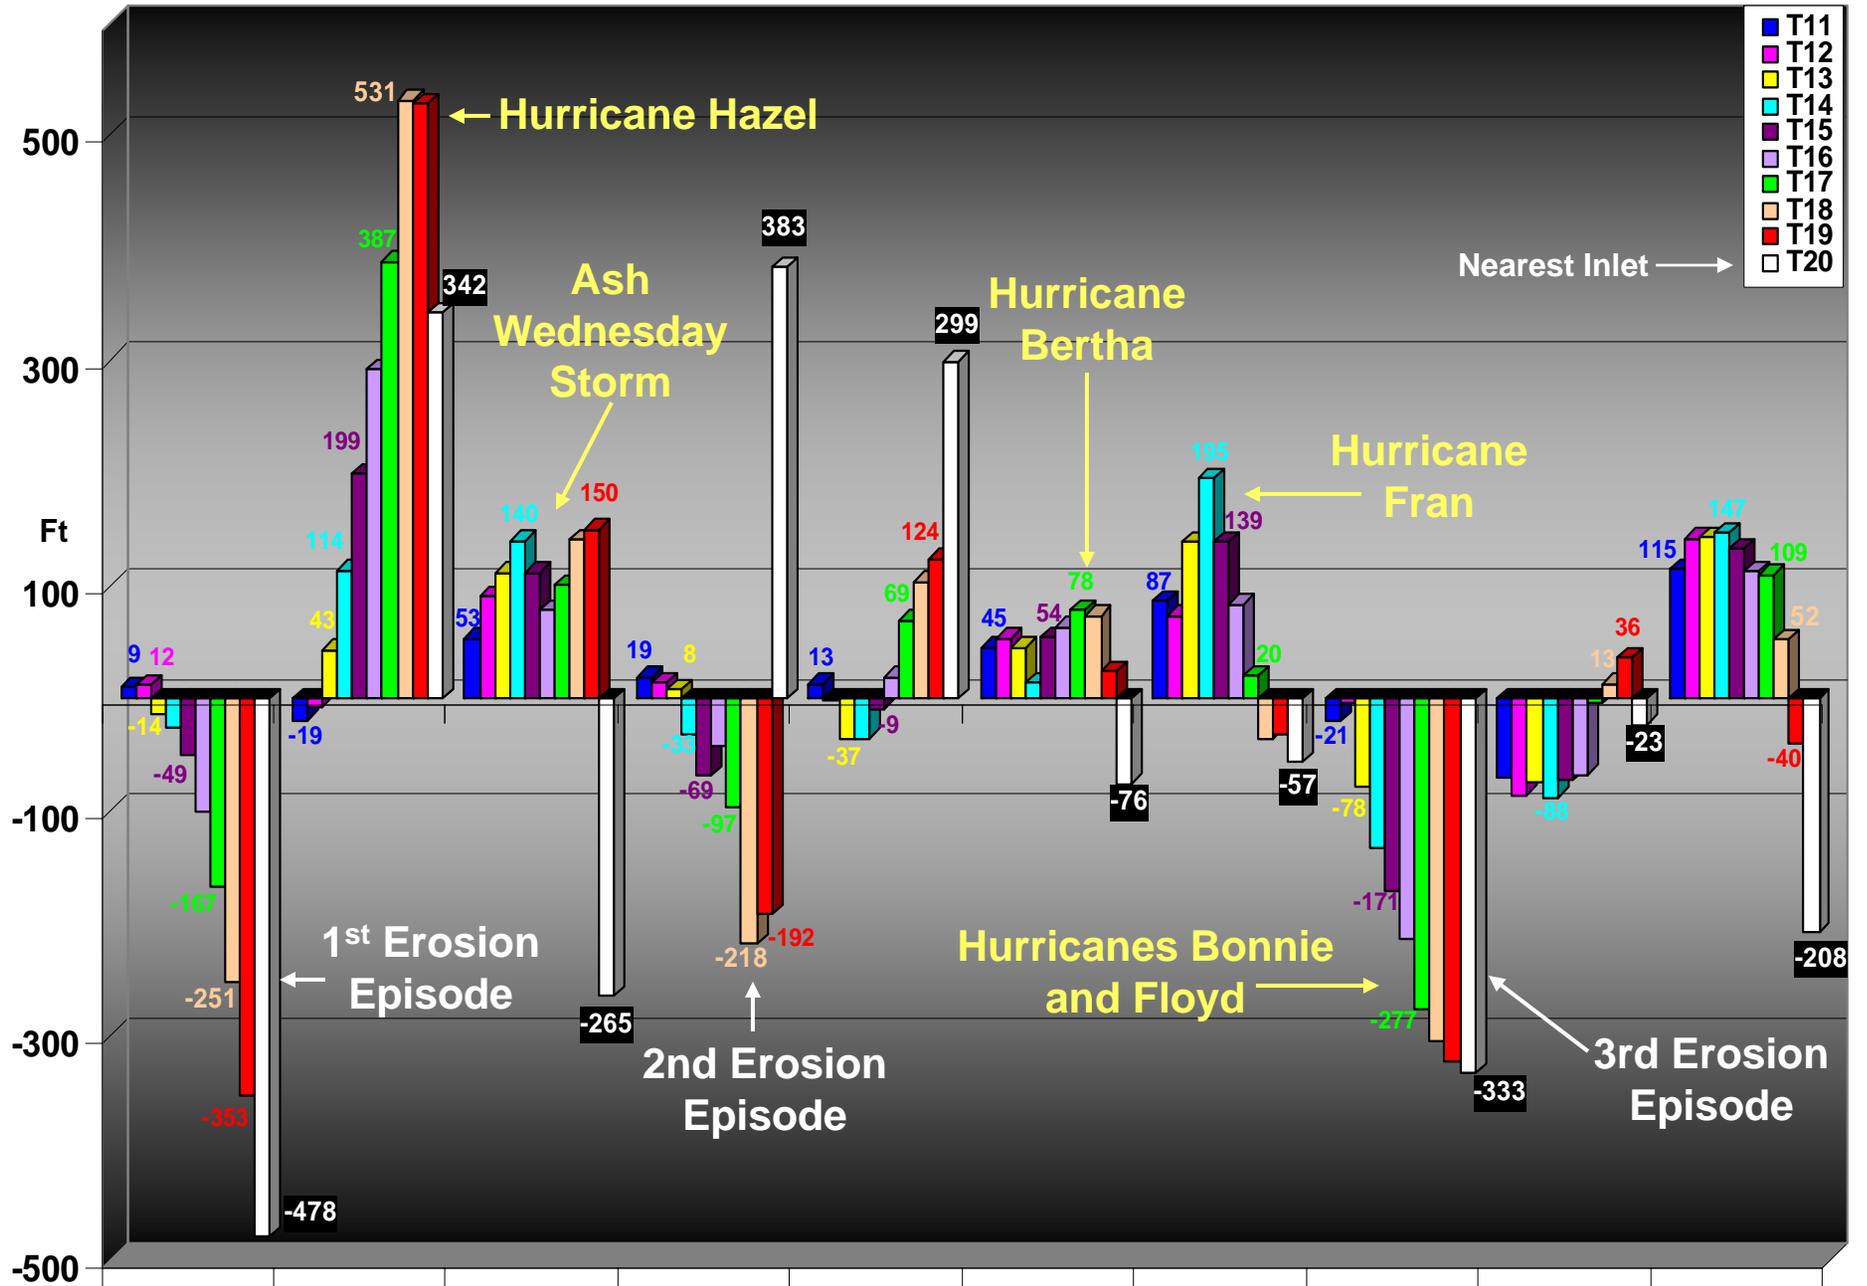
1938-1945 1945-1956 1956-1974 1974-1989 1989-1993 1993-1996 1996-1998 1998-2002 2002-2007 1938-2007
Figure 15. Bar graph depicting short-term shoreline changes along the oceanfront between the T11 and T 20 from 1938 to 2007. The oceanfront shoreline segment lies within the F8I portion of the Rich Inlet IHA.

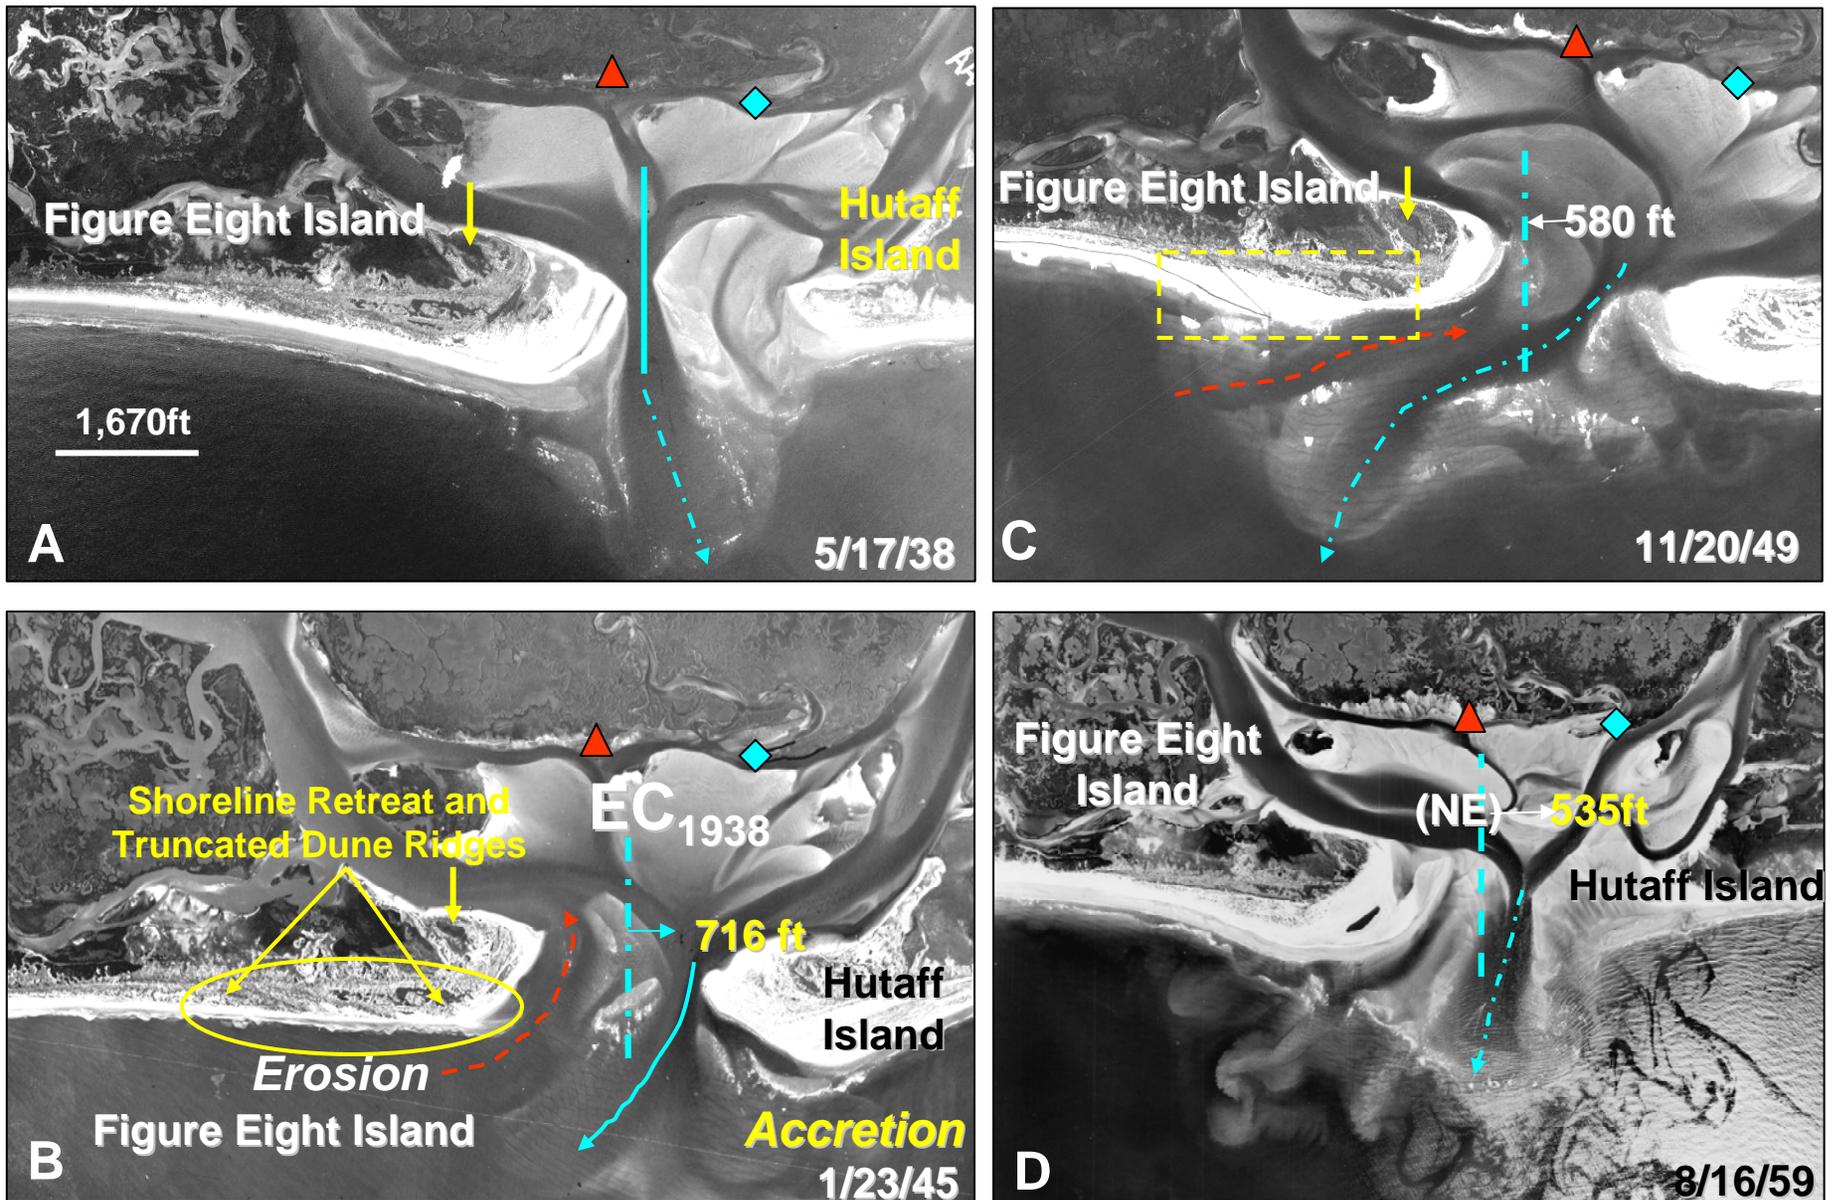
Figure 16. Historic aerial photographs (1938 –1959) illustrating shoreline changes along F8I downdrift of Rich Inlet. **A.** View (517/38) of the north end of F8I showing accretion zone downdrift of Rich Inlet. **B.** View (1/23/45) of the erosion along the accretion zone. Note truncated dune ridges and the encroachment of the flood channel due to the skewed ebb channel. Also note the progradation of the HI shoreline. **C.** View (11/20/49) depicting the skewed ebb channel and the buildup of the shoreline in the lee of the flood channel. Note the erosion of the HI oceanfront. **D.** View (8/16/59) showing progradation of the F8I oceanfront and inlet margin accretion (spit buildup). The erosion of HI is due to the NE shift of the ebb channel and development of the flood channel. Red triangle and light blue diamond are reference points.

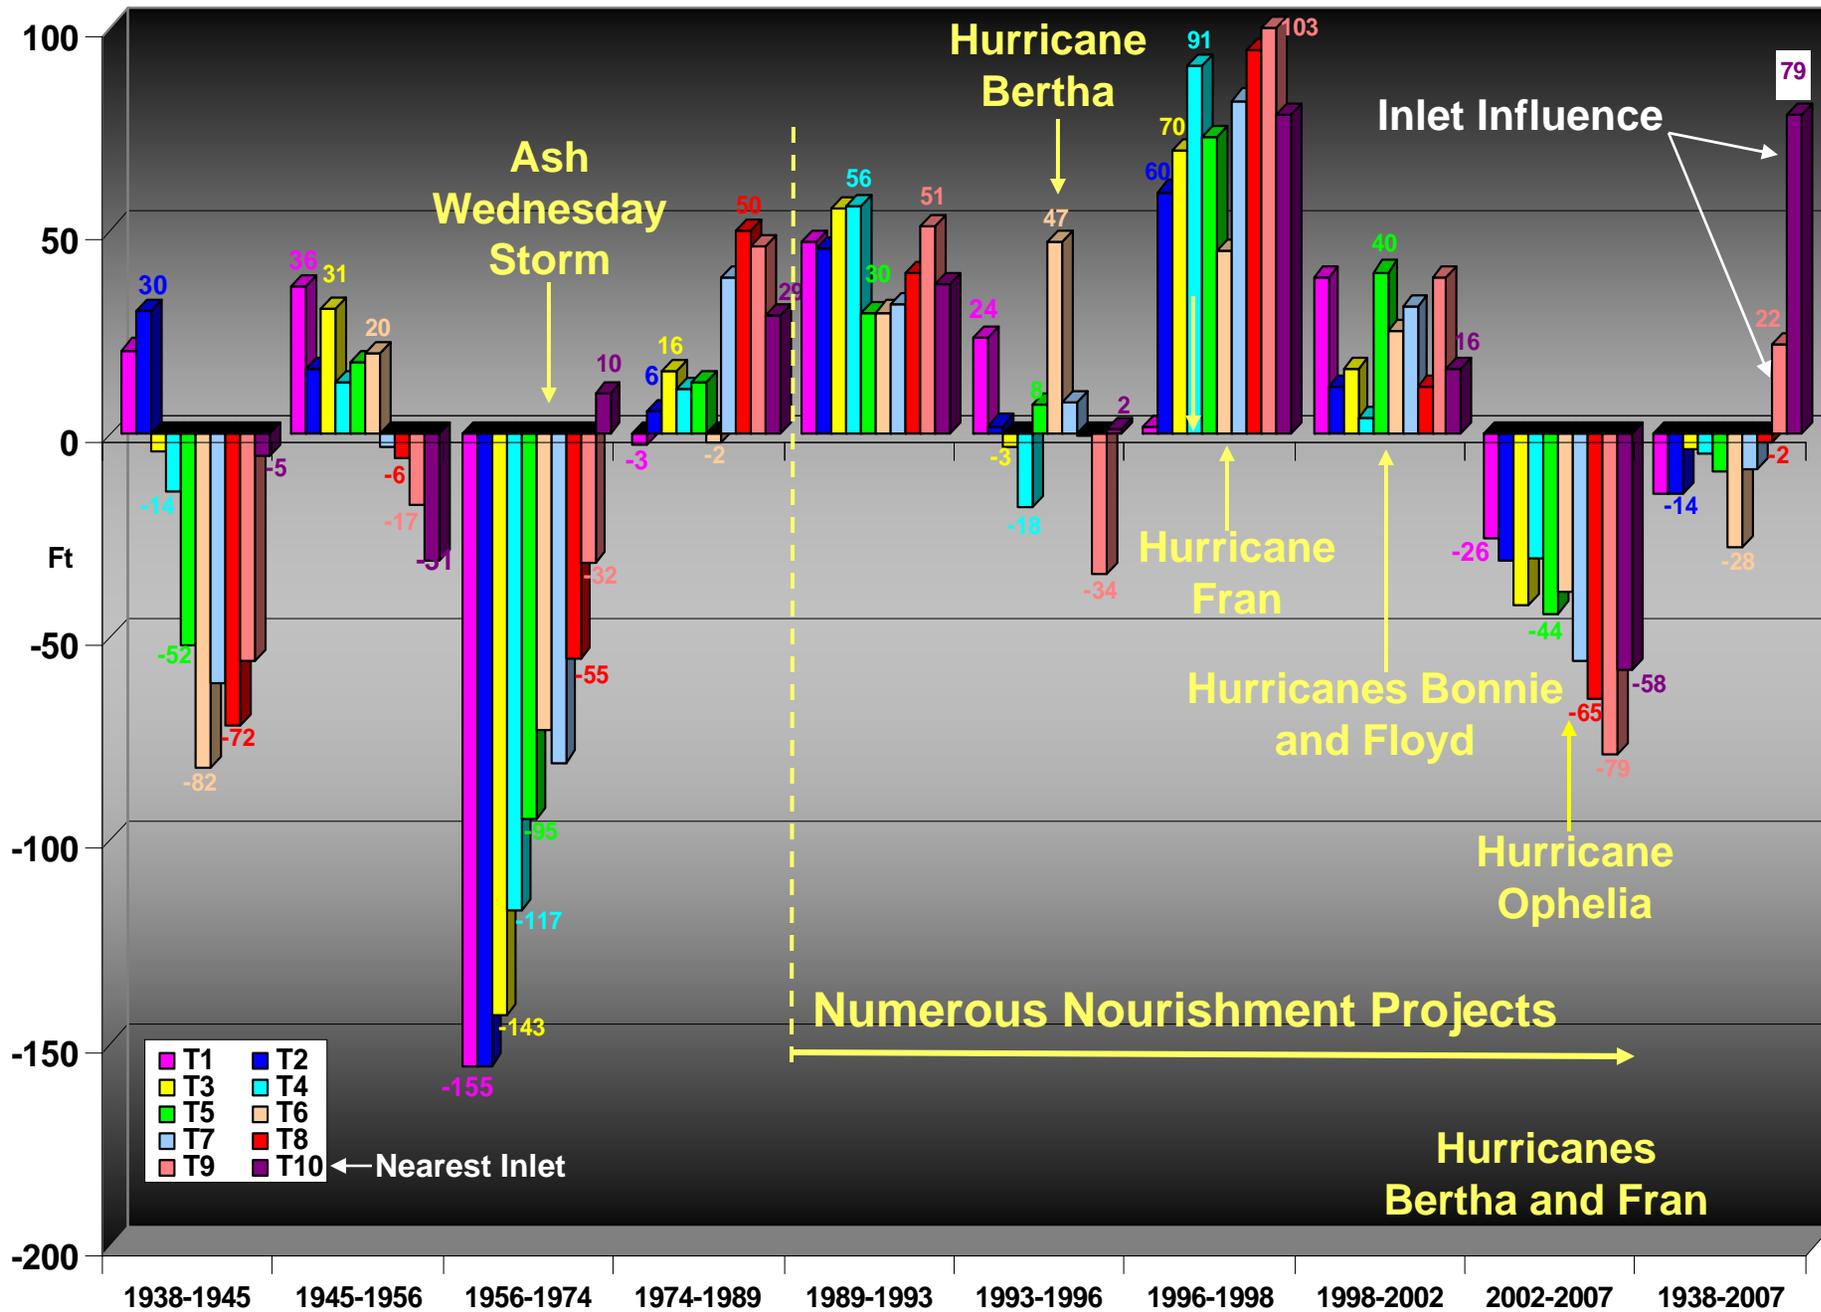
Figure 17. Bar graph depicting short-term shoreline changes from 1938 to 2007 along F8I between the T1 –T 10 the reach that lies outside the IHA.

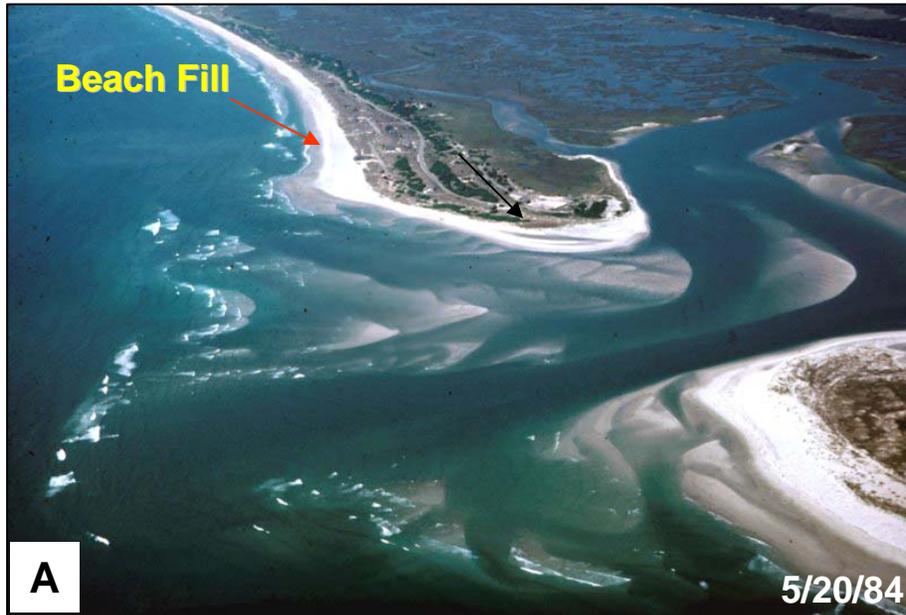
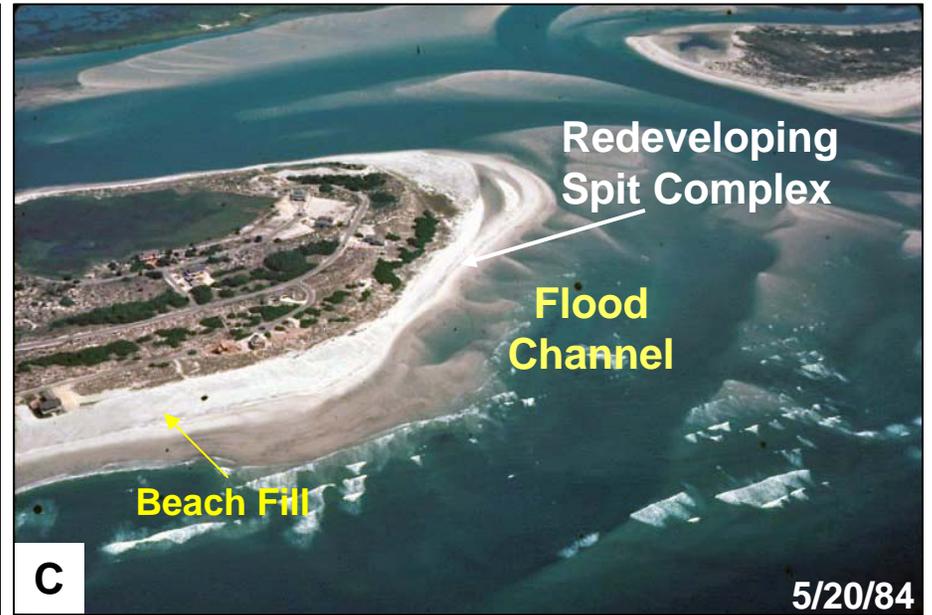
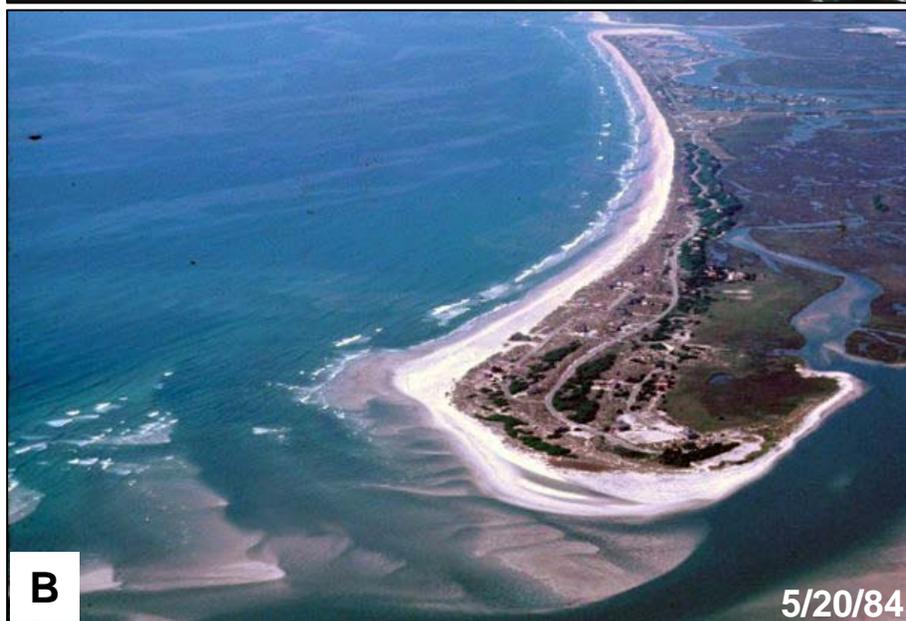
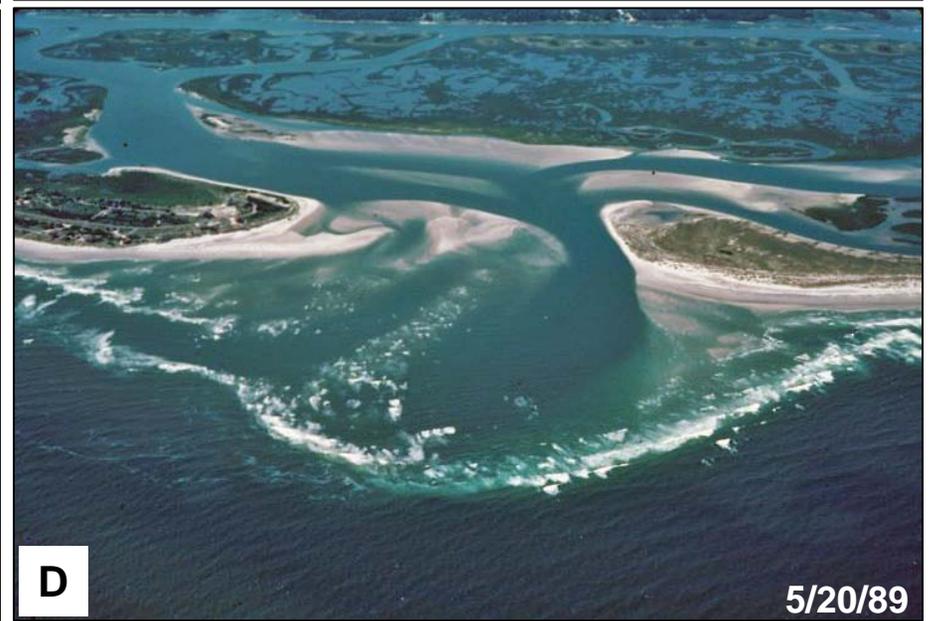
Figure 18. Aerial photographs depicting condition of nourished oceanfront shoreline prior to mid 1984 erosion episode. **A.** and **B.** (5/20/84). Views of nourished shoreline segment and swash bar welding onto F8I. **C.** View (5/20/84) showing the onset of erosion of redeveloping inlet shoreline **D.** Landward view (5/20/89) of Rich Inlet showing spit development along scarped inlet shoreline. Note lack of shrub line along scarp line.

shoreline bordering the marginal flood channel was rapid and short-lived, and rates as high as 3.0 ft/day for a brief period of time were recorded (Cleary, 2001). By early 1985, the erosion along the inlet shoreline ceased, and rapid progradation began. Figures 18 D and 19 D depict the F8I inlet shoreline conditions in 1989.

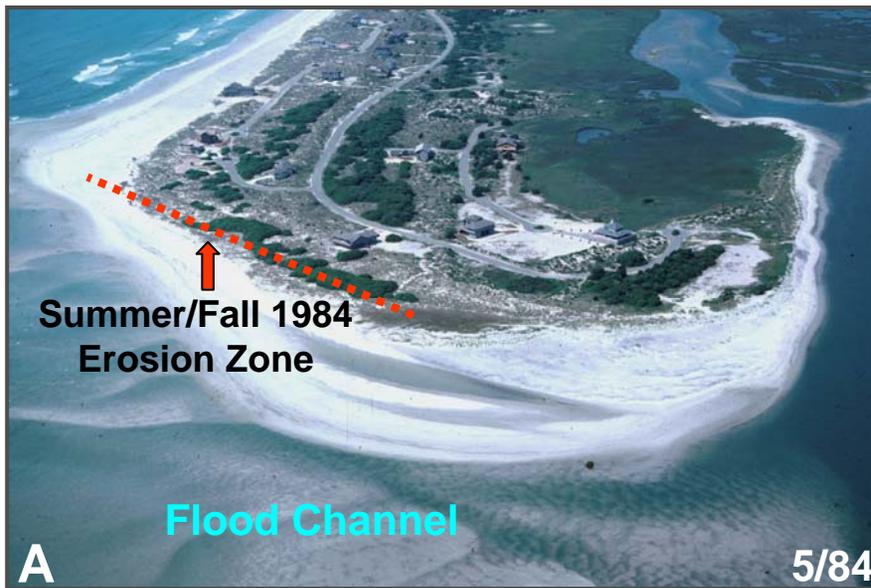
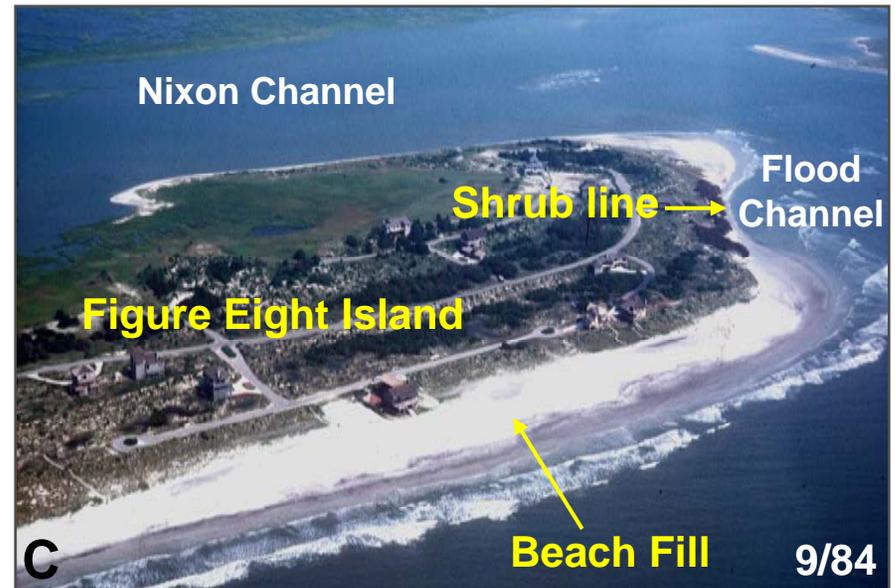
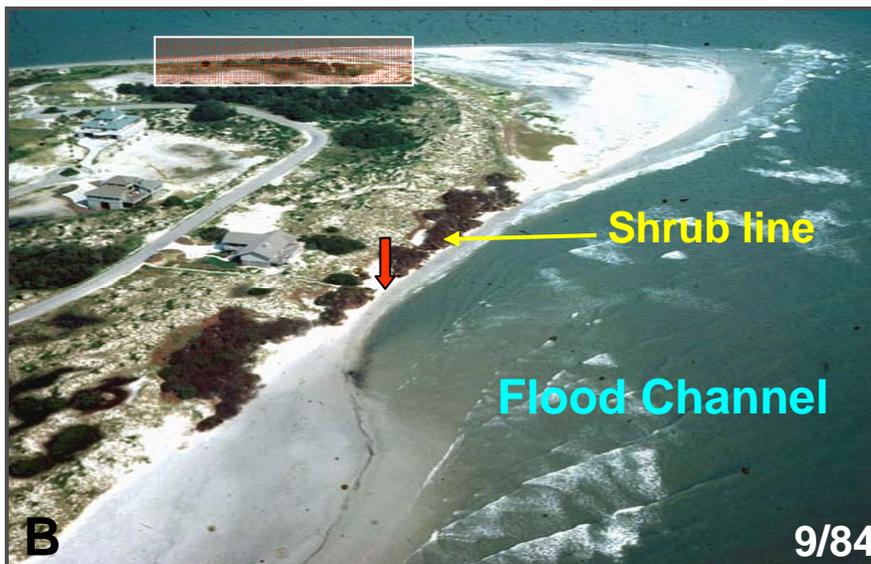
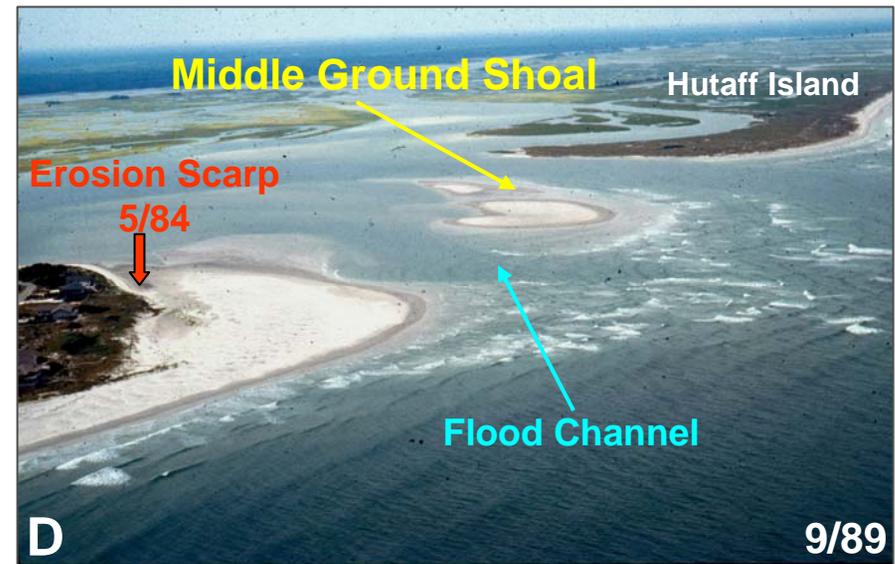
Figure 19. Oblique aerial photographs of F8I and Rich's Inlet shoreline during 1984. **A.** Seaward view of the inlet shoreline depicting the redeveloping spit, ridge and swale features, and the intact shrub line. **B.** Oblique aerial photograph depicting very rapid erosion of the inlet shoreline and dying shrub thickets. Compare to "A". **C.** Landward view (9/84) of eroded and scalloped inlet shoreline. **D.** Landward view (9/89) of rebuilt and elongating inlet shoreline spit. Note the occluded channel adjacent to the scarped uplands and the lack of shrubs. By 1993 the spit had enlarged considerably and the flood channel had infilled while the mid-inlet shoal became incorporated into the barrier.
