**APPENDIX B
ENGINEERING REPORT**

Inlet-Related Shoreline Changes: Rich Inlet, North Carolina

Update Through 2007

William J. Cleary

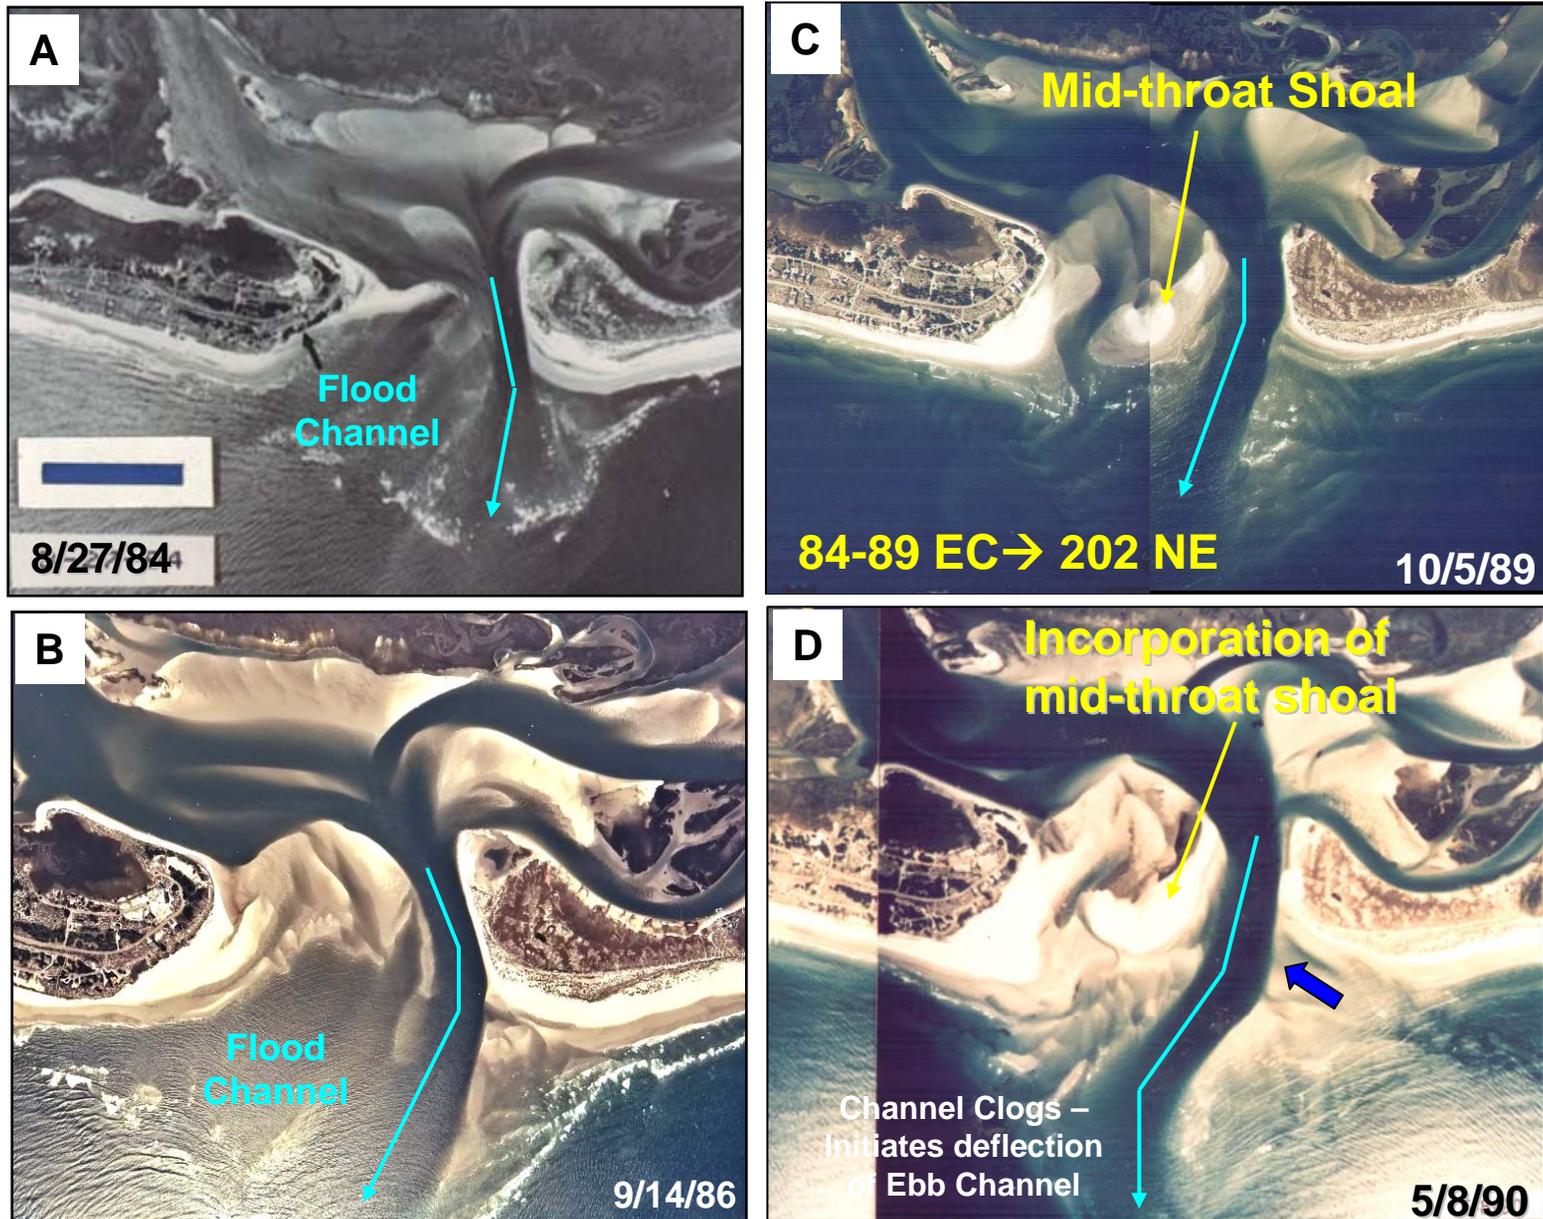
Figure 20. Aerial photographs (8/84- 5/90) of flood channel changes along F8I margin. **A.** View (8/27/84) of erosion along F8I shoreline. Note position of ebb channel. **B.** View (9/14/86) of redeveloped spit along F8I inlet margin. **C.** View (10/5/89) of mid throat shoal and northward developing spit. **D.** View (5/8/90) of nearly infilled flood channel. Note narrow inlet and initial incorporation of mid throat shoal

Figures 20 B and 21A (Appendix) depict the washover dominated topography conditions of the Hutaff Island during the beginning of the period from May 2002 to April 2007. Hurricane Ophelia (September 15, 2005), whose western eye-wall skirted the coast in the southeastern NC, as it tracked northward, caused minor beach erosion and breaches in the re-developing dune line (Fig. 21 B Appendix). Figure 31 (Appendix) illustrates the shoreline change rates for the period between May 2002 and April 2007. Inspection of the above-mentioned figure shows that erosion was prevalent along much of the oceanfront shoreline. Erosion rates along the northern segment of the oceanfront varied from 3 to 10 ft/yr, while along the southern segment, where erosion was more severe ranged from 4 to 23 ft/yr. Shoreline progradation during this period was limited to the oceanfront segment between T28 to T33 where accretion rates varied from 3 ft/yr to 7 ft/yr.

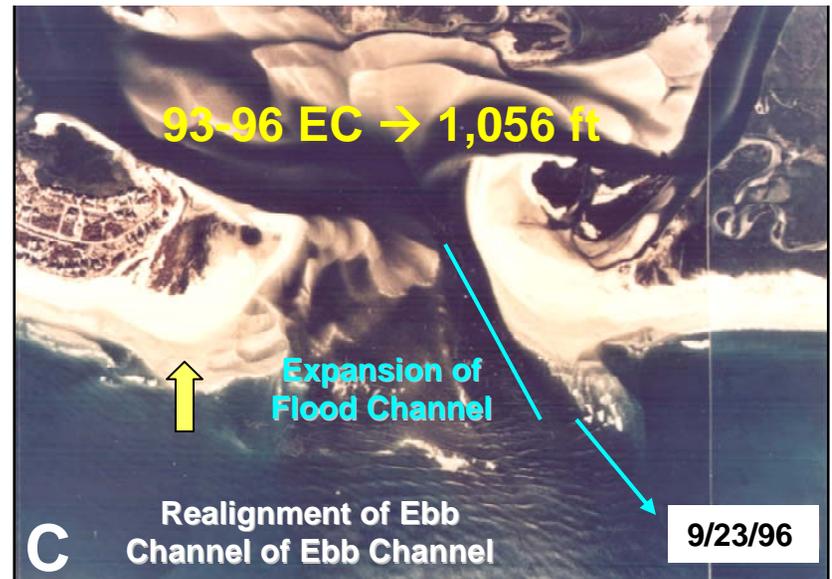
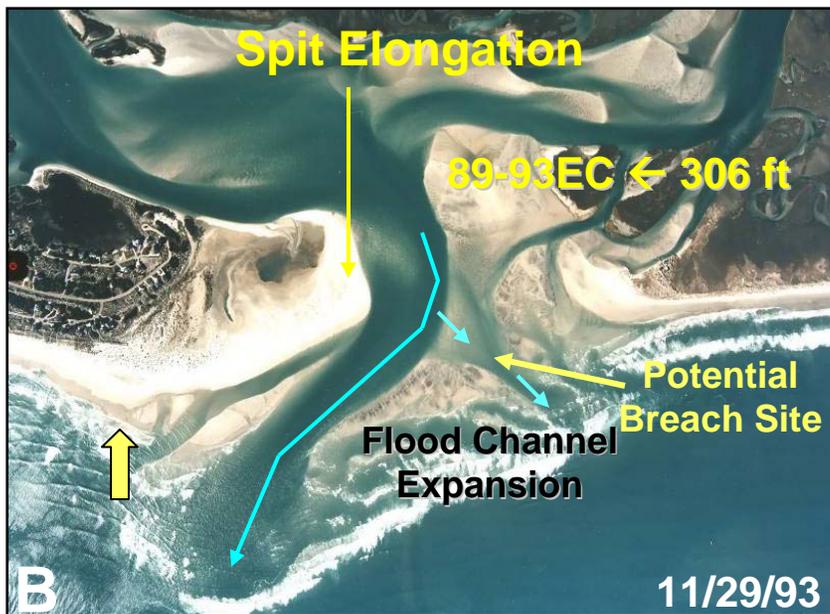
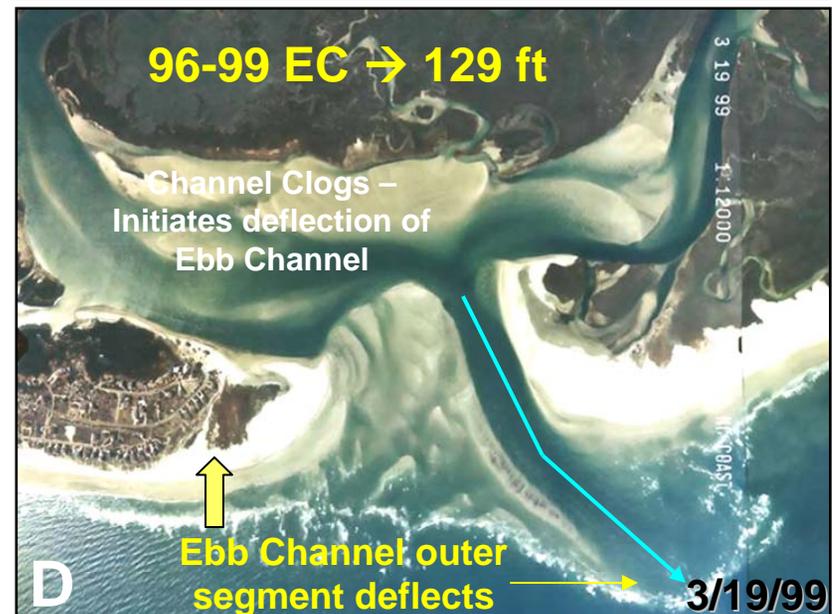
Figure 21. Aerial photographs of Rich Inlet (11/92-3/99). Photographs depict oceanfront shoreline changes related to ebb delta breaching and ebb channel deflection (A-D), spit development/erosion on F8I inlet margin and changes in the symmetry of the ebb-tidal delta (A-D). Note the change in the wave-sheltering effect with channel shift to NE (B-D).

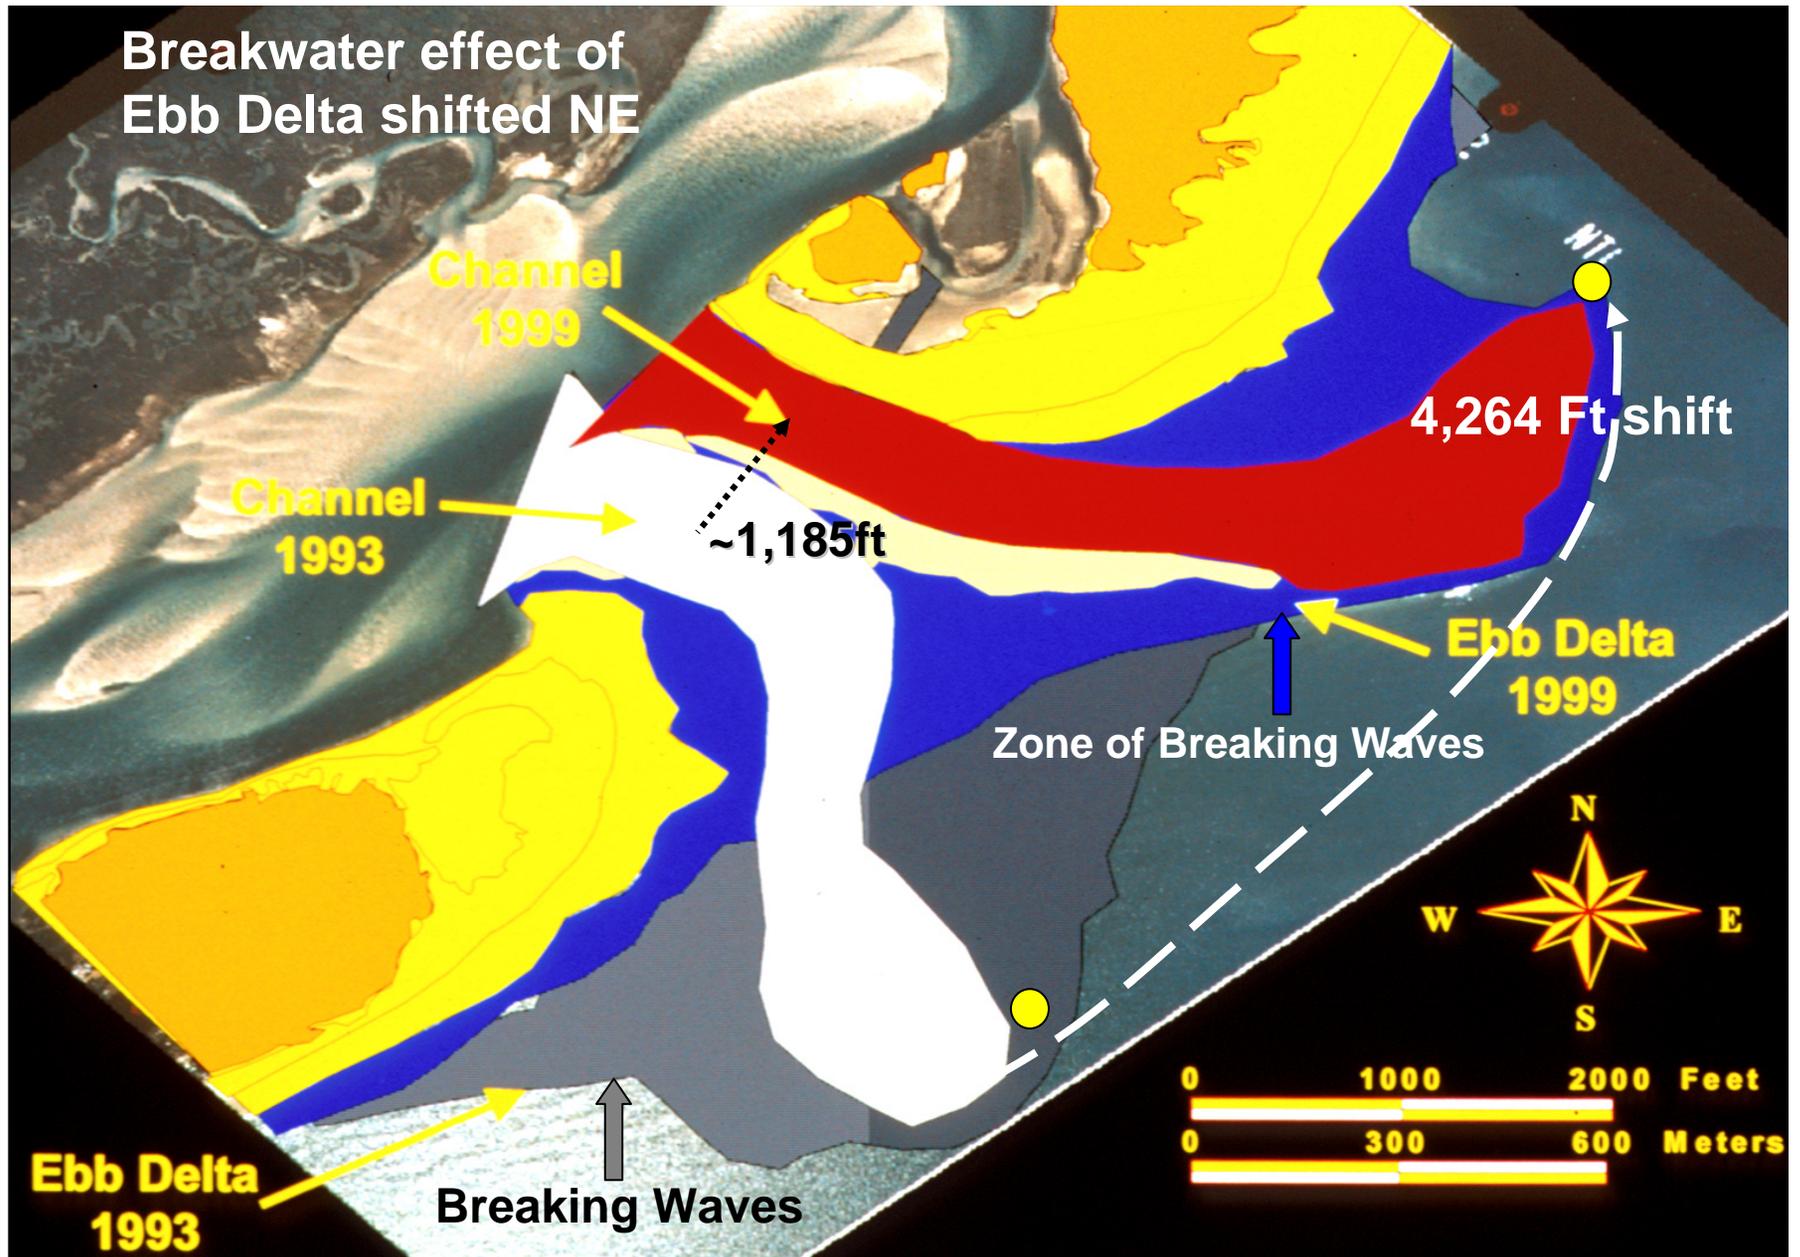
Figure 22. Cartoon illustrating the effects of ebb channel repositioning and outer channel realignment on the F8I oceanfront shoreline. The image shows the superposition of the 1993 and 1996 zone of breaking waves along the ebb-tidal delta and the location of the throat segment of the ebb channel. A NE shift of the ebb delta exposed the F8I oceanfront to incident waves. In this configuration swash bars no longer attached to the F8I oceanfront but rather moved into the flood channel and eventually the estuary and interior channels.

barrier, whose susceptibility to increased overwash penetration has increased over time. Figure 22 and Figure 26 (Appendix) depict the general conditions of the barrier in January 2008.

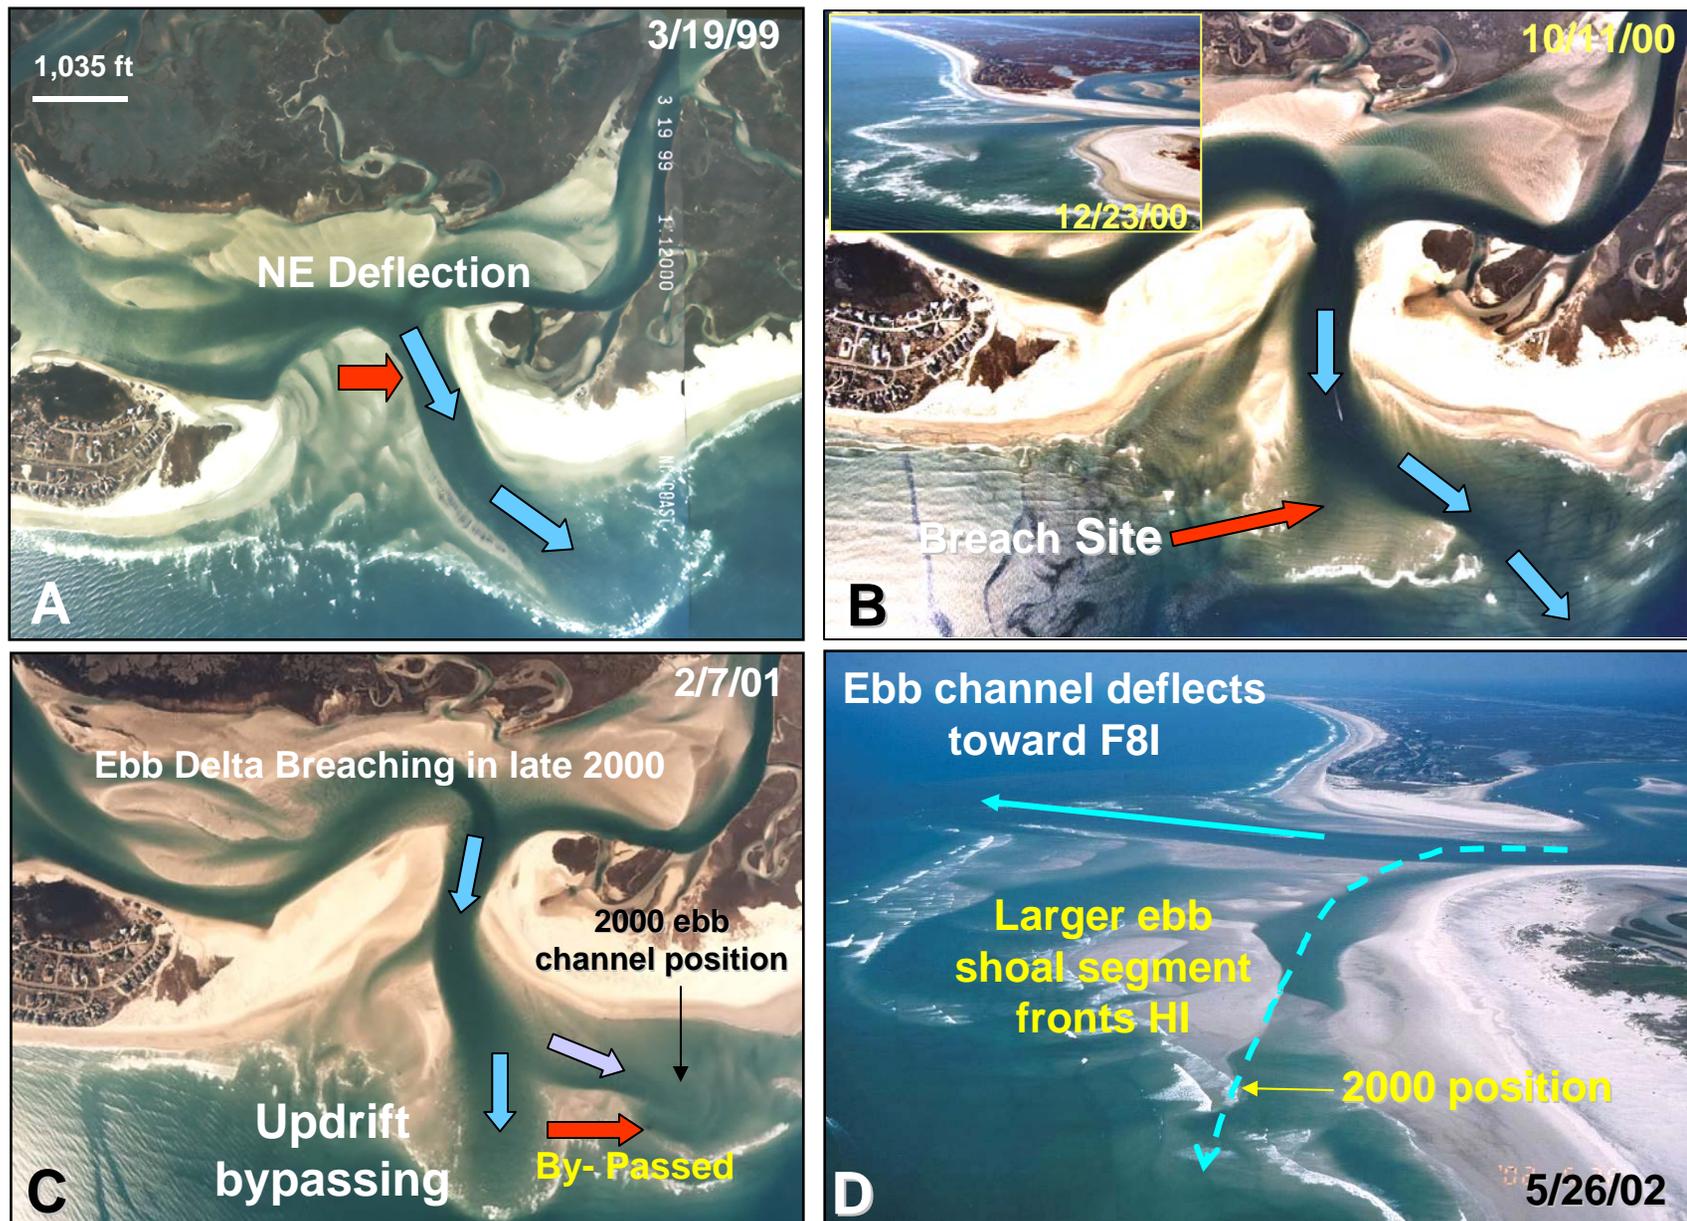
Figure 23. Aerial photographs (1999-2002) depicting the effects of ebb channel repositioning, realignment and bar by-passing. **A.** Image (3/19/99) depicts post-breaching deflection of ebb channel to NE. **B.** View (10/11/00) of ebb delta prior to beaching showing near breach. Insert shows breach. **C.** Photograph (2/7/01) depicts recent ebb delta breaching event (Dec 2000) and the large sand package in the process of being by-passed updrift. **D.** Southward view of ebb channel shifting southward and the larger ebb delta segment located NE of the channel fronting HI. Note the lack of any significant breakwater effect offshore F8I.

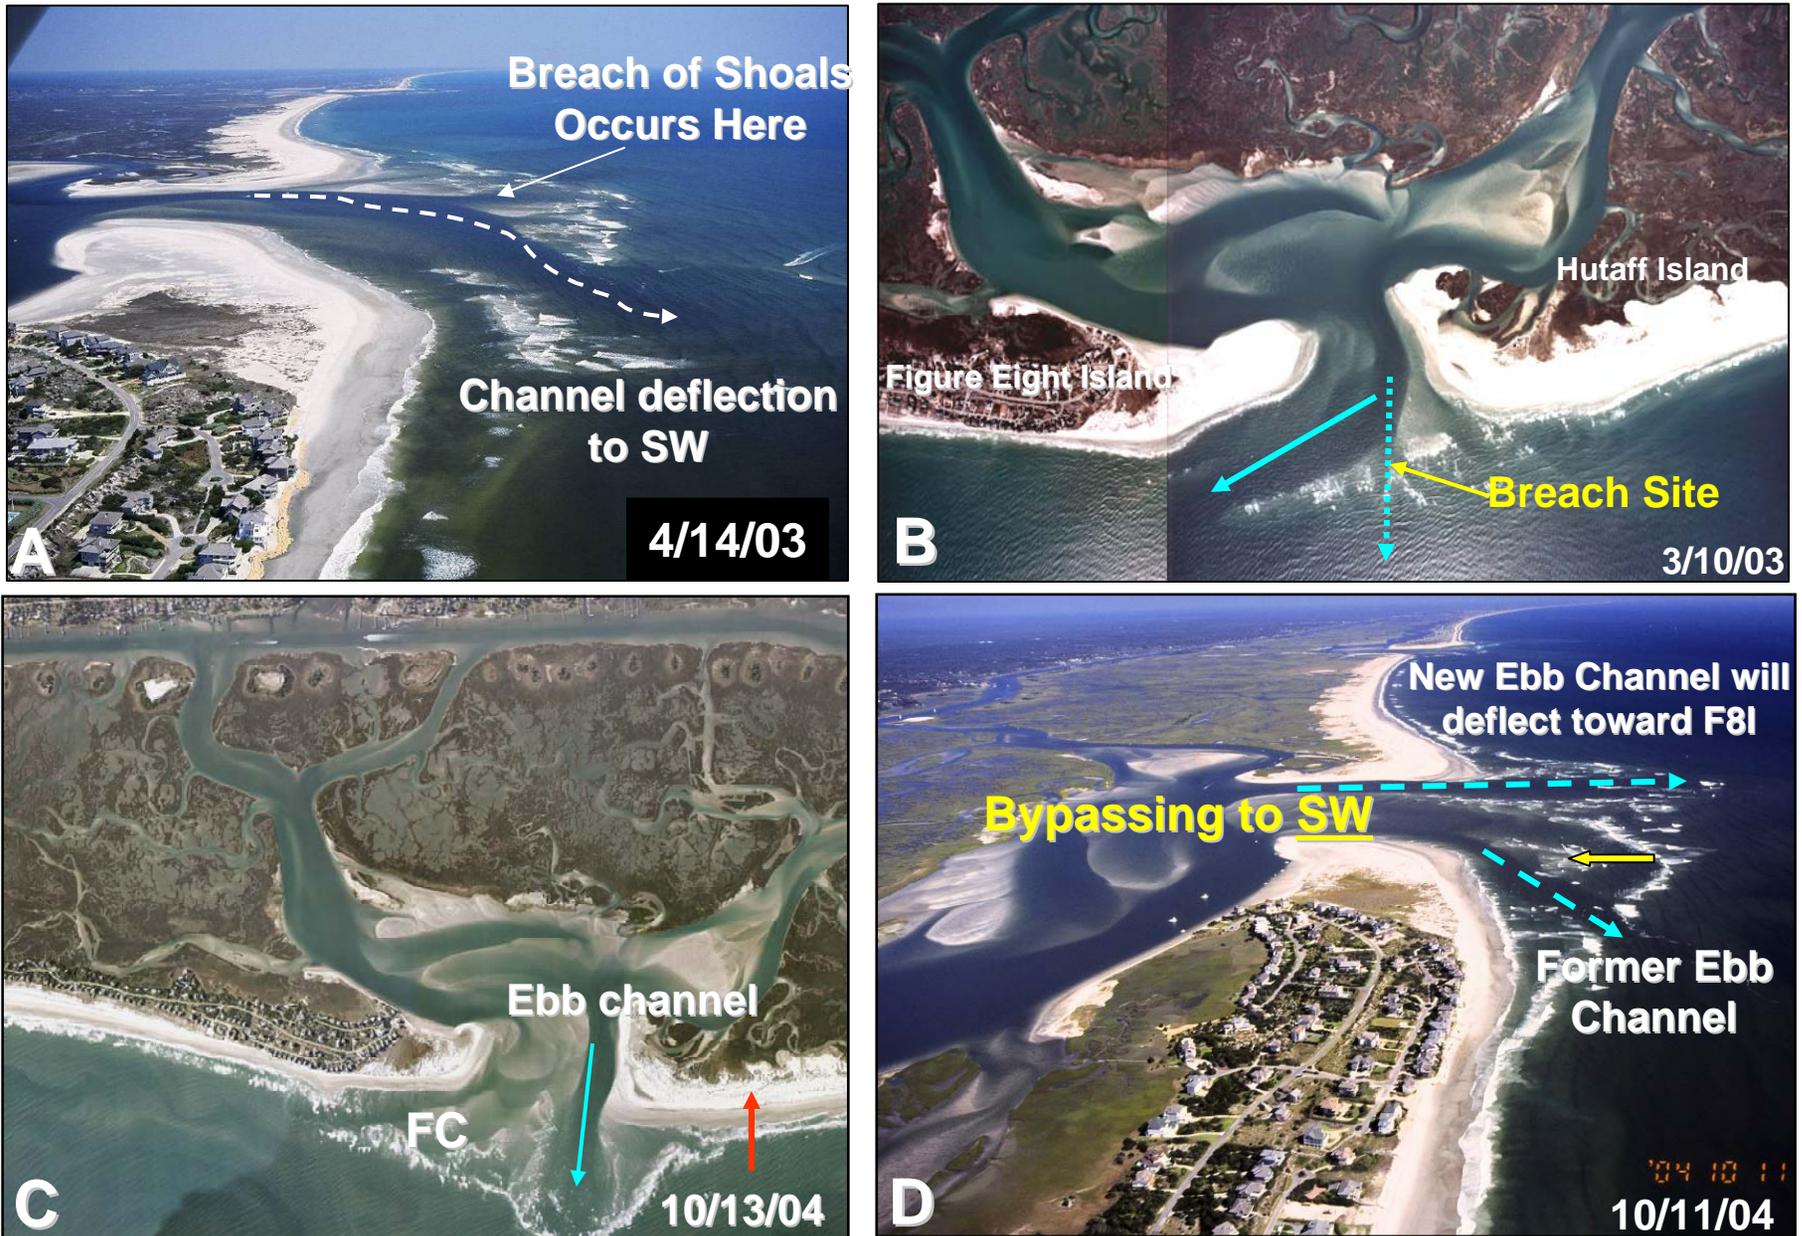
Figure 24. Aerial photographs (4/14/03- 10/11/04) depicting an ebb delta breaching event and SW bar by-passing event. **A.** Oblique image(4/14/03) showing channel aligned toward F8I. **B.** Photograph (3/10/03) depicting breach site note configuration of elongating spit. **C.** Image (10/13/04) illustrating realigned shore-normal ebb channel expanded flood channel adjacent to F8I. Note change in F8I spit. **D.** Oblique photograph depicting a NE view of former and new position of ebb channel. Ebb shoal segment depicted in “A and B” was by-passed to the SW.

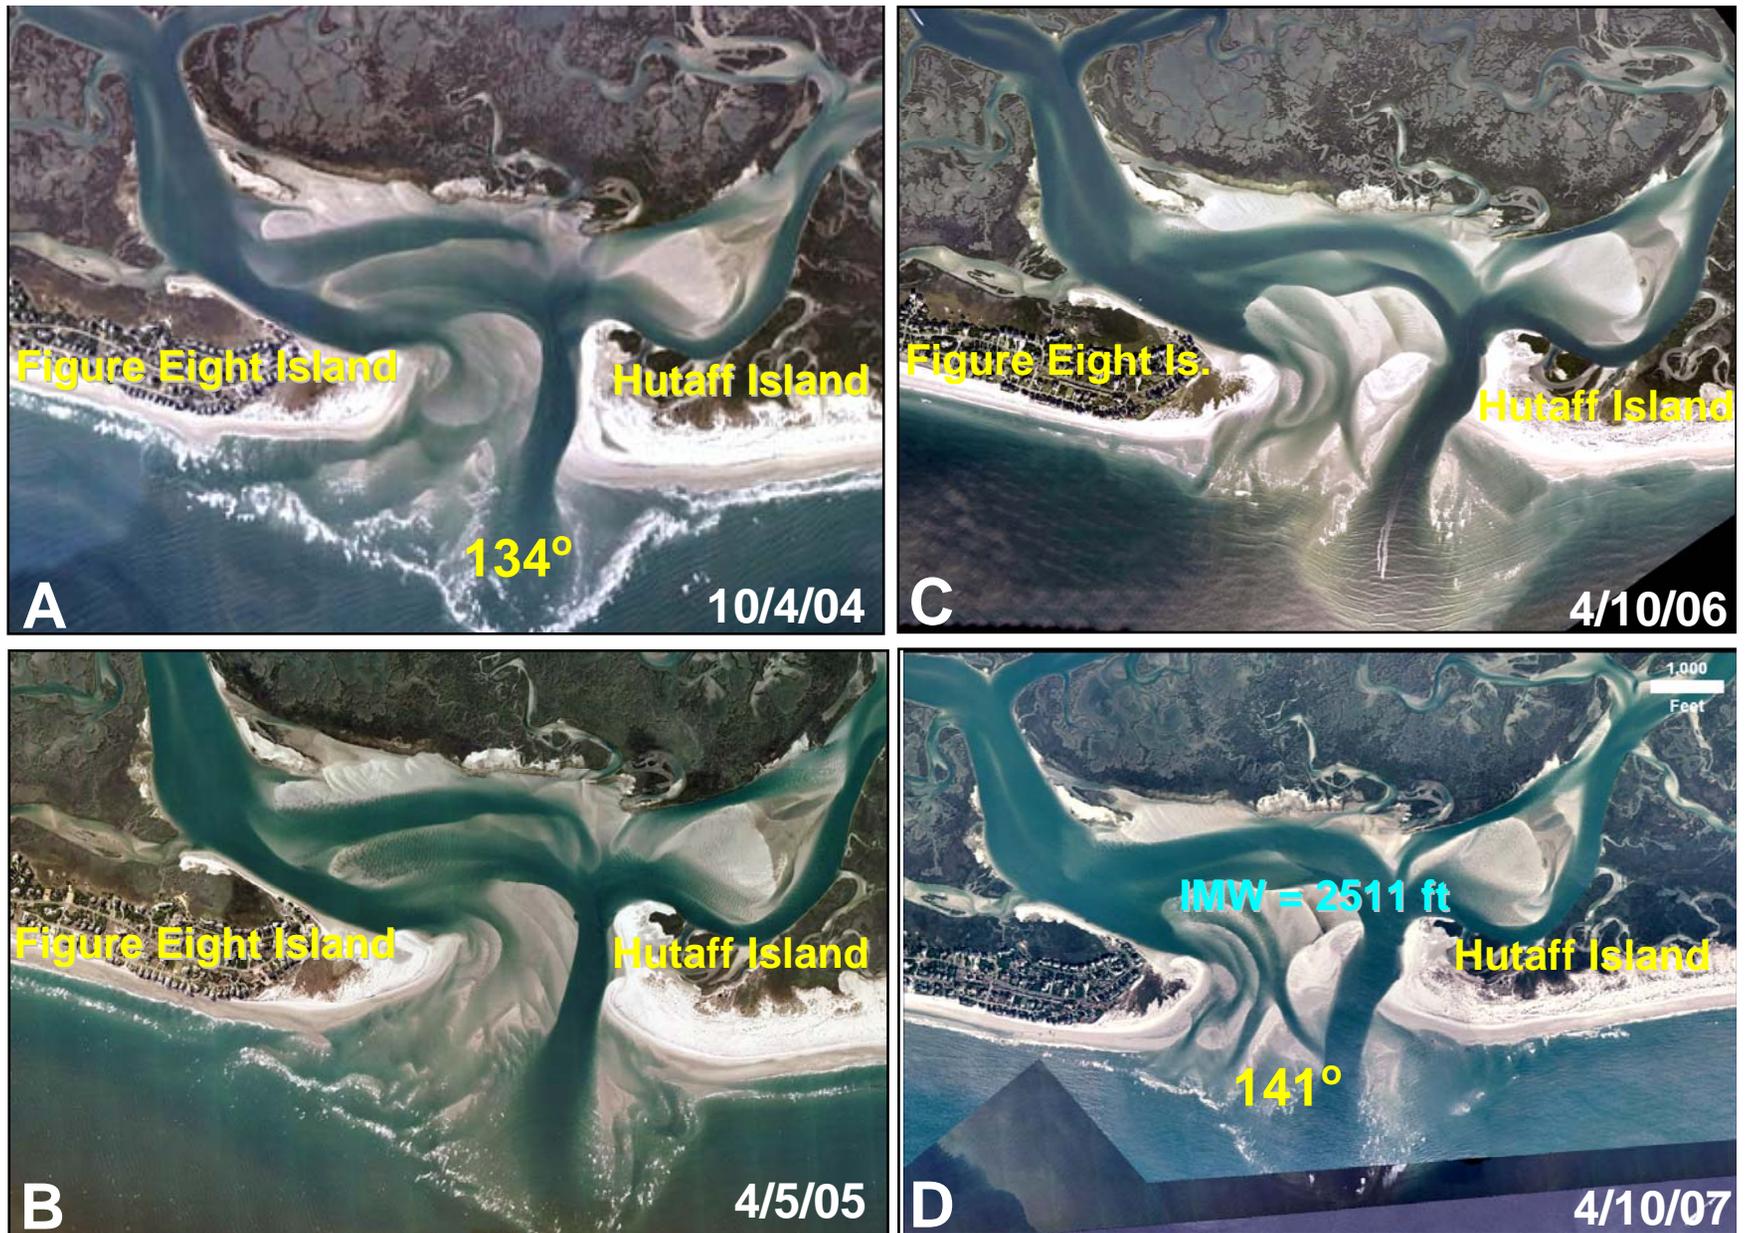
Figure 25. Aerial photographs (A. 10/4/04, B. 4/5/05, C. 4/10/06 and D. 4/10/07) depicting recent shoreline and inlet changes. Note the alignment of the ebb channel has remained fairly constant since 2004 while the ebb channel has shifted ~ 415 ft toward F8I (SW) since 2004.

Although conjectural, it appears that the position of the ebb channel, has caused the location of the sand lobes to shift northward in the estuary within Nixon Channel and along the interior marsh shoreline (Fig. 25). In general and as a consequence, the channel thalweg and flow have been directed toward the seaward margin of Nixon Channel resulting in continued erosion of the developed segment of the estuarine shoreline (Fig. 32 and 38 Appendix). Erosion along this reach during the period from 2001 to 2007 ranged from 53 ft to 156 ft, while erosion rates have varied from 9 ft/yr at T8 to 25 ft/yr at T9. Figures 43 D, 44 and Figure 39 (Appendix) depict the retreating shoreline and the exposure of a large peat bed along portions of the channel margin. Since 1938, the cumulative land loss along this reach, between T8 and T9, ranged from 147 to 392 ft (Fig. 43 B). Erosion in this area is likely to continue for a period of time if the ebb channel remains in its current location. However, if the developing estuarine spit (Figs. 1 and 26) elongates landward along the channel's seaward margin progradation may occur if and when the thalweg is shifted toward the center of the channel.

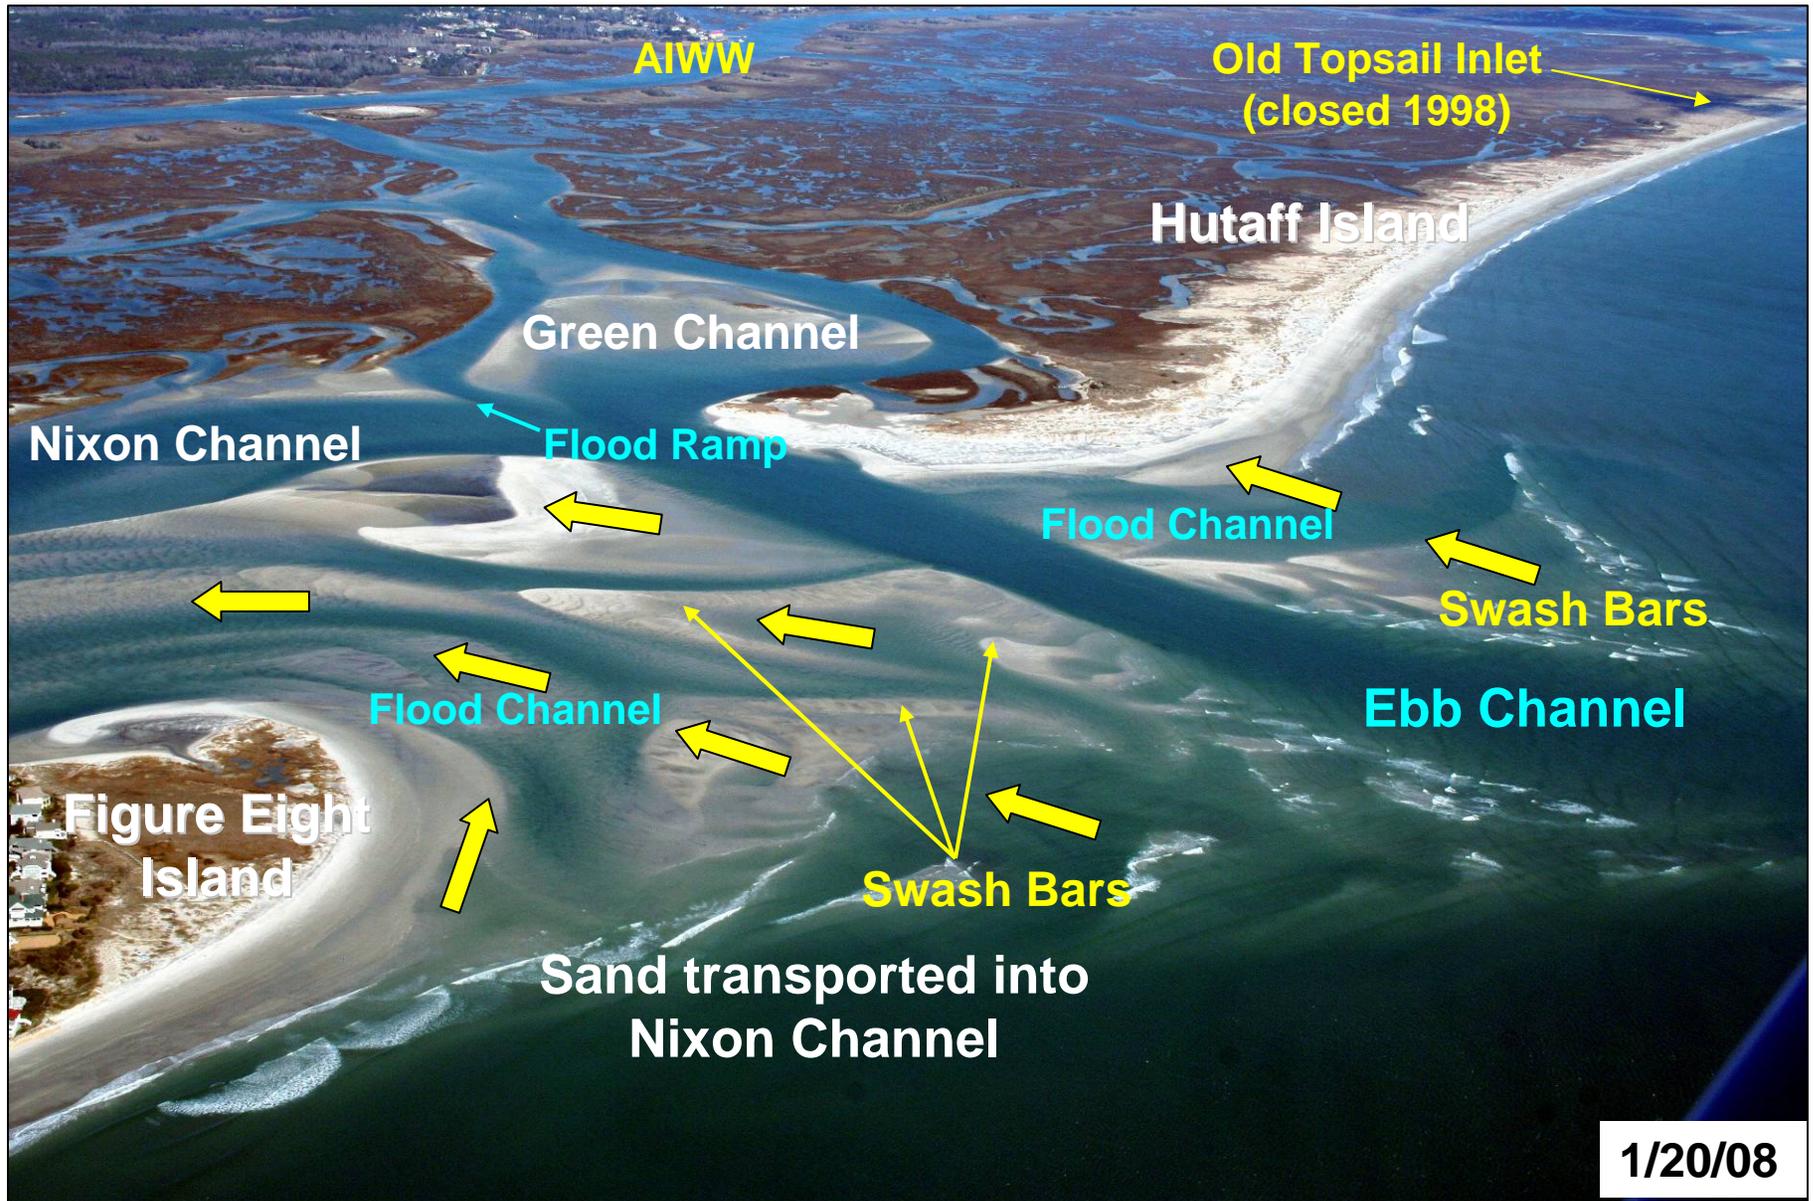
Figure 26. Oblique aerial photograph (1/20/08) of Rich Inlet and portions of the interior channels. Note the asymmetrically shaped ebb tidal delta and the location and alignment of the ebb channel. The wide marginal flood channel that abuts F8I is the major corridor for the transport of large volumes of sand into the estuary and Nixon Channel. Swash bars that formerly attached along F8I currently migrate through the flood channel. Note the attachment of swash bars along HI.

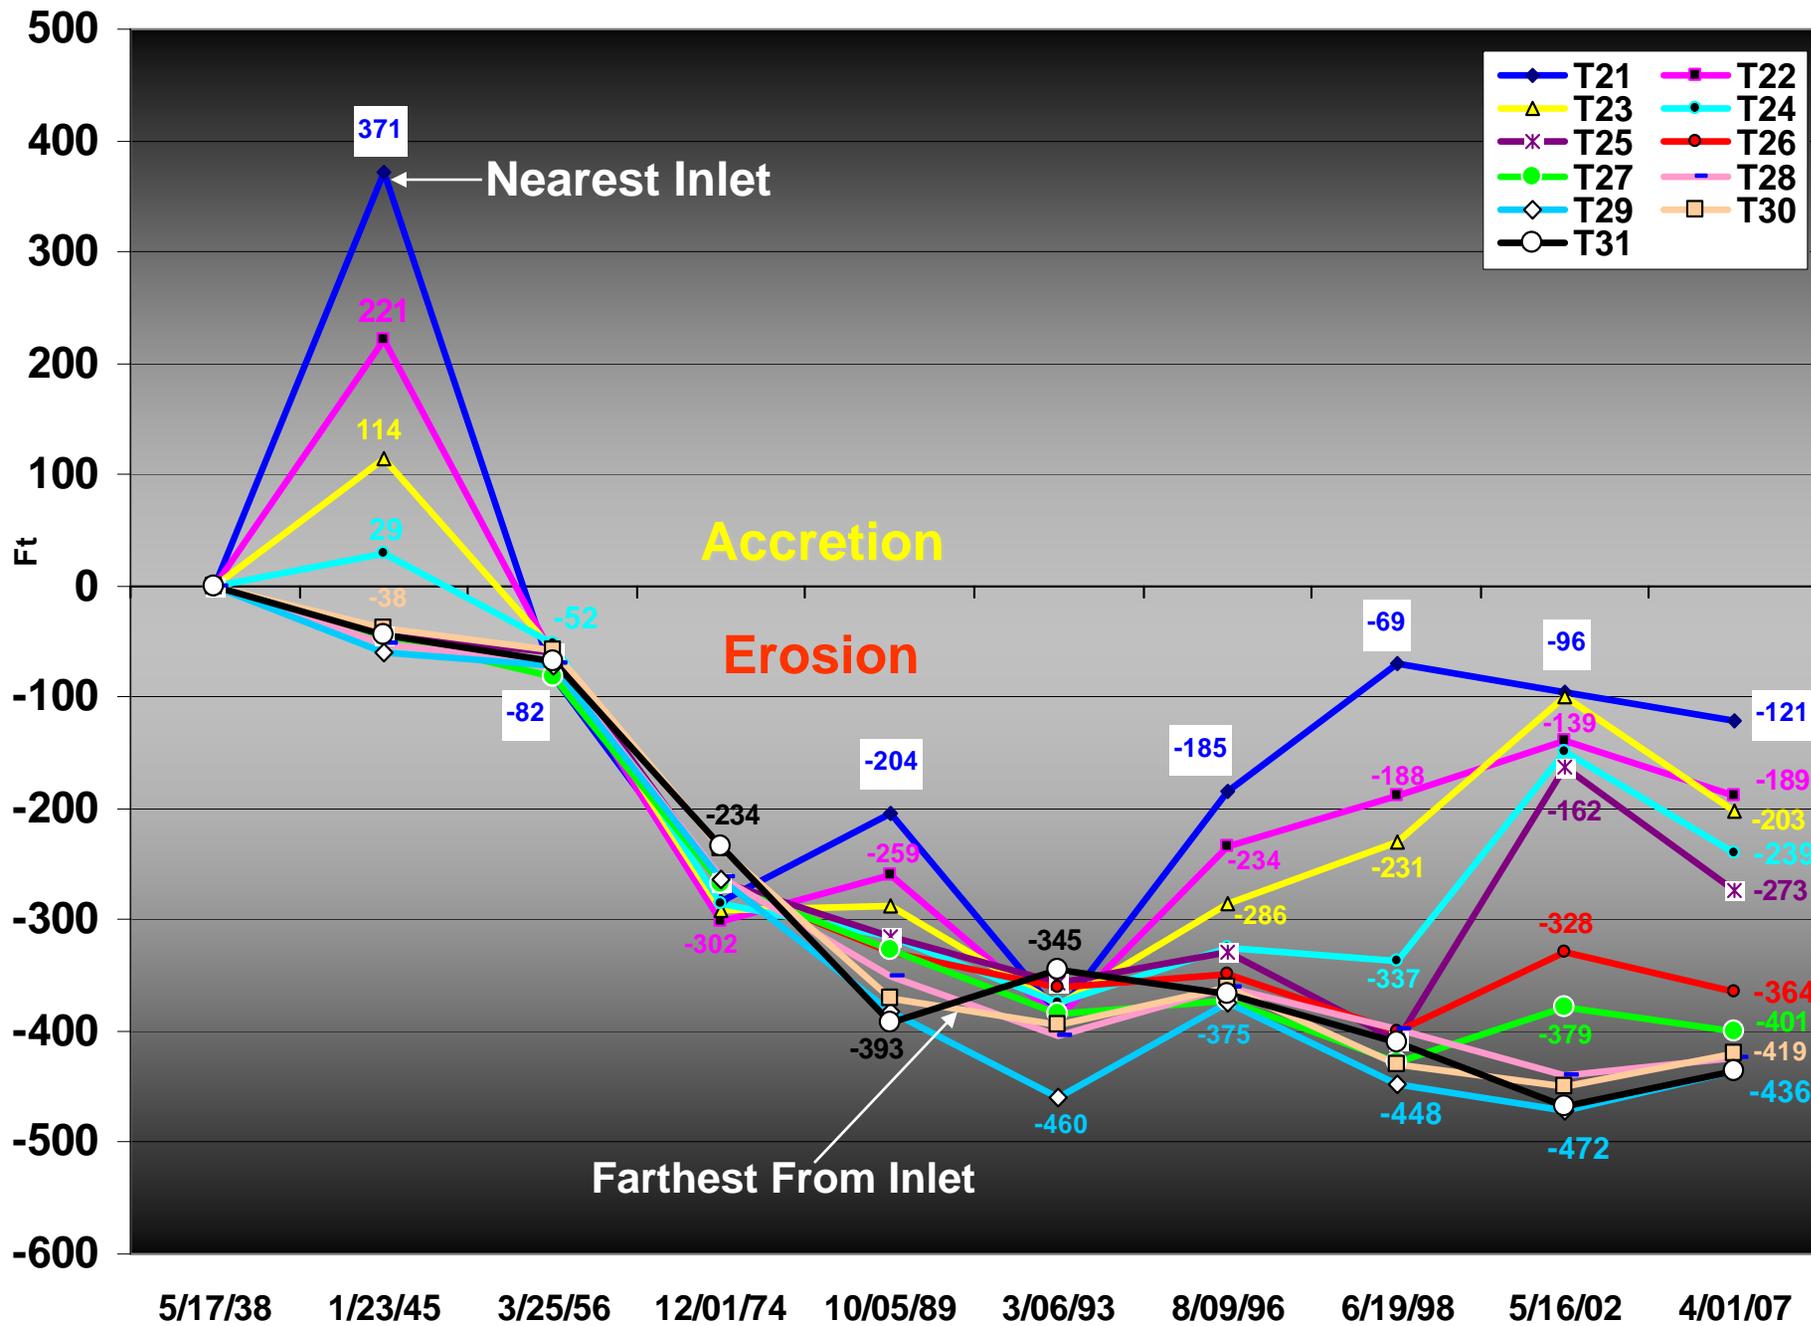
Figure 27. Graph depicting cumulative shoreline changes between 1938 and 2007 along transects T21 to T31 on HI. Note the shoreline at all transects has been characterized by net erosion that ranged from 121 to 436 ft. See Figure 13 for transect locations.

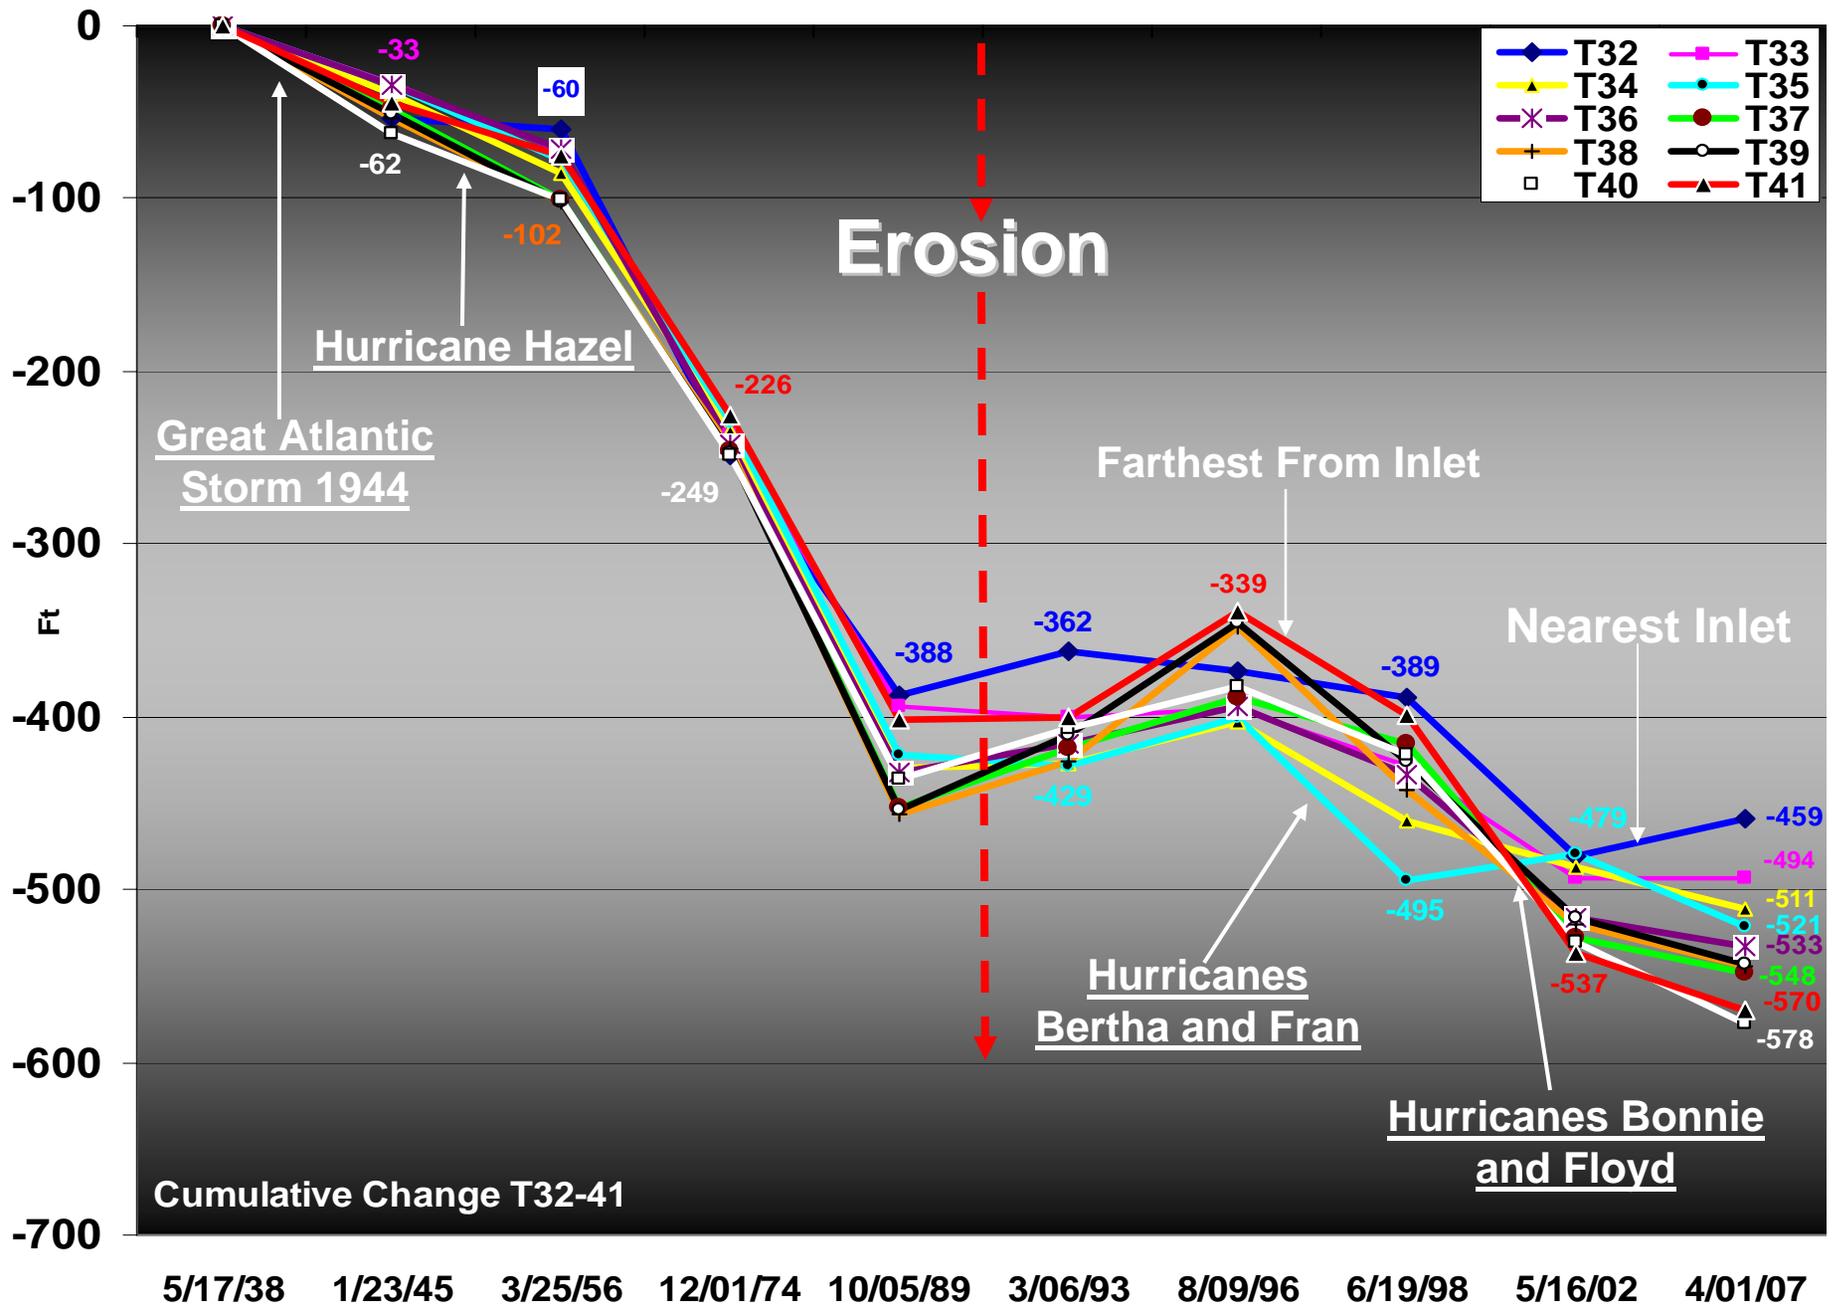
Figure 28. Graph depicting cumulative shoreline changes between 1938 and 2007 along transects T32 to T41 on HI. Note the shoreline at all transects has been characterized by net erosion that ranged from 459 to 578 ft. See Figure 13 for transect locations.

Figure 28 (Appendix) illustrates the shoreline change rates for Figure Eight and Hutaff Islands for nine periods between 1938 and 2007. Shoreline change rates along the oceanfront within the Inlet Hazard Area (T11-20) for the nine time periods were extremely variable due to the above mentioned factors. During the first erosion episode (1938-1945) related to inlet changes, the erosion rates along the oceanfront ranged from a minimum of 2 ft/yr at T13 to a maximum of 71 ft/yr at T20 near the inlet. Along the remainder of the oceanfront shoreline south of the IHA, change rates varied from +2 ft/yr

Two storms with significantly elevated water levels (Hurricanes Bonnie [8/26/98] and Fran [9/16/99]) occurred during the period from March 1998 to May 2002 that impacted the oceanfront shoreline (Figs. 28 D-E Appendix). During the above period, a number of mitigation projects were completed that included the January 1999 beach “bulldozing” operation for the repair of the 1997 Post-Fran beach fill project, placement of sand bags along threatened homes in early 2000 (Fig. 1 A-B Appendix), and lastly the placement of ~ 350,000 cy of material along the northern 9,000 ft of the oceanfront (Figs. 5 and 6 Appendix). Figure 28 A (Appendix) depicts shoreline change rates and shows that shoreline retreat was commonplace along the northern segment of the oceanfront between T11 and T20 where erosion rates ranged from a minimum of 1 ft/yr at T12 to a maximum of 85 ft/yr along the shoreline in vicinity of T20 near the inlet. The longevity of the previously mentioned fill project along much northern shoreline reach was minimal (Fig. 6 Appendix). In contrast to the above, the shoreline reach (T1-T10) to the south prograded slightly, at rates ranging from 1 ft/yr to 10 ft/yr.
