**APPENDIX B
ENGINEERING REPORT**

Inlet-Related Shoreline Changes: Rich Inlet, North Carolina

Update Through 2007

William J. Cleary

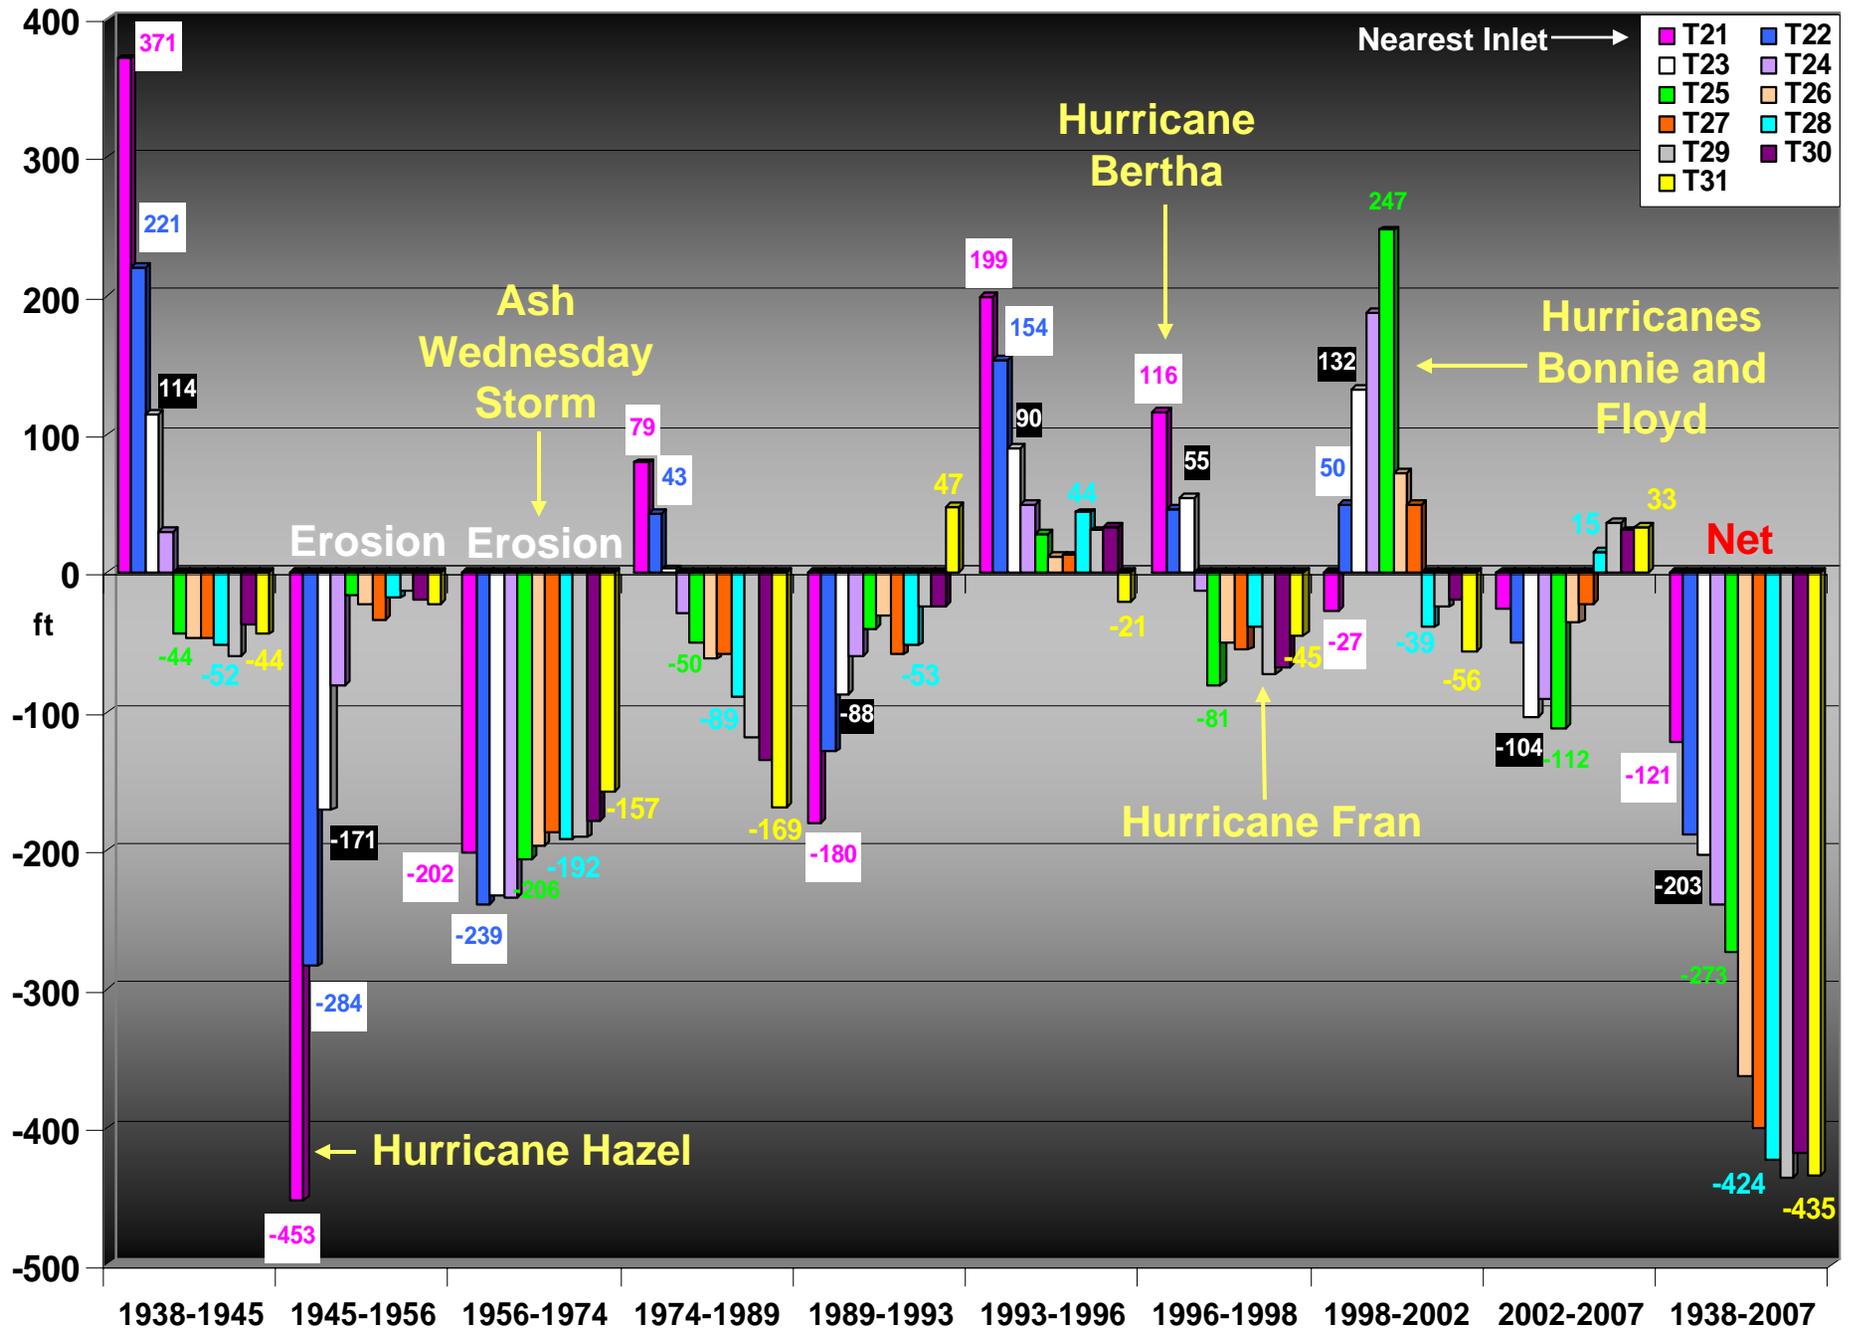
Figure 29. Bar graph depicting short-term shoreline changes along the HI oceanfront between the T21 and T 31 from 1938 to 2007. The entirety of the HI oceanfront shoreline lies within an IHA. Periods of accretion are inlet-related.

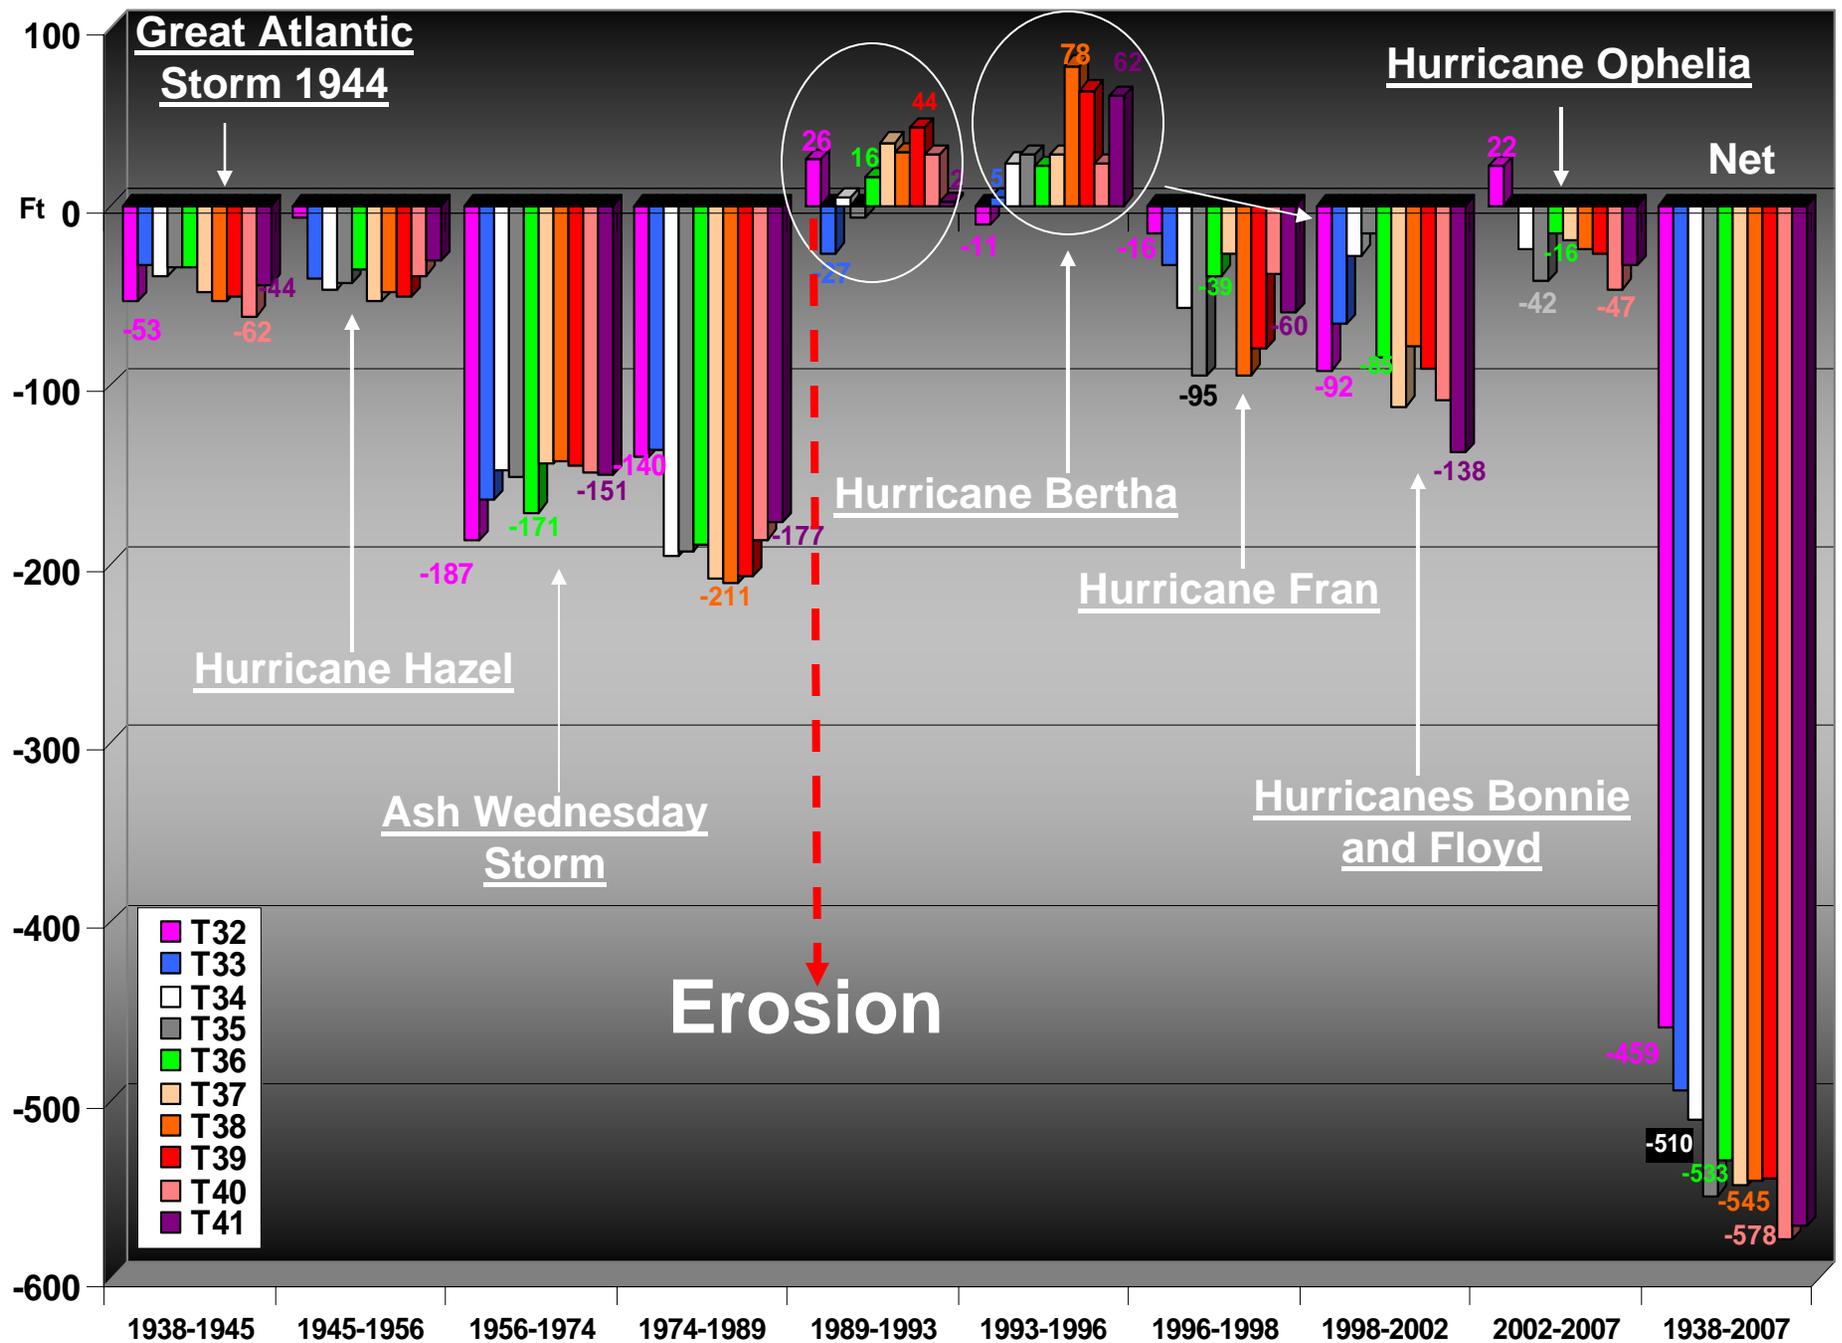
Figure 30. Bar graph depicting short-term shoreline changes along the HI oceanfront between the T32 and T 41 from 1938 to 2007.

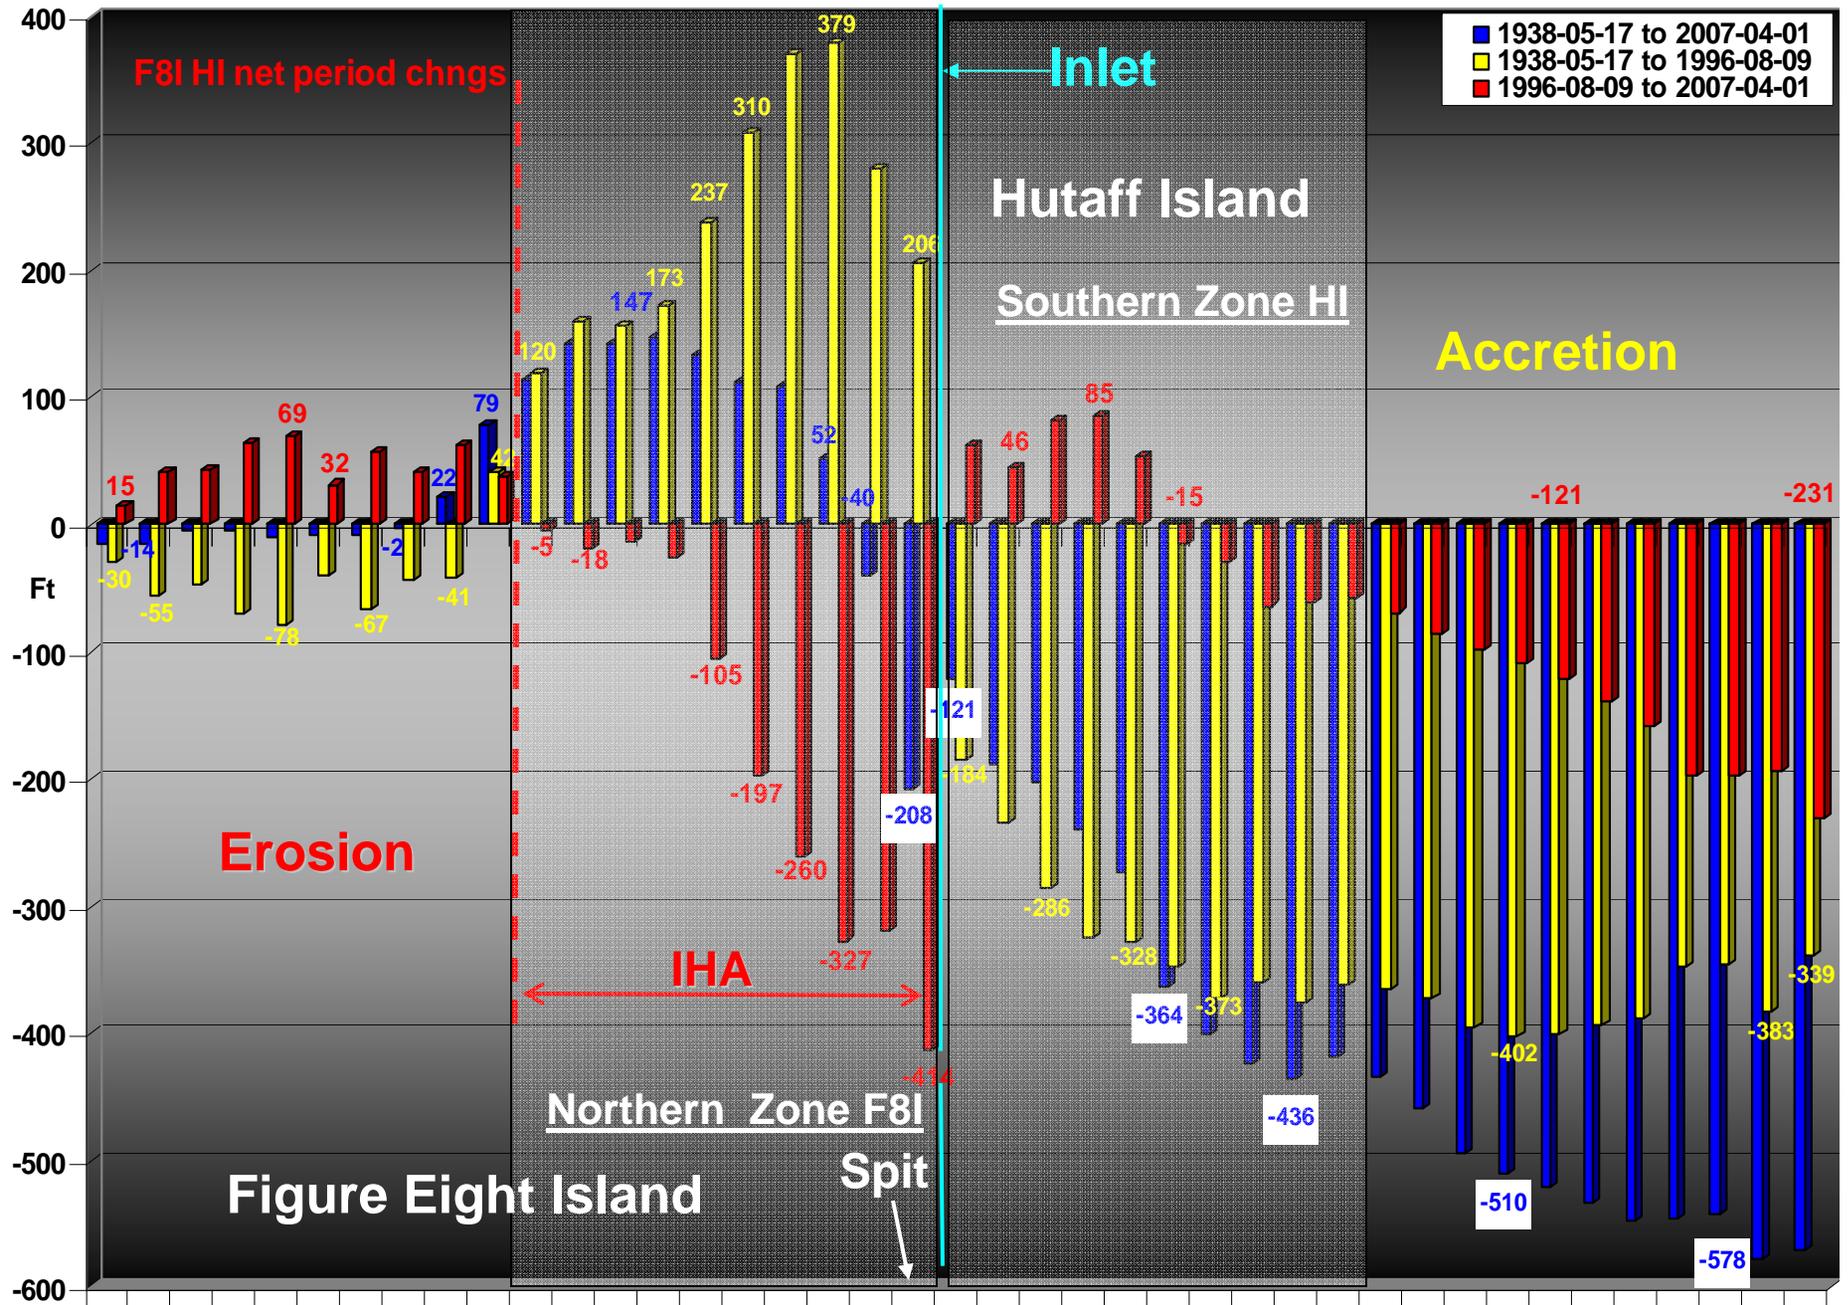
Figure 31. Graph depicting the net shoreline changes along the F8I and HI oceanfront for selected periods of time between 1938 and 2007. A contrasting pattern of shoreline change characterizes F8I (Transects 1-20) and HI (Transects 21 - 41).

Although the oceanfront along the northern portion of Figure Eight Island has experienced several periods of erosion since 1938, net progradation has characterized the past seven decades of oceanfront shoreline change (Fig. 31). Between 1938 and 2007 the shoreline within the Inlet Hazard Area, between T10 and T 20, prograded an average of 70 ft (Fig. 32). The great majority of the natural oceanfront progradation occurred periodically between 1938 and 1996, when the ebb channel was positioned within ~715 ft of its 1938 position (Fig. 14 Appendix). The coast-wise extent of the shoreline buildup varied and depended upon the proximity of the ebb channel, its alignment and the location of the zone of swash bar attachment. Between 1938 and 1996, the shoreline segment between T10 and T 20 prograded an average of 239 ft (Fig. 32). Subsequent to the ebb delta breaching event in 1994, which repositioned the ebb channel 1,056 ft to the northeast, the ebb delta and the F8I oceanfront entered a transition period when the system was adjusting to the new position and alignment of the channel. The reconfiguration of the ebb delta that was likely completed by late 1998 marked the onset of major island planform changes and the chronic erosion that currently exists along the

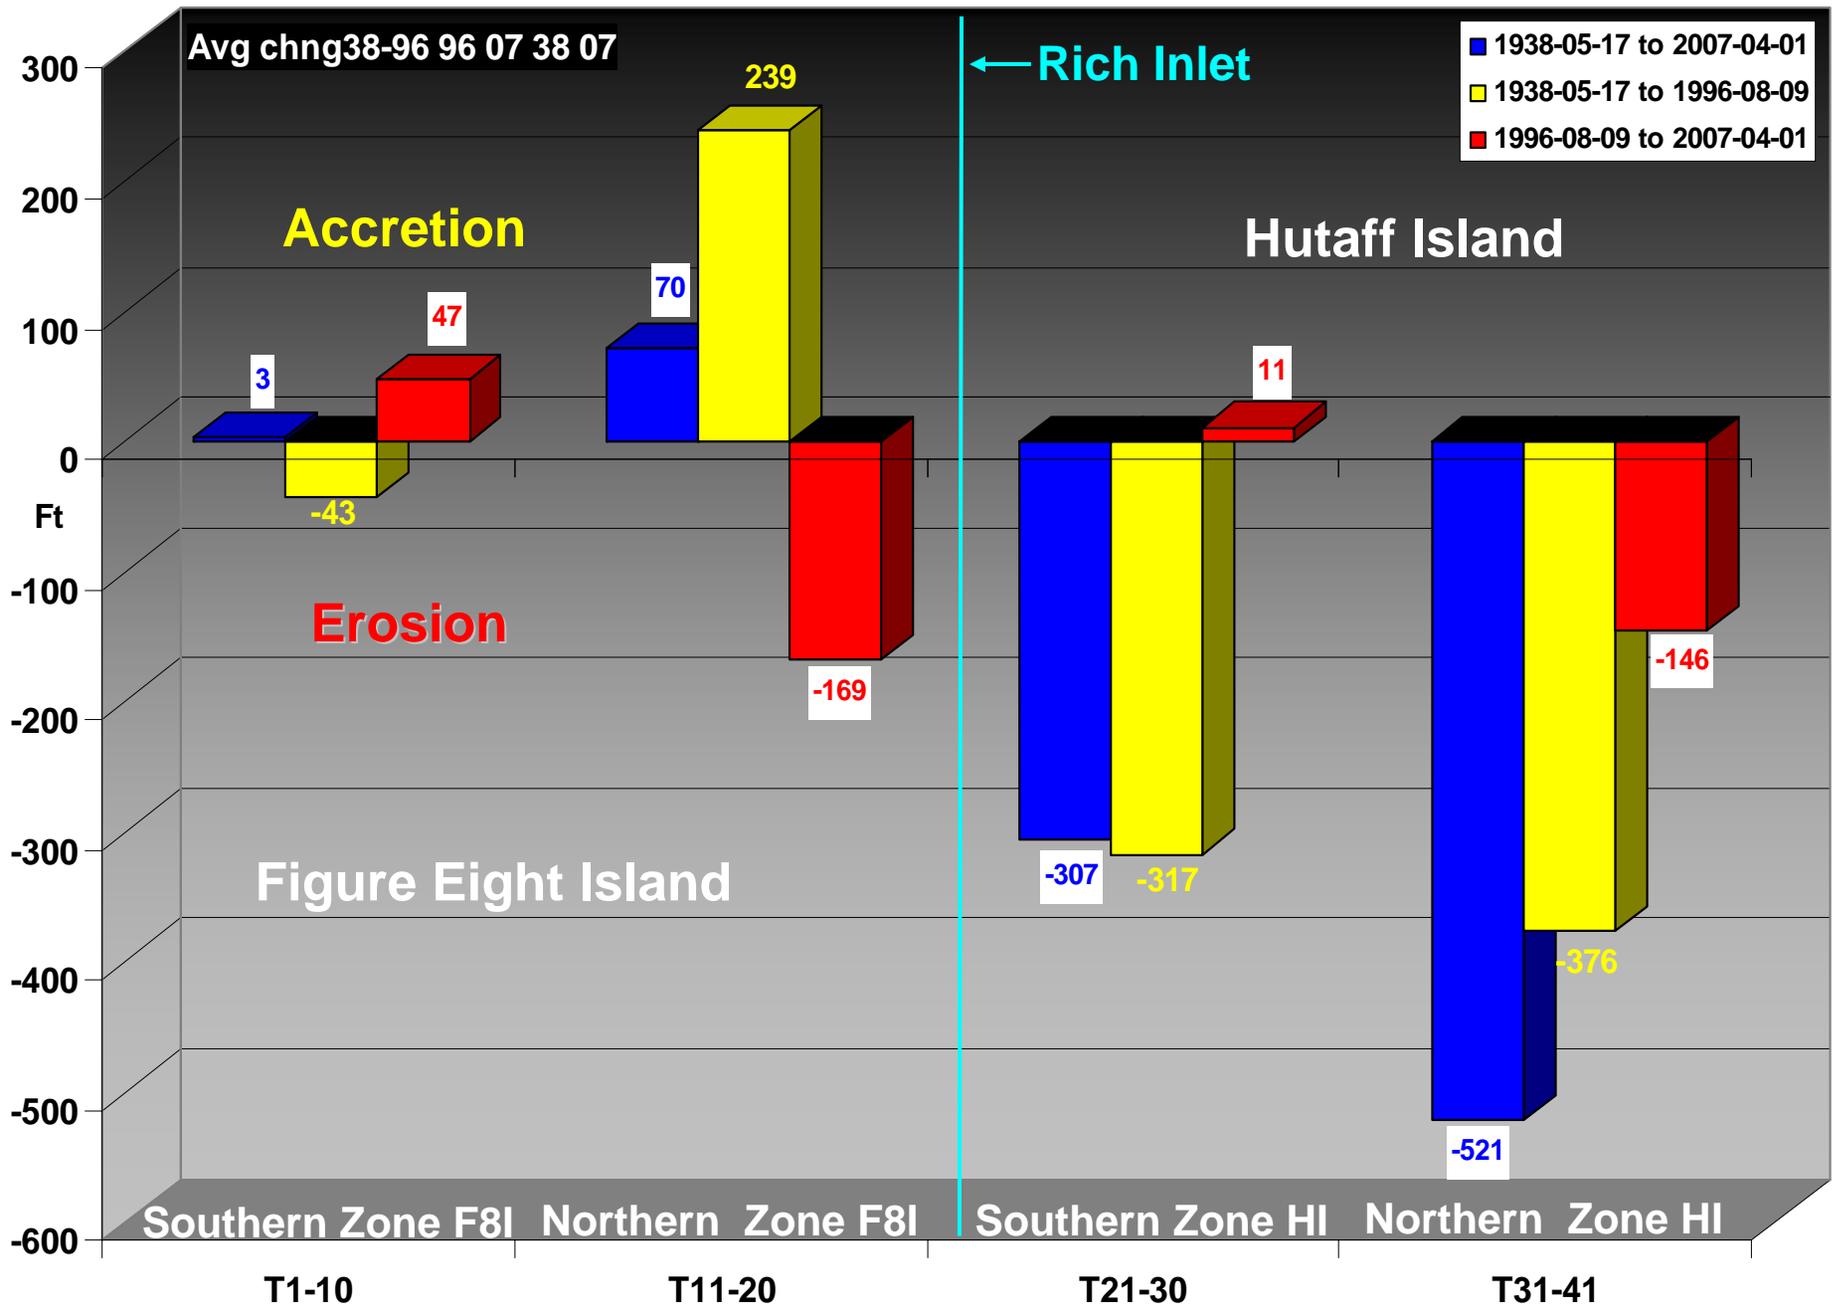
Figure 32. Graph depicting the average net shoreline changes along the F8I and HI oceanfront zones (T1-10, T11-20, T21-31 and T32-41) for selected periods of time between 1938 and 2007. A contrasting pattern of shoreline change characterizes F8I (Transects 1-20) and HI (Transects 21 - 41).

The above-mentioned increased erosion along the Nixon Channel T7 - T9 shoreline segment (Fig. 37 and Fig. 32 Appendix) has led to the development of a high hazard zone where shoreline retreat has become a serious management issue. Figures 18 A-B, 19 B and Figure 41 (Appendix) illustrate the condition of the estuarine shoreline and adjacent uplands in the area. The presence of a series of shrub thickets in the early

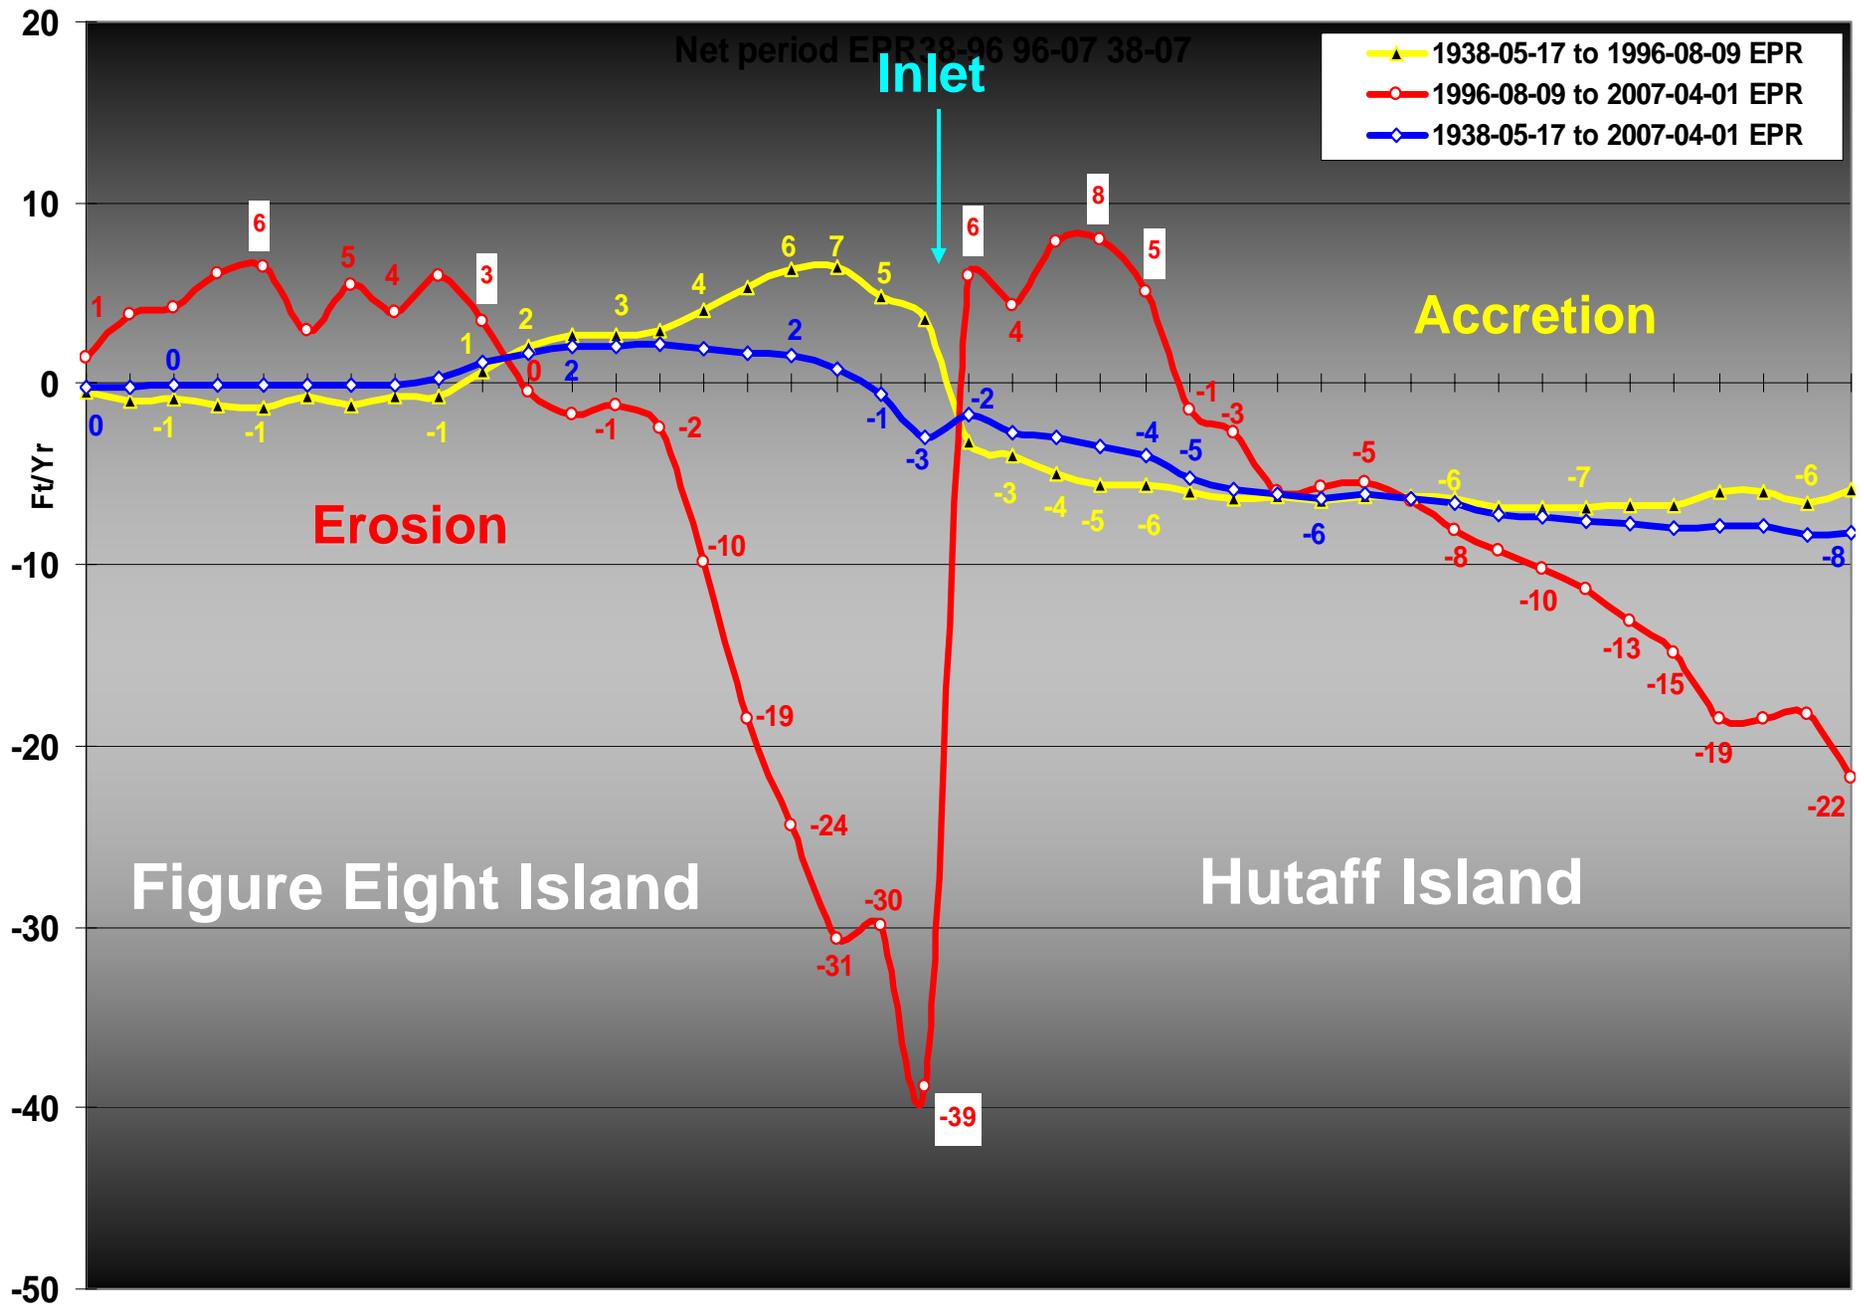
Figure 33. Graph depicting the shoreline change rates (end-point rate) for all transects along F8I and HI for various periods of time between 1938 and 2007.

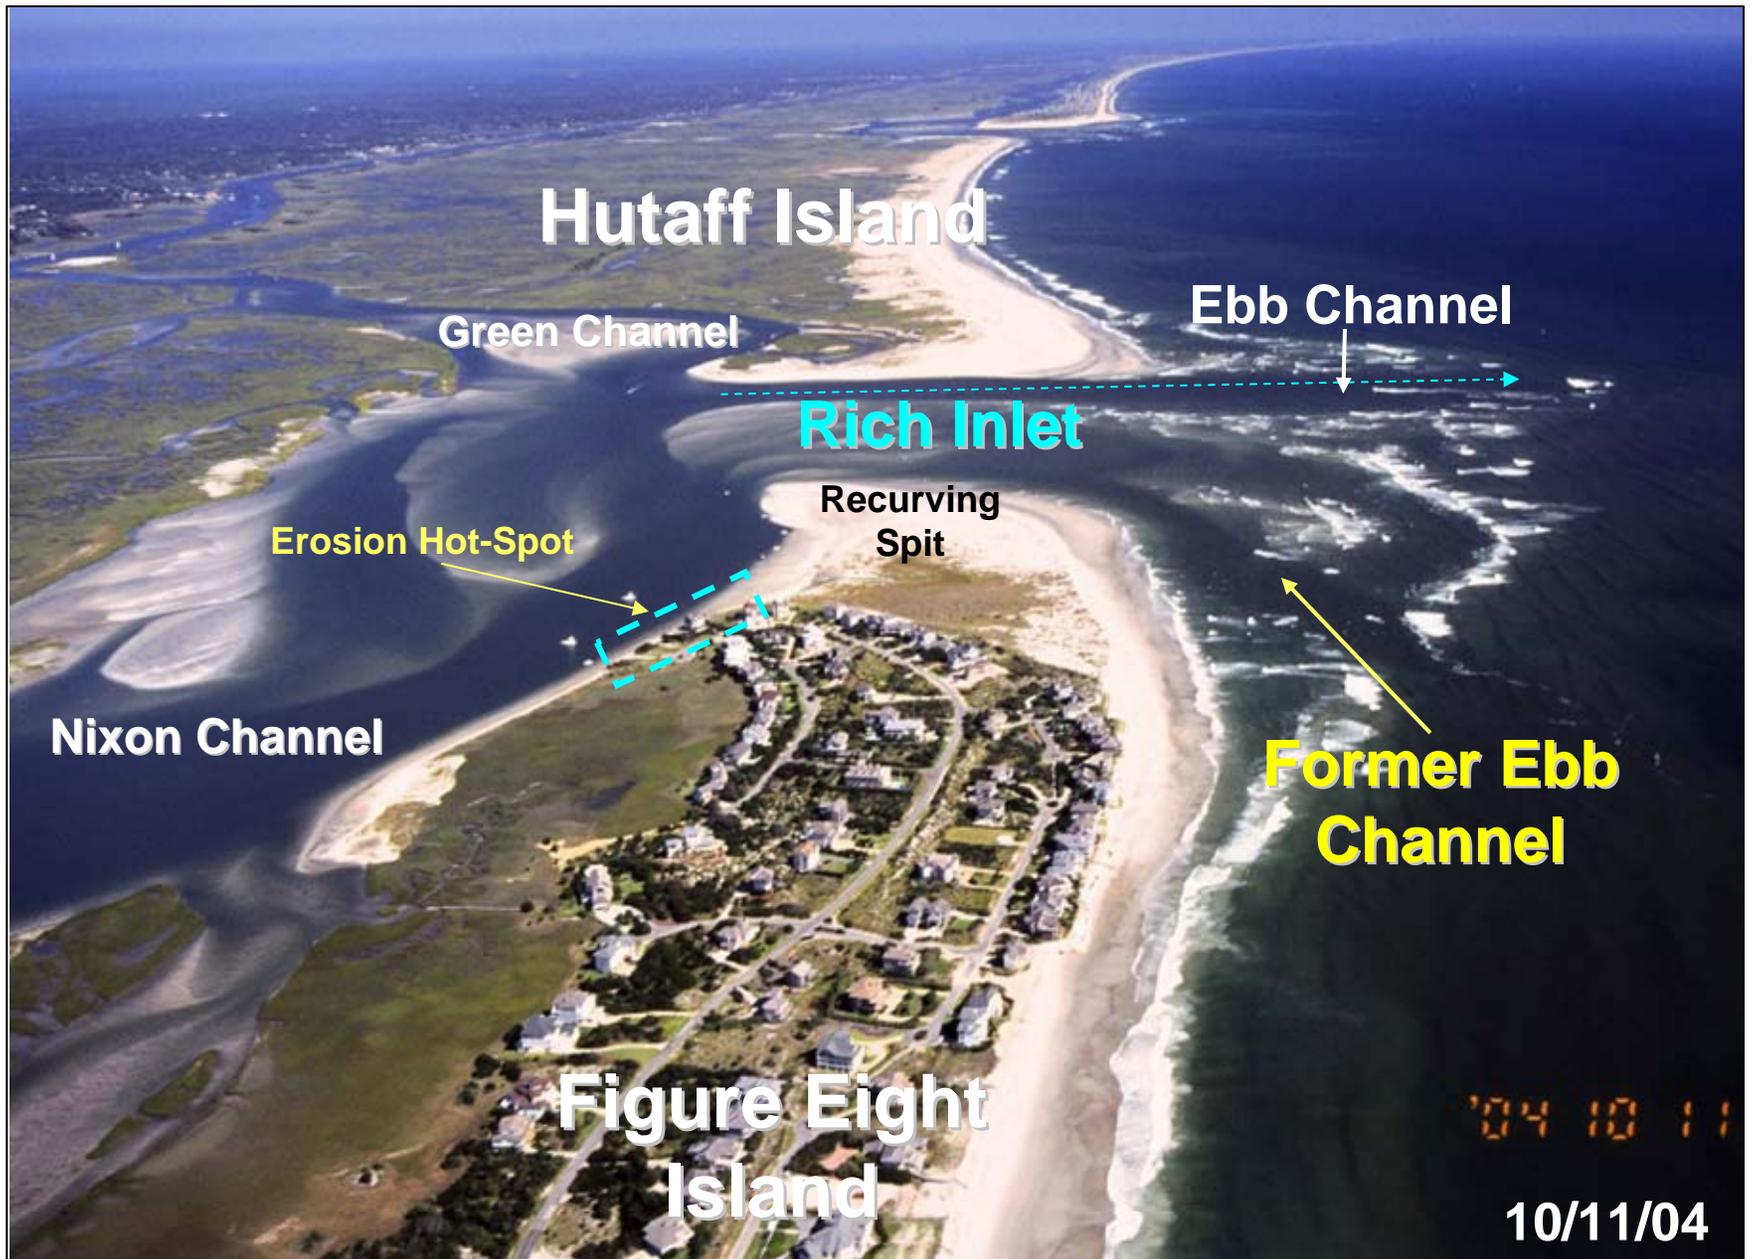
Figure 34. Oblique aerial photograph (10/11/04) illustrating the oceanfront conditions along northern end of F8I, the interior channels and location of the estuarine erosion hot-spot (light blue dashed line box).

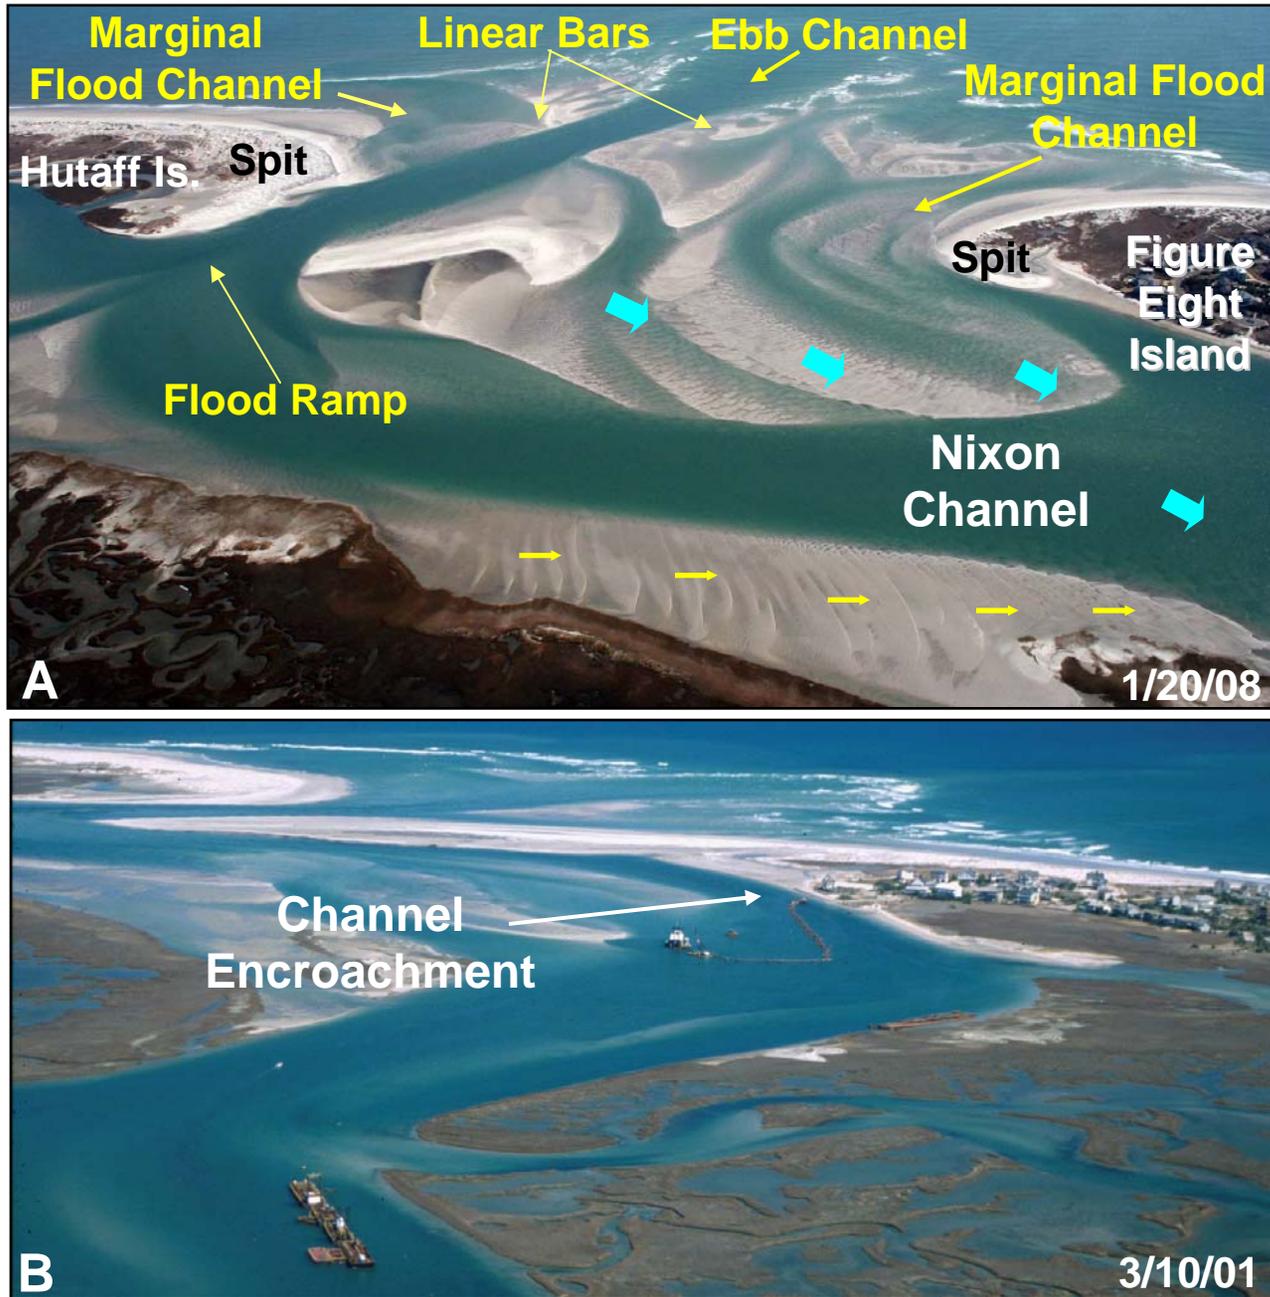
Figure 35. Aerial photographs depicting migration of bed forms (sand bars) and subsequent shoaling of the navigation channel. **A.** Seaward view (1/20/08) of the ebb and flood deltas and the multitude of bed forms. The majority of the sand packages are moving into Nixon Channel. **B.** Seaward view (3/10/01) of Nixon Channel depicting dredging operations associated with the 2001 nourishment project.

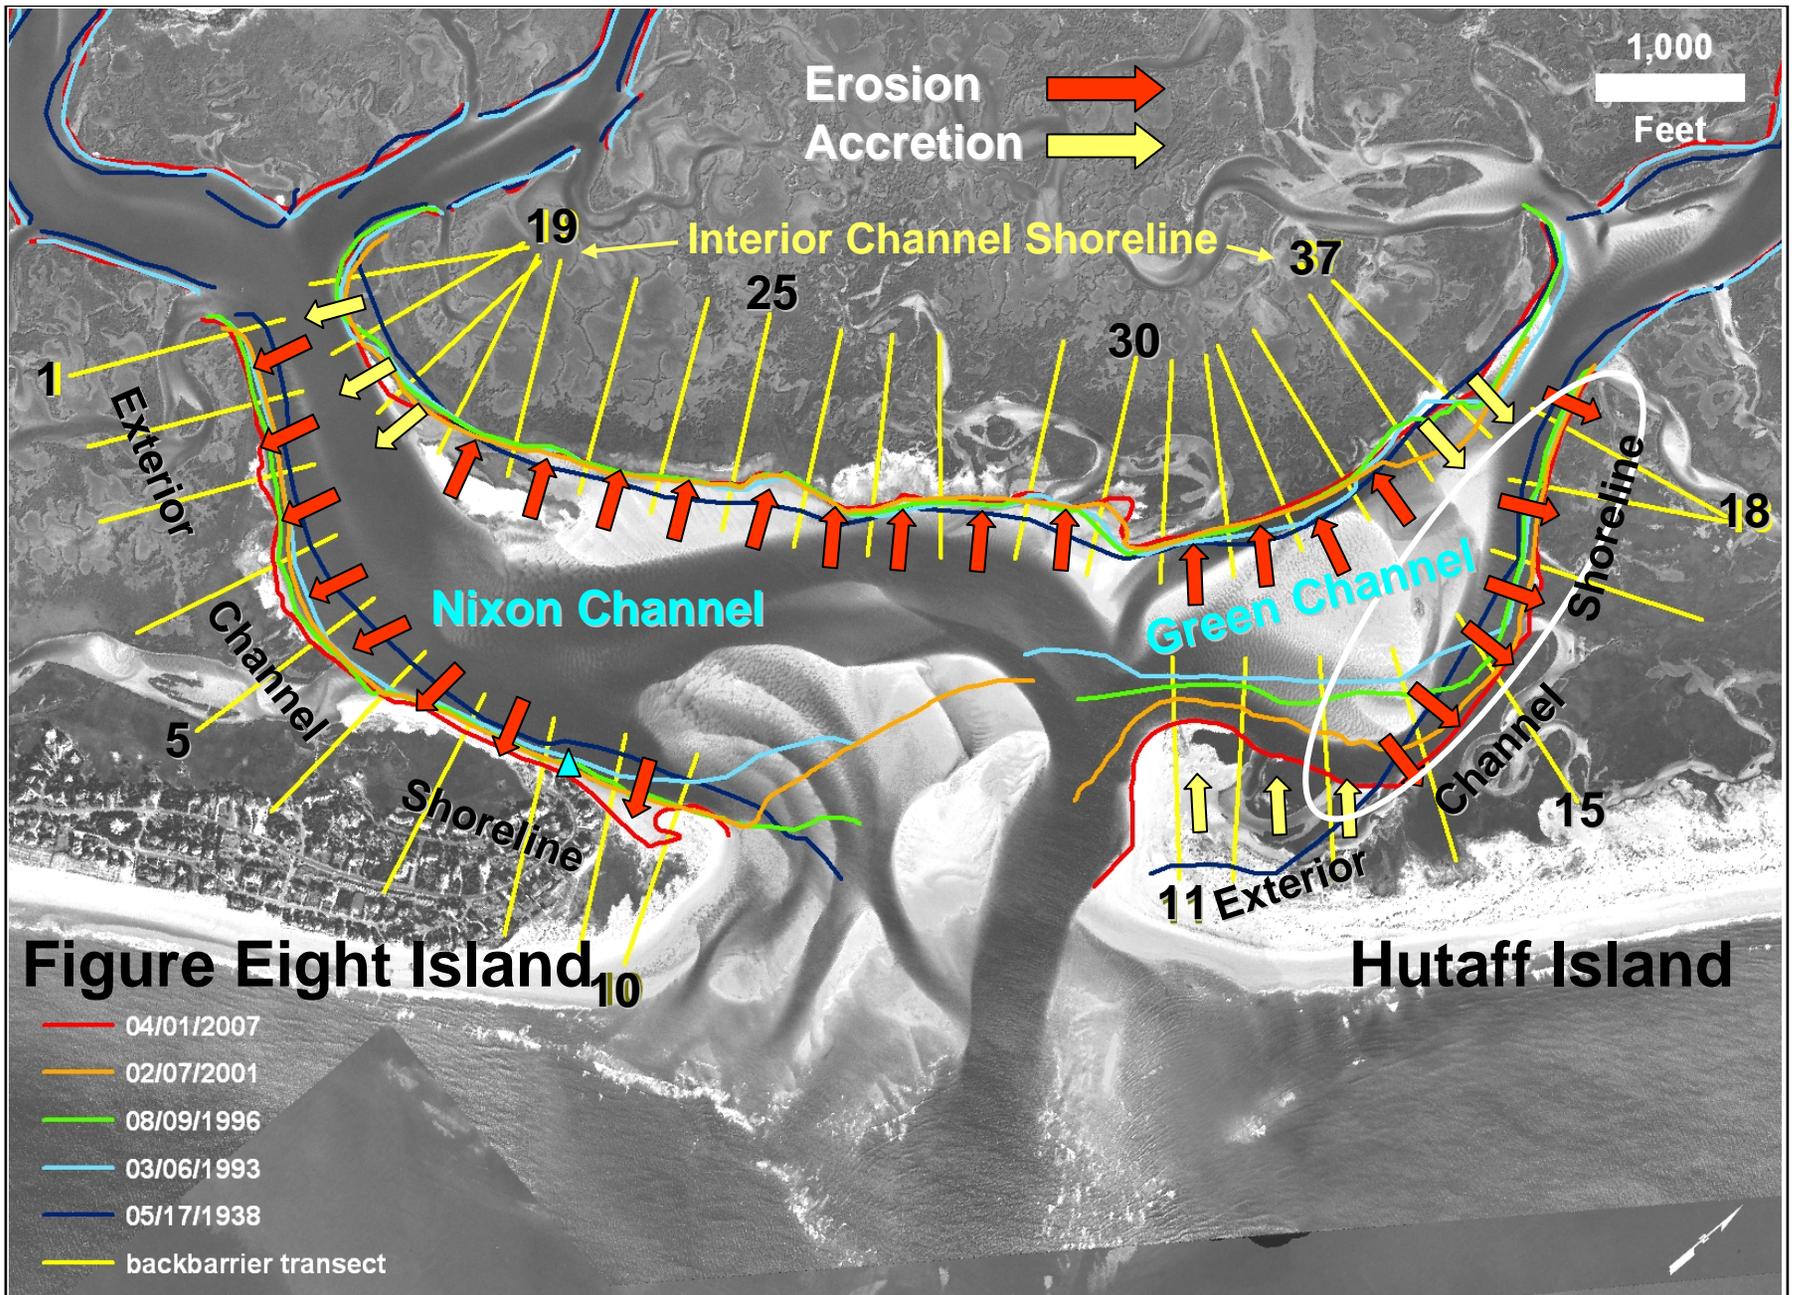
Figure 36. Aerial photograph (2007) depicting the location of transects along the margins of Green and Nixon Channels and the positions of the estuarine channel margins (selected years 1938-2007). Red colored arrows denote erosion while yellow arrows denote accretion.

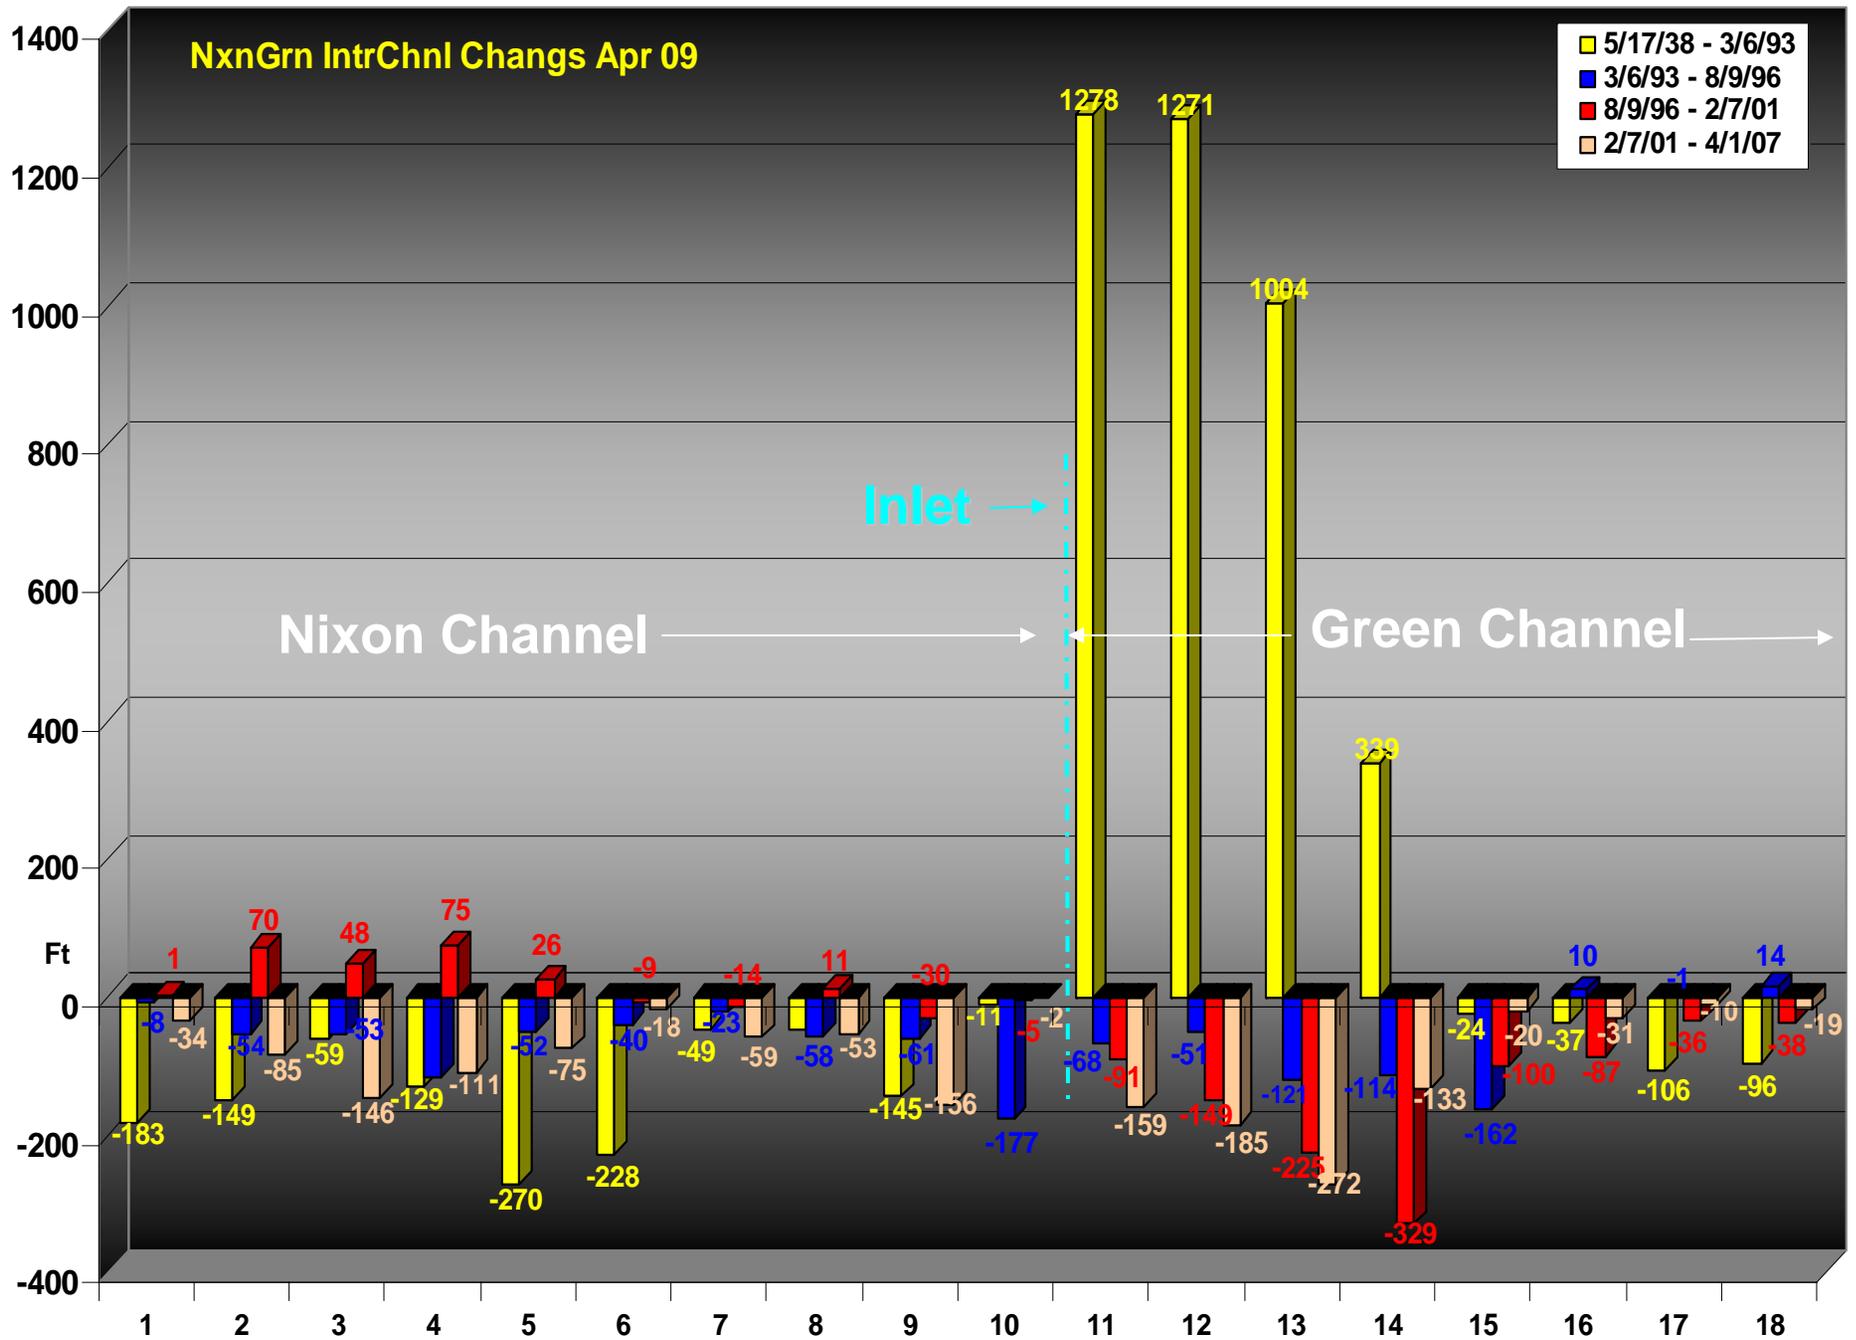
Figure 37. Bar graph illustrating net shoreline changes for various periods between 1938 and 2007 along the external (seaward) channel margin from T1 to T18. See Figure 36 for transect locations.
