**APPENDIX B
ENGINEERING REPORT**

Inlet-Related Shoreline Changes: Rich Inlet, North Carolina

Update Through 2007

William J. Cleary

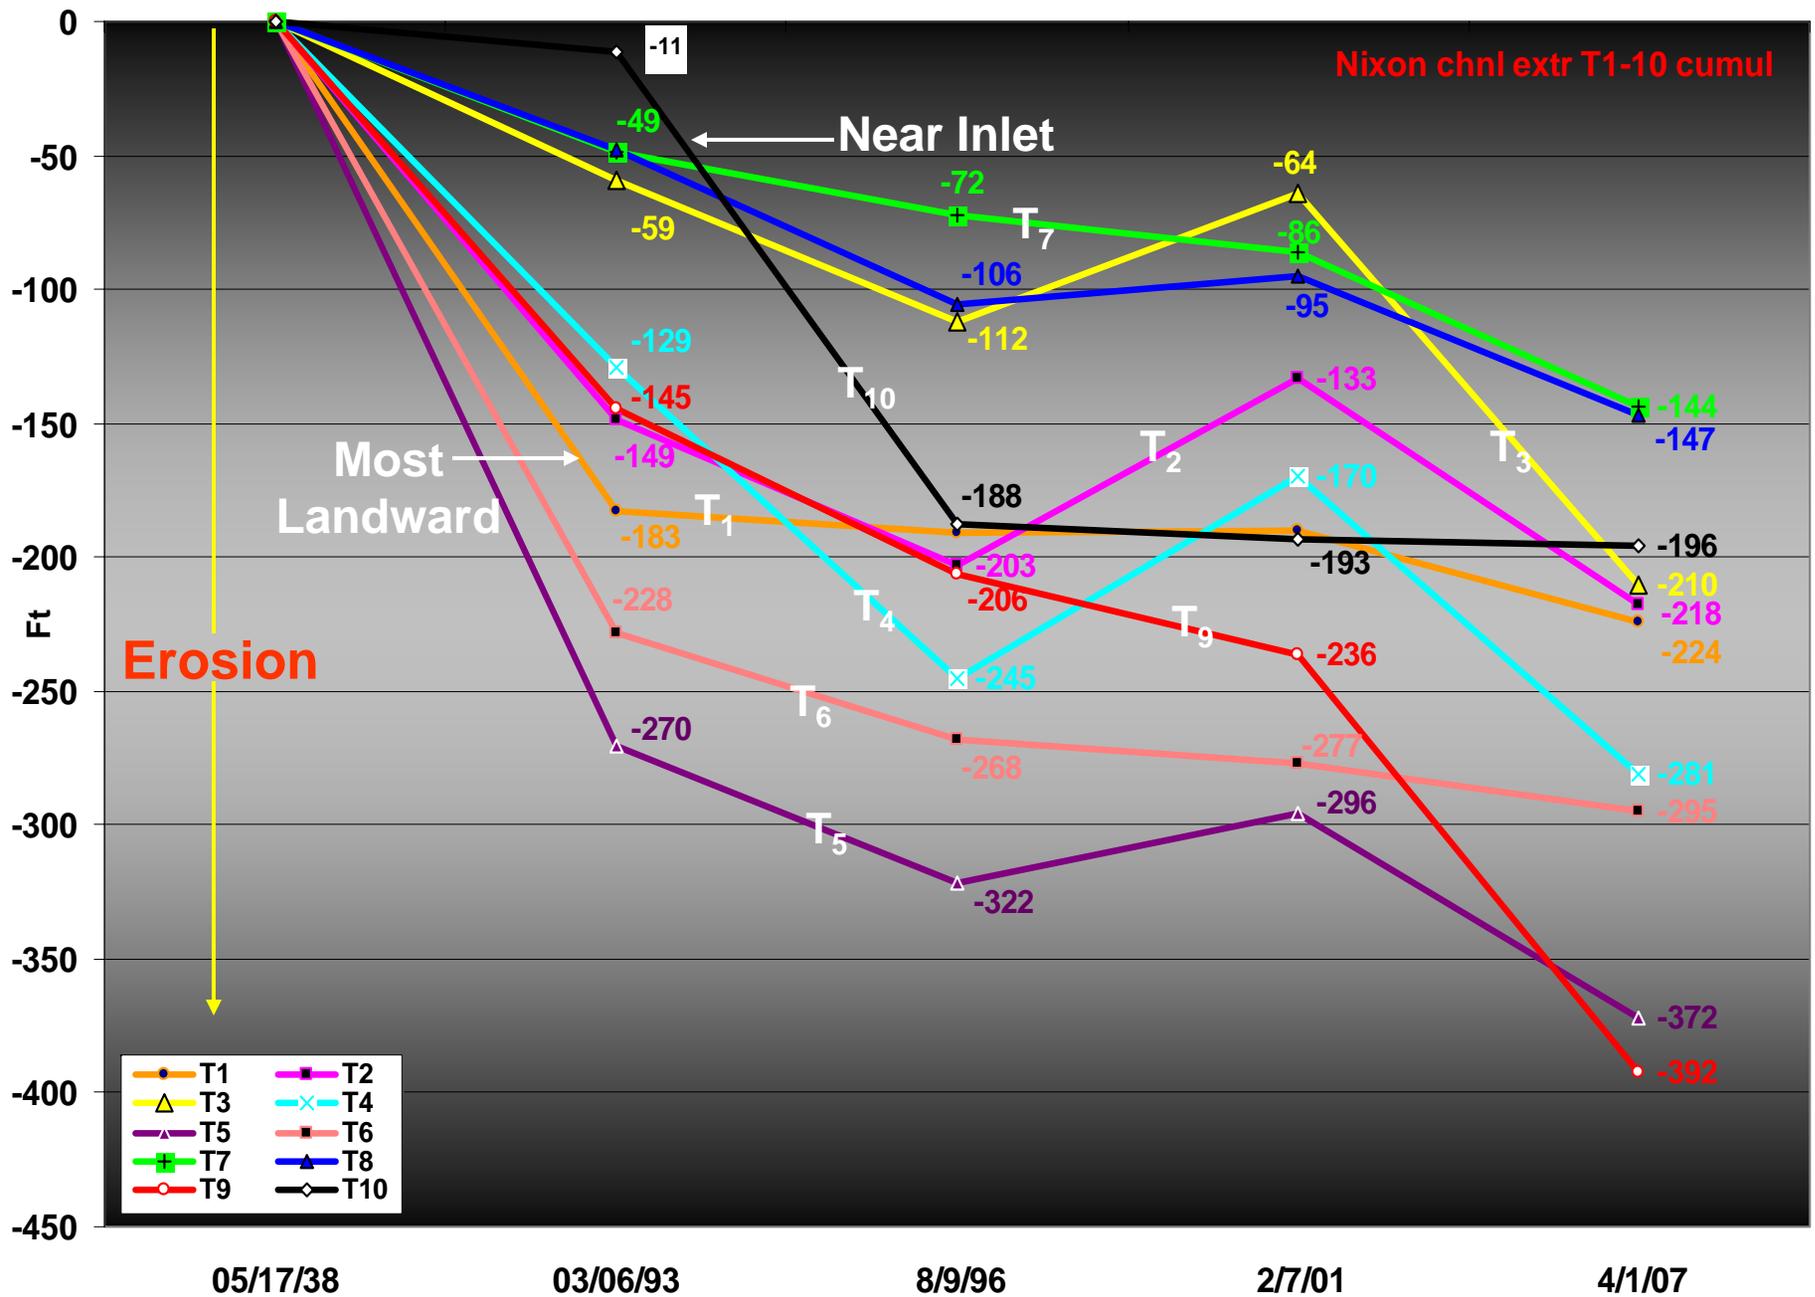
Figure 38. Graph depicting the cumulative shoreline change along the Nixon Channel exterior (seaward) margin. Note X axis is not to scale. See Figure 36 for location of transects along F8I channel margin.

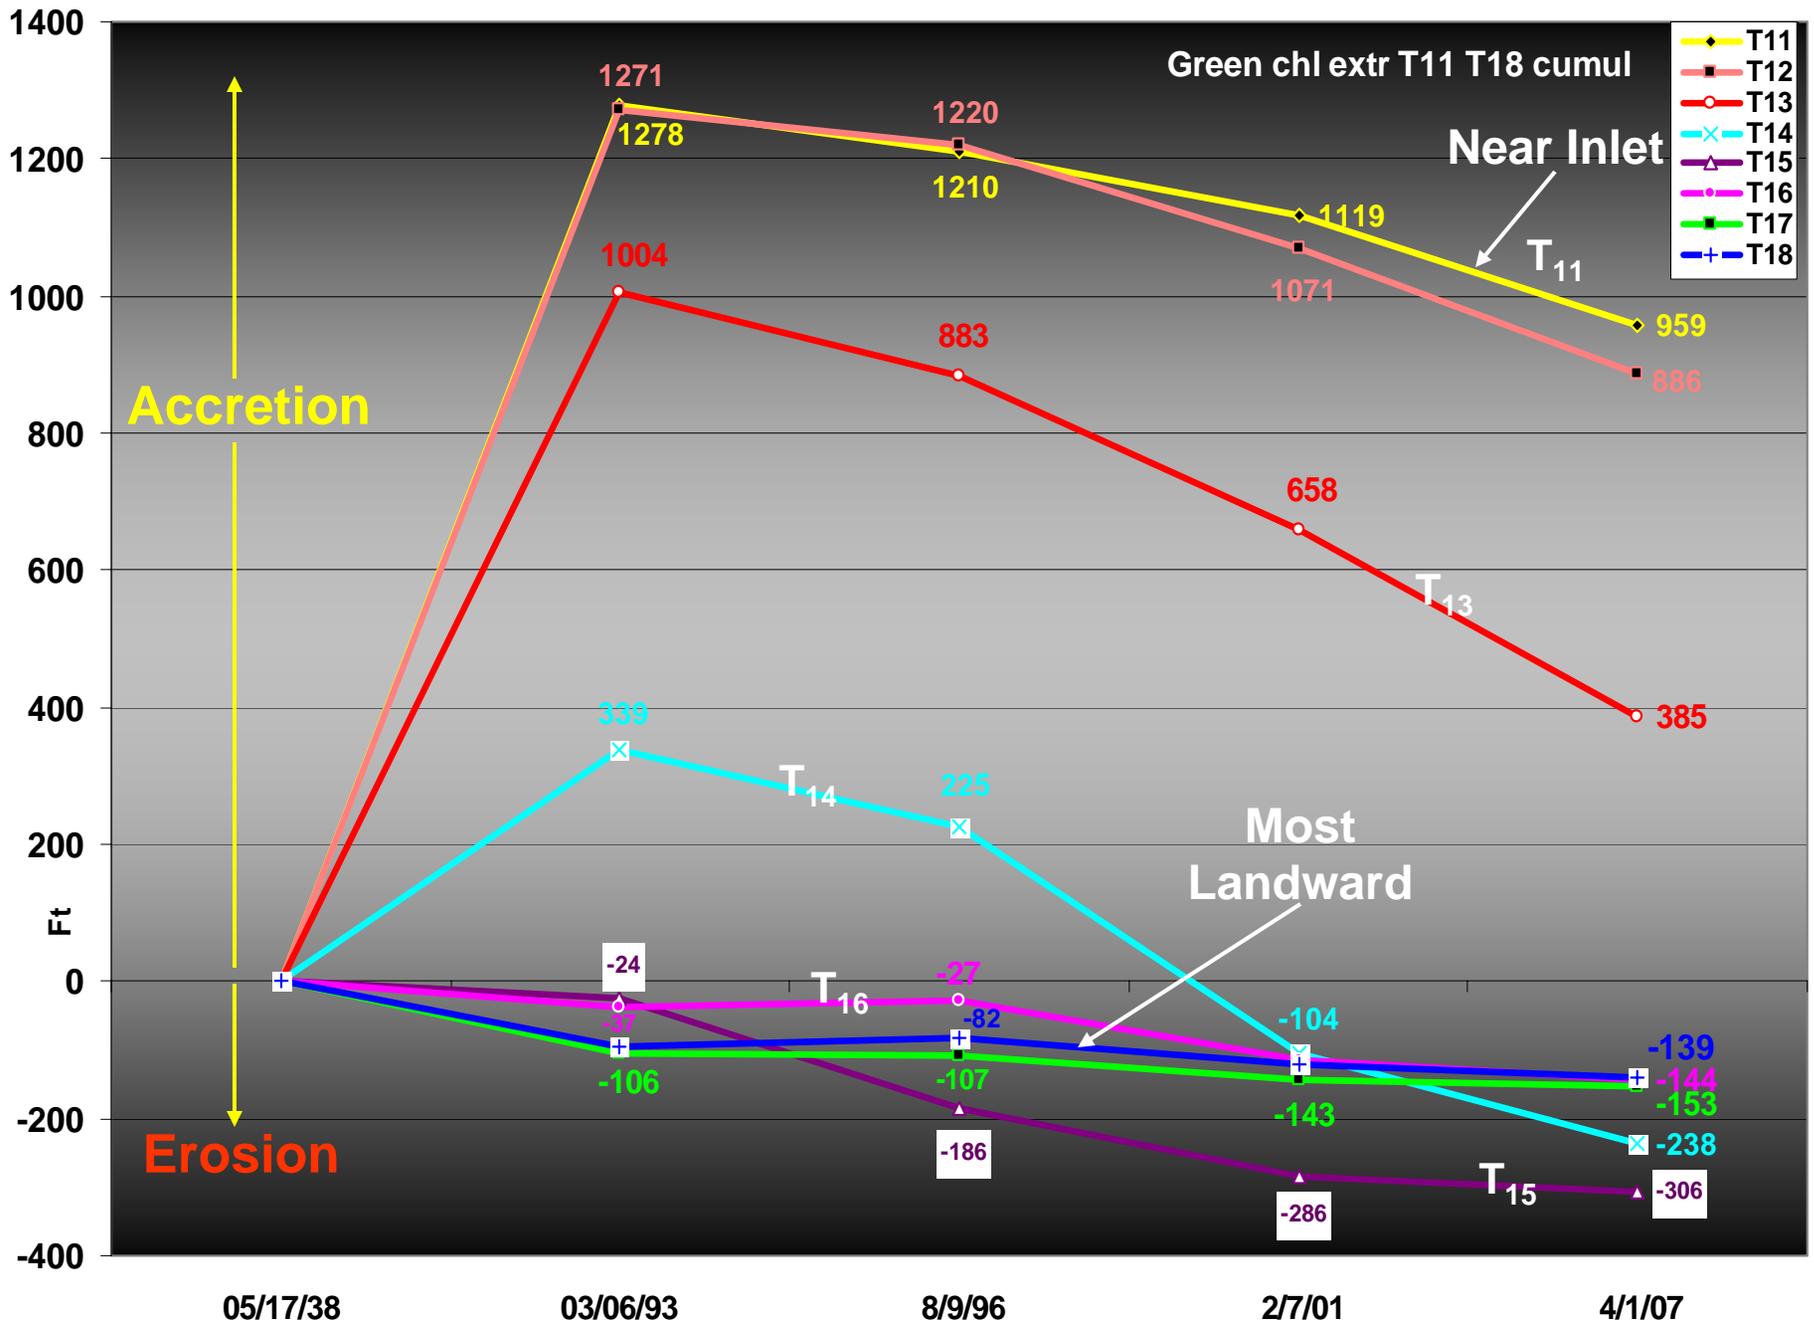
Figure 39. Graph depicting the cumulative shoreline change along the Green Channel exterior (seaward) margin. Note X axis is not to scale. See Figure 36 for location of transects along HI channel margin.

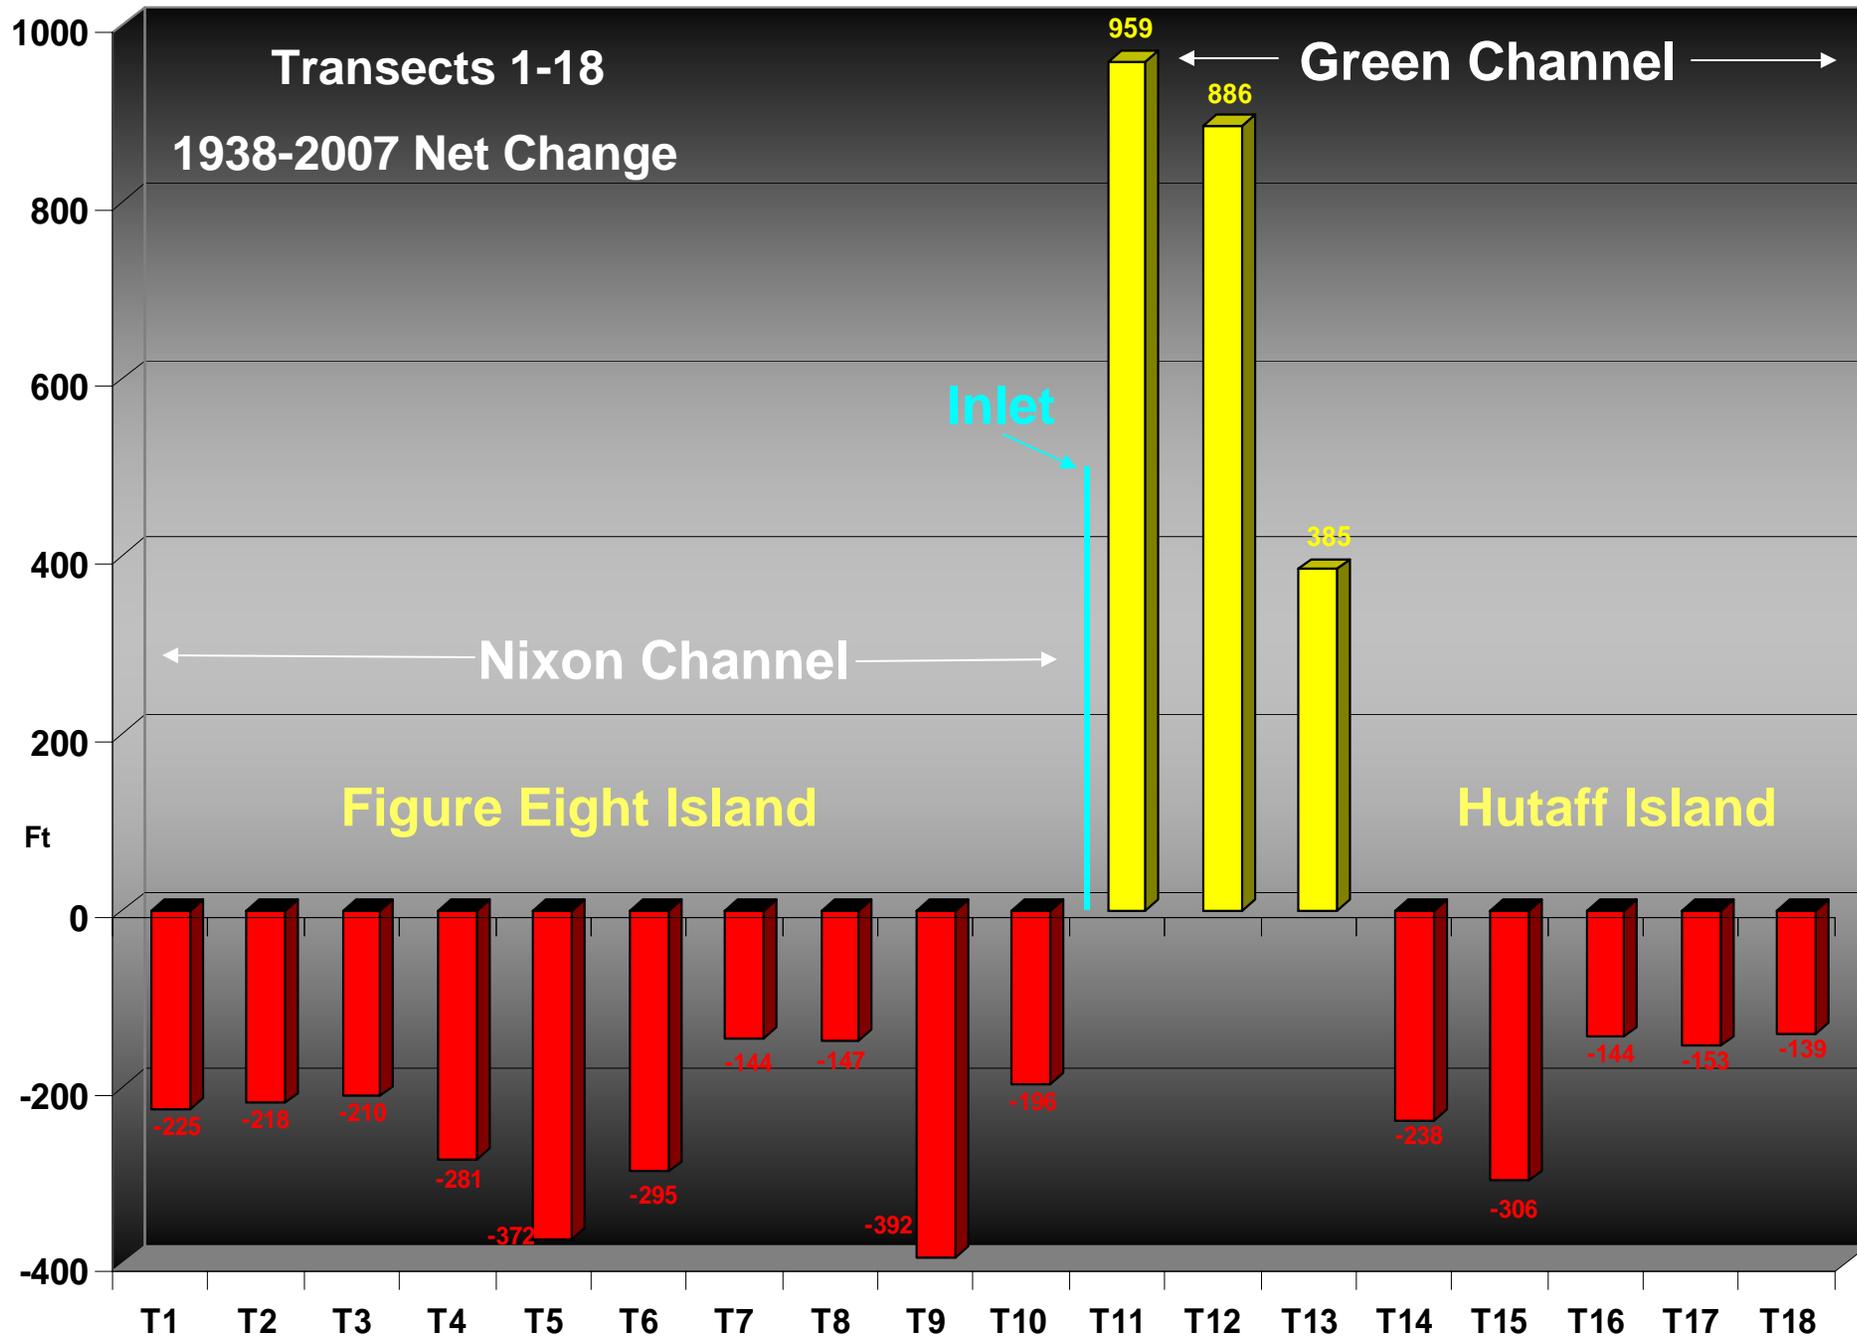
Figure 40. Bar graph depicting net shoreline change along external (seaward) margin (T1-T18) of Green and Nixon Channels from 1938-2007.

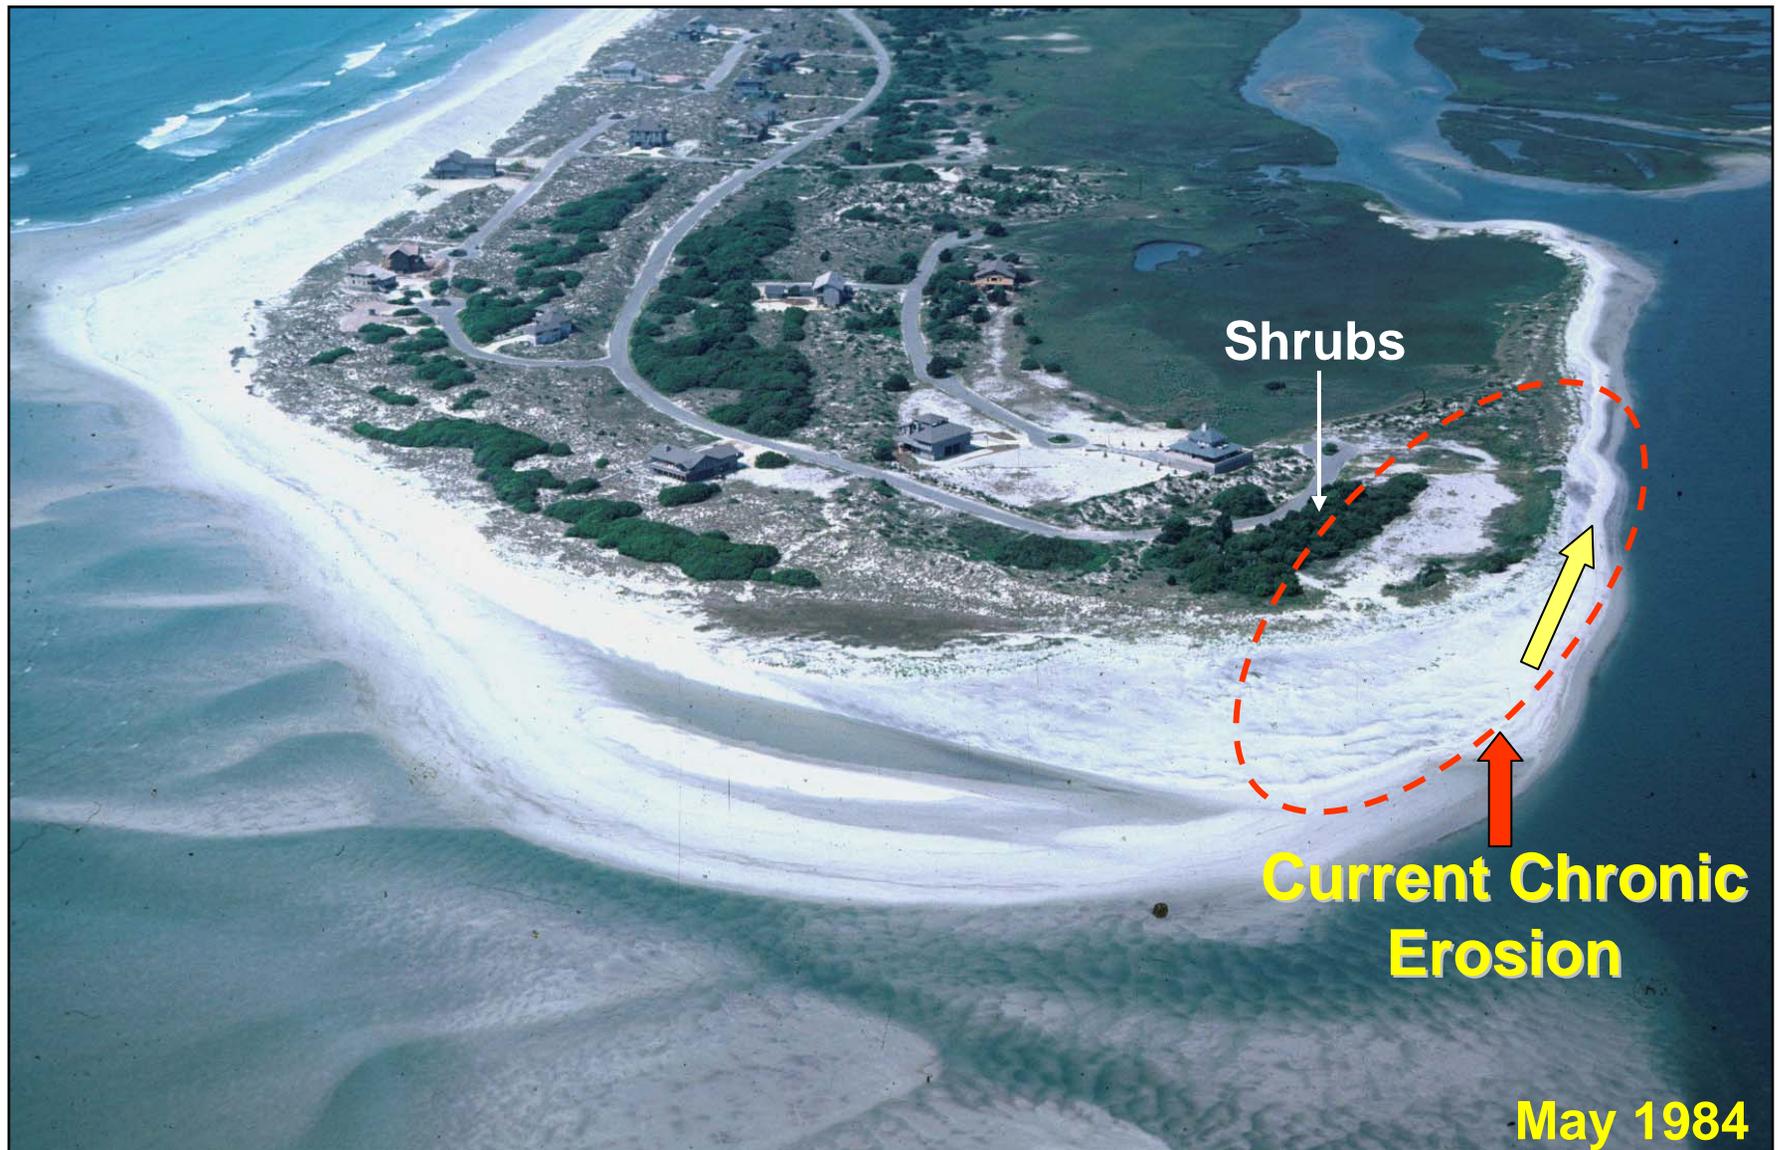
Figure 41. Oblique photograph (5/84) of the current erosion hot-spot along Nixon Channel. Note the relatively wide estuarine beach, dune field and shrubs. Also note the incipient spit development (yellow arrow).

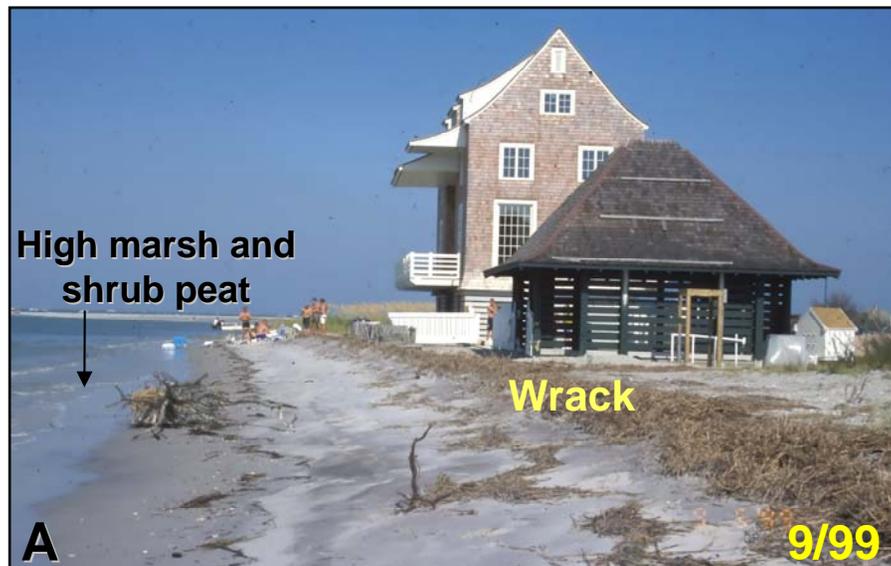
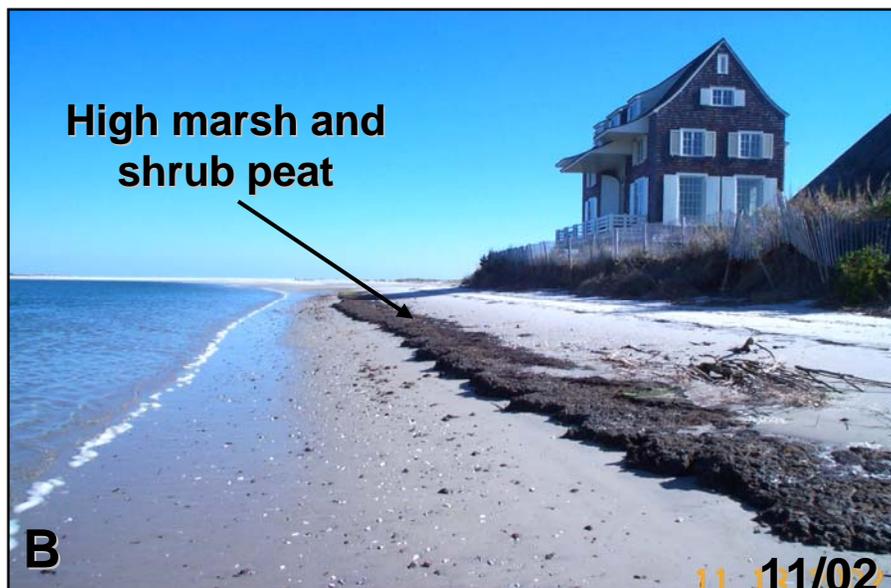
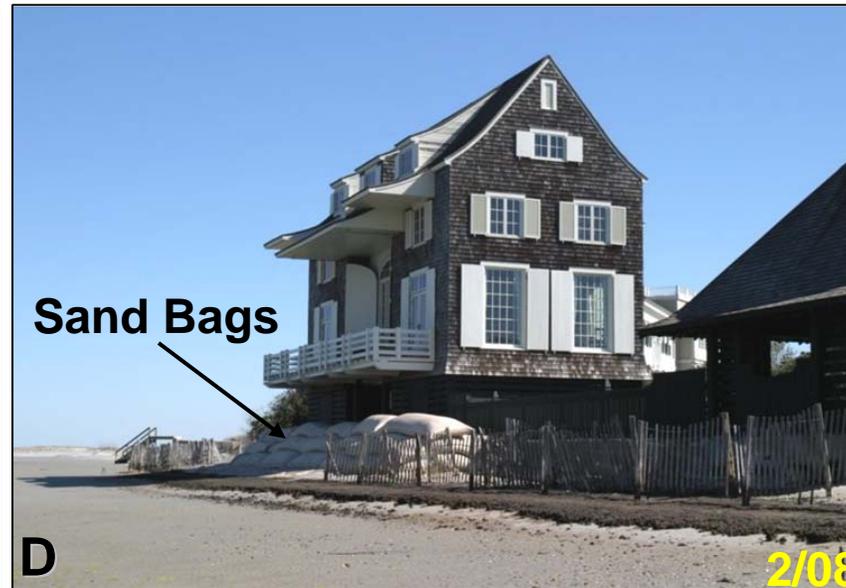
Figure 42. Photographs depicting erosion and shoreline retreat along Nixon Channel shoreline between 9/99 and 2/08. **A.** Seaward view (9/99) of eroding channel margin shoreline. Thin veneer of sand mantles offshore peat subcrop. **B.** Seaward view (11/02) of peat exposure and shrub stumps. **C.** Seaward view (10/06) of peat exposure and sand accumulation due to wave swash. **D.** Seaward view (2/08) of newly emplaced sand bags.

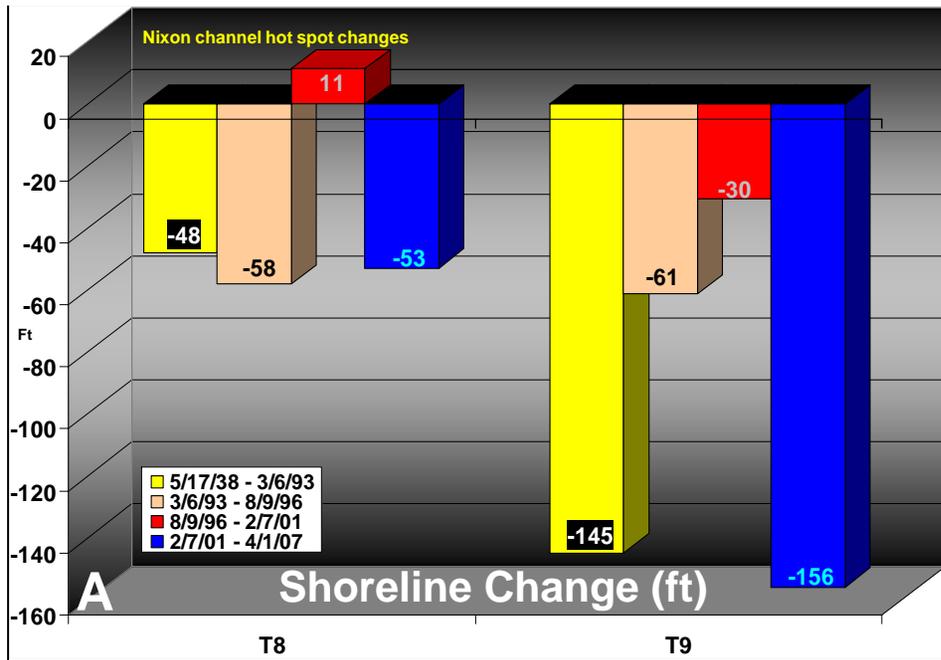
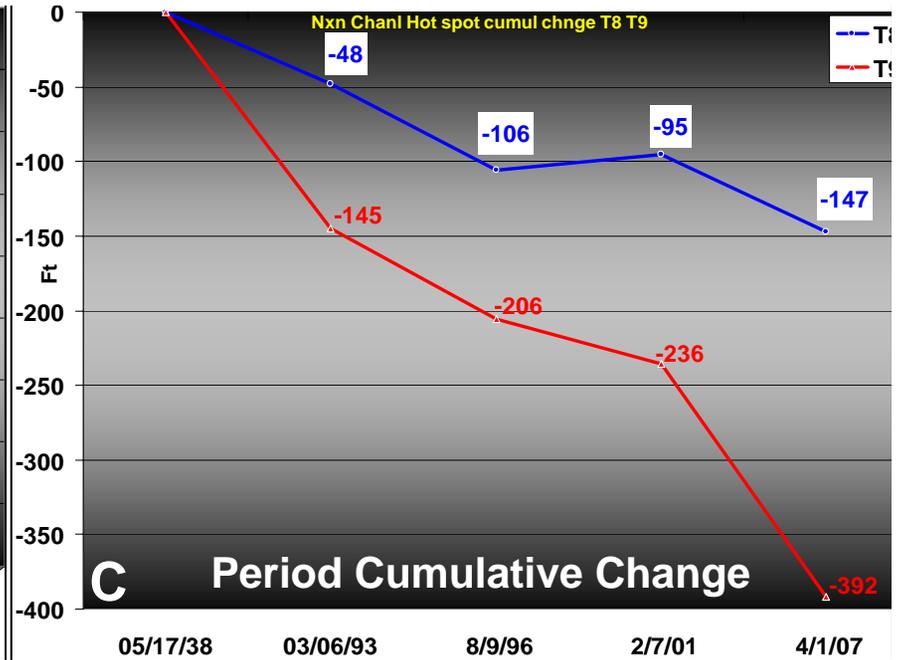
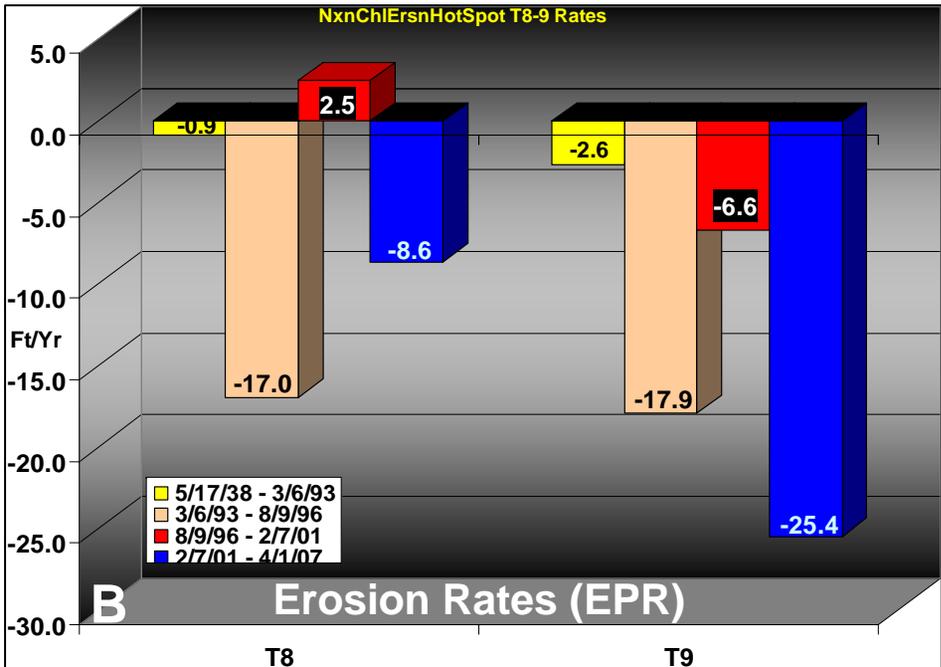
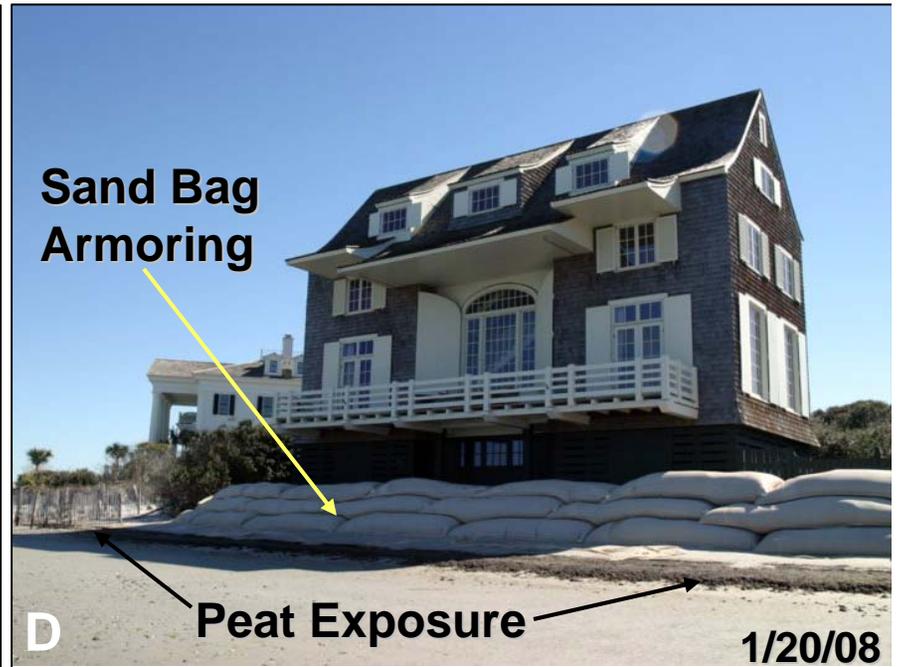
Figure 43. Estuarine channel erosion hot-spot (T8-9) along Nixon Channel. **A.** Shoreline graph for various periods between 1938-2007. **B.** Graph depicting T8-9 erosion rates (EPR). **C.** Graph of cumulative shoreline changes. **D.** Photograph (1/20/08) depicting armored shoreline and extensive peat exposure along low tide beach.

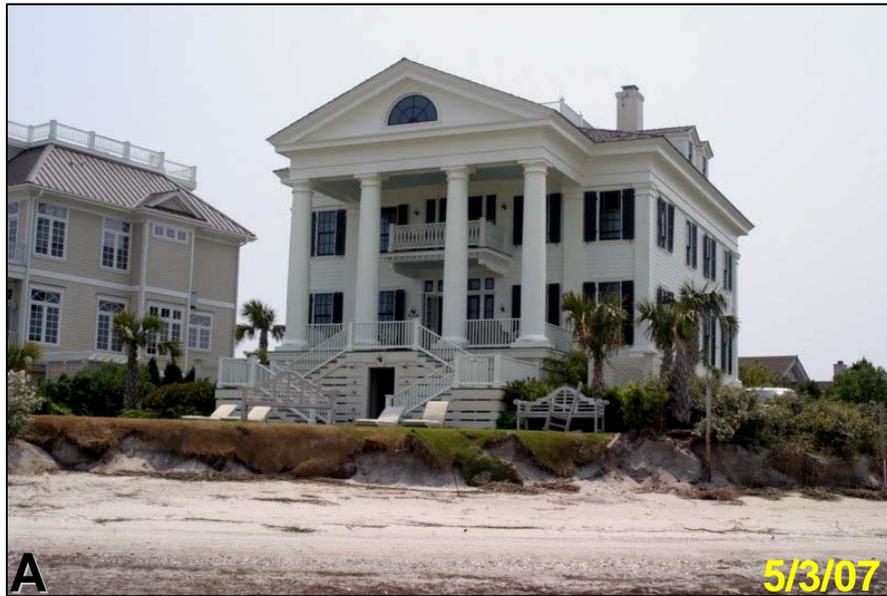
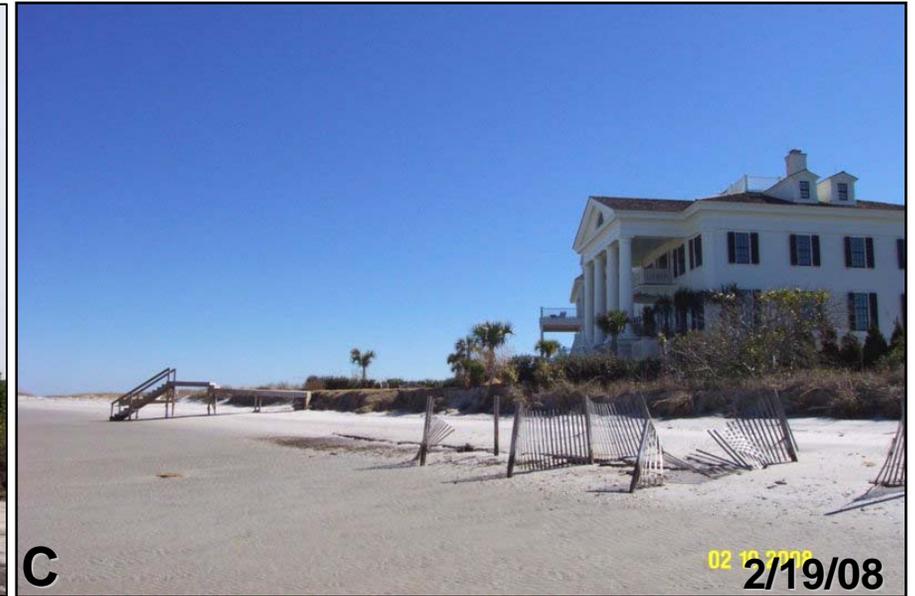
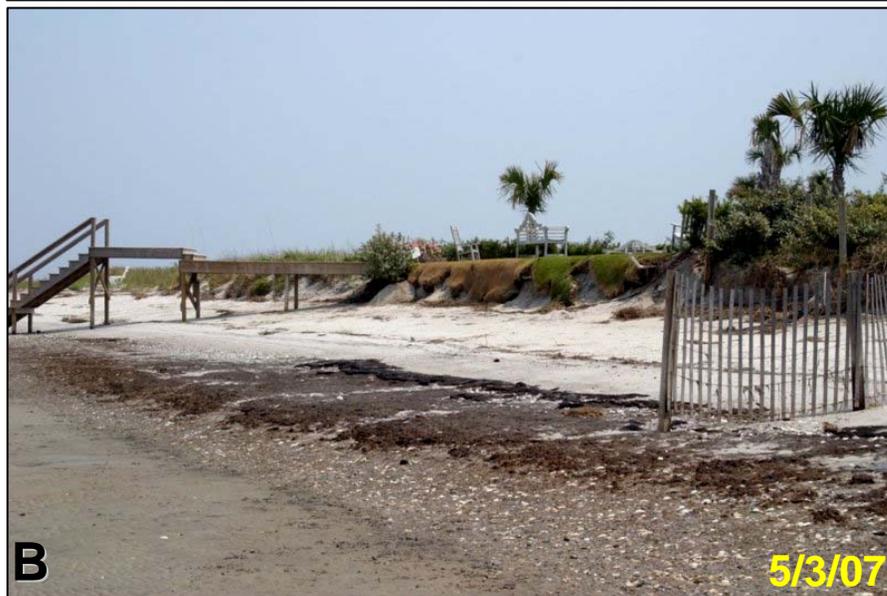
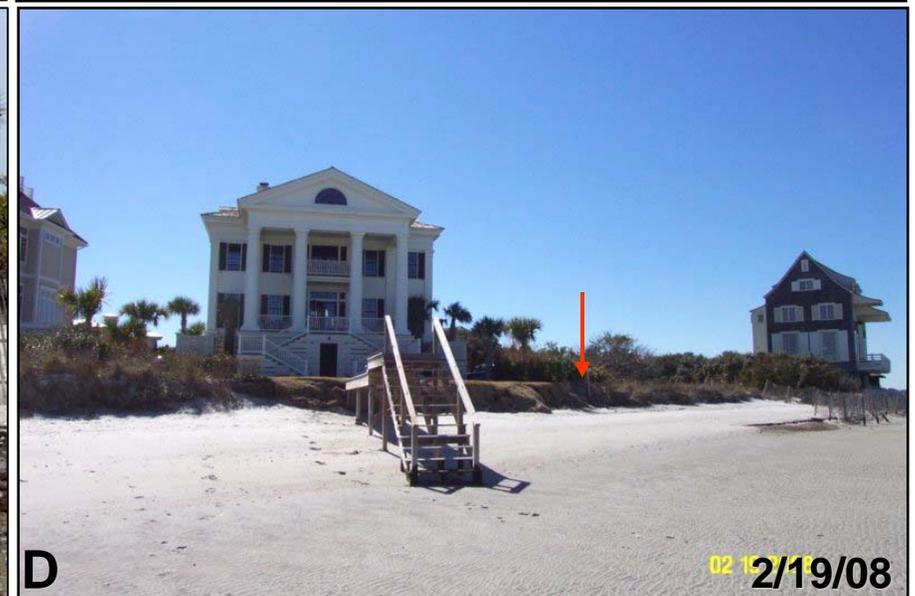
Figure 44. Photographs depicting erosion along a portion of the Nixon Channel shoreline. **A.** Landward view (5/3/07) illustrating erosion of the upland area. **B.** Landward view (5/3/07) of peat exposure along intertidal beach, stranded walkover and slumping of “sod”. **C.** Seaward view (2/19/08) of retreating shoreline imaged in “A” and “B”. **D.** Landward view (2/19/08) of structure in “A” and “C” and small scarp (red arrow) that extends toward adjacent home that is fronted by sand bags and a peat exposure.

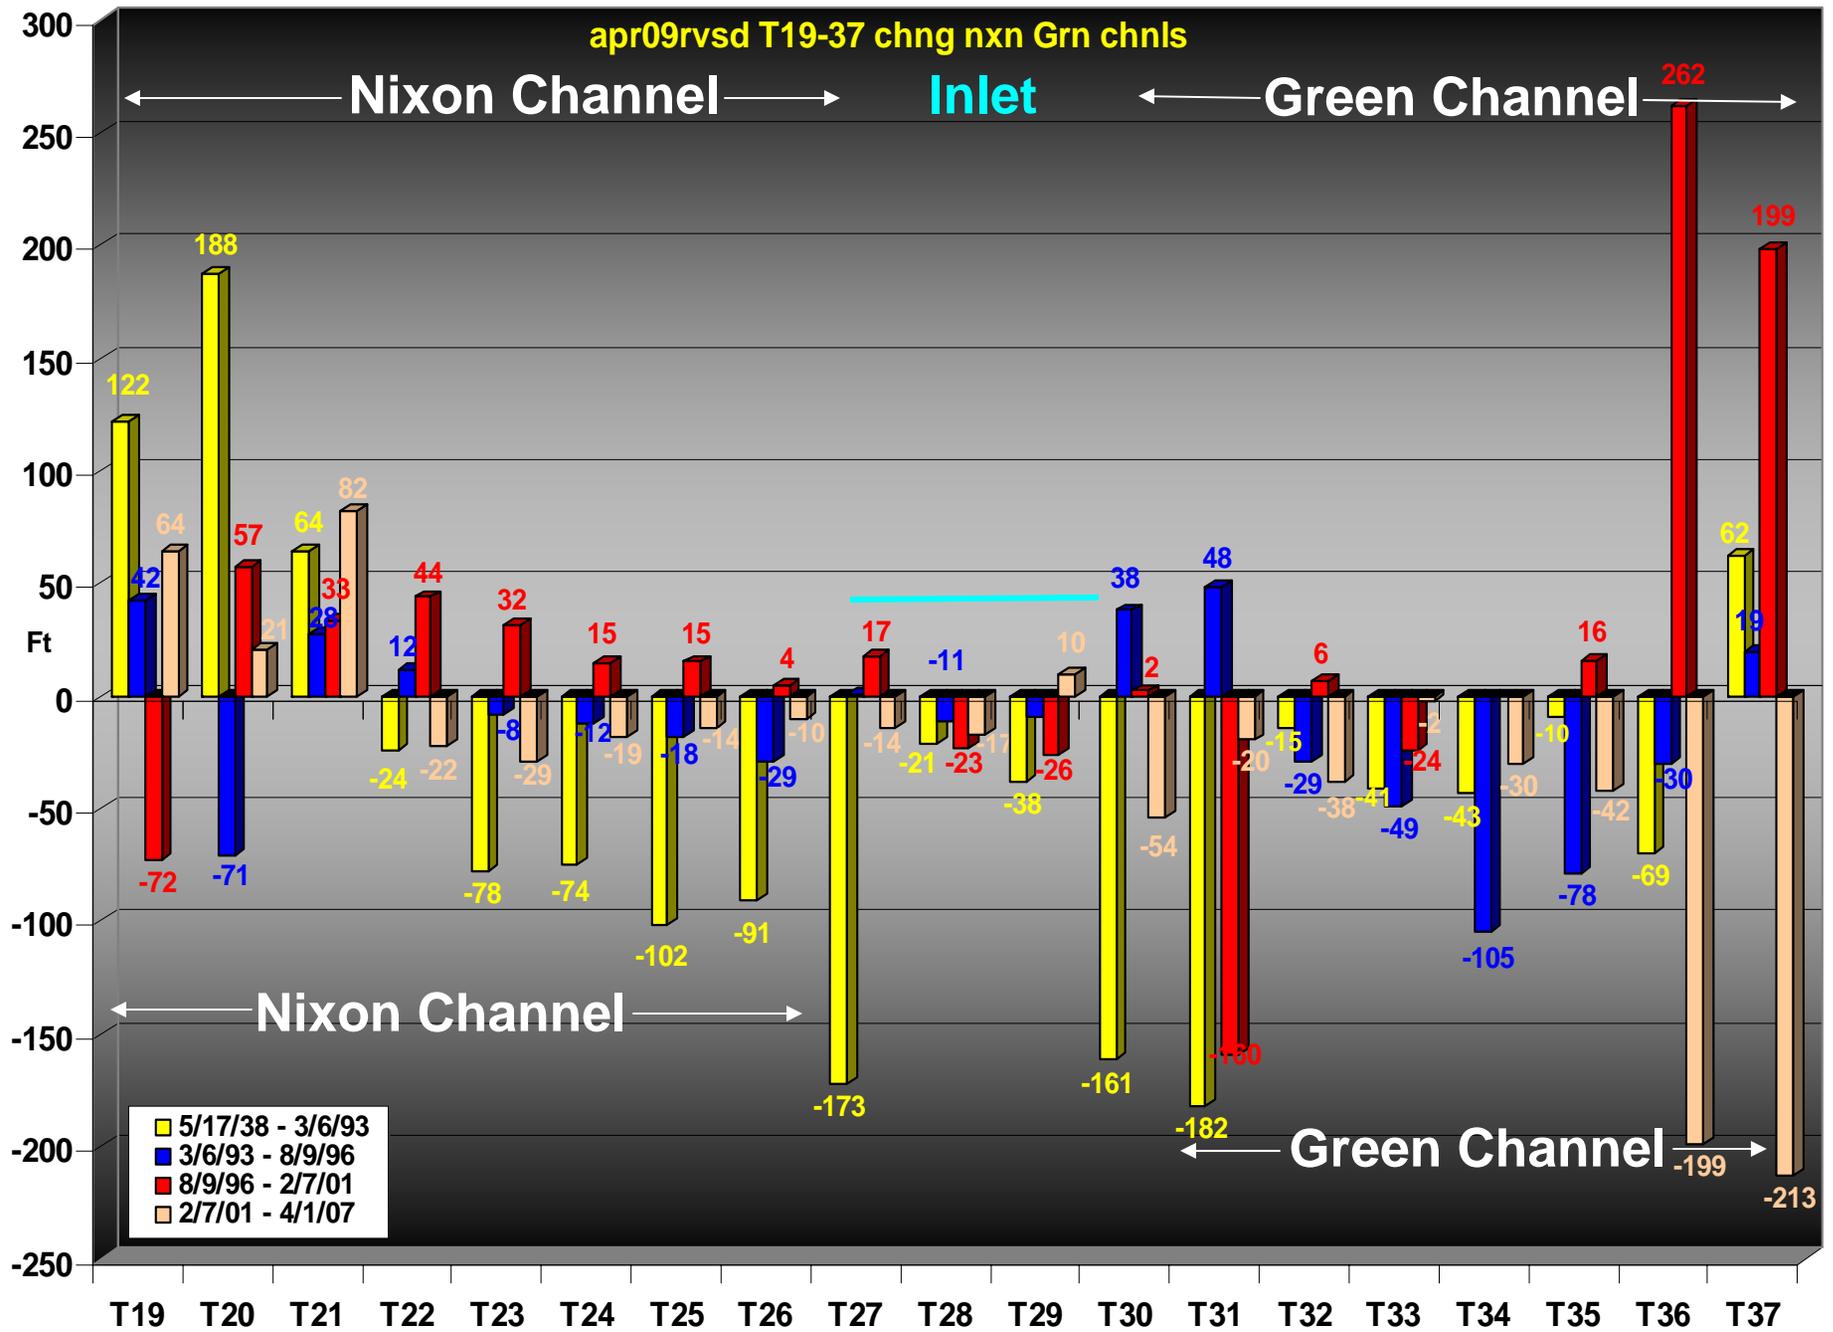
Figure 45. Bar graph illustrating net shoreline changes for various periods between 1938 and 2007 along the internal (landward) channel margin from T19 to T37. See Figure 36 for transect locations.

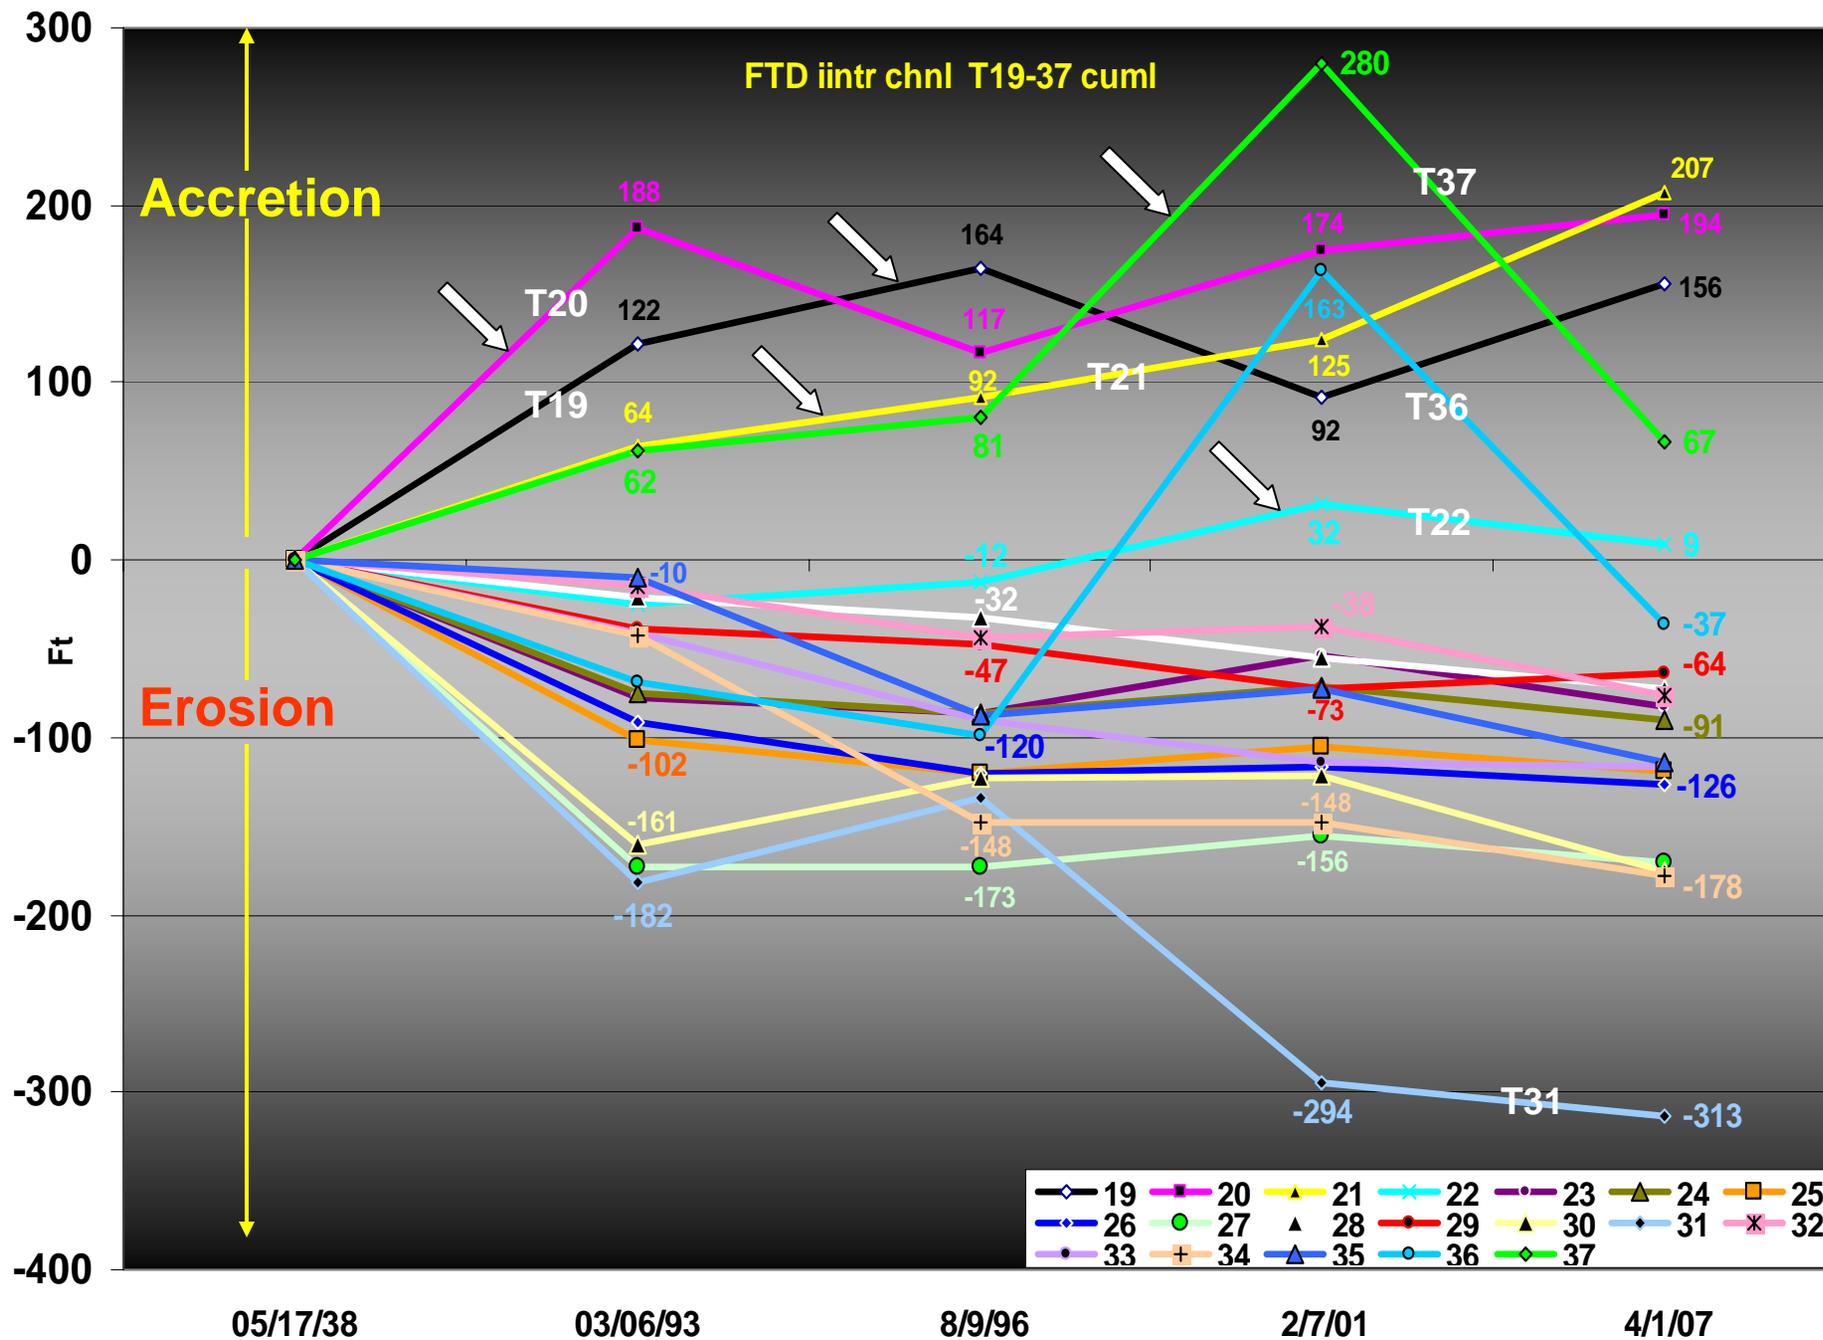
Figure 46. Graph depicting the cumulative shoreline change along Green and Nixon Channel's interior (landward) margin. Note X axis is not to scale. See Figure 36 for location of transects along flood tidal delta margin. White arrows represent transects where net accretion has occurred.
