**APPENDIX B
ENGINEERING REPORT**

Inlet-Related Shoreline Changes: Rich Inlet, North Carolina

Update Through 2007

William J. Cleary

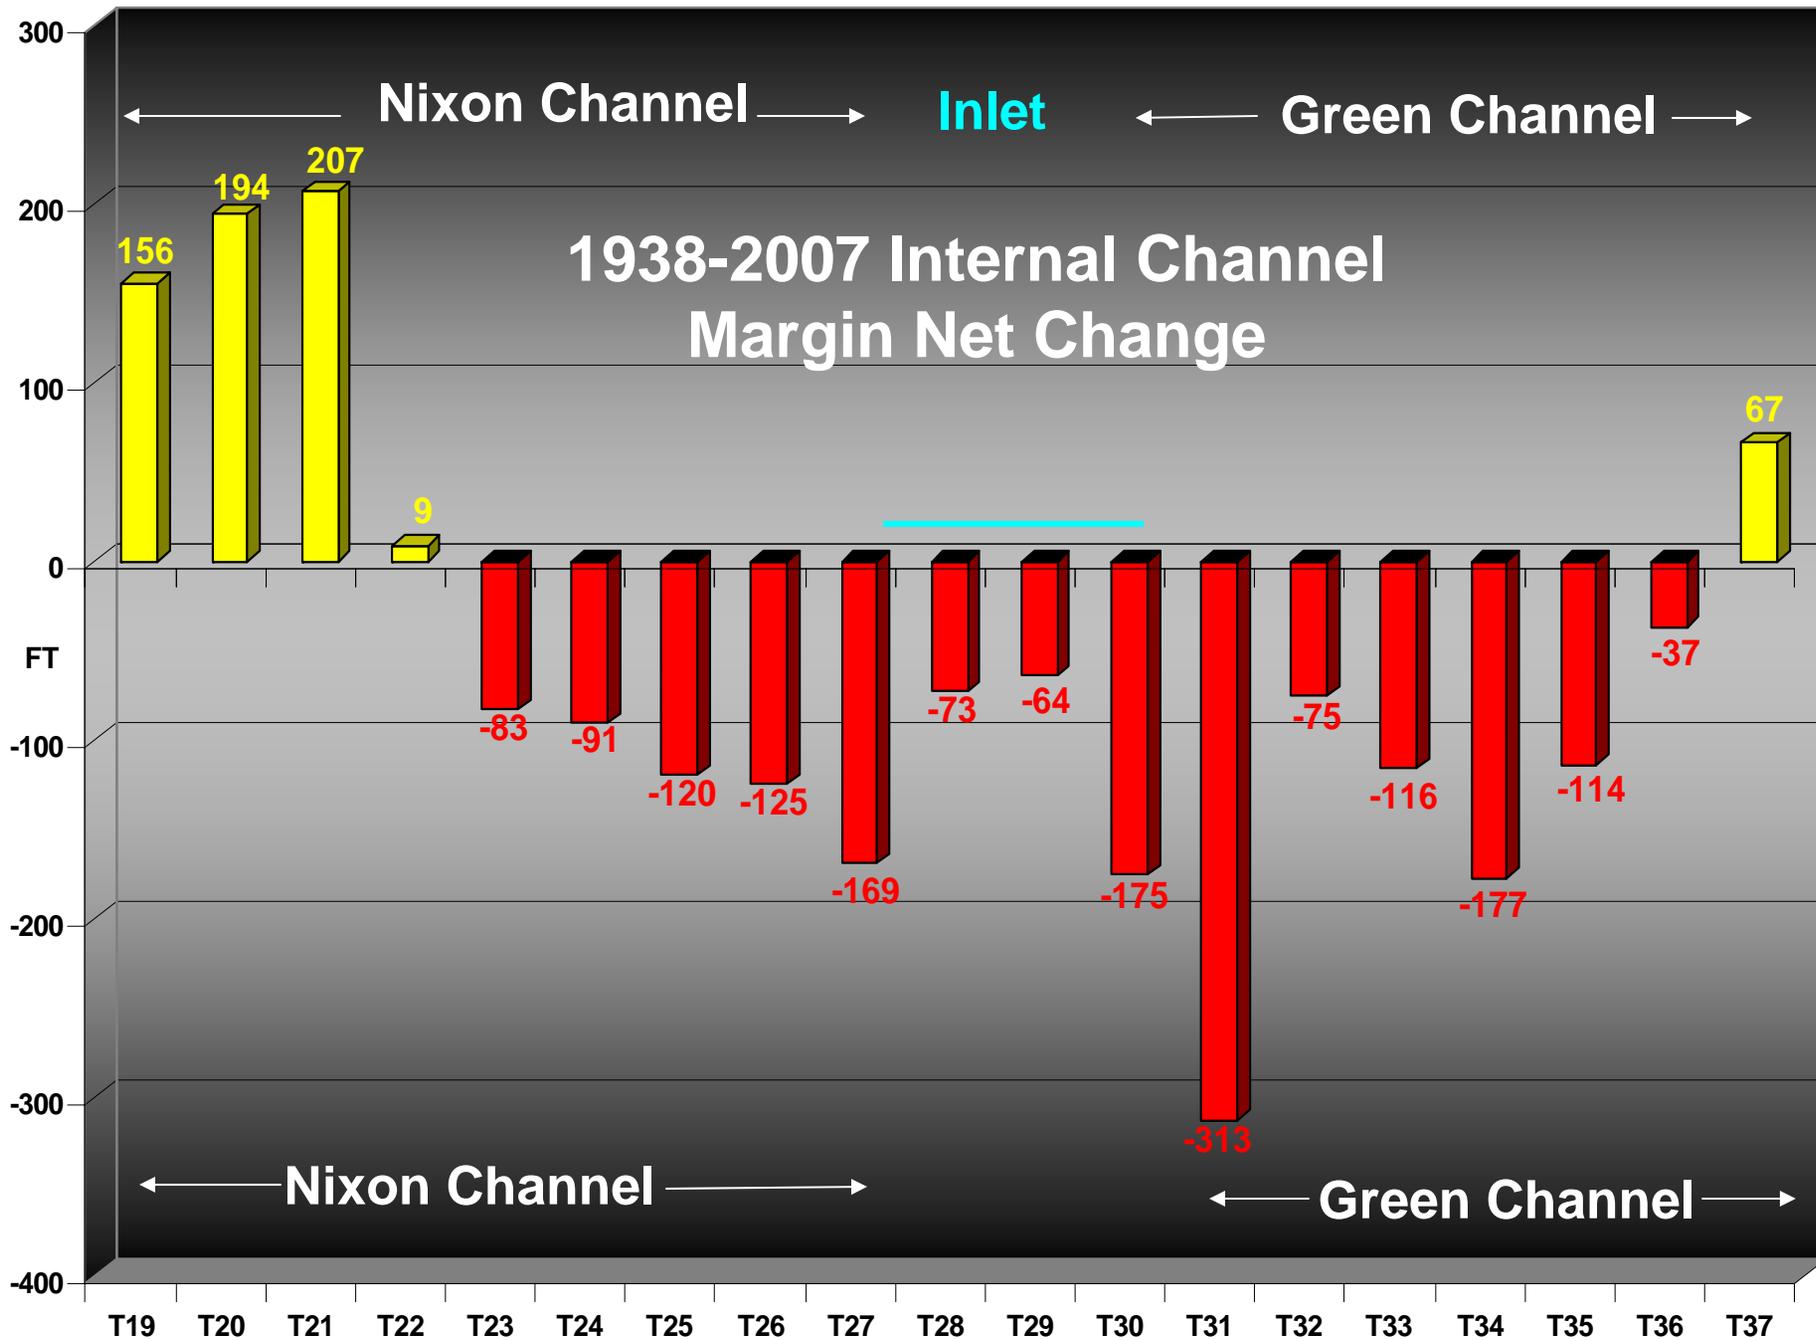
Figure 47. Bar graph illustrating net shoreline change along the internal channel margin reach between T19 and T37 during the period from 1938-2007. See Figure 36 for transect locations

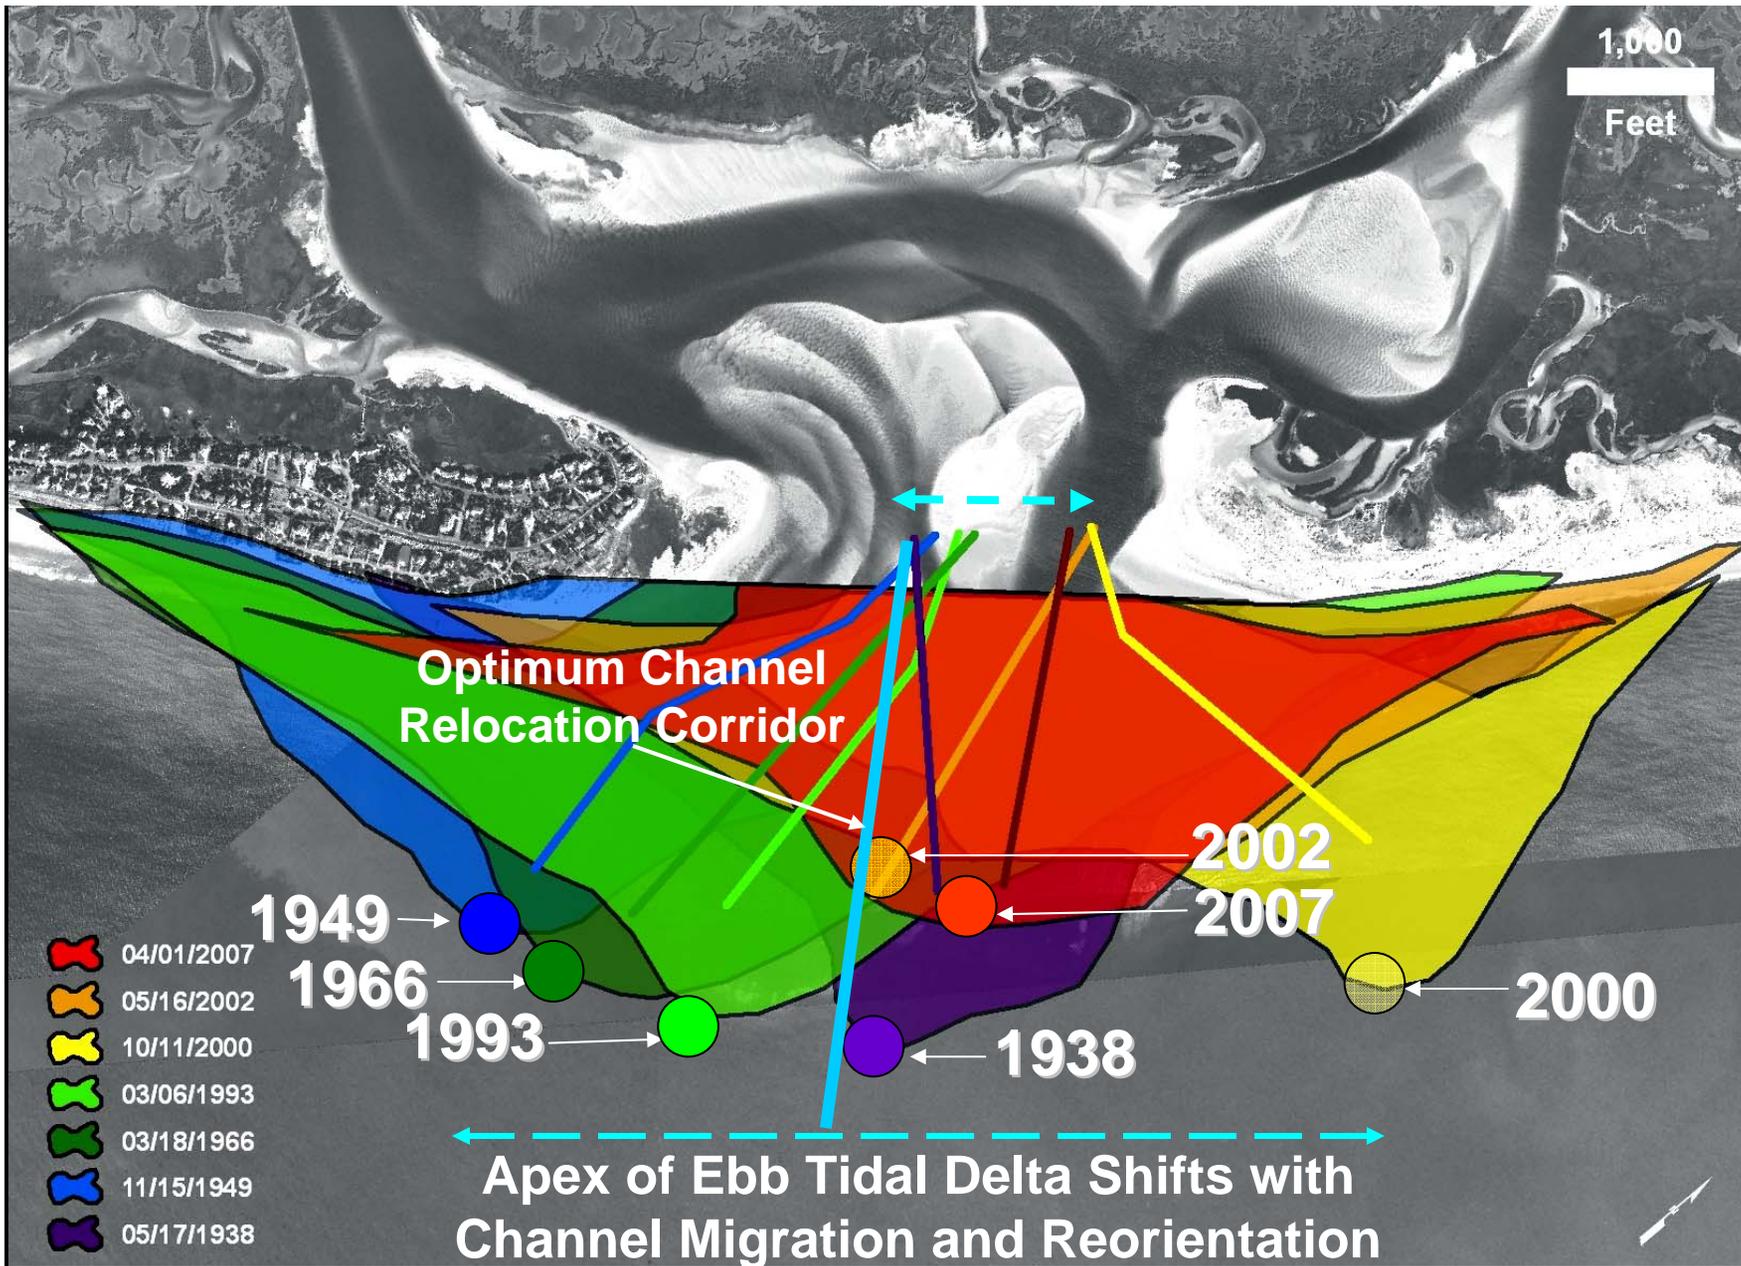
Figure 48. Aerial photograph (2007) of Rich Inlet depicting the shapes of various ebb tidal deltas and ebb channel positions for selected years between 1938 and 2007. Colored circles represent the ebb delta apex.

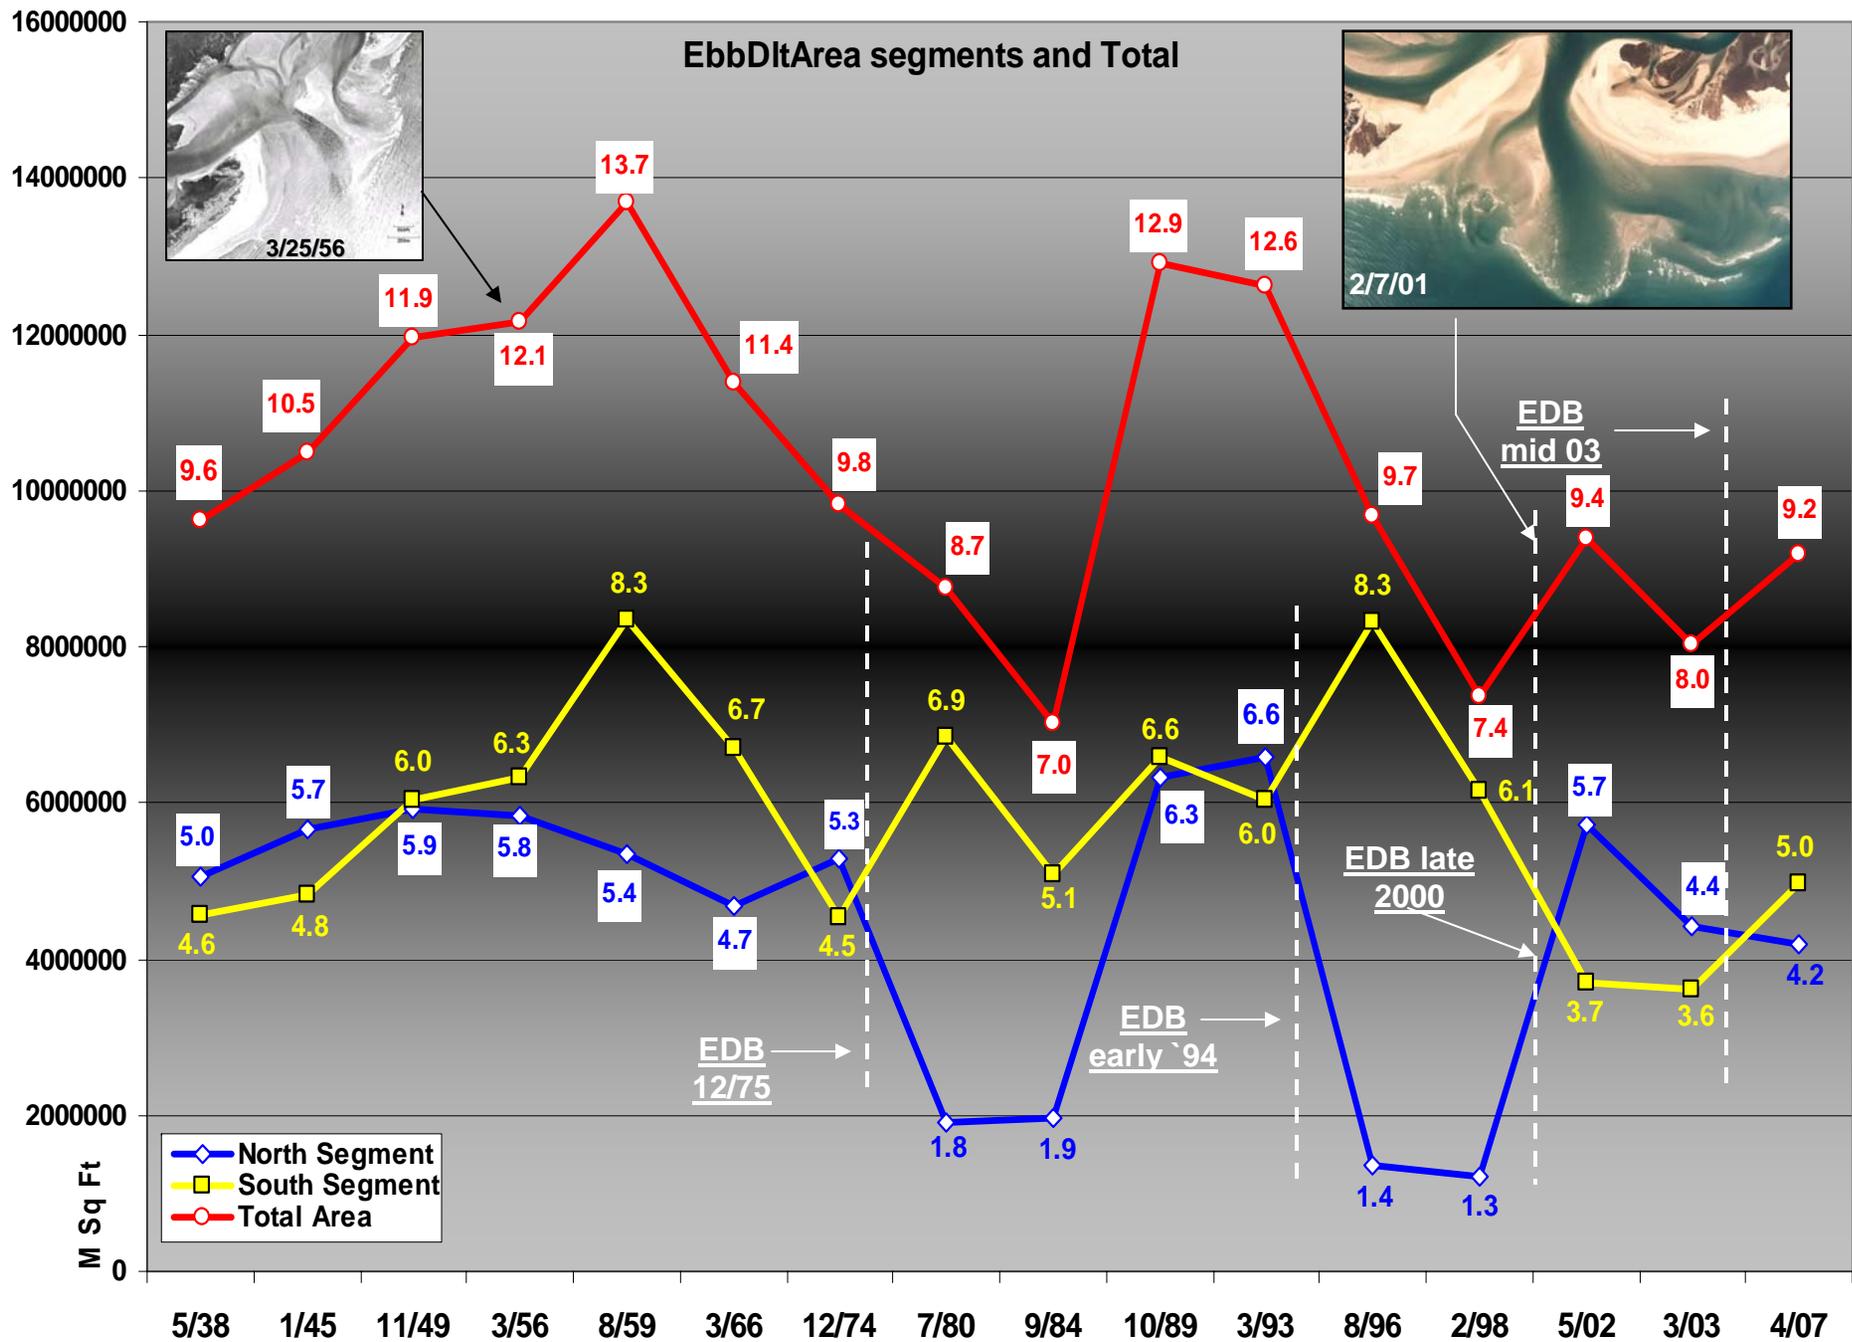
Figure 49. Graph depicting the area of the ebb delta segments (A [North] and B [South]) and total ebb-tidal area in millions of square feet (Sq. Ft.) since 1938. Ebb delta breaching events (EDB) are referenced by dashed white colored lines.

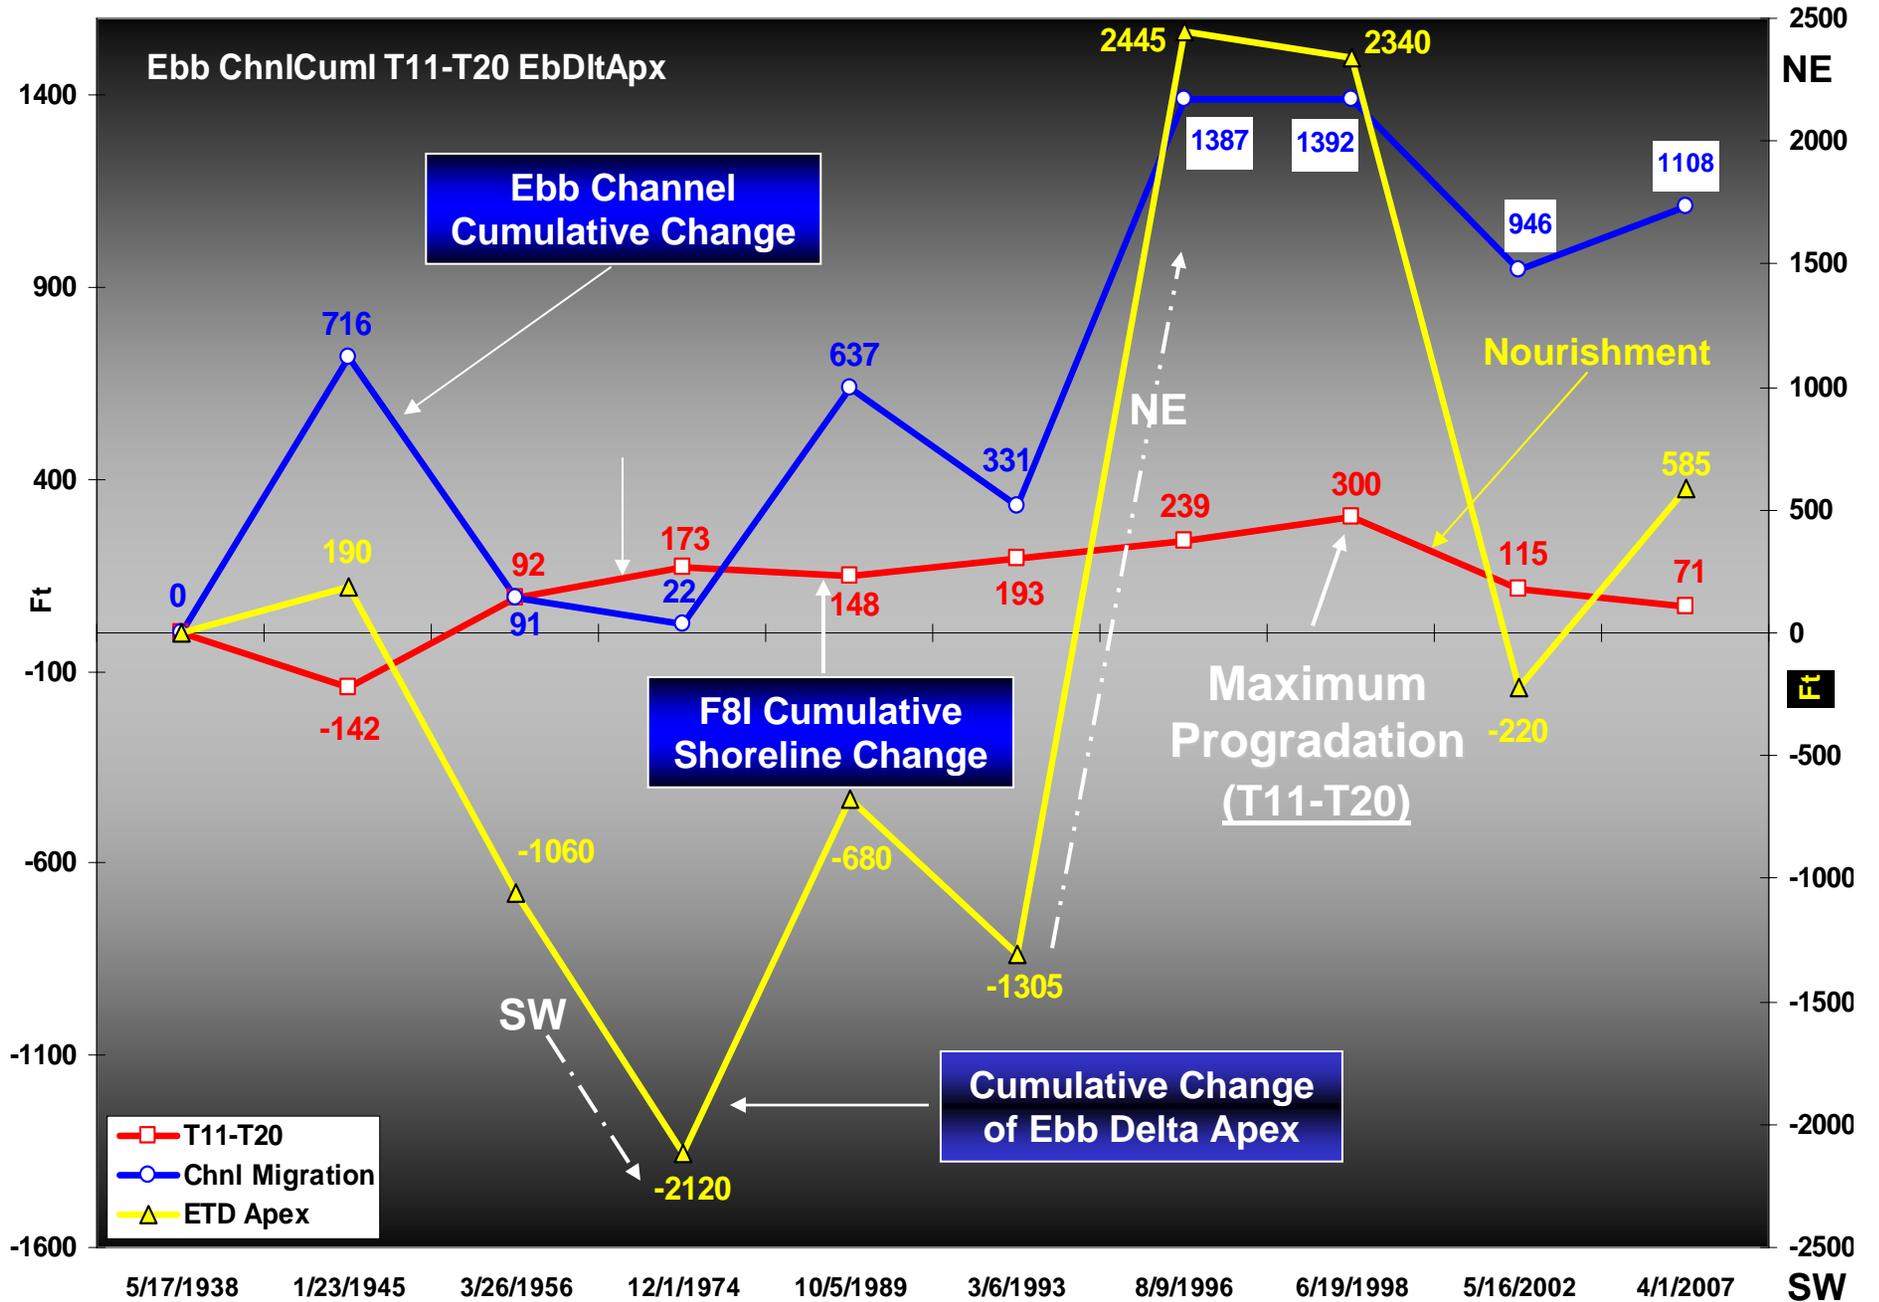
Figure 50. Line graph depicting cumulative migration of the ebb channel, cumulative shoreline change (Avg. T11-20) on Figure Eight Island and cumulative change of the ebb delta apex between 1938 2007.

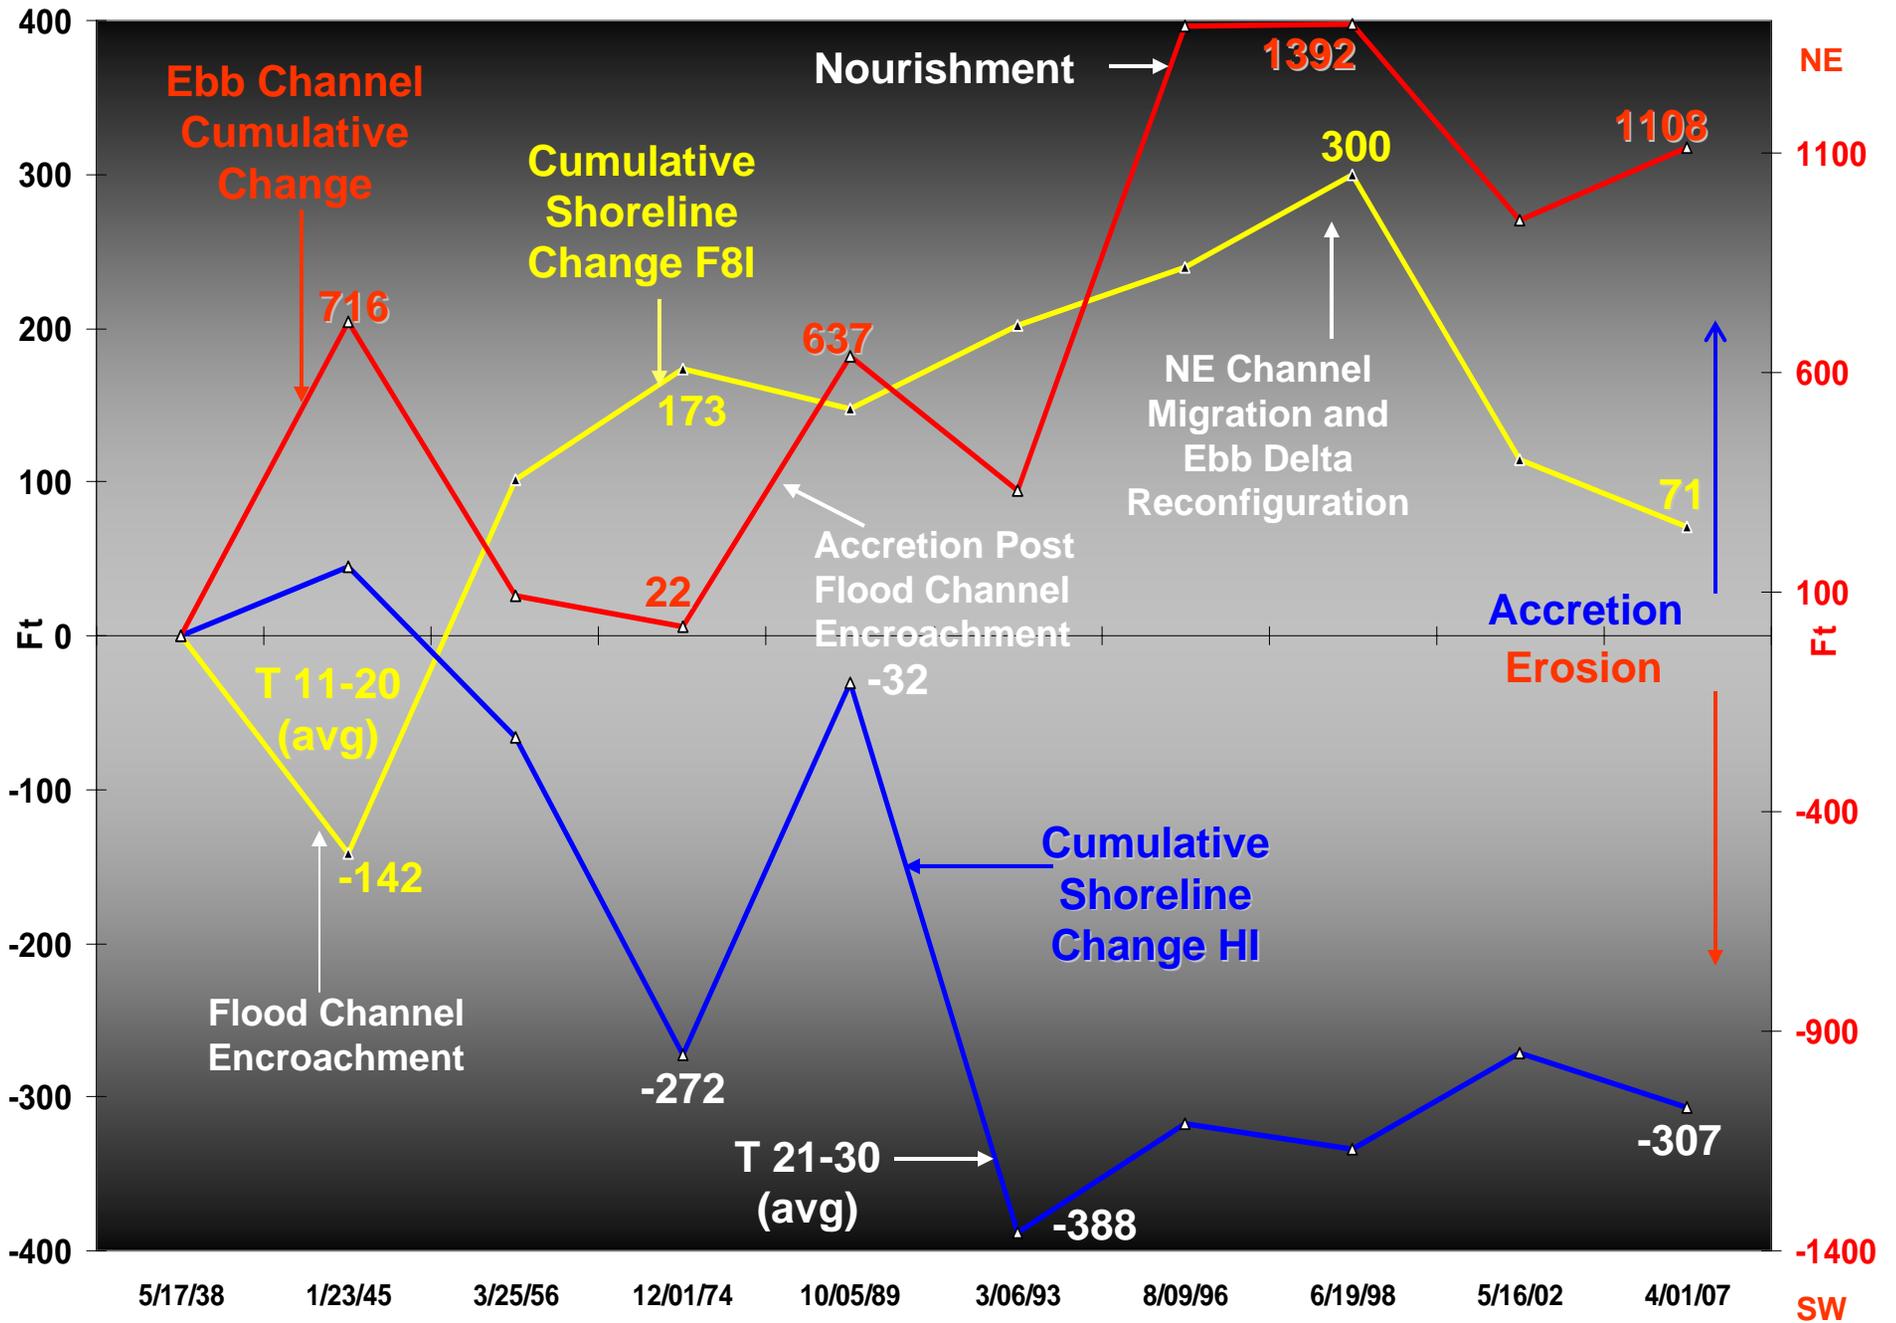
Figure 51. Graph comparing F8I and HI cumulative average oceanfront shoreline change (inlet-influenced reach) and ebb channel mid-point migration.

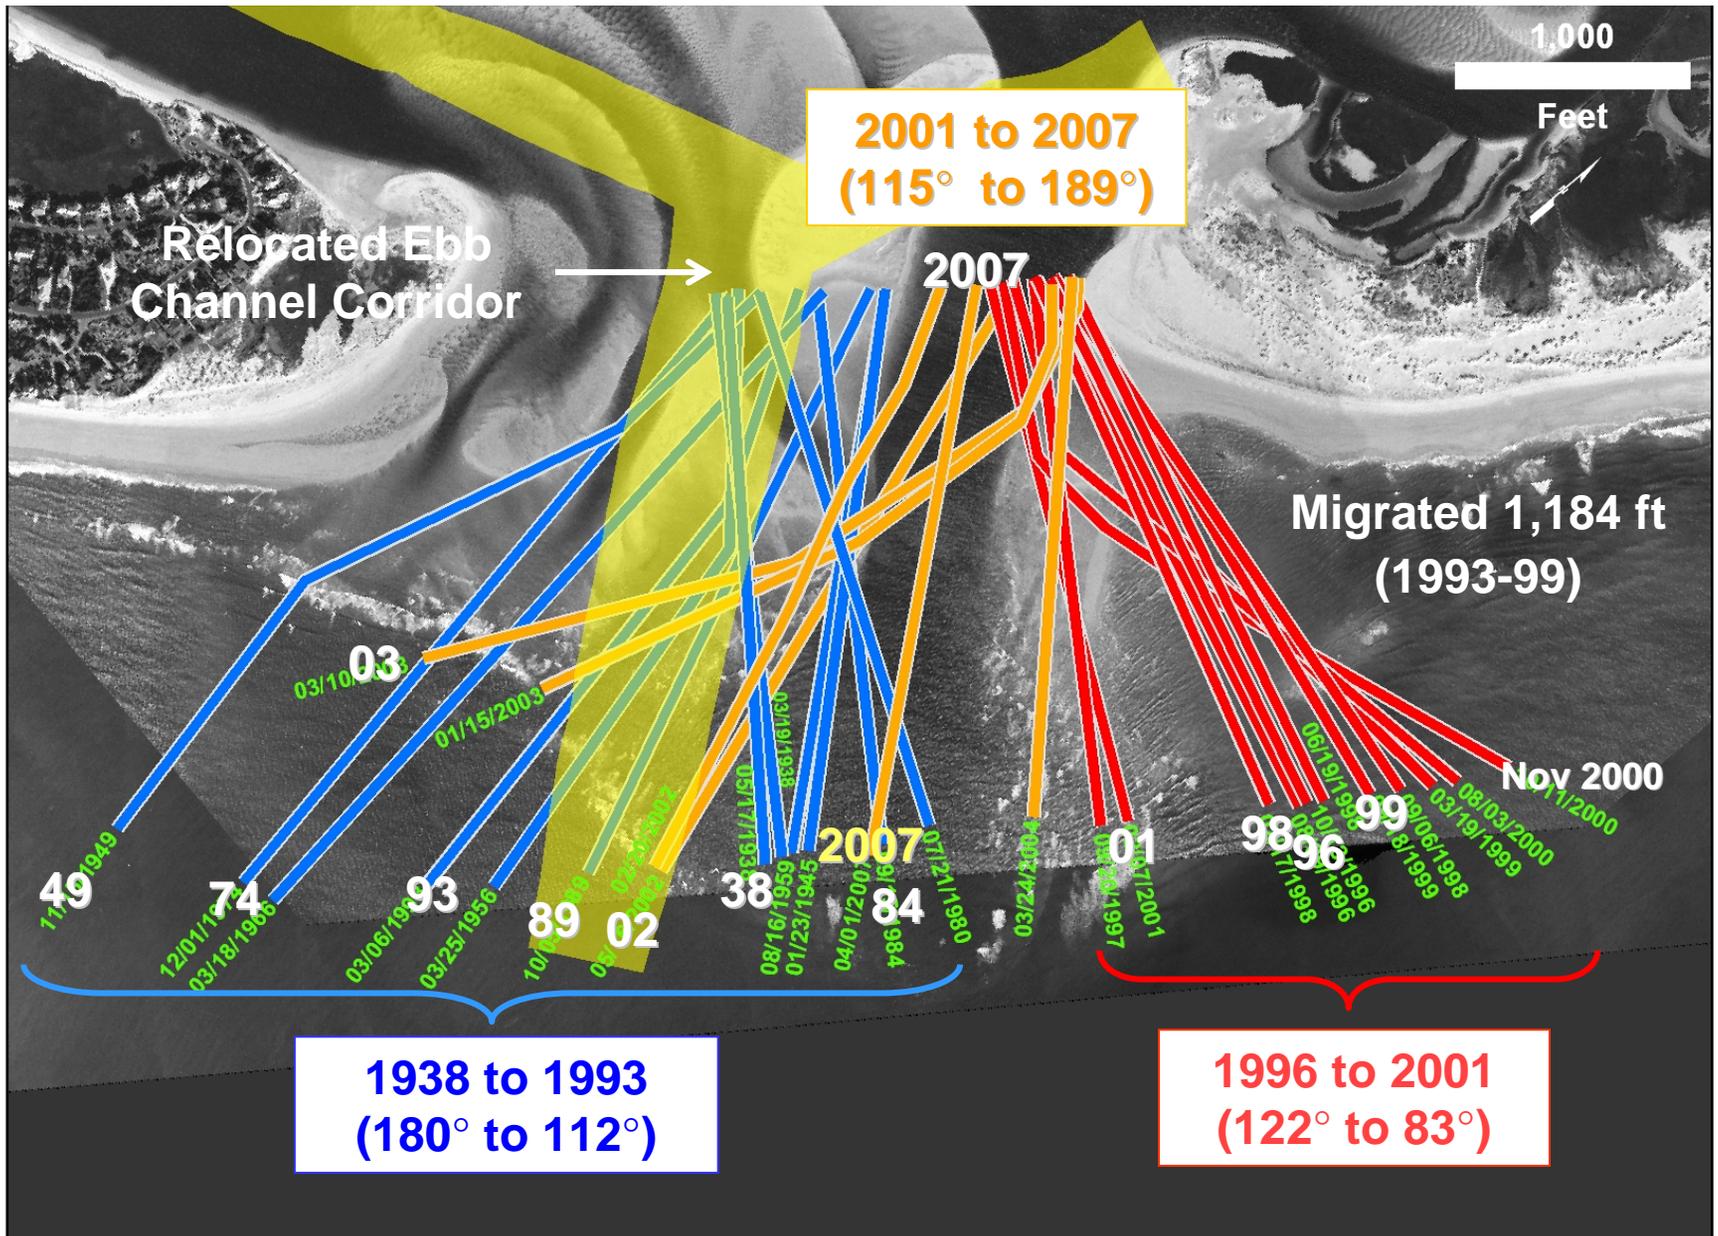
Figure 53. Aerial photograph mosaic (2006) depicting position and alignment of the ebb channel between 1938 and 2007. The yellow polygon represents the proposed ebb channel relocation corridor. The proposed channel relocation site represents the most advantageous position and alignment that will promote accretion along the F8I oceanfront shoreline.
