CULTURAL RESOURCE INVESTIGATION: LOCATION OF THE REMAINS OF THE *WILD DAYRELL* IN RICH INLET

*Location of the Remains of the Wild Dayrell
in Rich Inlet
Pender County, North Carolina*

Cultural Resource Investigation: Terrestrial and Submerged Cultural Resource Survey Rich Inlet, Figure Eight Island, North Carolina

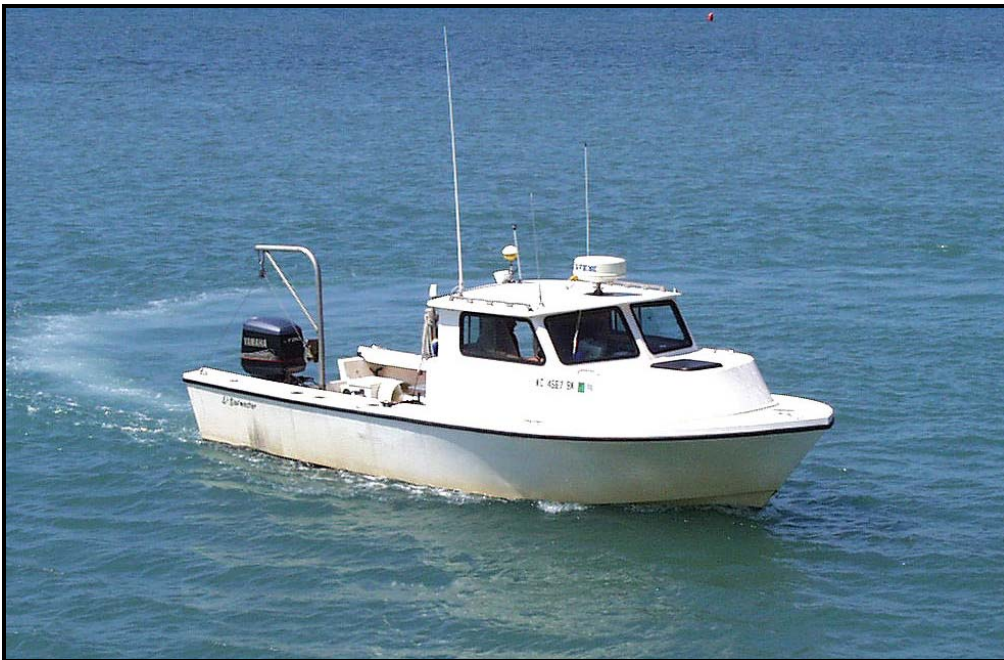
Figure 3. Photograph of the 25-foot survey vessel *Atlantic Surveyor* employed during the Rich Inlet survey.

To locate the remains of *Wild Dayrell*, TAR personnel used a 24-foot shallow-draft vessel for conducting the remote sensing survey (Figure 3). The wreck site was identified using an EG&G GEOMETRICS 881 cesium vapor magnetometer (Figure 4). Once the position of the wreck was established, a series of survey lanes were created in HYPACK®MAX to refine the magnetic signature. Because the wreck is now completely buried in the shoal on the south side of the Rich Inlet channel, breaking surf and shallow water made sonar imaging impossible. Data collection during the survey was controlled using a TRIMBLE differential global positioning system assuring reliable geographical location of the remains of *Wild Dayrell*.

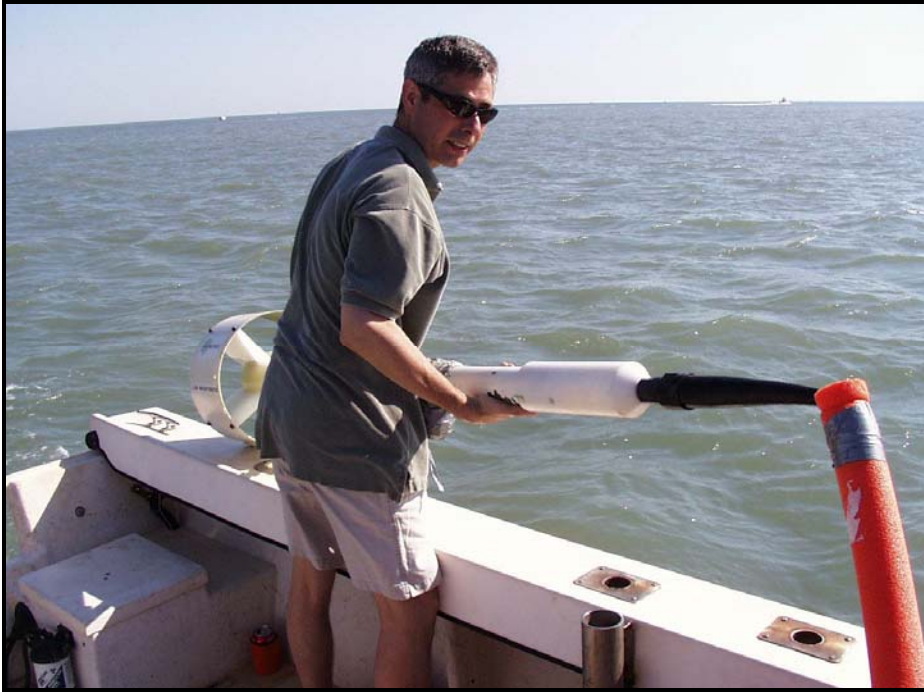
Figure 4. Photograph of magnetometer sensor being lowered into the ocean.

An EG&G Geometrics G-881 marine cesium magnetometer capable of plus or minus 0.001 gamma resolution was employed to collect magnetic data in the survey area (Figure 4). To produce the most comprehensive magnetic record, data was collected at 10 samples per second. Due to shoal water and the possibility of snags in the project area, the magnetometer sensor was towed just below the water surface at a speed of approximately 3 knots. Magnetic data were recorded as a data file associated with the computer navigation system. Data from the survey were

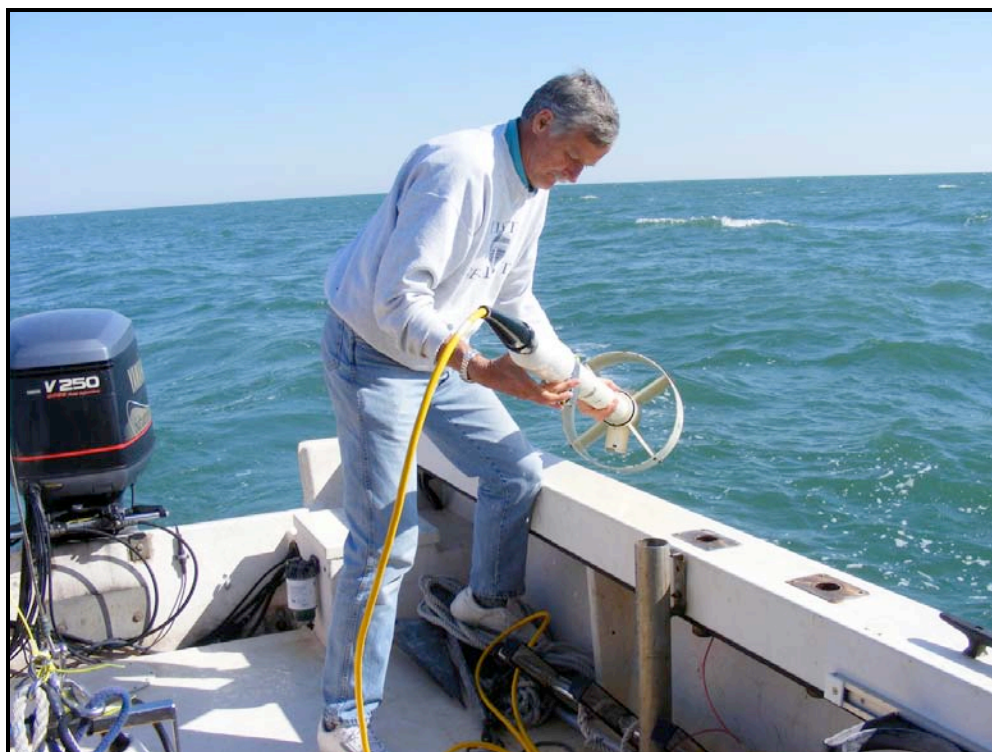
Figure 2. Launching the EG&G GEOMETRICS G-881 cesium vapor magnetometer.

An EG&G GEOMETRICS G-881 marine cesium magnetometer, capable of plus or minus 0.01 gamma resolution, was employed to collect magnetic data for the submerged portion of the survey area (Figure 2). To produce the most comprehensive magnetic record, data was collected at 10 samples per second. On 8 March 2010, the magnetometer sensor was towed just below the water surface at a speed of approximately three to four knots due to shoal water within the project area. On 1 April 2010, the magnetometer sensor was mounted to the bow of the vessel. Magnetic data were recorded as a data file associated with the computer navigation system. Data from the survey were contour plotted using QUICKSURF® computer software to facilitate anomaly location and definition of target signature characteristics. All magnetic data were correlated with the acoustic remote-sensing records.

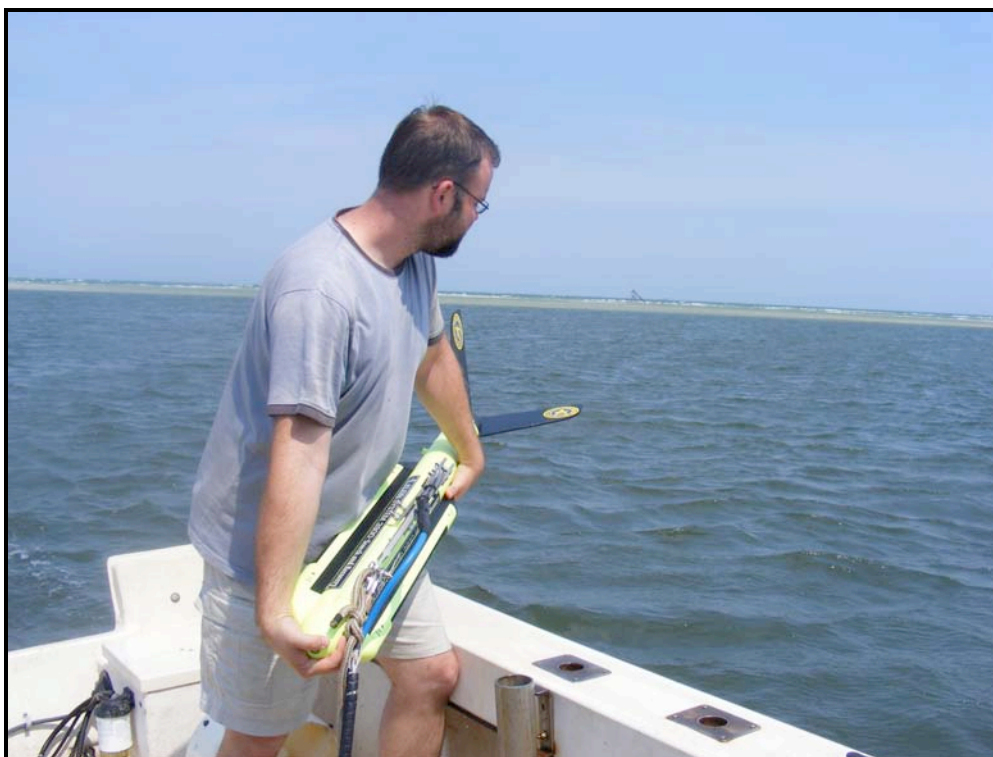
Figure 3. Launching the KLEIN SYSTEM 3900 digital sidescan sonar.

A 445/900 kHz KLEIN SYSTEM 3900 digital sidescan sonar (interfaced with SONARPRO SONAR PROCESSING SYSTEM) was employed to collect acoustic data in the submerged portions of the survey area (Figure 3). Due to shoal water within the project area, the sidescan sonar transducer was deployed and maintained between 3 and 5 feet below the water surface. Acoustic data were collected using a range scale of 30 and 50 meters to provide a minimum of 200% coverage and high target signature definition. Acoustic data were recorded as a digital file with SONARPRO and tied to the magnetic and positioning data by the computer navigation system.

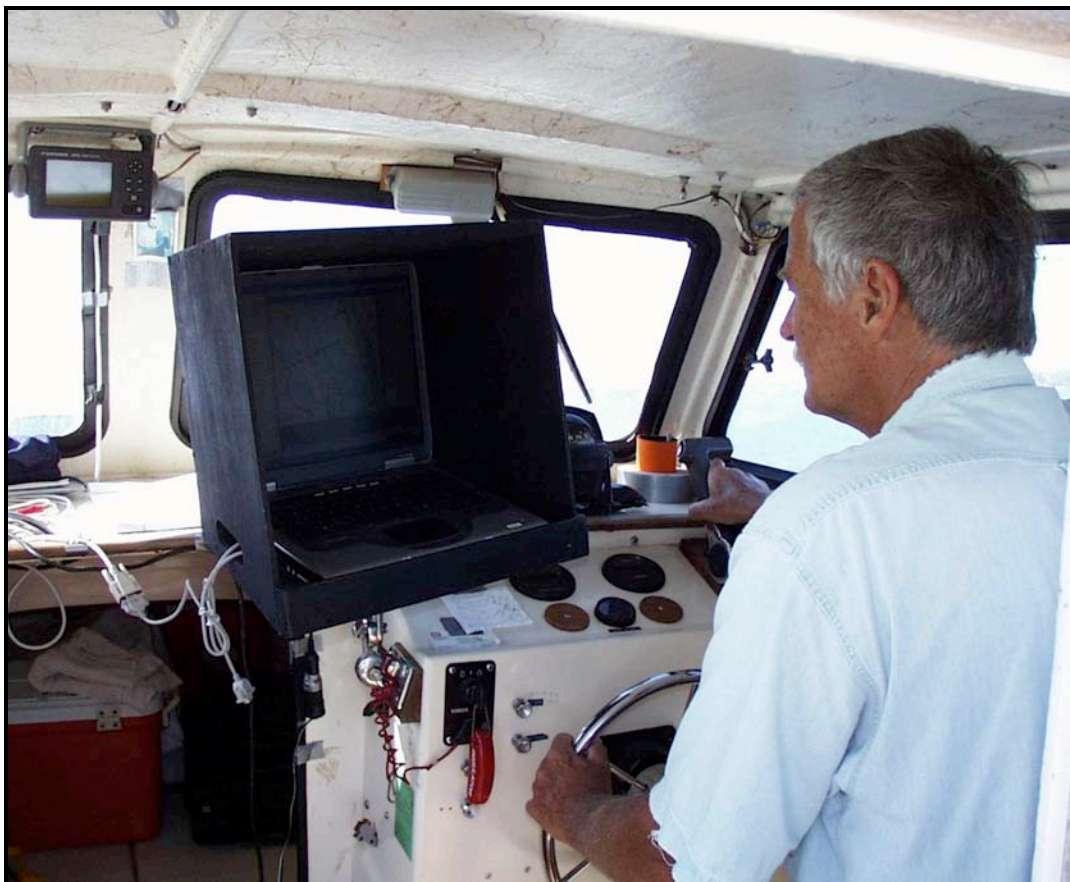
Figure 4. Computer navigation system located at the research vessel helm.

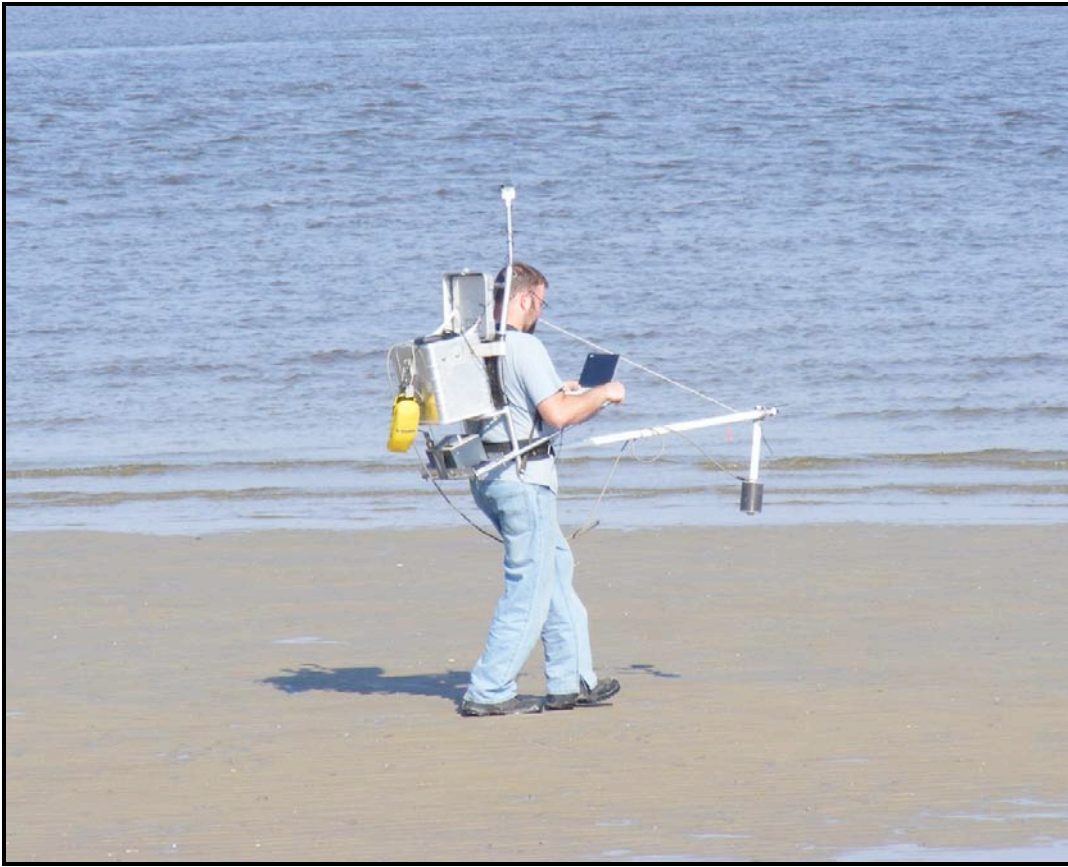
Figure 5. Terrestrial survey using the LITTLEMORE magnetometer.

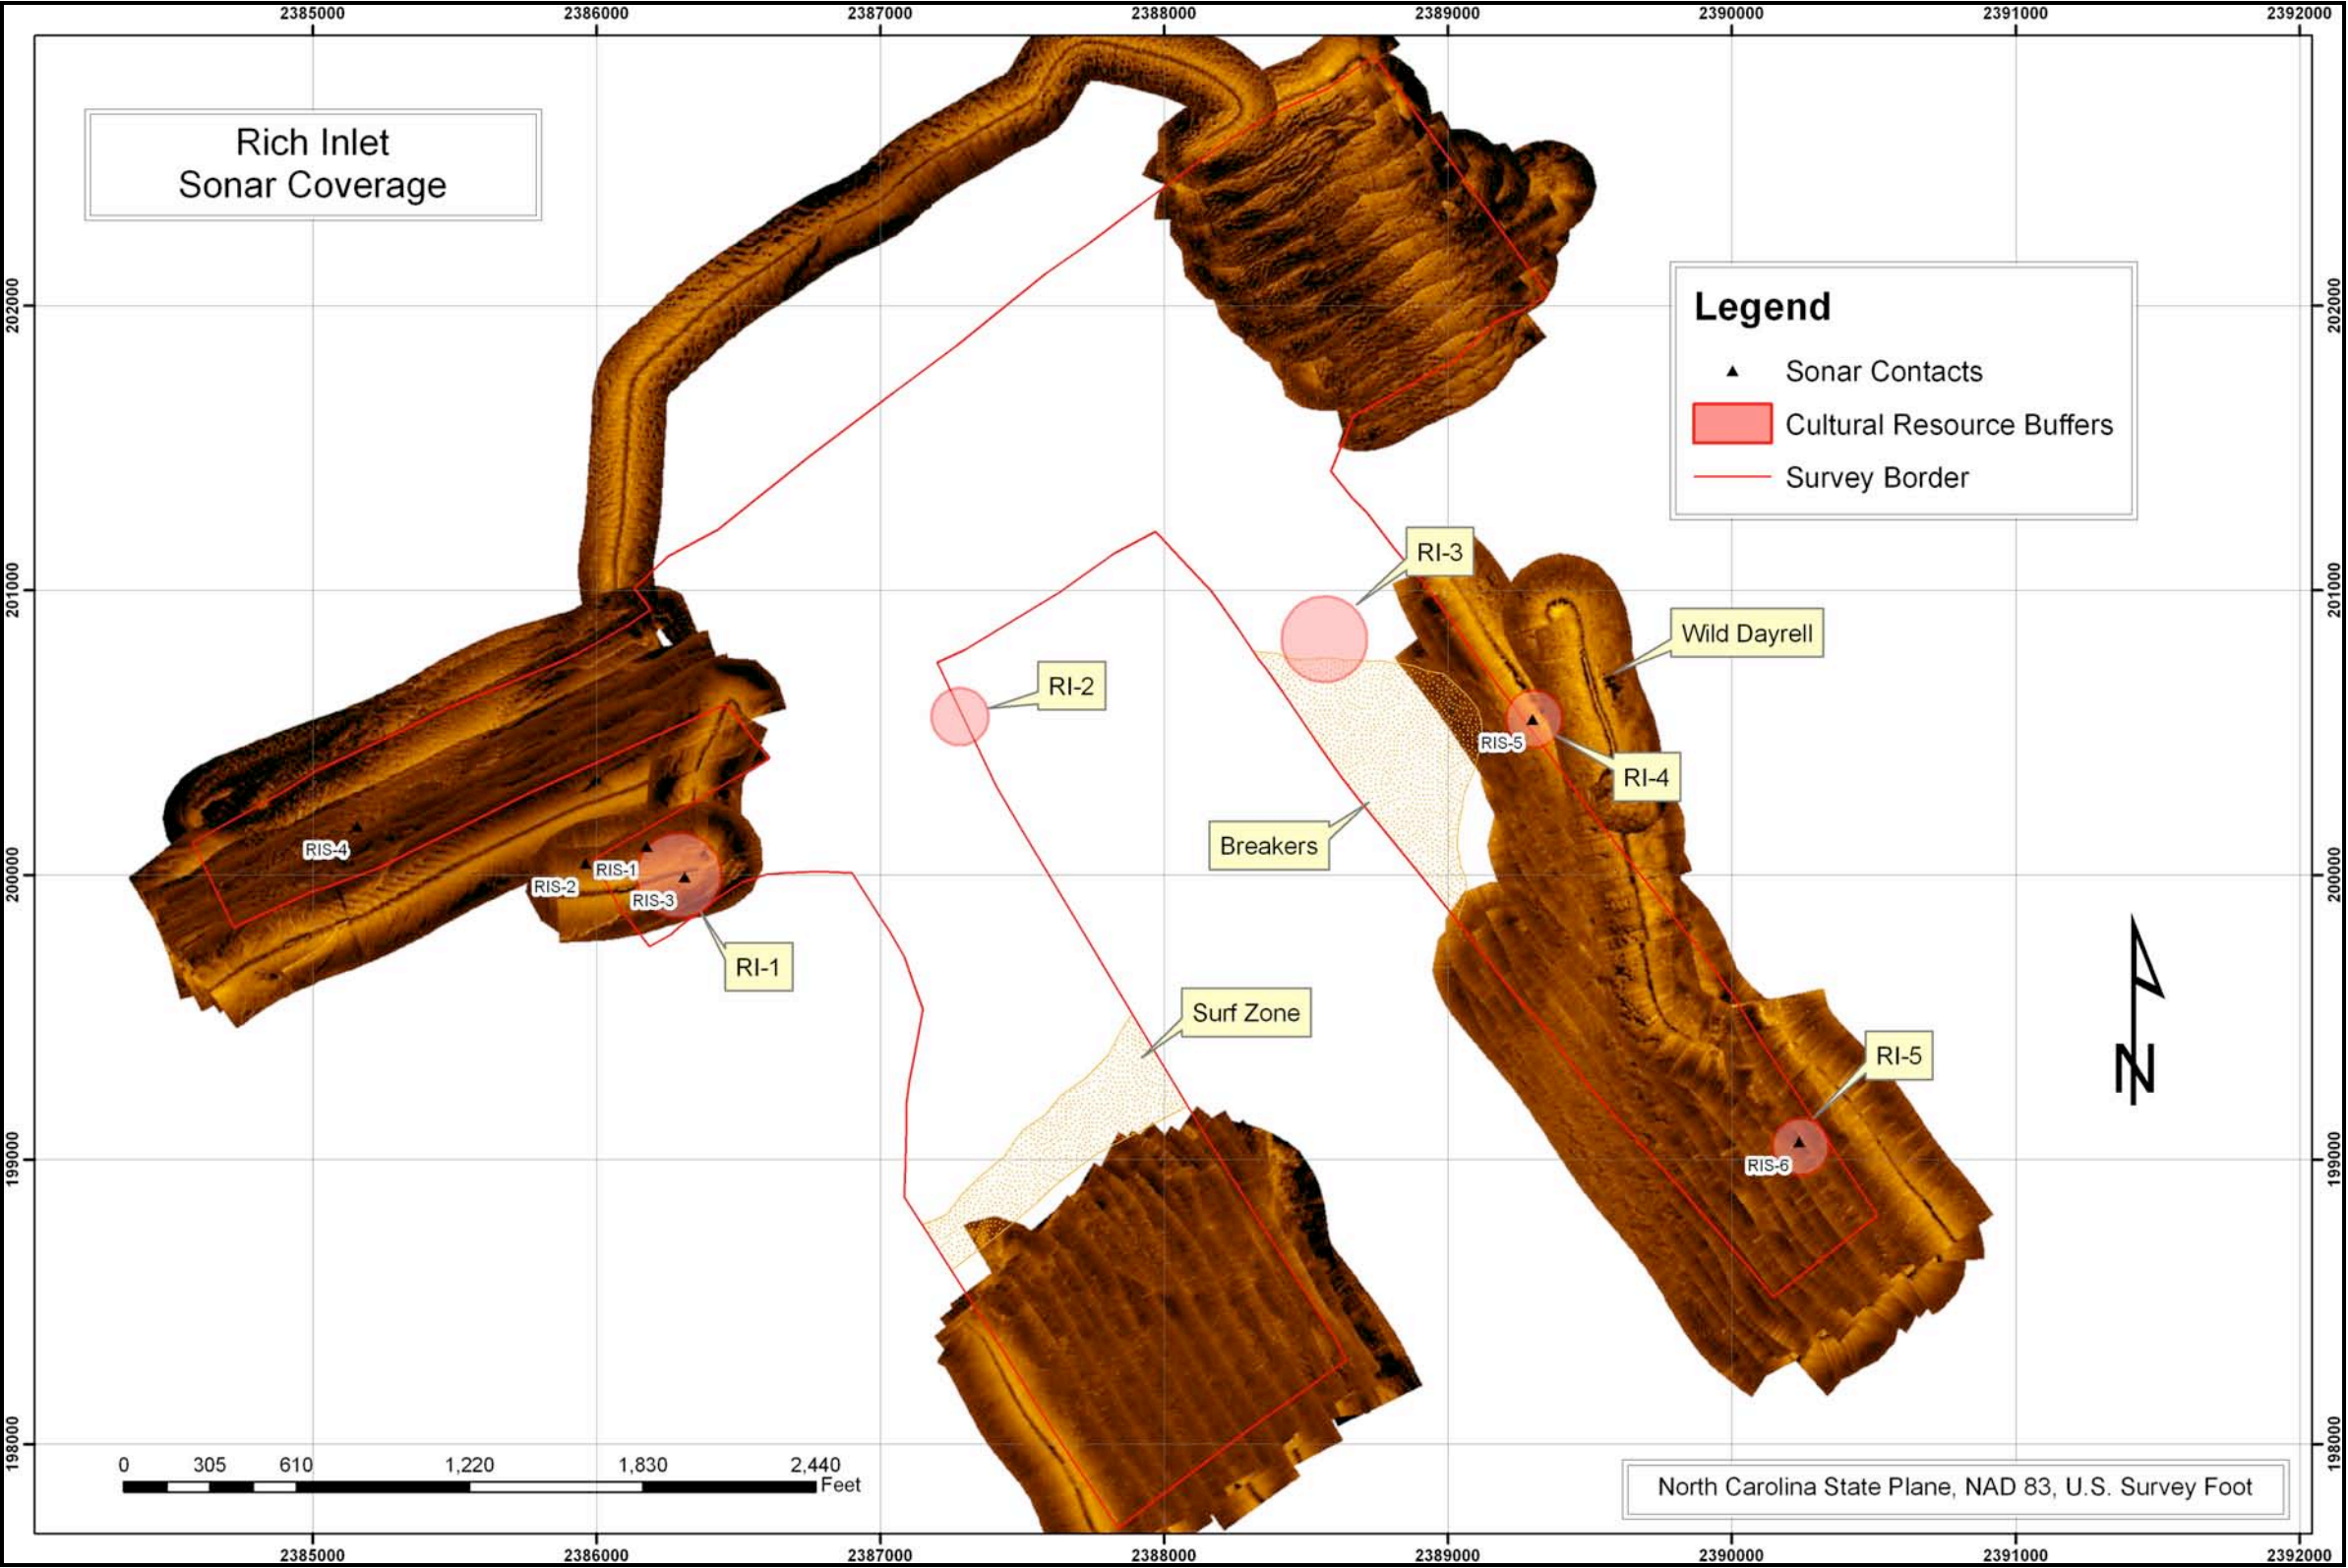
An analysis of the remote-sensing data identified a total of 116 individual magnetic anomalies and 6 sonar targets within the area surveyed (Figure 8, Appendix B and Figure 9). Five clusters, composed of 13 individual anomalies, contained signature characteristics suggestive of potentially significant cultural material. Cluster RI-1 is composed of two associated magnetic signatures and a sonar image suggestive of possible ballast (Figure 8, Appendix B and Appendix C). As these signatures are suggestive of potentially significant cultural material, avoidance of these targets is recommended by the creation of a 150-foot radius buffer. Cluster RI-2 is composed of three magnetic anomalies (Figure 8 and Appendix B). Their proximity to each other along with their signature characteristics are suggestive of potentially significant cultural material. Avoidance of cluster RI-2 is recommended by the creation of a 100-foot radius buffer. Cluster RI-3 is composed of five magnetic anomalies (Figure 8 and Appendix B). Their proximity to each other along with their signature characteristics are suggestive of potentially significant cultural material. Avoidance of cluster RI-3 is recommended by the creation of a 150-foot radius buffer. Anomaly RI-4 is composed of a single magnetic anomaly (Figure 8 and Appendix B). Sonar identified possible structural debris at the site (Appendix C). Due to this anomaly's proximity to the *Wild Dayrell*, it could be disarticulated structure associated with that wreck. Avoidance of RI-4 is recommended by the creation of a 100-foot radius buffer. Cluster RI-5 is composed of two magnetic anomalies and a sonar image suggestive of possible structural debris (Figure 8, Appendix B and Appendix C). As these signatures are suggestive of potentially significant cultural material avoidance is recommended by the creation of a 100-foot radius buffer. Should avoidance prove impossible, additional investigation designed to fully assess each anomaly's historical and archaeological significance in terms of NRHP eligibility is recommended.

Figure 9. Sonar coverage map.
