SLH 105-08-8
SURVEY DATE: 16 OCTOBER 2008
FILE NAME: bfs1016cs.dgn
PLOT SCALE: 1" = 200'

CONDITION SURVEY

SILVER LAKE HARBOR, NORTH CAROLINA

BIGFOOT SLOUGH CHANNEL

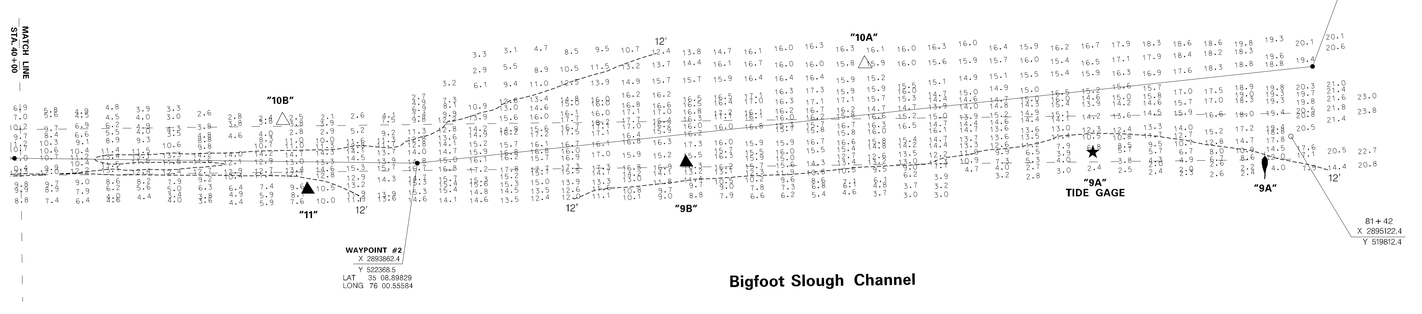
Controlling Depth = 16.0'
