Kerr Lake Vegetation Survey

January 21, 2015

Report submitted by NC State University

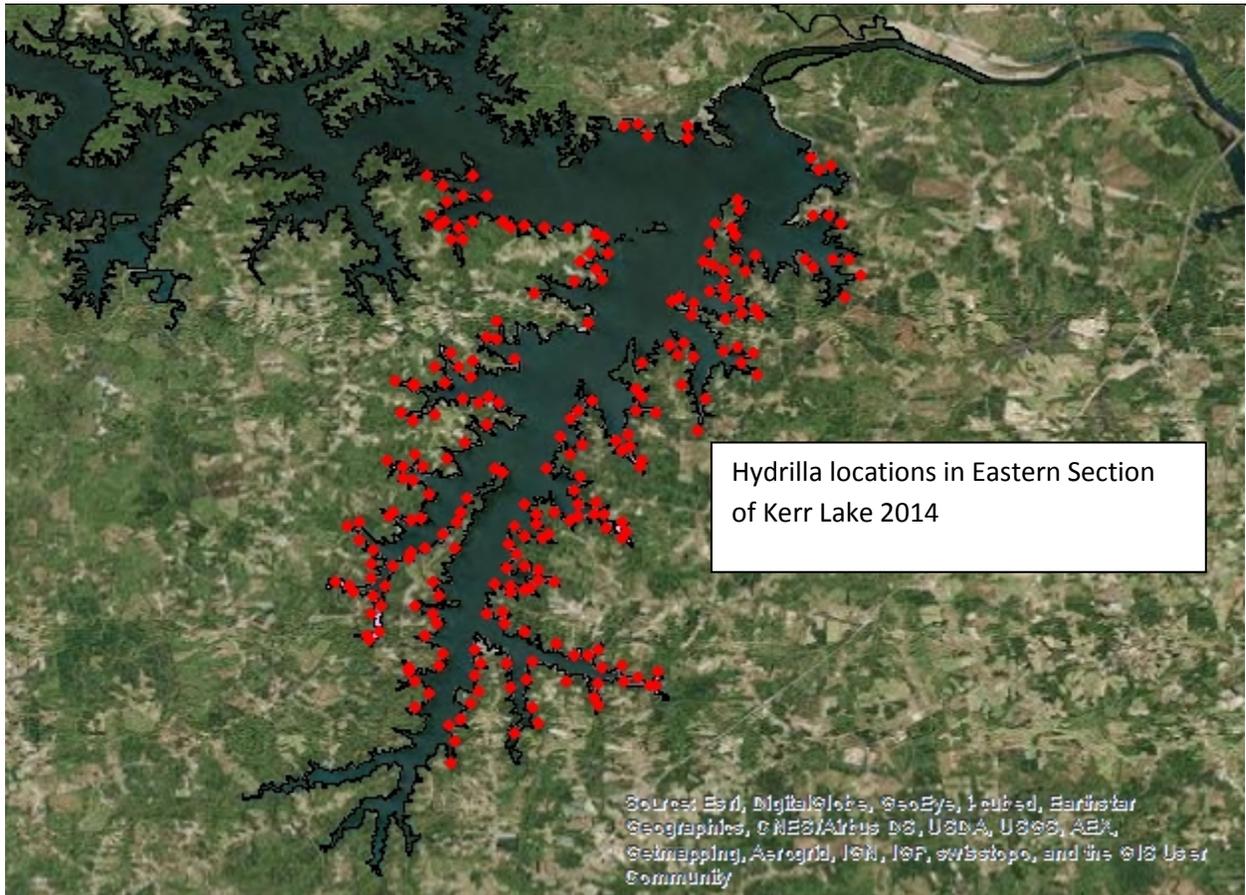
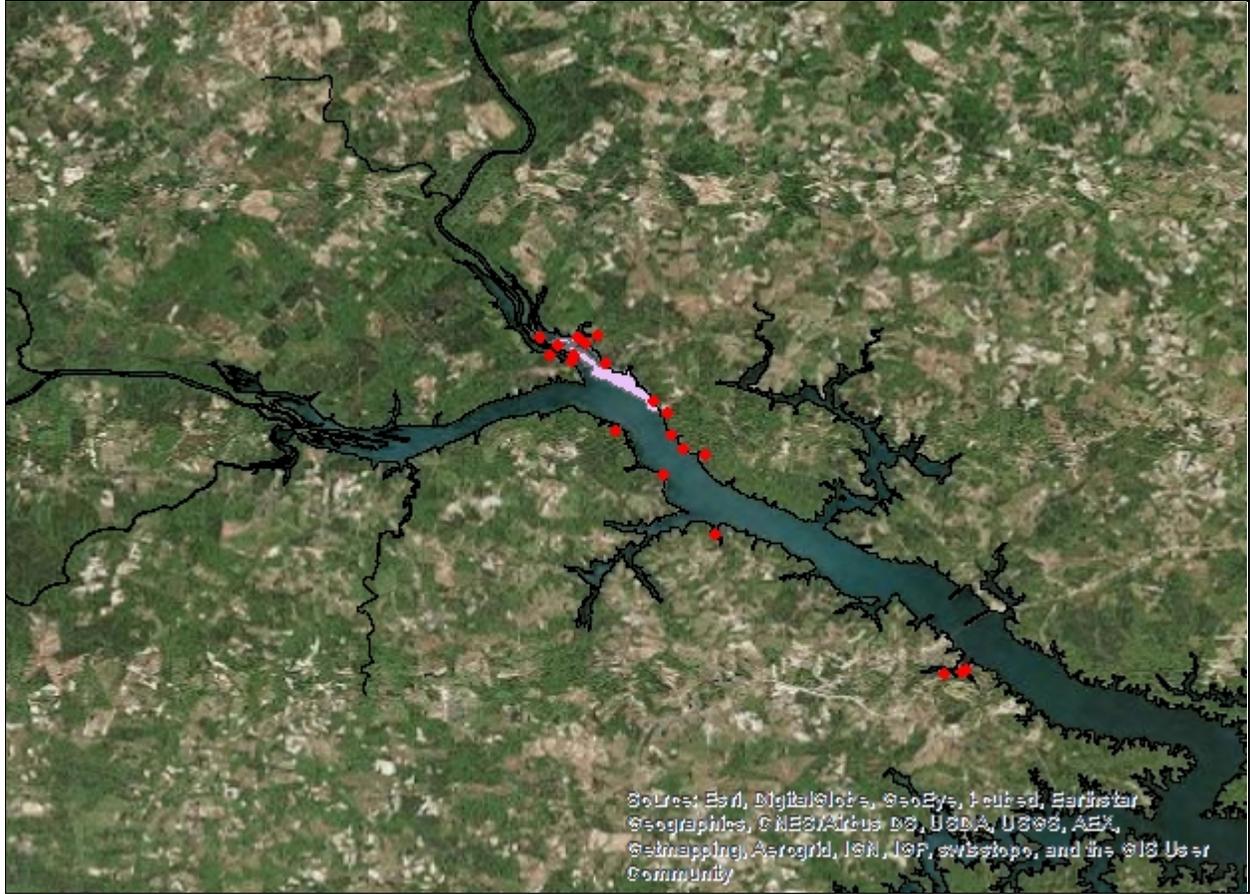
**Hydrilla
Locations**

During the survey process it was noted that most of the Hydrilla infestations occurred in areas of high human use including State Parks, boat ramps, commercial marinas, and in areas of higher populations of people based on number of docks. As in previous years large areas of undeveloped shoreline west of Nutbush Creek were found to contain almost no Hydrilla. It was noted in 2013 that Hydrilla has begun to spread west and north outside the Nutbush Creek area. Additional points were found in the same area in 2014, but infestations are generally small in size. The single point in Eastland Creek that was identified in 2013 as having Hydrilla was carefully examined in 2014 and no Hydrilla was found. Close monitoring of this area will continue in future surveys. Higher than usual water levels again allowed more points to be surveyed in 2014, than in previous years.

Areas around Stanton View contained significant acreages of Hydrilla similar to that seen in 2011 and 2013. Higher water levels allowed more of this area to be surveyed and also may have allowed more Hydrilla to grow.
