**US Army Corps
Of Engineers**
Wilmington District

PUBLIC NOTICE

Issue Date: **March 13, 2008**
Comment Deadline: **April 11, 2008**
Corps Action ID #: **200230652/200702076**

The Wilmington District, Corps of Engineers (Corps) has received an application from Balsam Mountain Preserve, LLC, seeking Department of the Army authorization to modify the Individual Permit issued on March 25, 2003 (Action ID 200230652). Balsam Mountain Preserve is an approximately 4,400-acre low-density residential development located 6 miles east of Sylva in Jackson County, North Carolina. This after-the-fact request for permit modification has been submitted in an effort to resolve noncompliance issues with the existing Individual Permit. Balsam Mountain proposes the following: (1) authorization of unpermitted impacts; (2) authorization of the revised mitigation plan, and; (3) authorization of stream restoration required as a result of an onsite dam failure.

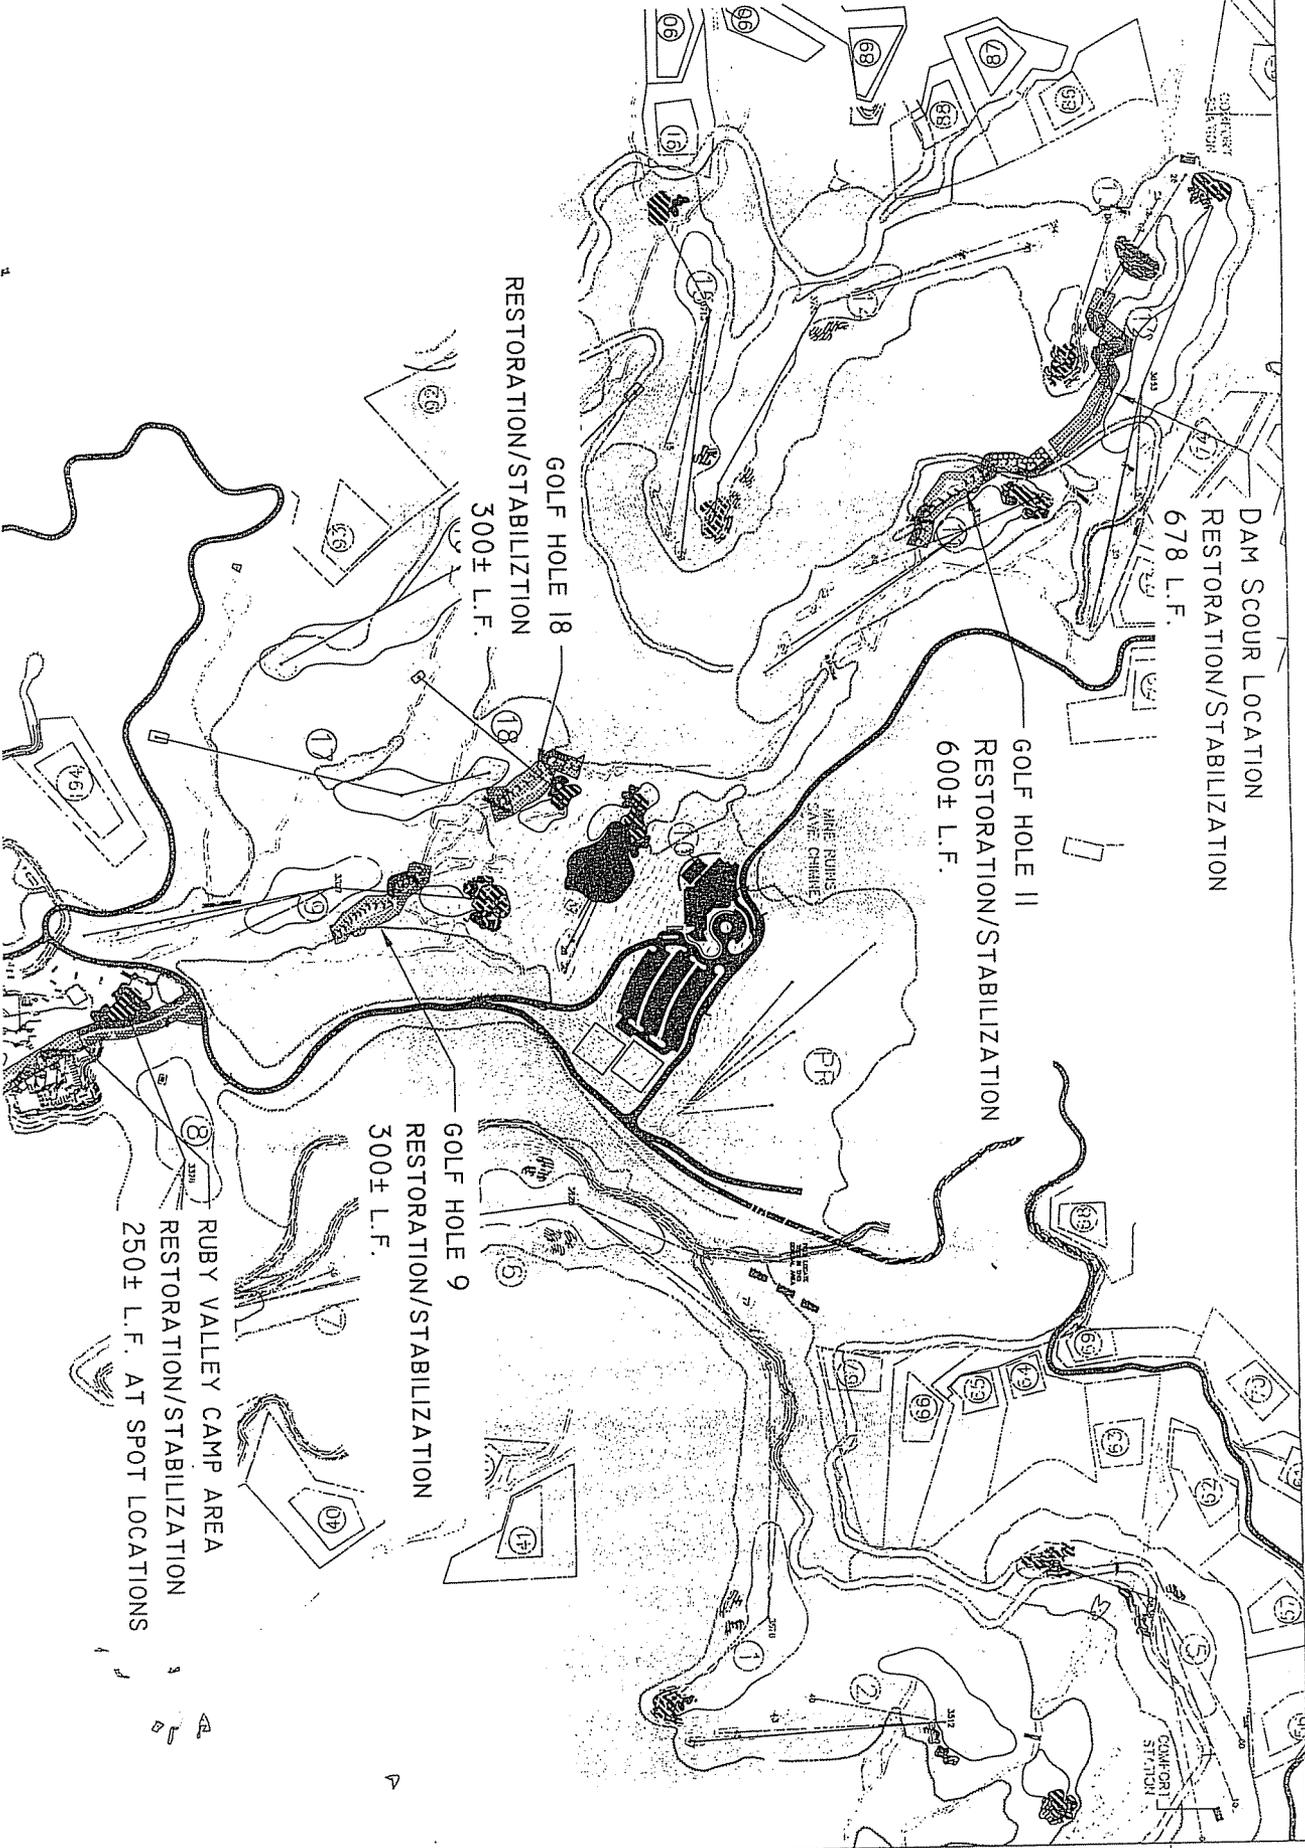
RESTORATION/STABILIZATION
300± L.F.
GOLF HOLE 18

RESTORATION/STABILIZATION
600± L.F.
GOLF HOLE 11

BANK TREATMENT B

BANK TREATMENT C

As part of this permit modification request, BMP is also requesting on-site restoration/stabilization along four other stream segments impacted by the pond failure. Damage to these stream segments was the result of both scouring and sediment deposition.

BMP proposes to restore and/or stabilize a total of 300± linear feet of stream channel at various locations. The banks would be reconstructed to match undamaged existing conditions upstream and/or downstream of each location. Most of this reach is heavily vegetated with localized damages. Following construction, the banks would be matted, seeded, and live staked. Shrub planting (up to 937 shrubs) would take place in the remaining riparian areas where riparian cover does not exist.

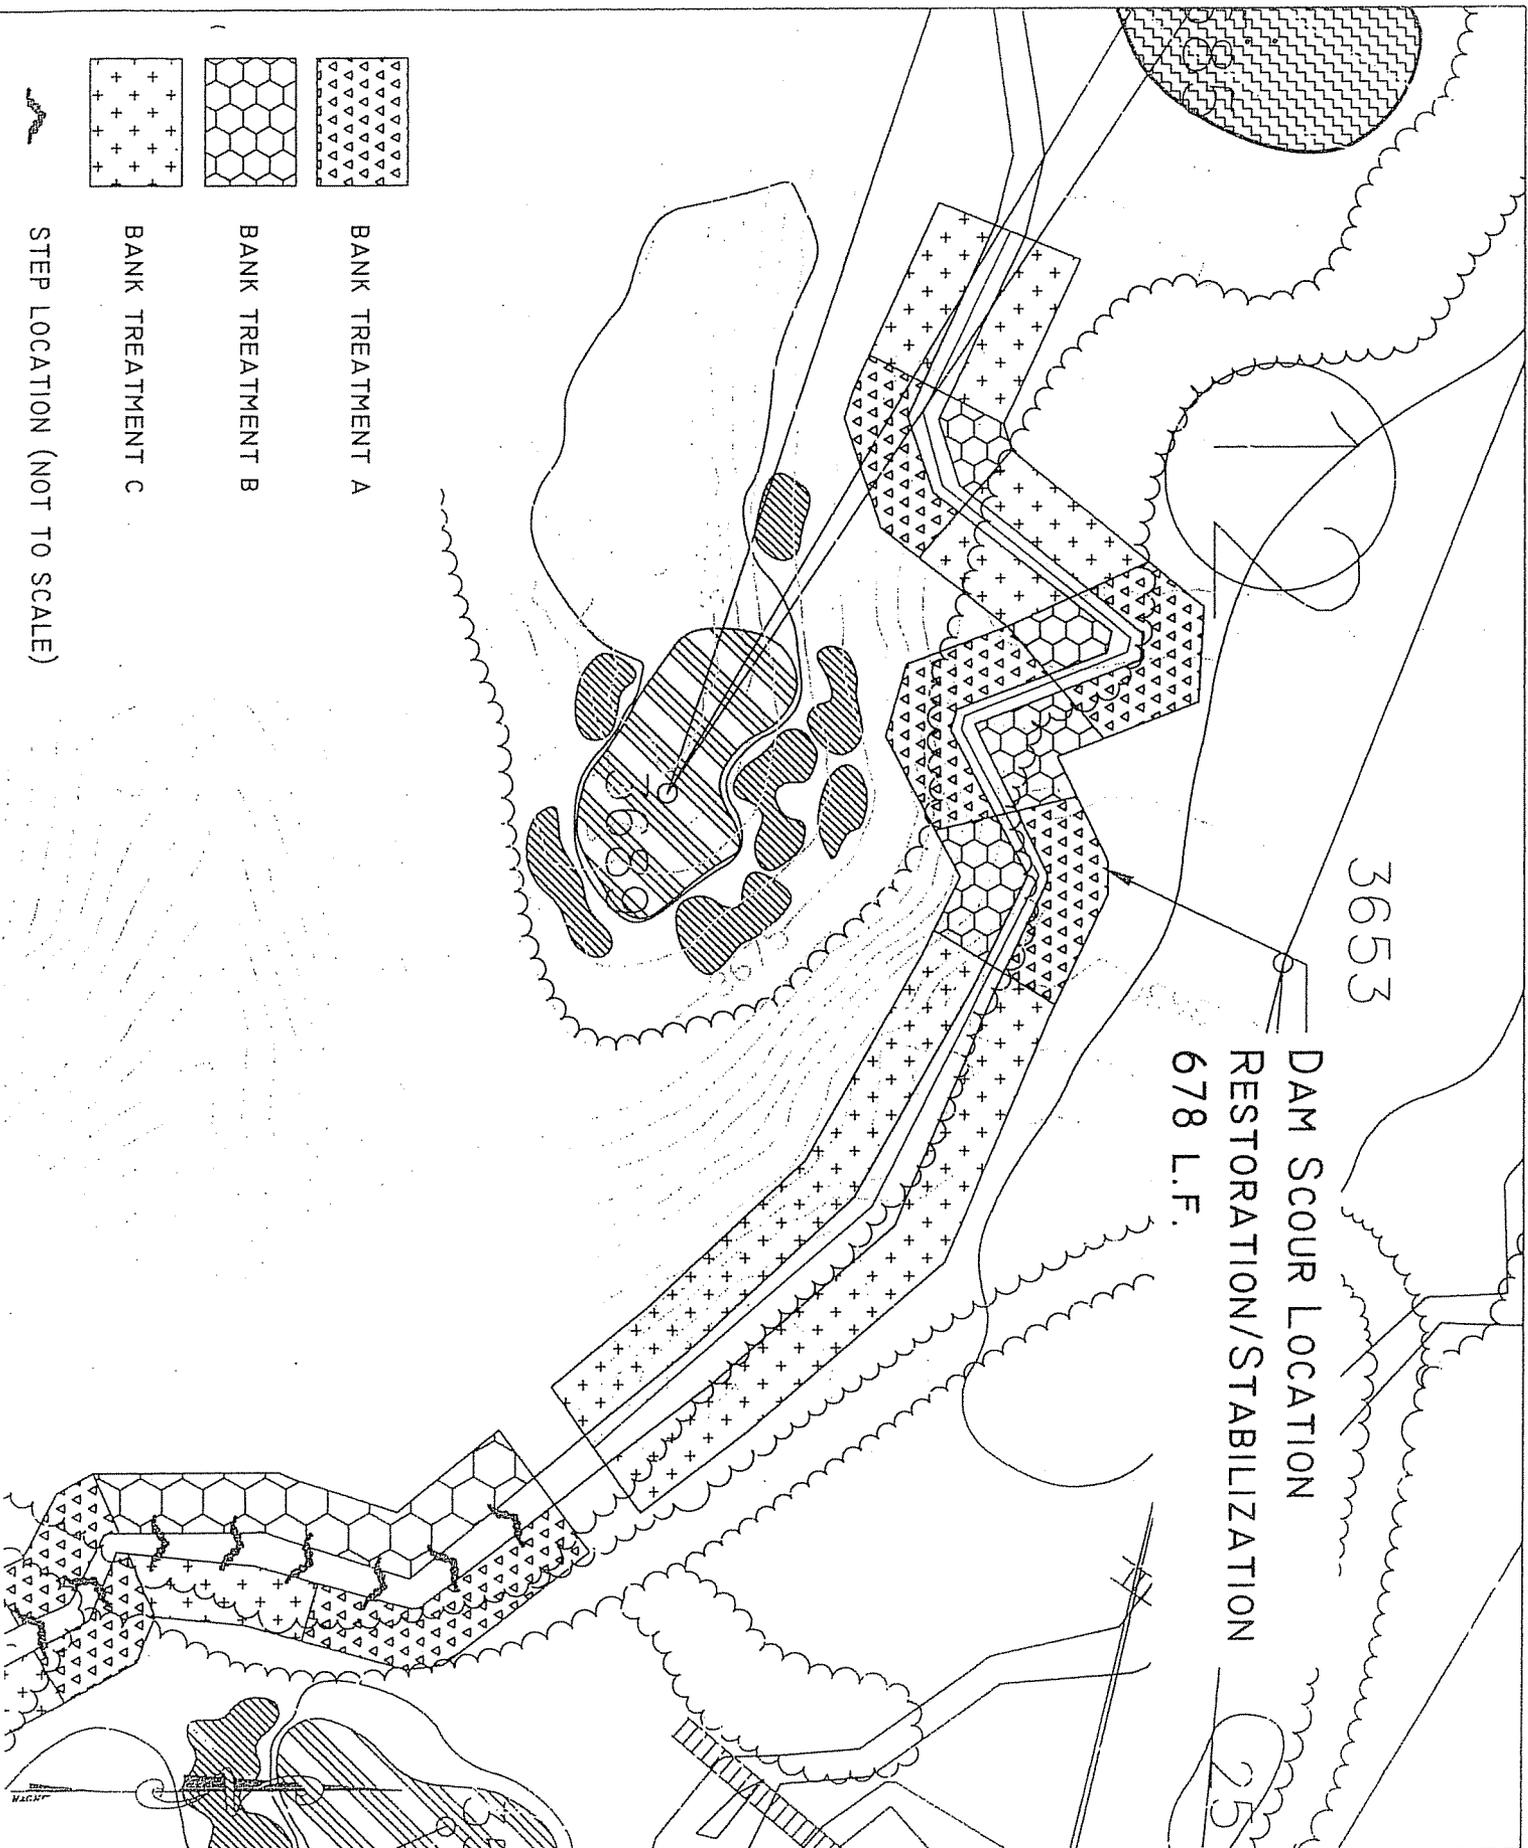
DAM SCOUR LOCATION RESTORATION/STABILIZATION 678 L.F.

STEP LOCATION (NOT TO SCALE)

GOLF HOLE II
 RESTORATION/STABILIZATION
 600± L.F.

Due to the velocity and volume of water released from the dam, the unnamed tributary of Sugarloaf Creek located directly downstream of the dam failure received more scour damage than any other stream segment. Survey data indicates that the impacted area is approximately 678 linear feet. Cross section measurements and visual assessments indicate that the reach experienced lateral erosion and down cutting. Down cutting in the channel was somewhat limited by the presence of shallow bedrock that behaved as grade control. The bedrock is currently maintaining grade for this section of stream. Assessment of this reach indicates not all stream function or ecological value has been lost (USACE Stream Quality Assessment Worksheet score = 63.5).

Confluence Engineering has performed a preliminary evaluation of this stream reach and believes it possible to perform beneficial repairs to this upstream reach that would at-least partially restore stream functions and improve overall stream quality. The bed and bank scour would be addressed through a combination of the following three practices:

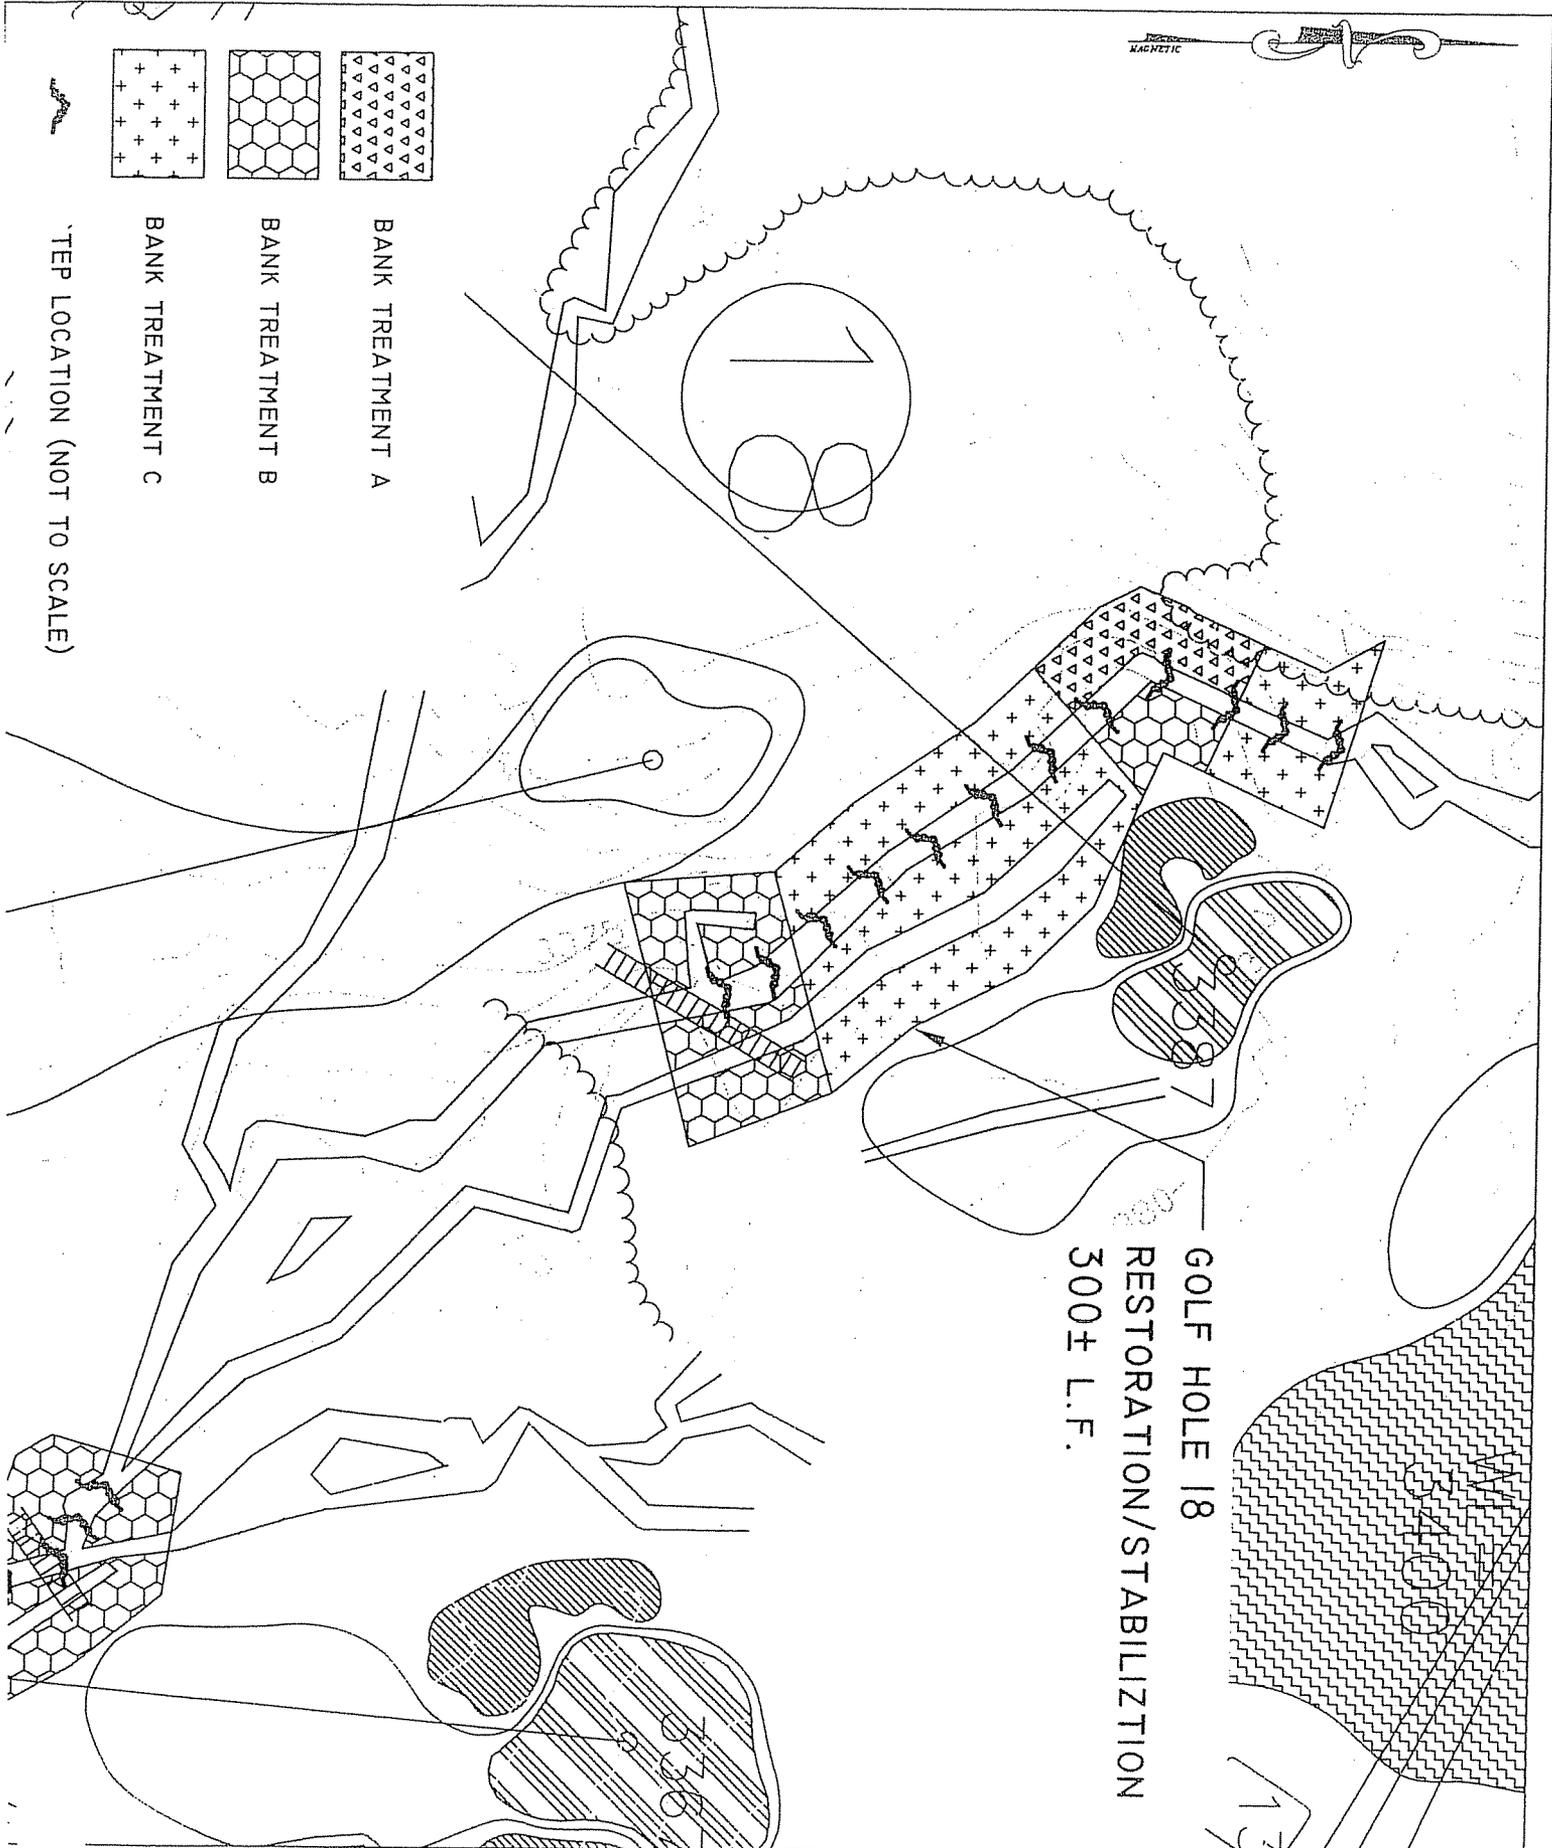
GOLF HOLE 18
RESTORATION/STABILIZATION
300± L.F.

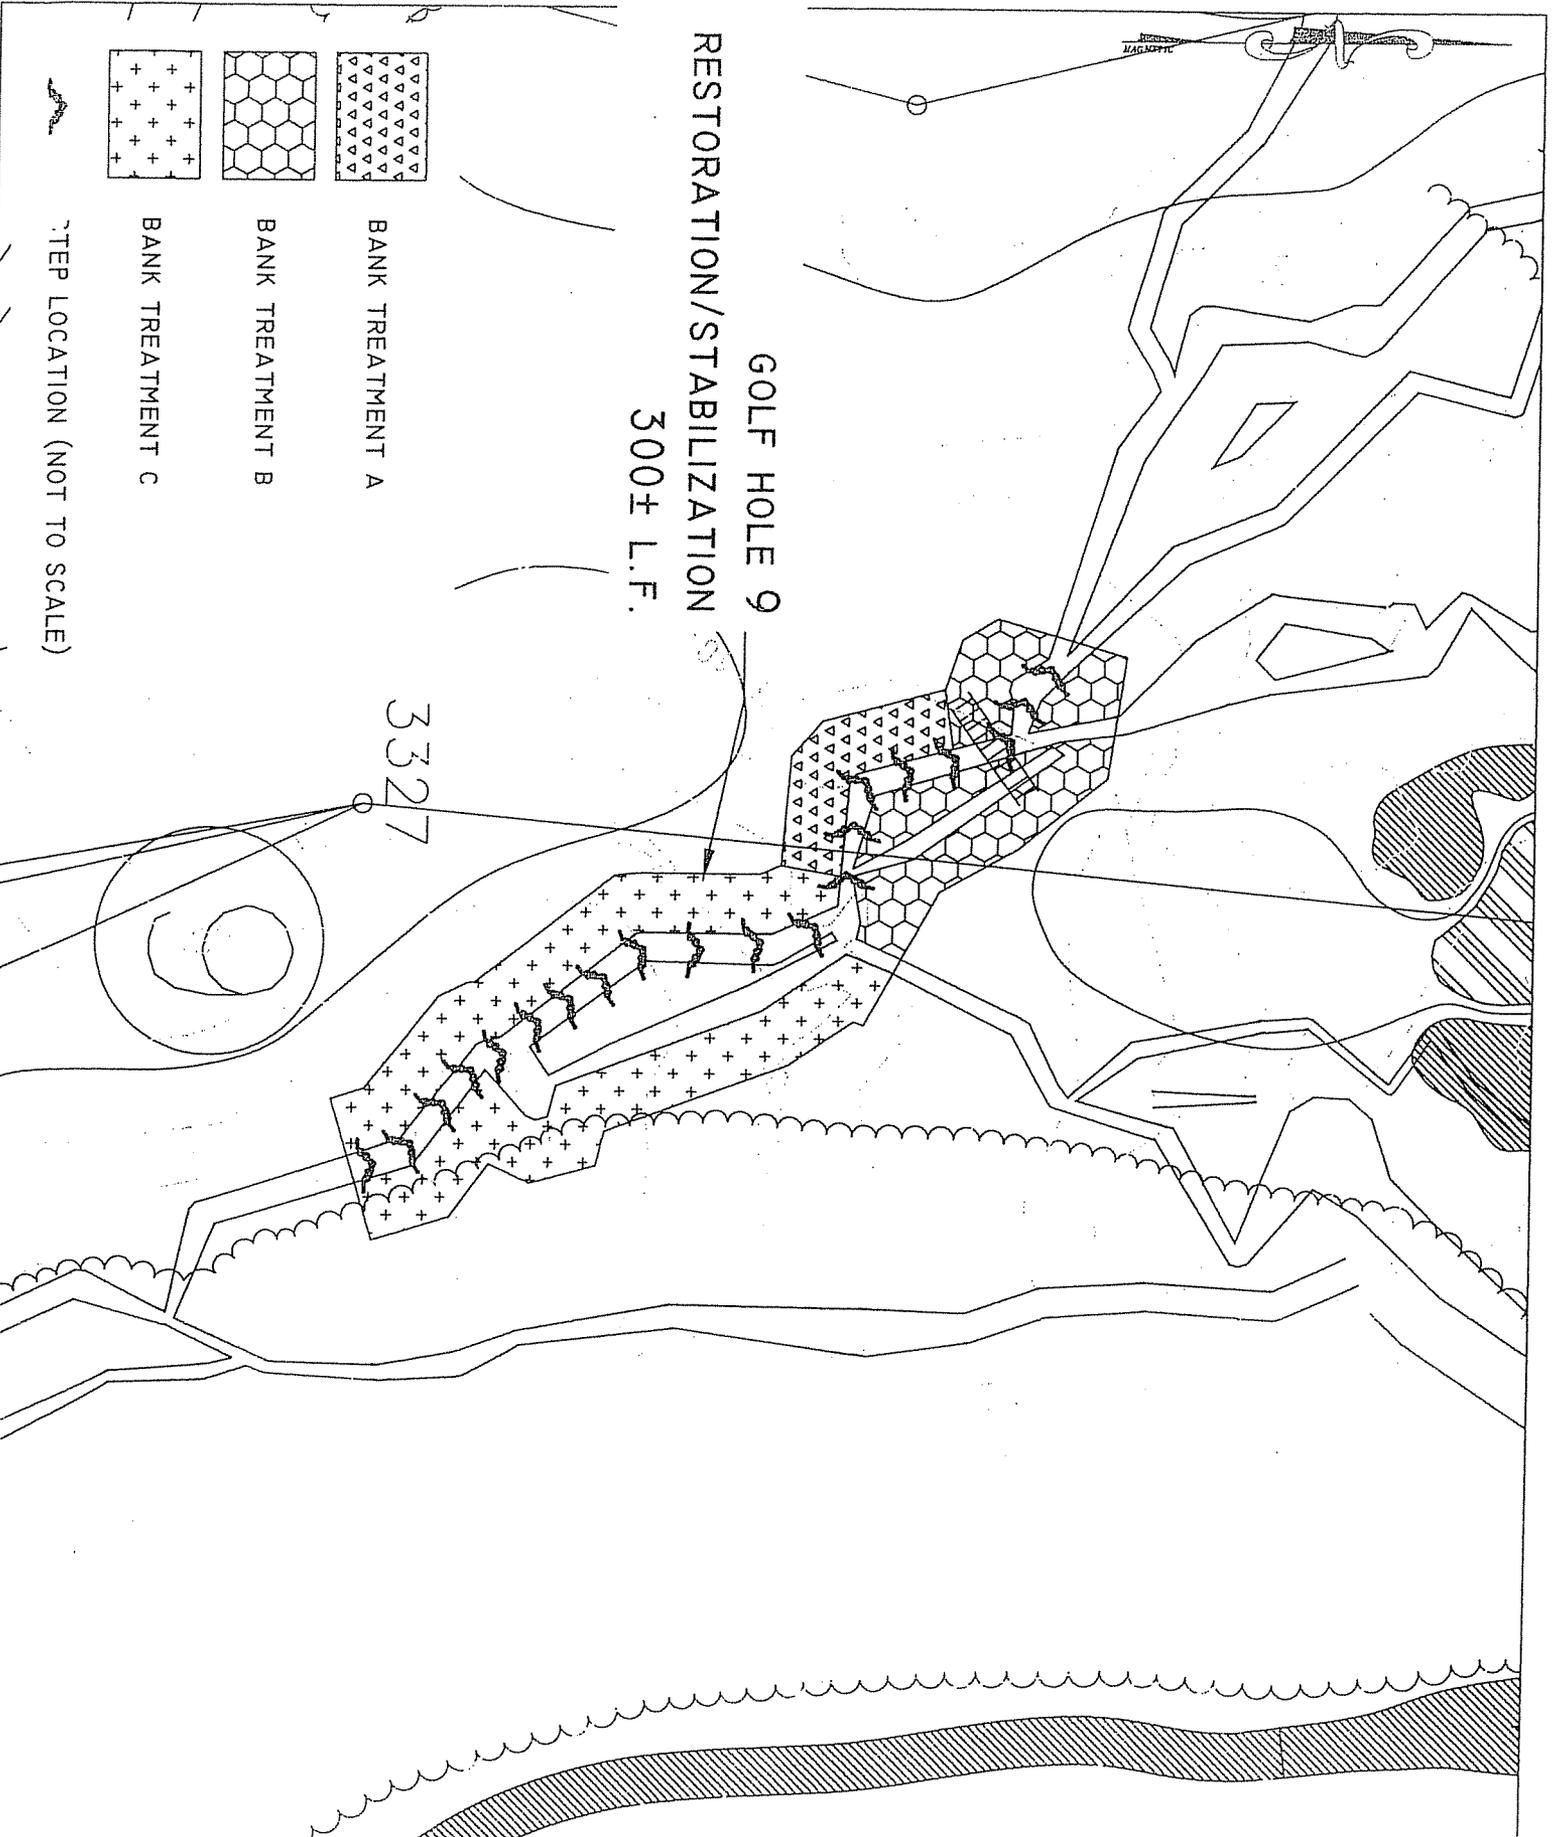
RESTORATION/STABILIZATION
 300± L.F.
 GOLF HOLE 9

BANK TREATMENT A

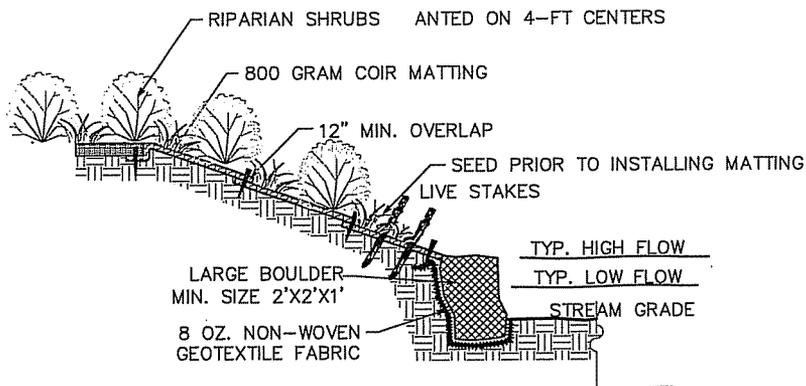
BANK TREATMENT A

TYPICAL LIVE STAKE

- NOTES:
1. LIVE STAKES SHOULD BE PLANTED EVERY 2' IN STAGGERED ROWS
 2. LIVE STAKES SHOULD BE DRIVEN WITH AT LEAST 1/4 OF TOTAL LENGTH BELOW GROUND
 3. SPLIT STAKES SHOULD NOT BE USED
 4. LEAF BUDS SHOULD POINT UPWARD
 5. STAKES SHOULD BE INSTALLED PERPENDICULAR TO STREAM BANK
 6. LIVE STAKES SHOULD BE SPECIES NATIVE TO BALSAM MOUNTAIN PRESERVE
 7. RIPARIAN PLANTINGS SHOULD BE 1 TO 3-GALLON PLANTS PLACED ON 4-FT CENTERS IN STAGGERED ROWS
 8. SPECIES COMPOSITION FOR PLANTINGS SHOULD BE NATIVE TO BALSAM MOUNTAIN PRESERVE
