Prospectus

Falling Creek Mitigation Site
Wayne County, NC

Neuse River Basin
HUC 03020201

USACE Action ID No. 2015-00940

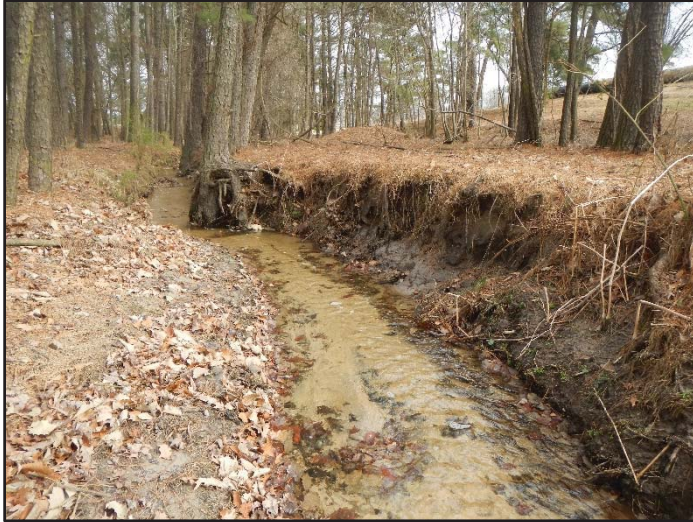
Coriander Creek, upstream. Restoration Reach

Downstream of Adams Branch, Coriander Creek transitions from a forested riparian buffer to an open agricultural pasture. This reach has been historically channelized and relocated to its westernmost valley wall. While the channel is not incised, it lacks a natural meandering pattern, aquatic habitat, and bedform diversity. As Coriander Creek flows downstream towards the floodplain of Falling Creek its width to depth ratio increases, its channel slope decreases and its floodplain widens. This decrease in channel slope has caused a significant increase in sediment deposition. Sediment deposition within the first 200 feet of forested area is so great that it has buried the forest understory and is endangering the existing trees. At this point Coriander Creek transitions into a braided system, creating several flow paths through the deposited sediment.

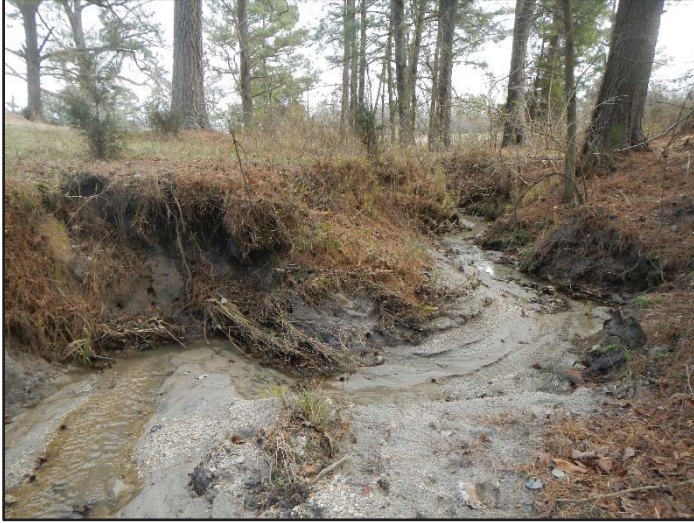
Adams Branch. Restoration Reach

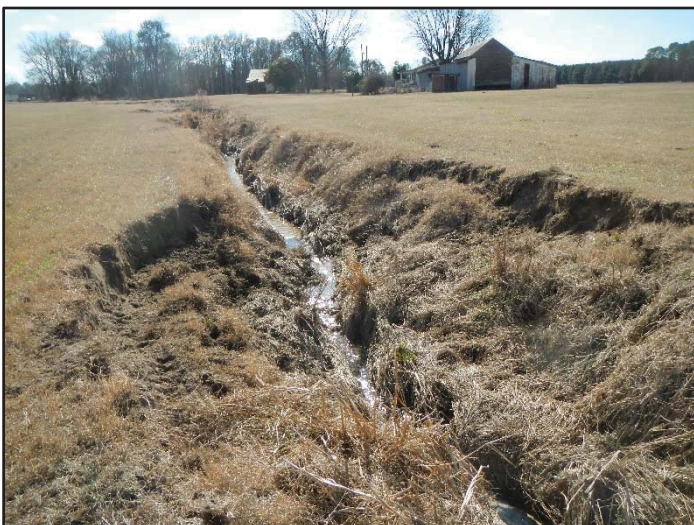
Gurley Branch. Restoration Reach.

Gurley Branch enters the site at the southern boundary along Corbet Hill Road, west of Grady Branch. It is a severely incised and entrenched ditched system that travels south through an active livestock pasture. This reach is undergoing a recurring process of bank failure whereby water flowing through Gurley Branch erodes the bottom third of the streambank and creates an undercut bank. This bank eventually collapses and the sediment from the bank travels downstream and deposits in the stream channel and floodplain. This is one source of excess sediment found in the floodplains of Coriander Creek. The lack of riparian vegetation also contributes to the lack of stability within the system. All of the aforementioned factors and processes have left Gurley Creek with poor aquatic and riparian habitats.

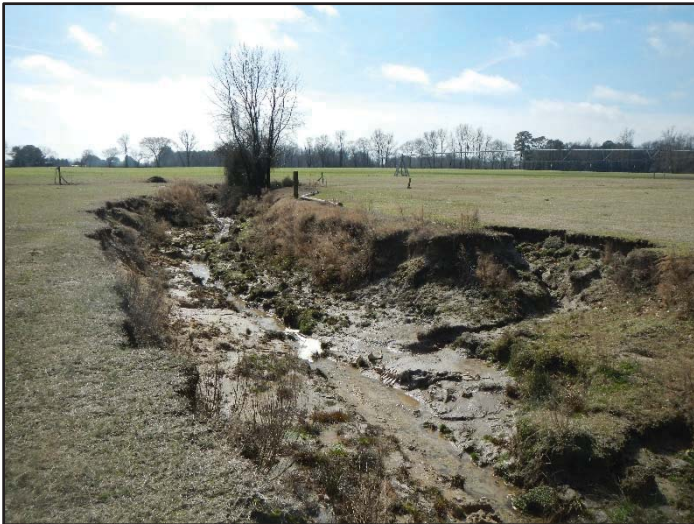
Mourning Dove Branch, Restoration Reach

Mourning Dove Branch originates from roadside ditches draining along Grantham School Road and flows northwest across a livestock pasture. The stream has been ditched and is incised, with banks greater than six feet in height. Erosion along the channel length has led to bank failure and mass wasting of bank material. A small bench has formed along the bottom of the channel as it begins to change from a process of widening to one of aggradation. The lack of vegetation and bedform diversity has resulted in poor aquatic and terrestrial habitat along the reach.

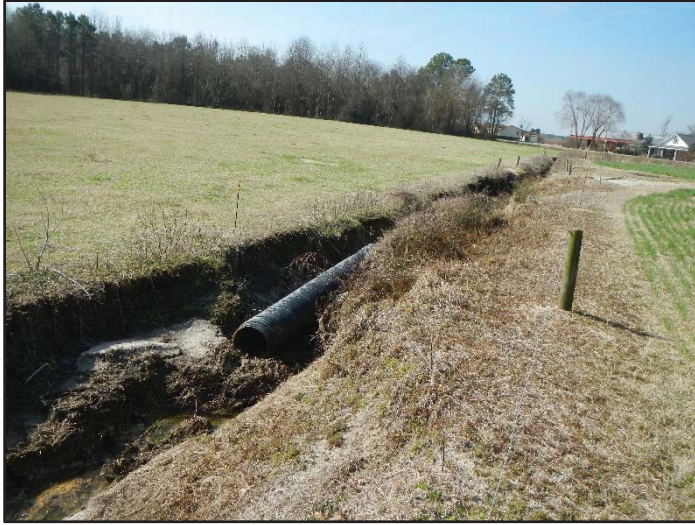
Sadler's Branch, upstream. Restoration Reach

Sadler's Branch originates upstream of Grantham School Road and enters the site through a roadway culvert before flowing northeast towards Falling Creek. It is the mainstem of the stream system on Falling Creek East. The upstream portion flows through an agricultural field used for livestock grazing and pasture. The upstream reach is severely incised (banks > 6 feet) with evidence of ongoing bank failure along its length. Bank failure can be attributed to cattle access as well as erosive flows from runoff. The eroded channels draining the fields are lined with Cattail and green briar. As Sadler's branch enters the forested area the incision gradually decreases from severe to moderate and floodplain connectivity varies along the length. There are some riffle pool sequences and several debris jams within the channel. Banks in this reach are eroded due to shear stress in the channel, lack of bank vegetation and livestock access.

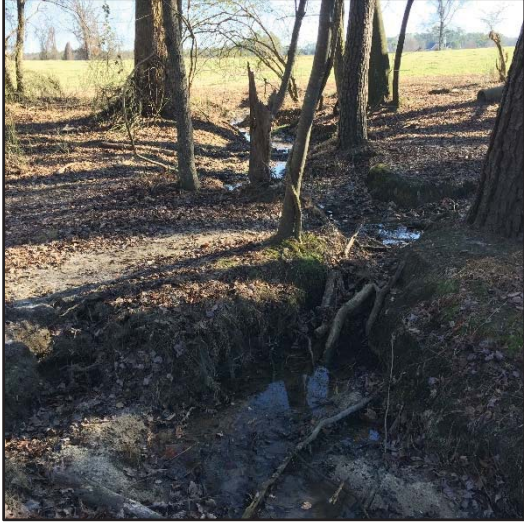
Anise Branch. Enhancement II/Restoration Reach Break.

Anise Branch is a small tributary to Sadler's Branch that drains an agricultural field. The upstream end is relatively stable in dimension, but has been trampled by livestock access. A headcut is located approximately 50 feet downstream of the edge of the field, after which the channel becomes moderately incised. There is erosion on the top third of the stream banks that indicates the stream has been susceptible to bank failure. The riparian area of Anise Branch is forested with the same species composition of Sadler's Branch.

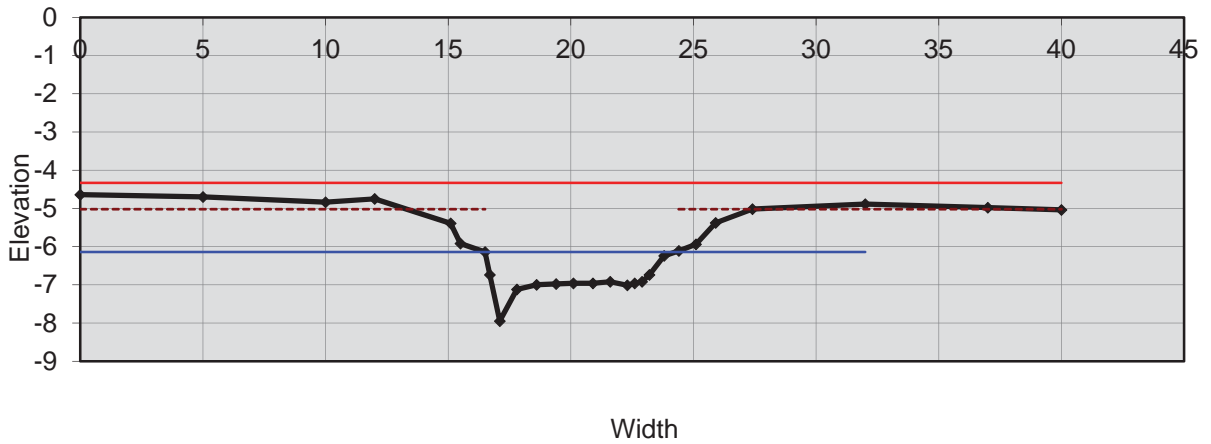
Grady Branch, XS10, Riffle (EII)

Bankfull Dimensions

6.2	x-section area (ft.sq.)
7.8	width (ft)
0.8	mean depth (ft)
1.8	max depth (ft)
9.7	wetted parimeter (ft)
0.6	hyd radi (ft)
9.7	width-depth ratio

100.0	W flood prone area (ft)
12.9	entrenchment ratio
2.9	low bank height (ft)
1.6	low bank height ratio

Once Grady Branch flows into the wooded riparian area (downstream of its intersection with Gurley Creek) it becomes only mildly incised. It is hydraulically connected to the floodplain and has a stable pattern that can be used as reference during design. Grady Branch appears to be successfully moving a large amount of sand through the system while remaining relatively stable. Livestock do have access to this area, which is the primary source of stress to this reach. The riparian area has mature trees, but lacks an understory, and there is evidence of minor bank failures from cattle crossing.

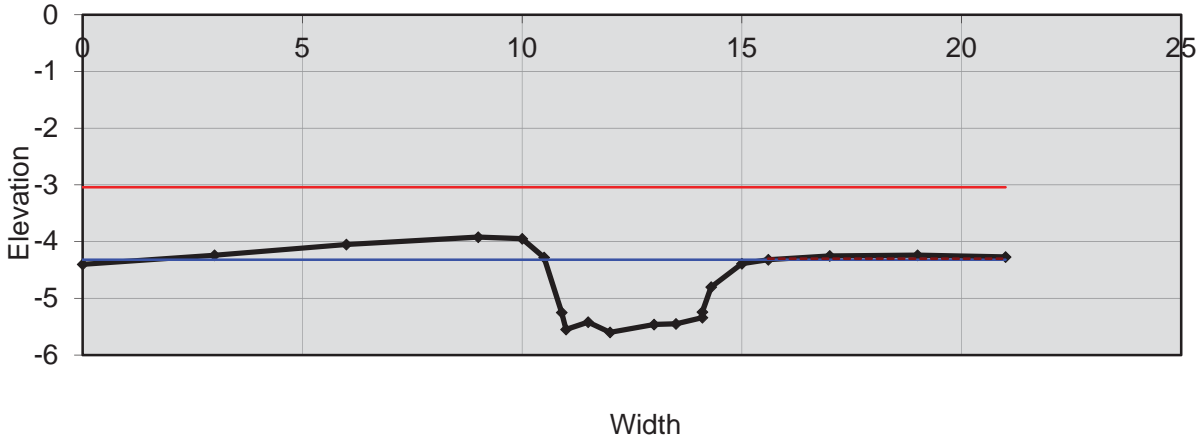
Mourning Dove Branch, XS17, Riffle (R)

Bankfull Dimensions

- 4.3 x-section area (ft.sq.)
- 6.6 width (ft)
- 0.7 mean depth (ft)
- 1.3 max depth (ft)
- 8.0 wetted parimeter (ft)
- 0.5 hyd radi (ft)
- 10.1 width-depth ratio

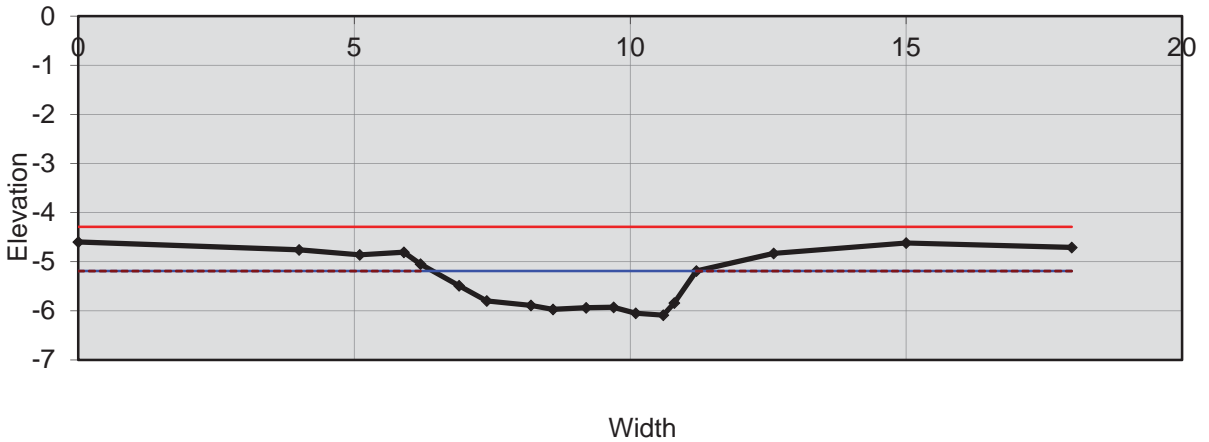
Thornton Creek, XS14, Riffle (EII)

Bankfull Dimensions

- 3.0 x-section area (ft.sq.)
- 4.8 width (ft)
- 0.6 mean depth (ft)
- 0.9 max depth (ft)
- 5.5 wetted parimeter (ft)
- 0.5 hyd radi (ft)
- 7.6 width-depth ratio
