Chapter 2 PURPOSE AND NEEDS

Figure Eight Island Shoreline Management Project EIS

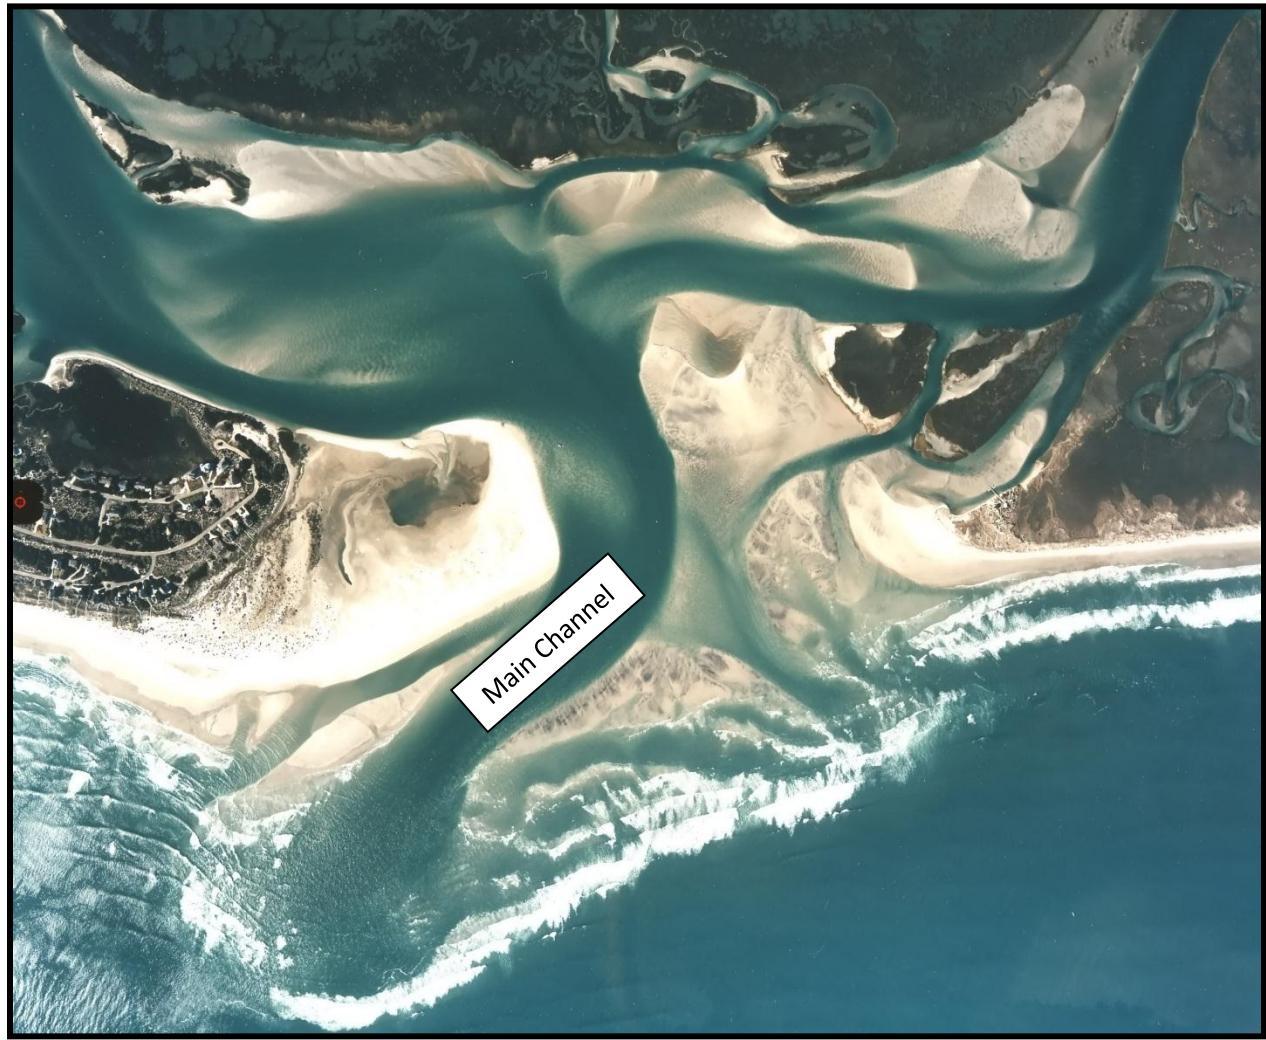
Figure 2.1- Southeasterly Orientation of the Main Channel within Rich Inlet as of November 1993

Although the relative position of the inlet has been stable over the past century, fluctuations in orientation of the main ebb-channel have forced subsequent periods of erosion and accretion on the adjacent shorelines of Figure Eight and Hutaff Islands (Cleary, 2009). Between 1938 and 1993, the main ebb-channel was oriented in a southeasterly direction between azimuths of approximately 112° to 181° (Figure 2.1). During this period, the Rich Inlet ebb-tide delta was aligned with the main ebb-channel in a more southerly orientation providing a wave sheltering effect for the north end of Figure Eight Island. This corresponded to the creation of a one-mile zone of accretion along the oceanfront shoreline immediately south of Rich Inlet.

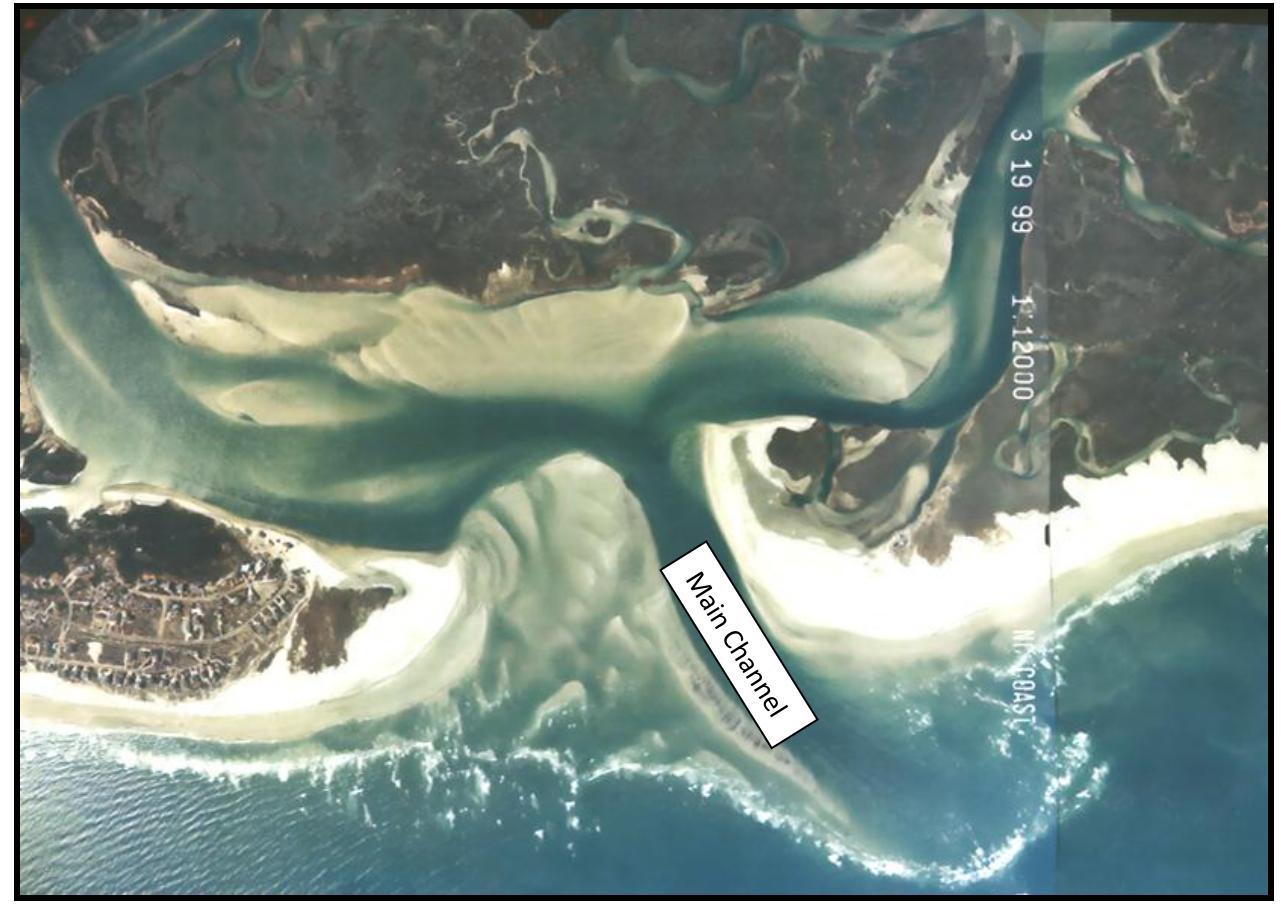
Figure 2.2- Northeasterly Orientation of the Main Channel within Rich Inlet as of March 1999

From 1993 to 2000, the ebb-channel shifted to a more northeasterly alignment with a maximum azimuth of 83° in October 2000 (Figure 2.2). With this shift came a northward migration of the ebb-tide delta, exposing the north end of Figure Eight Island to wave attack. During this period, extensive erosion occurred along the northern 1,400 m (4,500 ft) of the island with a maximum of 150 m (500 ft) of shoreline retreat. Subsequently, during this time period the northward migration of the ebb-tide delta provided wave sheltering to the south end of Hutaff Island leading to accretion of the shoreline with a maximum progradation of 120 m (390 ft).

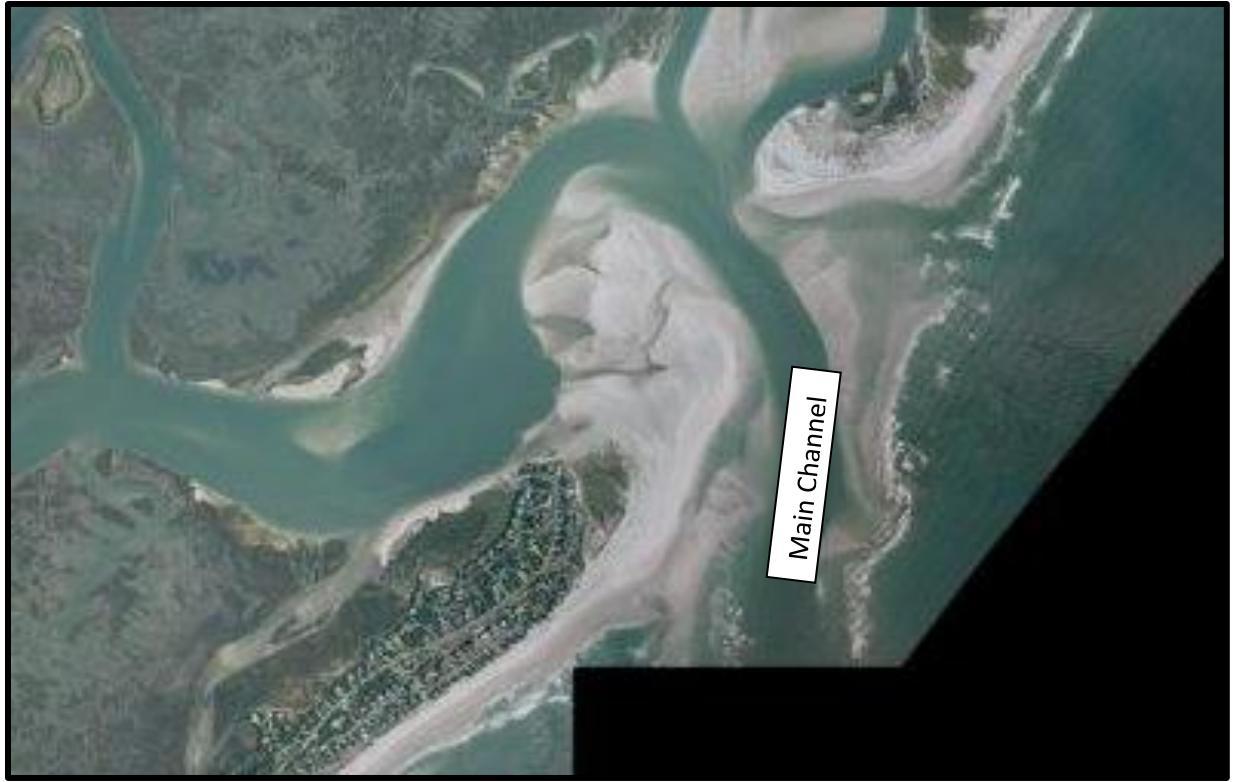
Figure 2.3- Southeasterly Orientation of the Main Channel within Rich Inlet as of July 2012

In 2010, the bar channel naturally shifted again to an alignment toward Figure Eight Island resulting in accretion along the north end of Figure Eight (Figure 2.3). While this orientation has proved favorable for Figure Eight Island in the short term, based on the past history of the inlet channel, the bar channel can reasonably be expected to again shift back toward Hutaff Island which will result in another round of erosion on the north end of Figure Eight. Predicting the time when any shifting would occur is not possible due to variability and contingency on weather and storm events.

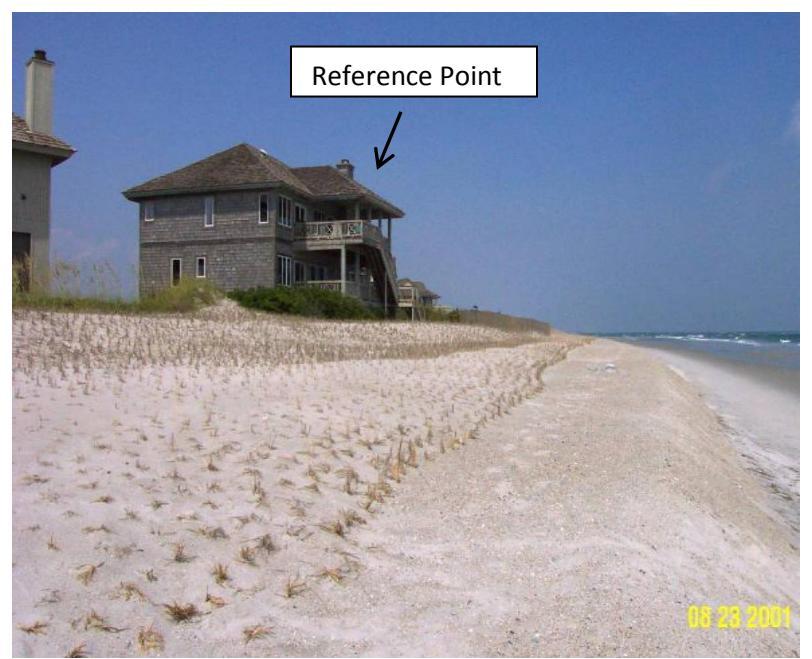
Figure 2.4. North End of Figure Eight Island after Nourishment Event in 2001

The ineffectiveness of the past beach nourishment attempts along the extreme north end of Figure Eight Island emphasizes the need to address the inlet related process that impacts the area (Figures 2.4 and 2.5). Without some change in the inlet's impact, future nourishment operations on the extreme north end of Figure Eight Island will suffer the same fate as the past efforts. Shoreline management issues south of Bridge Road on Figure Eight Island are being addressed through actions associated with the maintenance of the Mason Inlet Relocation Project and the periodic disposal of material removed to maintain the navigation channel in Banks Channel.

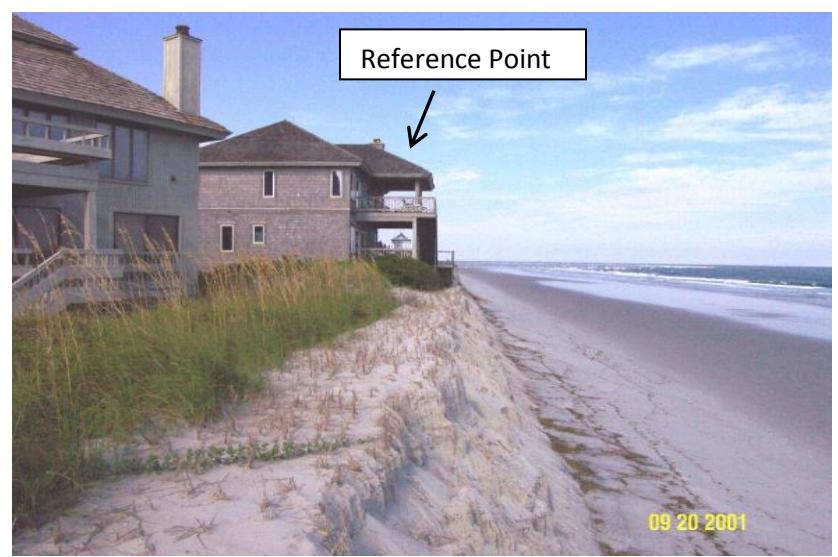
Figure 2.5. Evidence of Rapid Erosion Approximately One Month Following 2001 Nourishment

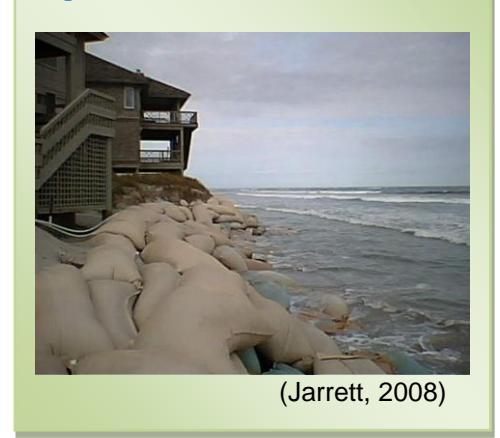
Sandbags protecting a home along the northern portion of Figure Eight Island, March 18, 2008

According to the Figure "8" Beach HOA, sandbag revetments were installed around 20 homes on the north end of Figure Eight Island between 2003 and 2010, however, one of the homes, located at 13 Comber Road, was relocated in 2010 leaving 19 homes along the north end of the island with sandbag revetments. Until the channel within Rich Inlet reconfigured to its current orientation, these structures had been considered imminently threatened as defined by State Standard Rule 15A NCAC 7H .0308 (NCDCM, 2007a) (Figure 2.6). The basic premise of this rule is that a structure in the Ocean Hazard Area is considered imminently threatened when its foundation is less than 6.1 m (20 ft) from the toe of the erosion scarp (see Figure 1.2 as depicted in the North Carolina CAMA Handbook [2003]). Figure 2.7 depicts the location of each residential structure on

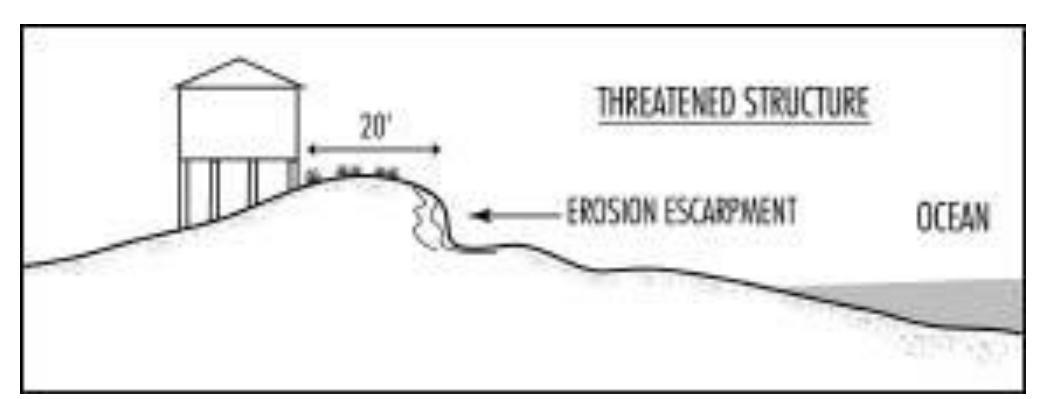
Figure 2.6 - Diagram Depicting Imminently Threatened Structures (NCDCM, 2003a)

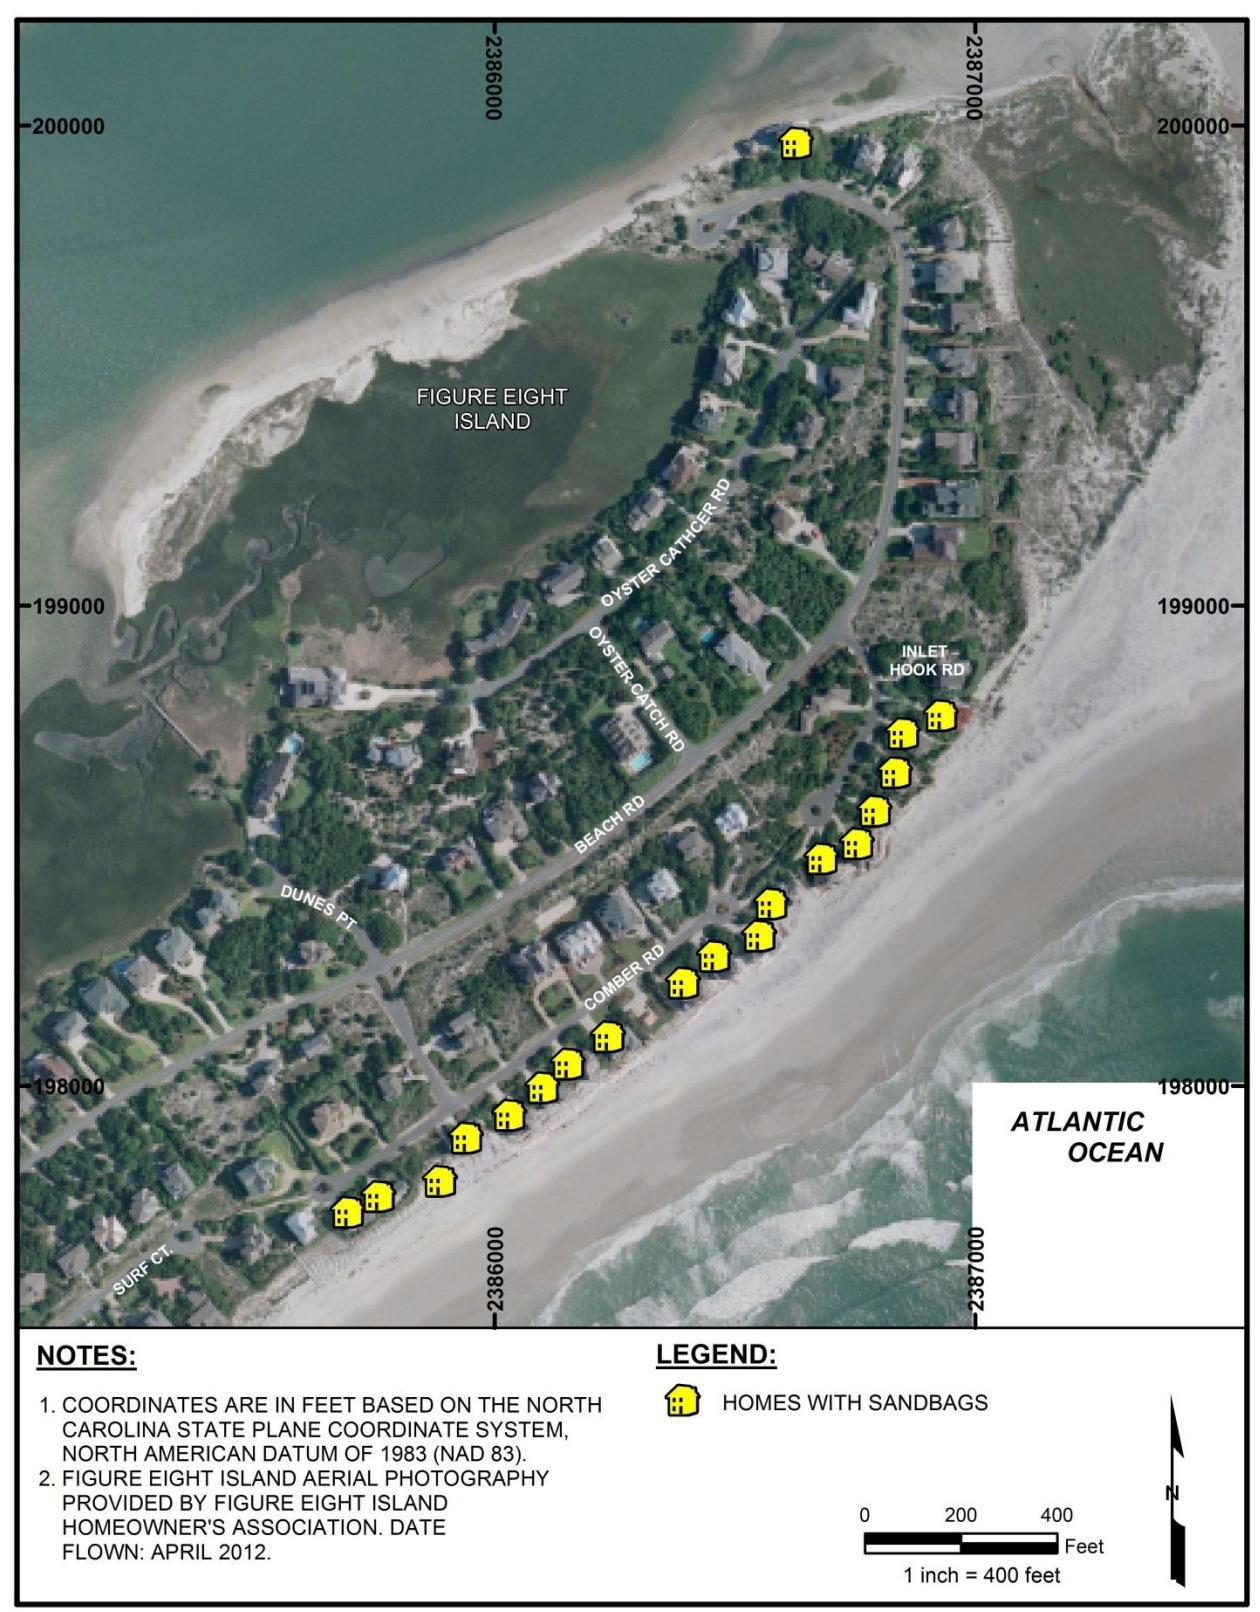
Figure 2.7 – Location of Imminently Threatened Residential Structures on Figure Eight Island
