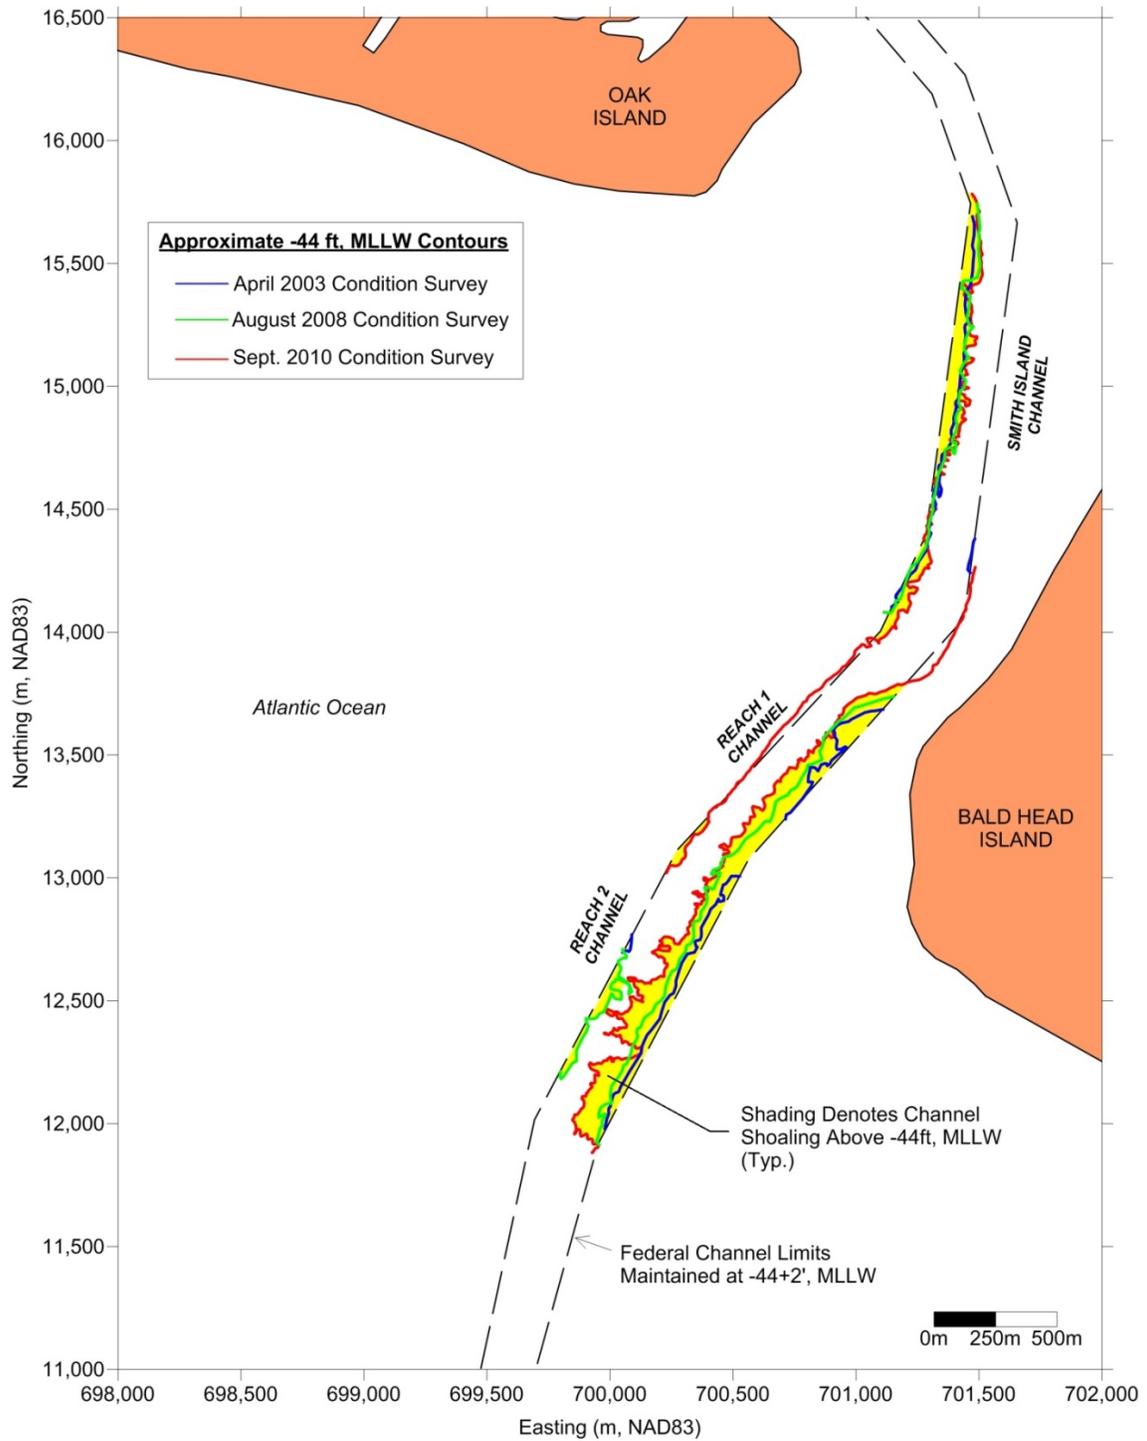
**Figure 4.32.** USACE Condition Surveys of the Navigation Channel in the Cape Fear Entrance, 2003 to Present (Olsen 2012). Note that shaded areas inside the channel limits depict shoaling above -44 ft, MLLW as indicated in the surveys.
