US Army Corps
of Engineers
Wilmington District

EXHIBIT 16: BOUNDARY LINE MARKINGS W.KERR SCOTT DAM AND RESERVOIR

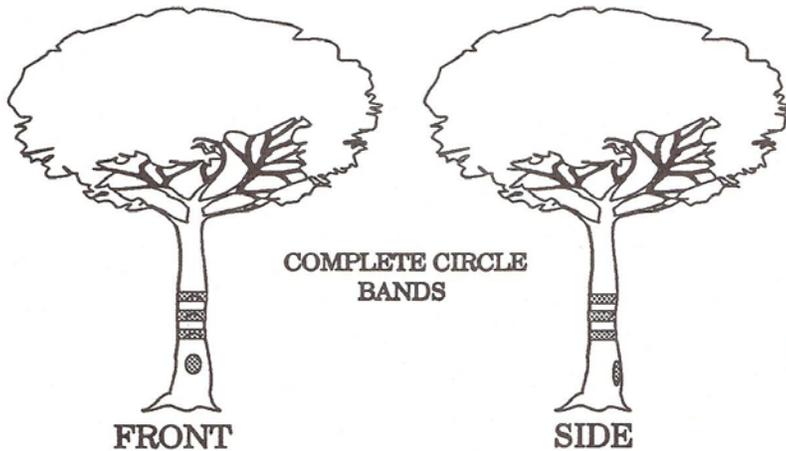
WITNESS TREE FOR CORNER

Three bands are painted completely around tree with hack marks in the band facing the corner. A blaze is located approximately waist high facing the corner.

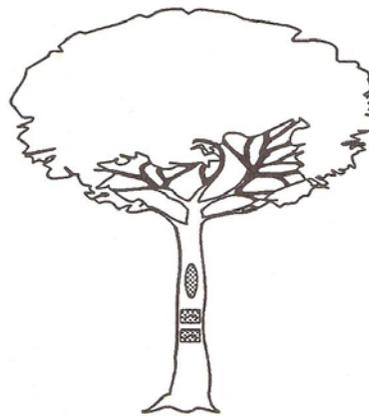
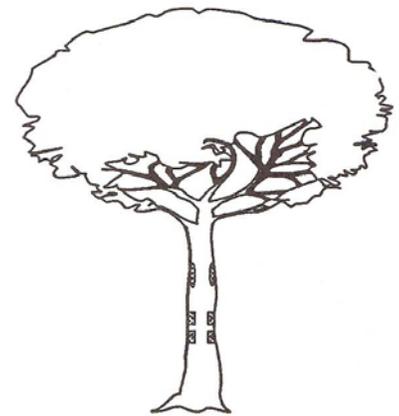
IN LINE TREE

Two bands each are painted on opposite sides of the tree in the direction of the line, with a hack cut in each band. The bands do not completely encircle the tree. A blaze is made above the bands. These markings indicate that the boundary line passes through the tree.

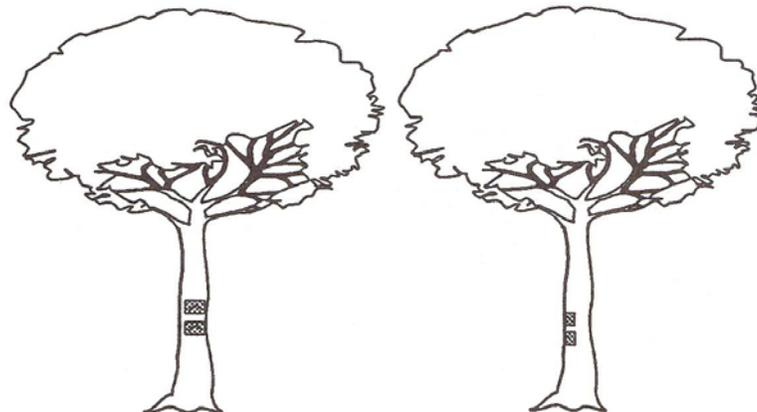
LINE WITNESS TREE

Two bands are painted on the tree with hacks facing in the direction of the line. The bands are painted around the edges of the tree, so that they may be seen from a distance when walking the line. These trees are normally on government property. Note that these trees are not the boundary line; they only illustrate on which side the boundary line falls.
